“Head Injury Mechanisms and Preventive Measures”

Seattle CIREN Team

“Correlation of head injury to vehicle contact points using Crash Injury Research and Engineering Network”
R. Nirula, C. Mock, R. Kaufman et al.

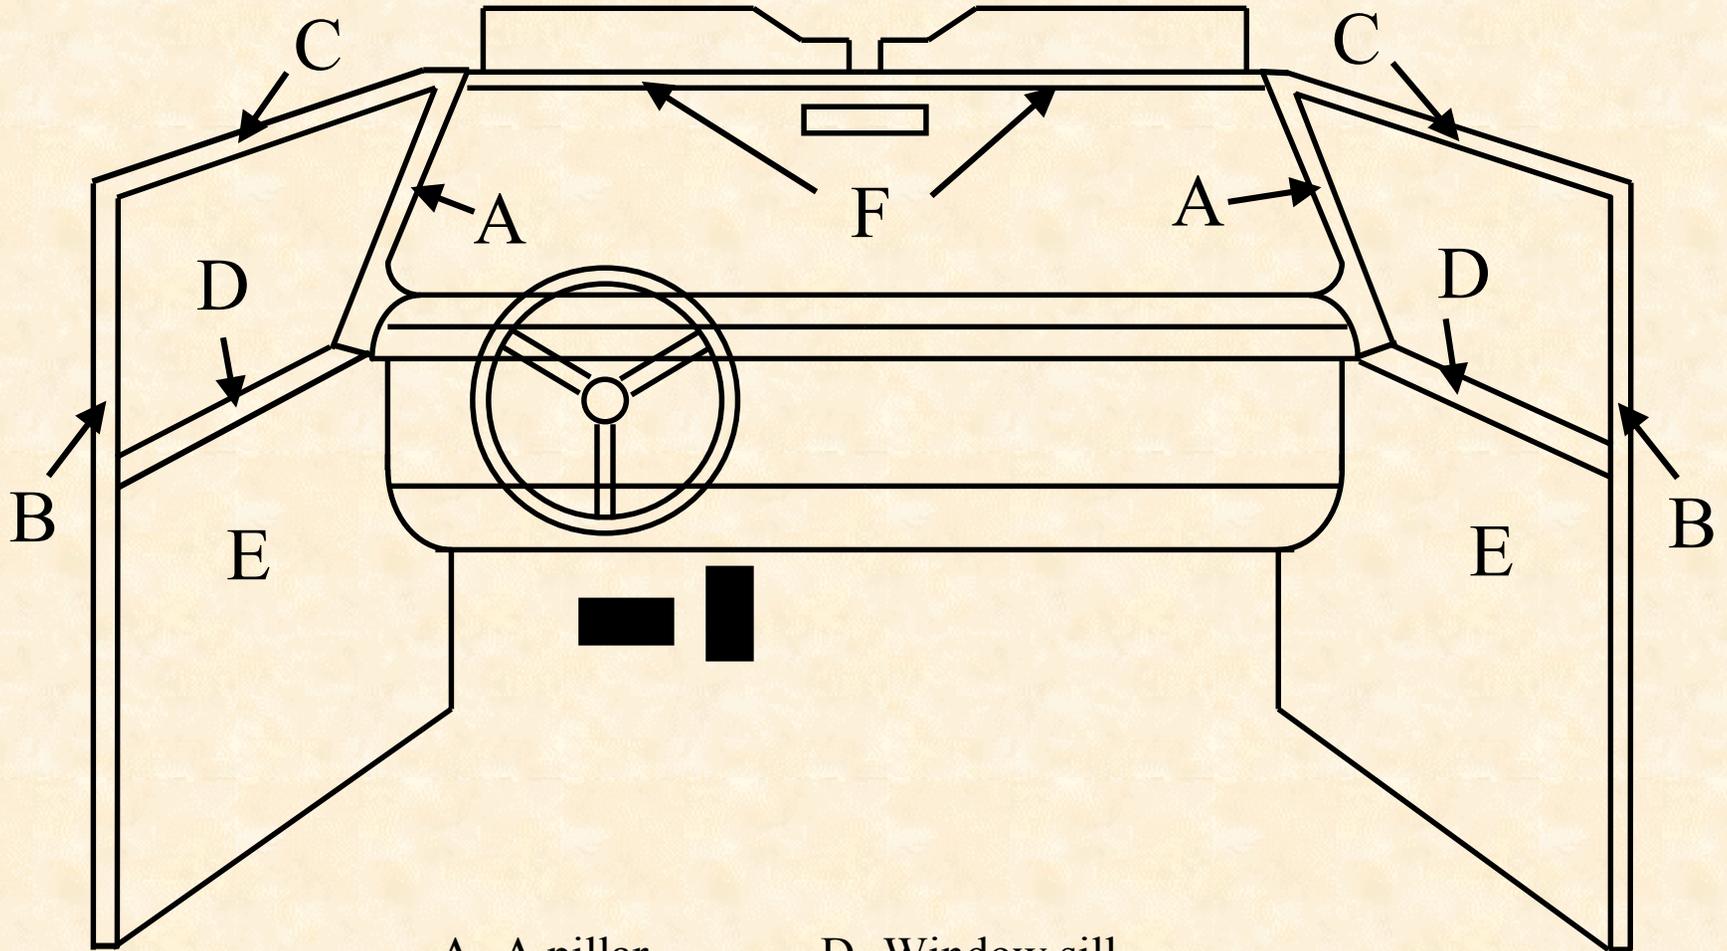
Direct contact source for critical head injuries

A- A pillar

D- Window sill

B- B pillar

E- Door panel

C- Roof side rail

F- Windshield Header

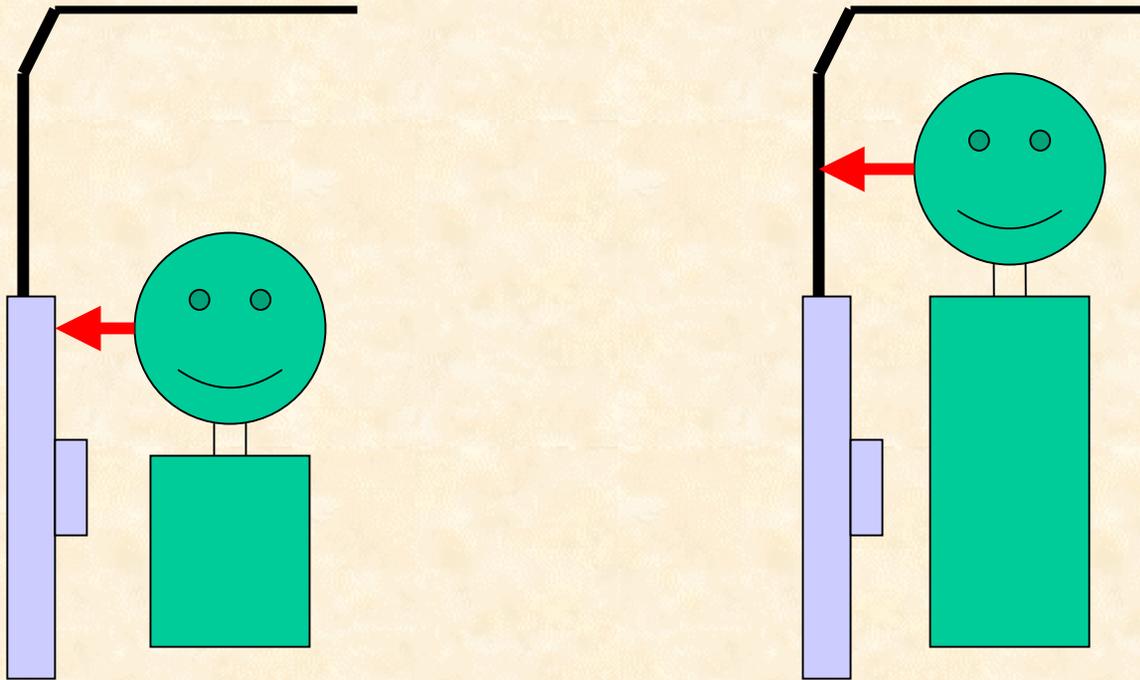
Children that are seated in vehicles expose themselves to more surface area for head contacts

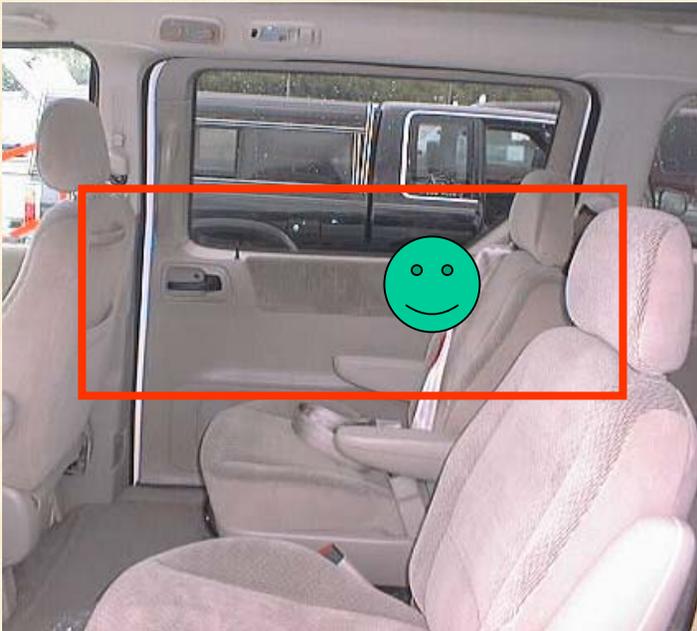
Adults head contacts will occur to the greenhouse structure (roof and roof pillars)

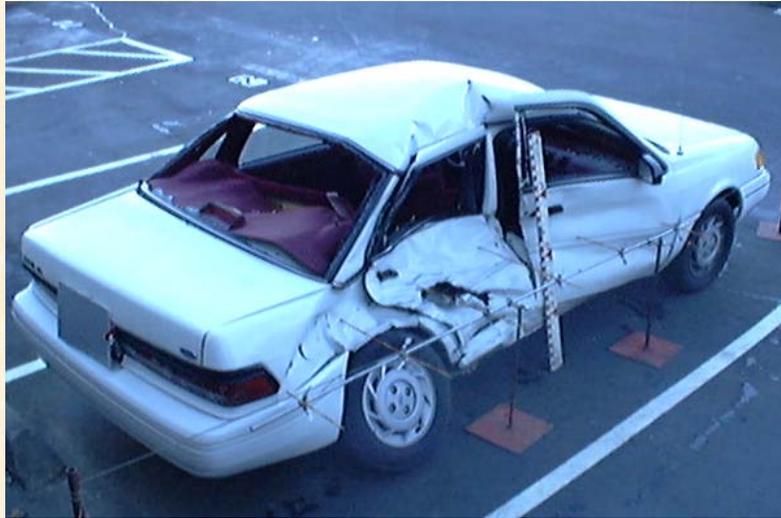
Critical Head Injuries - Child Side Impacts

90's Ford Sedan

20 mph Delta V

PDOF = 60

Struck by large pickup

Young Boy

Back right seat - fully restrained

Sleeping with head against door

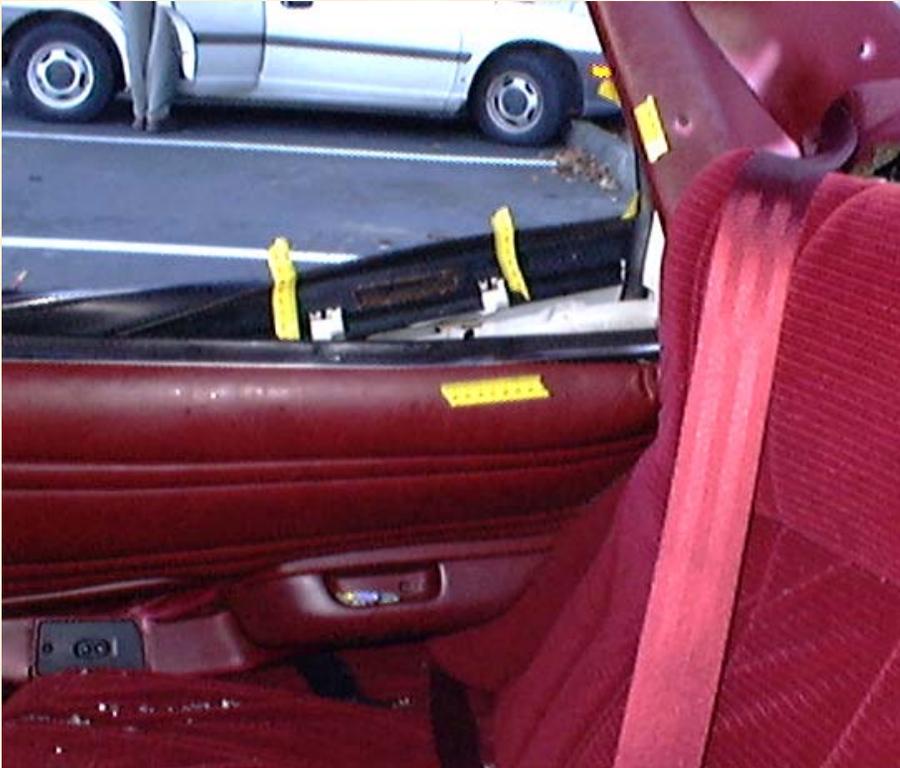
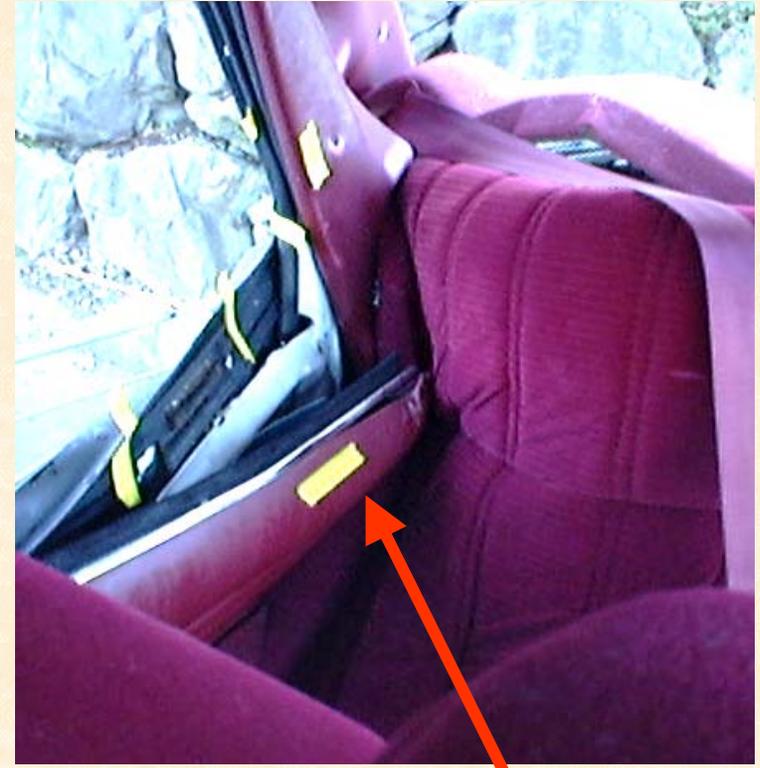
Critical Head Injuries - Child Side Impacts

40 cm of intrusion at door panel, window sill

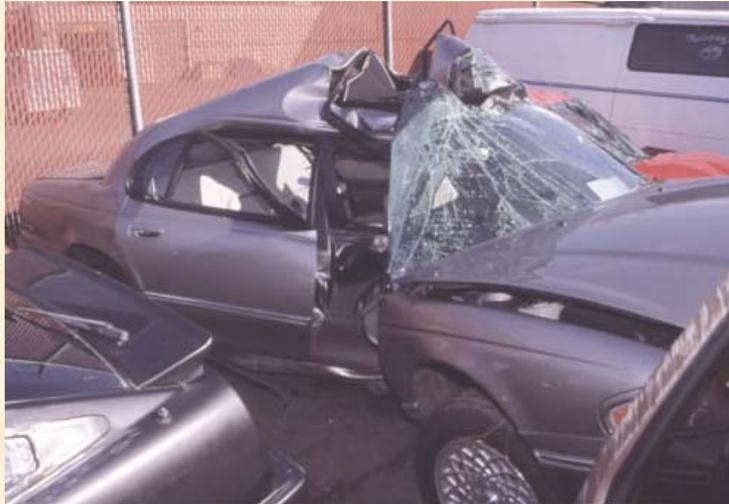
Critical Head Injuries - Adult Case reviews

LMY Chrysler large sedan

Delta V = 25 mph

PDOF = 95

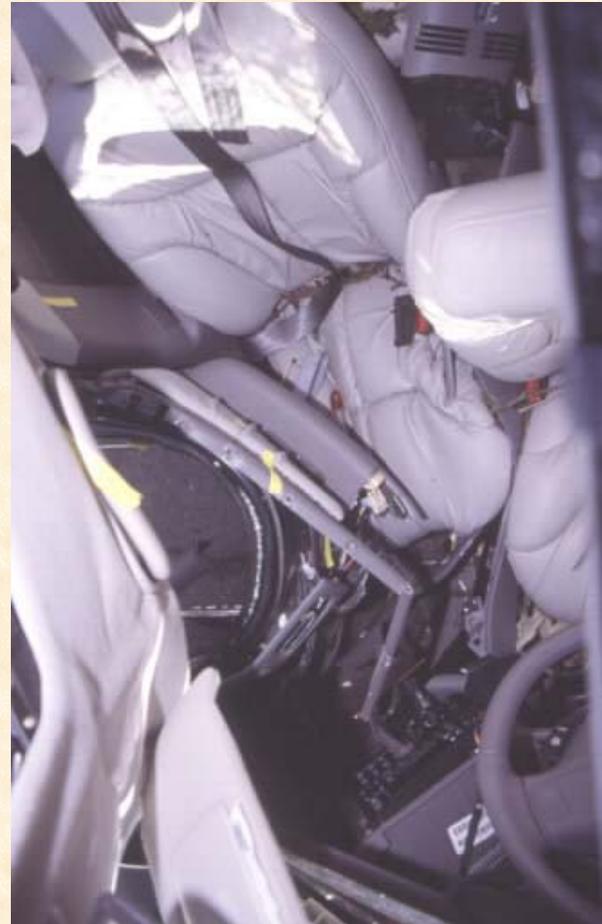
Critical Head Injuries - Adult Case reviews

Subject Right Front Passenger

Adult Male

Lap/Shoulder restraint used

Severe crush

Intrusion at legs and B pillar

External right scalp avulsion

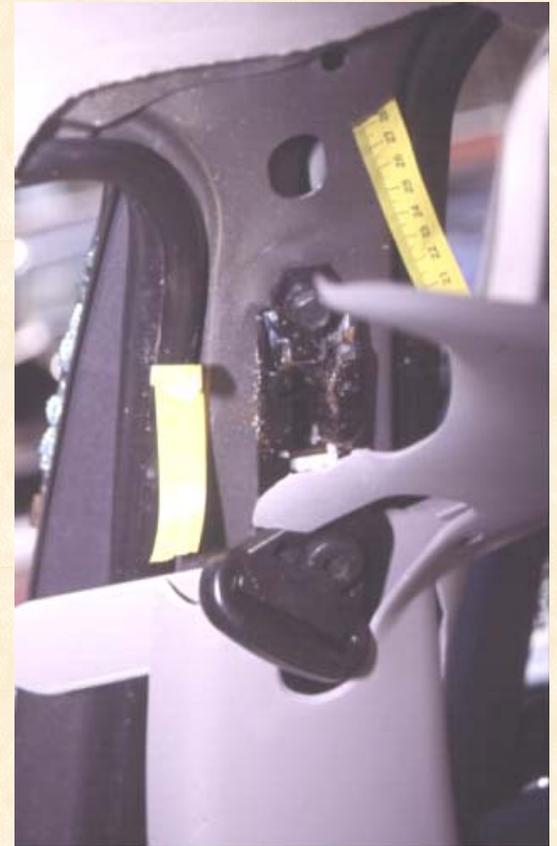
Critical Head Injuries - Adult Case reviews

- Bilateral intra-cranial hemorrhage and subarachnoid hemorrhage
- Left temporal contusion with shear - AIS 5

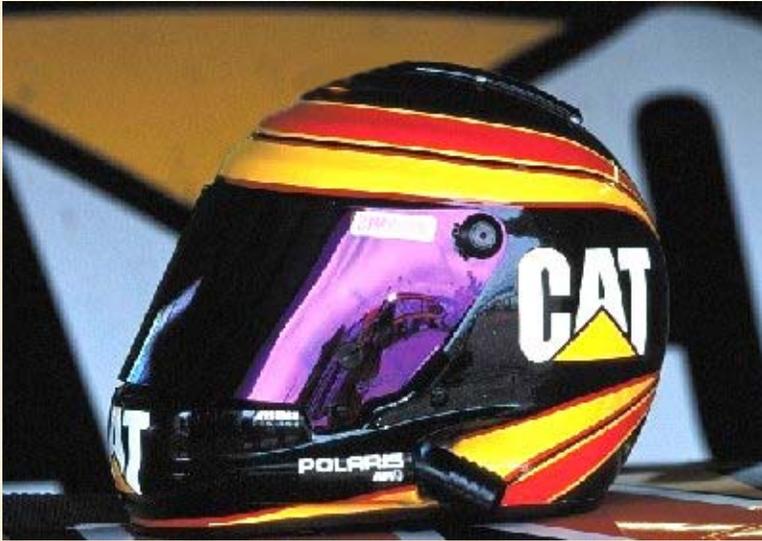
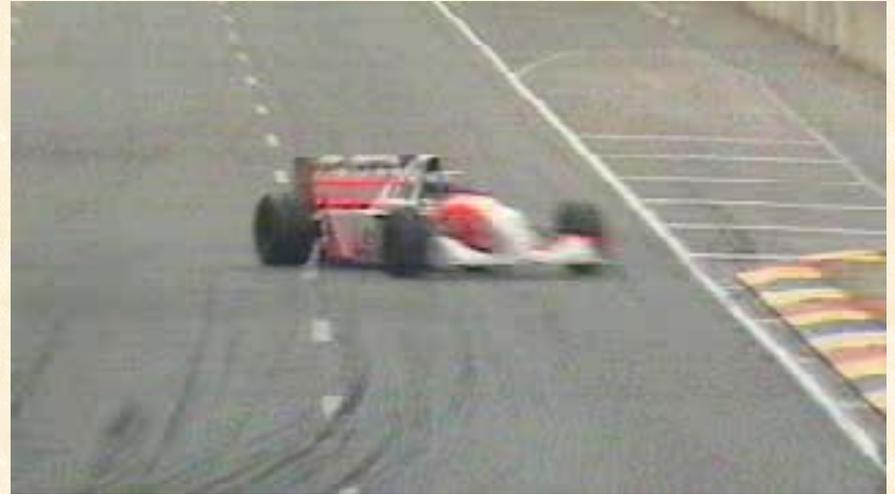
NASCAR Helmets

Race track crash occurs at 80-100 Gs.
100 Gs to 160lbs man = 16,000 lbs on top

BeadALL liner - special foam layer, poly

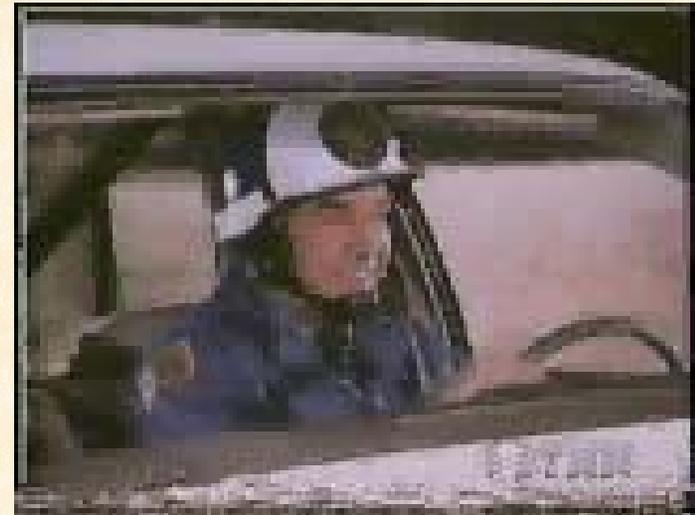
Impact resistance test

- If the peak acceleration impacting the metal head exceeds a magnitude of force equal or above 300G's, it is rejected.

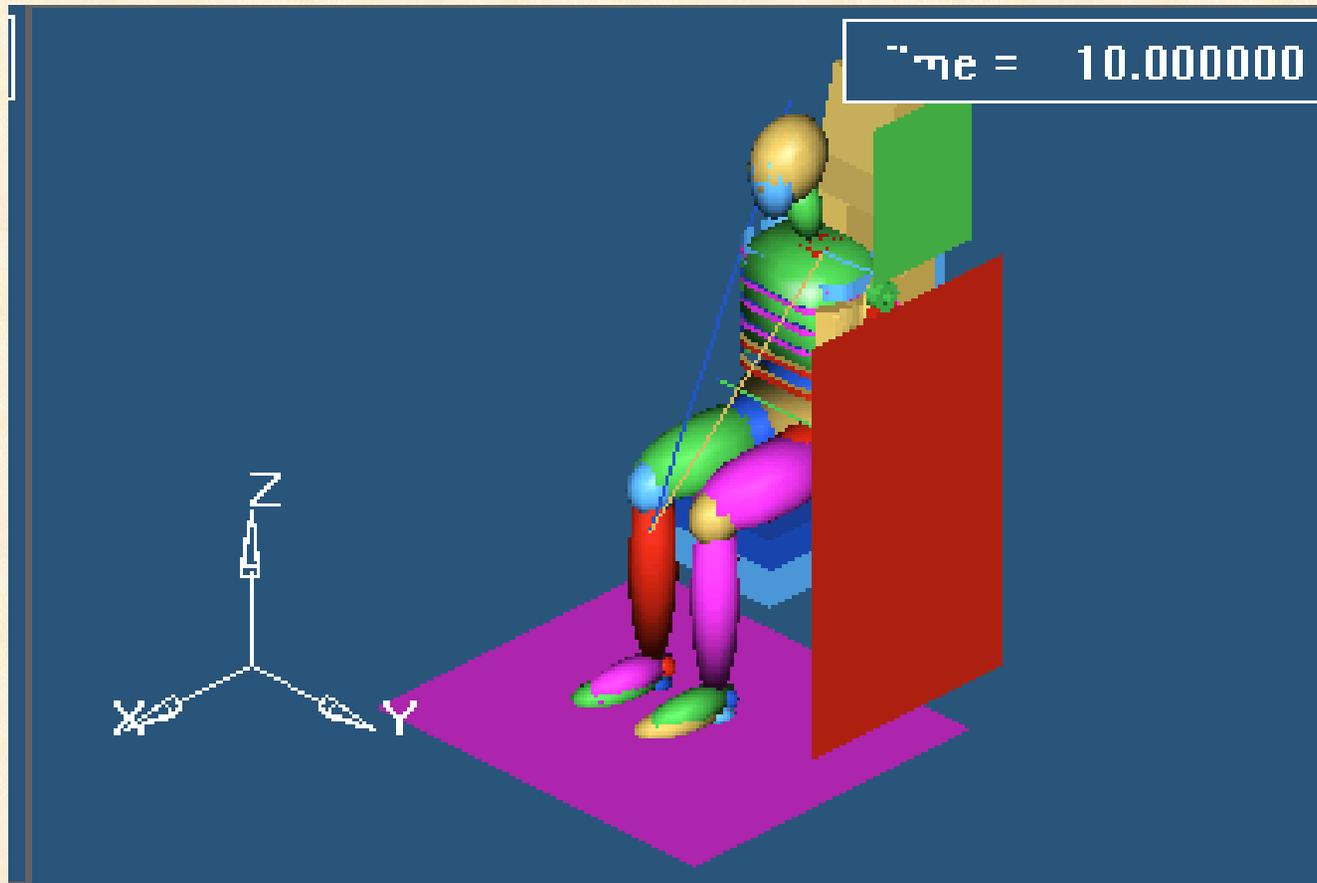
Head impact with pillar

- Used BIOSID in MADYMO
- Arbitrary Force of 20000N
- HIC based on frontal impact and linear measurement excluding rotational acceleration

- Roof pillars and side rails are very stiff
- Would slight change in pillar stiffness reduce the severity of head injuries, or HIC?
- Add-on padding, or changes in original design, might minimize head injury severity
 - less expensive than airbag technology

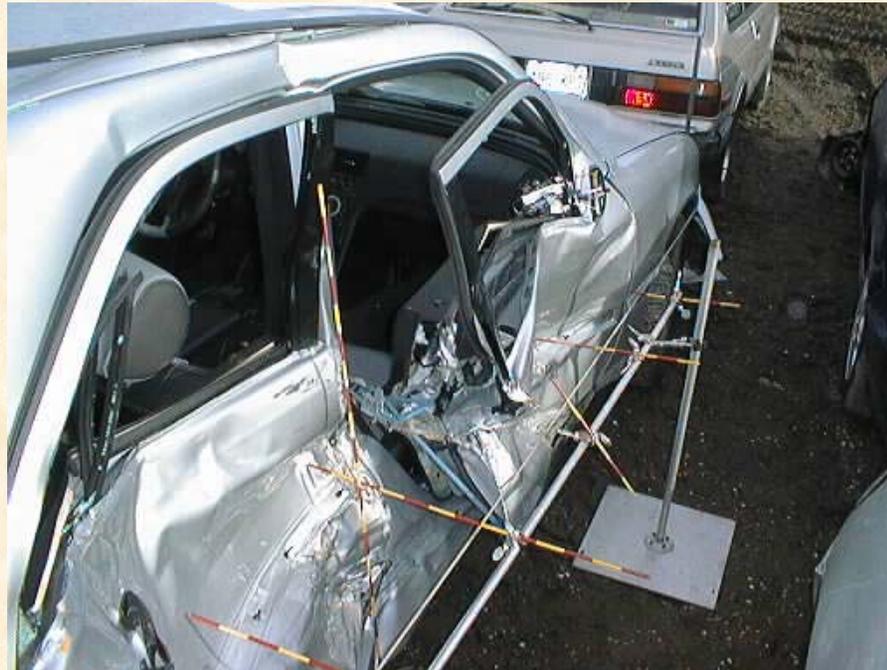
Subject Vehicle Damage

Right side direct lateral impact

Delta V Oldmiss = 18 mph

PDOF = 70

Extrication to door

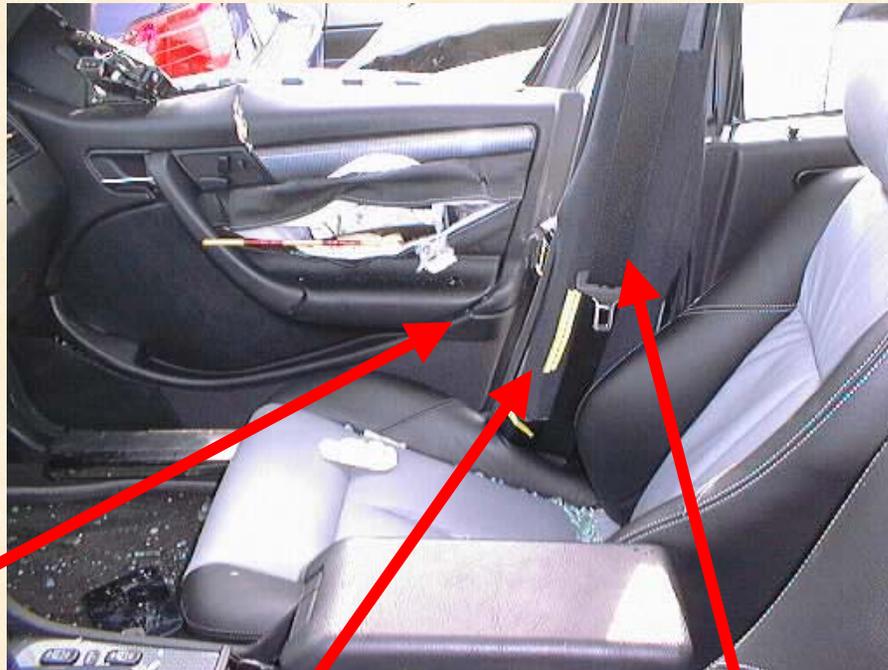
Lower door panel to
lower chest/abdomen

Pelvis scuff
to B pillar

Seatbelt locked in
position by
intrusion

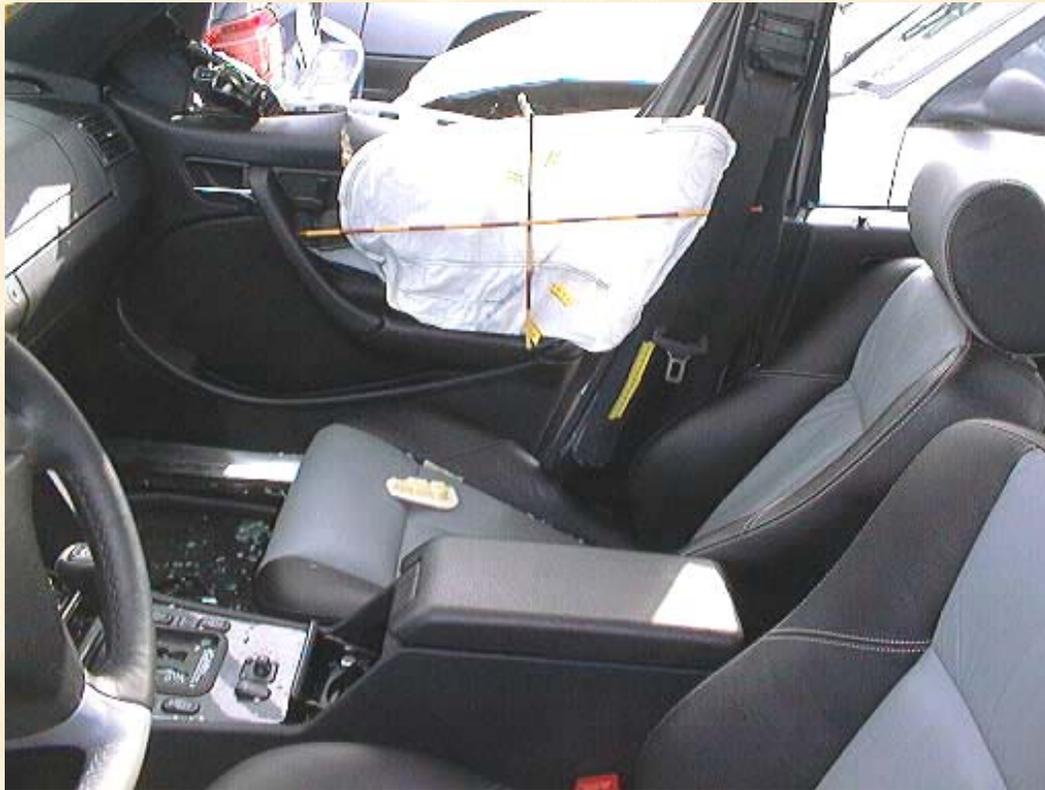
Door Mount Side Airbag

Main protection to upper thorax, but extends enough upward for some head protection

Upper chest and head appear to be protected by door mounted side impact airbag considering an SUV upper door impact.
