EVALUATION OF HEAVY TRUCK ROLLOVER ACCIDENTS

Jeffrey L. Evans
Stephen A. Batzer
Stanley B. Andrews
Renfroe Engineering, Inc.
United States
Paper Number 05-0140

DYNAMIC ROOF CRUSH INTRUSION IN INVERTED DROP TESTING

A METHOD TO EVALUATE DYNAMIC vs. RESIDUAL ROOF RAIL DEFORMATION IN DOLLY ROLLOVER TESTS

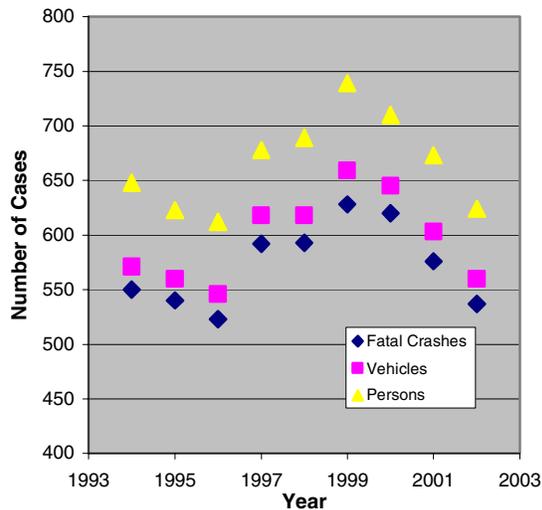
Figure 1 shows the results of all accidents from 1994-2002. The number of fatal accidents per year for heavy trucks peaked in 1999 at 659. The lowest number of fatal accidents for this time period was 523, which occurred in 1996. A downward trend is apparent from 1999-2002, with only 537 fatal crashes occurring in 2002. Since this data looks at all fatal heavy truck accidents, the number of vehicles and persons involved are somewhat higher every year than the number of fatal accidents.

Figure 1. FARS data for all fatal and incapacitating heavy truck crashes from 1994-2002.

The rollover data shown in Figure 2 shows some similar trends as the data for all heavy truck accidents shown in Figure 1. The highest number of fatal and incapacitating crashes, 126, occurred in 1998, with the lowest number of crashes, 93, being reported in 1993. A downward trend from 1998 to 2001 is seen, but in 2002 the number of crashes rose slightly from 107 in 2001 to 115 in 2002.

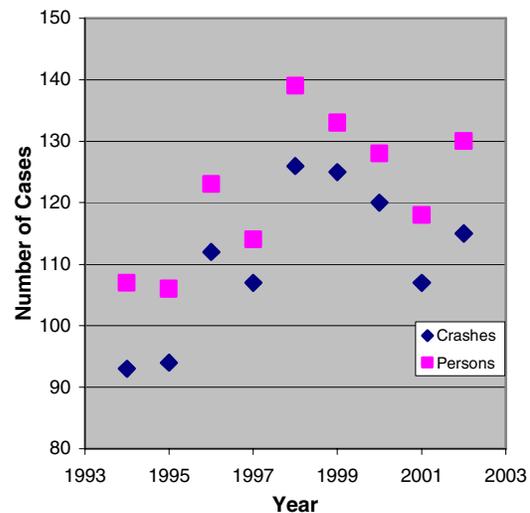
The rollover query was then submitted to the FARS database and the number of accidents that met the requirements of this query is shown in Figure 2. The average percent of fatalities and incapacitating injuries, which matched the rollover query, was 18%, with a high in 2002 of 21% and a low of 17% occurring in 1994, 1995, and 1997. Therefore, on average, 18% of all heavy truck incapacitating and fatal injuries were a result of a single vehicle rollover accident where the rollover was the most harmful event, either the first or subsequent event with contained occupants receiving fatal or incapacitating

Figure 2. FARS data for heavy truck rollover accidents from 1994-2002 that meet the described query.

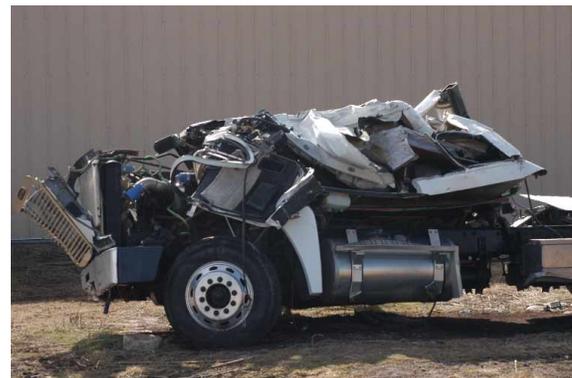
A seat-belted driver of a heavy truck was killed as a result of the structural collapse of his 1999 Freightliner FLD tractor cab during a 180° rollover accident. His truck was pulling a trailer carrying a full load of cylindrical hydrogen tanks. The rollover was precipitated by the impact of a full-size pick-up which swerved to the left, and struck the Freightliner truck, disabling the right steering mechanism. The Freightliner veered to the left and back to the right, eventually overturning and landing on the vehicle’s left side. The tractor and trailer slid down the roadway and started to slide onto the grassy shoulder to the right of the road. The tractor rolled onto its roof in the grass causing complete collapse of the cab. A photo of the accident vehicle is shown in Figure 3. The truck and trailer left the road and came to rest mostly parallel to the direction of traffic, with the trailer having crossed a driveway, and the cab resting on the driveway. According to the accident reconstruction, the speed of the tractor and trailer at the point of roll initiation was calculated to be in a range from 57 to 70 mph. The speed as the trailer exited the roadway was calculated to be approximately 35 mph.

Figure 3. Photograph of the accident vehicle – driver’s side.

The heavy truck suffered significant structural collapse during this rollover accident. The authors conducted an inspection of an exemplar vehicle and concluded that the all aluminum cab structure would not be sufficient for occupant protection in rollover accidents.

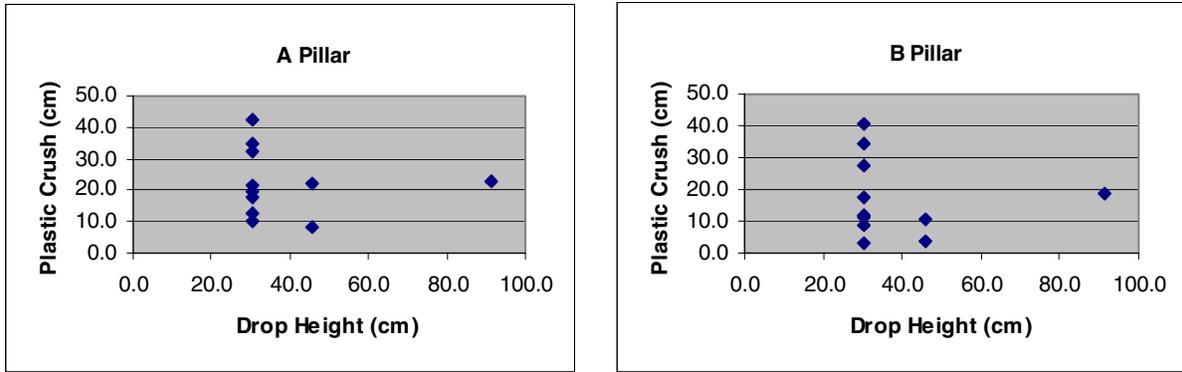
Figure 1. Plastic crush versus drop height for the A-Pillar.

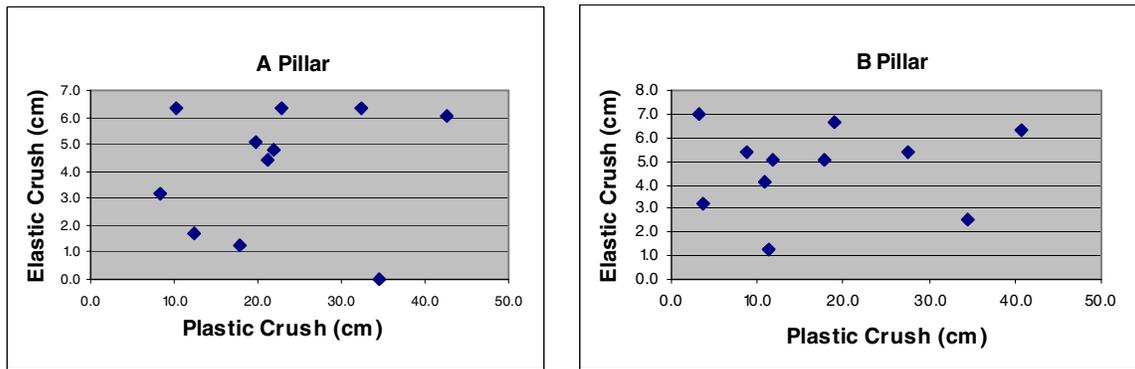
Figure 2. Elastic vs. plastic crush measurements.

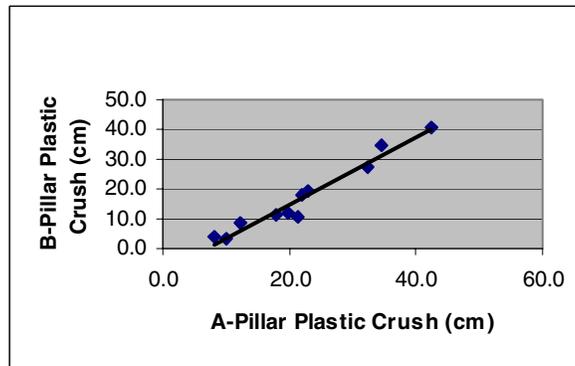
Figure 3 shows that A & B pillar plastic crush are strongly correlated. As expected, as the A pillar plastic crush increases, the B pillar residual crush also increases. The A-pillar plastic crush was always measured to be greater than that of the B-pillar plastic crush, although sometimes the two values differ only slightly. The average difference between the measurement sites was found to be 5.0 cm. The regression of the B pillar crush on to A-pillar crush is:

$$\hat{B} = 1.13A - 3.06 \quad (1)$$

Figure 3. B vs. A pillar plastic crush.

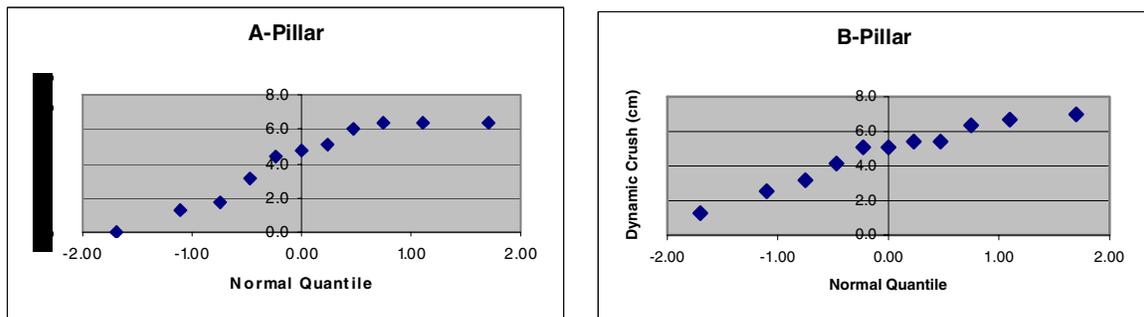
Figure 4. Q-Q Plots – A & B pillars.

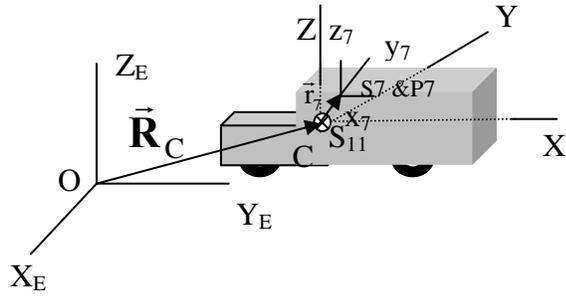
Since part of the acceleration of the sensors with respect to the center of gravity is due to the rotation of the vehicle, the angular velocity and angular acceleration of the vehicle-fixed axes must be used. Two methods were utilized in this investigation to determine the angular velocity, both with and without the use of a rollover sensor. If very good estimates of the angular velocity can be obtained then the vehicle's attitude may be obtained by numerical integration. Also, the parts of the accelerations of the sensors with respect to the center of gravity that are due to the rotation of the vehicle may be removed from equations like Eq. (2) and the part of the acceleration due only to deformation integrated to get deformation rates and displacements. Because each sensor has its own coordinate system, if the deformations are extreme (e.g. significant roof crush into the occupant survival space), then some method must be devised to account for the rotation of individual sensors.

Figure 1. Earth-Fixed, Vehicle-Fixed, and Sensor Coordinate Systems.

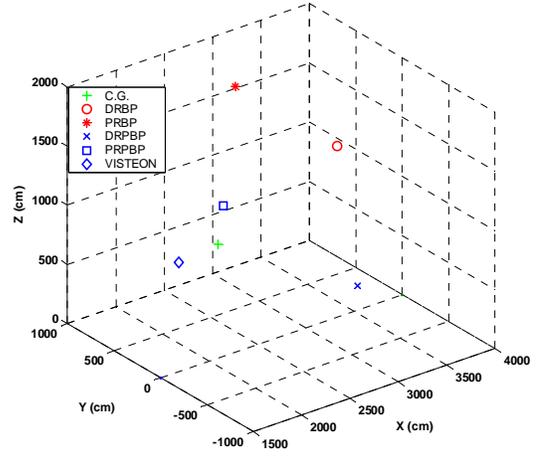
These points are shown in Figure 2.

Figure 2. Six Sensor Locations for Autoliv Test B190042

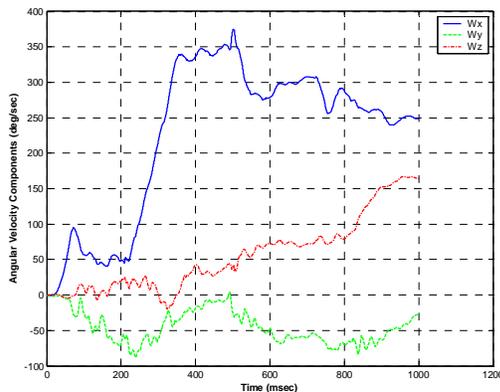
Figure 3. Estimated Angular Velocity Components – No Roll Rate Sensor Data (Autoliv Test B190042)

Note that because the vehicle Z-axis is initially directed upward and the X-axis is rearward, a positive pitch angle puts the nose of the vehicle higher and a positive yaw angle means that the nose of the vehicle has rotated towards the left from the viewpoint of a driver. A positive roll angle is initially a rotation of the driver's side of the vehicle toward the ground.

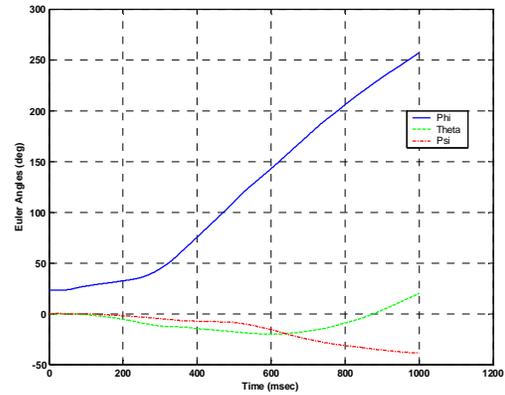
Figure 4. Estimated Euler Angles - No Roll Rate Sensor Data (Autoliv Test B190042)

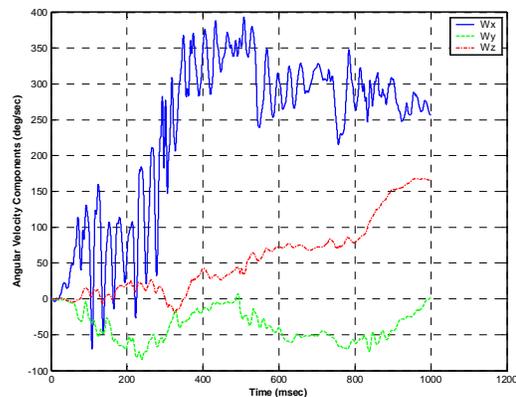
The data collected during Test B190042 included the output from the Systron Donner Roll Rate Sensor. Assuming that the “roll rate data” is actually the angular velocity about the X-axis of the vehicle, it may be used as the X-component of angular velocity in our estimate of angular velocity and the other two components may be obtained as indicated above. Figures 5 and 6 show the resulting time histories of the angular velocity components and the Euler angles. Note that the agreement between the time histories of the X-components of the angular velocity shown in Figure 3 and Figure 5 is very good except for the oscillatory content in ω_x in Figure 5. Because the rate data was used directly to obtain Figure 5, the ω_x time history shown there still has considerable oscillatory content. On the other hand, the ω_x plot in Figure 3, which was obtained by integrating the accelerometer outputs after they have been filtered (60 Hz), does not have the high frequency content.

Figure 5. Angular Velocity Components Including Systron Roll Rate Sensor Data

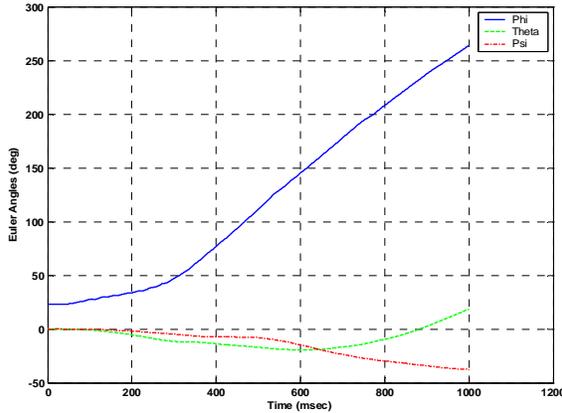
The results for the Euler angles that were obtained using the four accelerometers (CG, DRPBP, PRPBP, and VISTEON) and the Systron Donner Roll Rate Sensor are presented in Figure 6. Note that the assumption was made that the Systron Donner sensor measures the angular velocity about the X-axis, not the time rate of change of the Euler angle ϕ (Phi).

Figure 6. Estimated Euler Angles Including Systron Roll Rate Sensor Data.

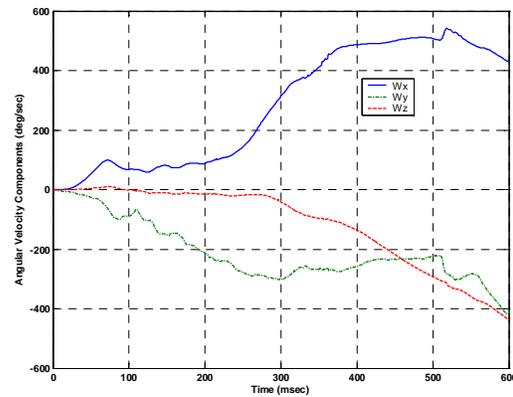
Figure 7. Angular Velocity Estimated from Accelerometer Data (Autoliv Test B190043)

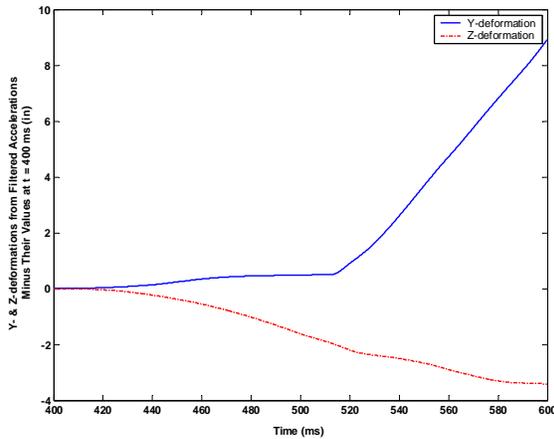
Equation (16) may be integrated component by component if both sides are written in terms of unit vectors fixed in CXYZ. Figure 8 shows the results for the roof rail/B-pillar deflection/crush using this method. Thus, the direct integration of acceleration data provides meaningful results, if the data is chosen properly.

Figure 8. B-pillar Dynamic Deformations Integration Start at 400 ms. (Autoliv Test B190043)

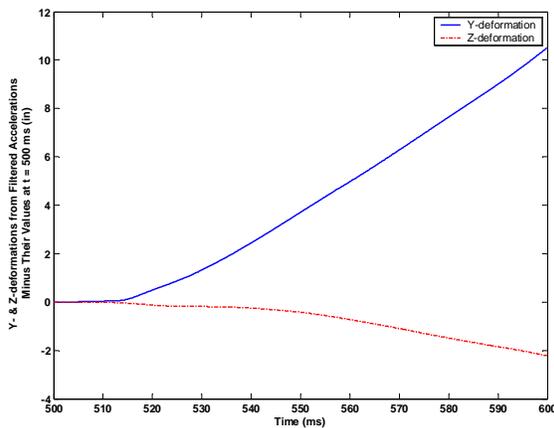
Figure 9. Y- and Z-deformations of the B-pillar Integration Start at 500 ms (Autoliv Test B190043)

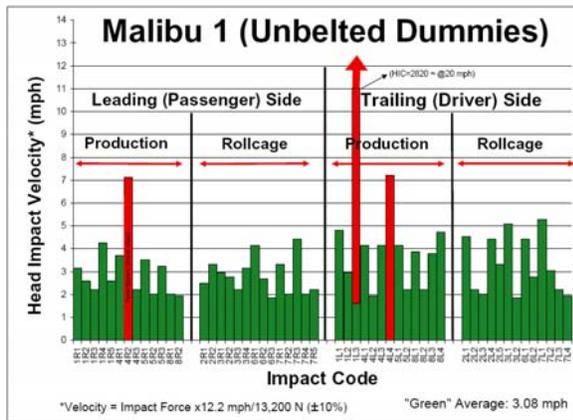
Figure 1. Malibu I neck compression velocities.

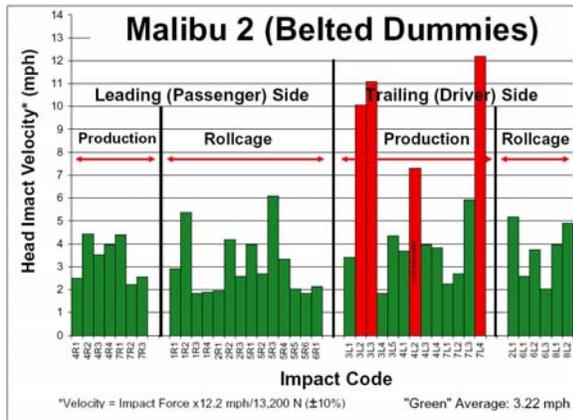
Figure 2. Malibu II neck compression velocities.

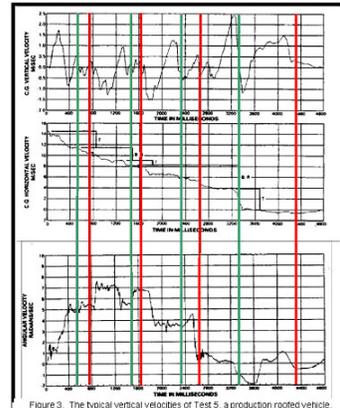
rollover impacts were similar and about 1 mph in production and about 3 mph in roll caged vehicles as shown in Figures 3 and 4 [4].

Figure 3. Contact Velocities in a Production Malibu.

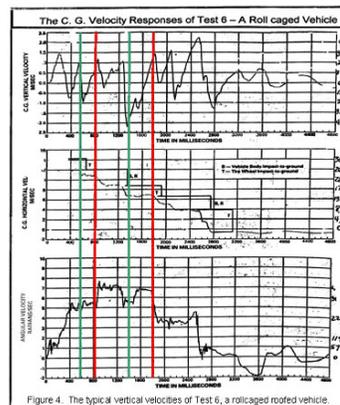
Figure 4. Contact Velocities in a Rollcaged Malibu.

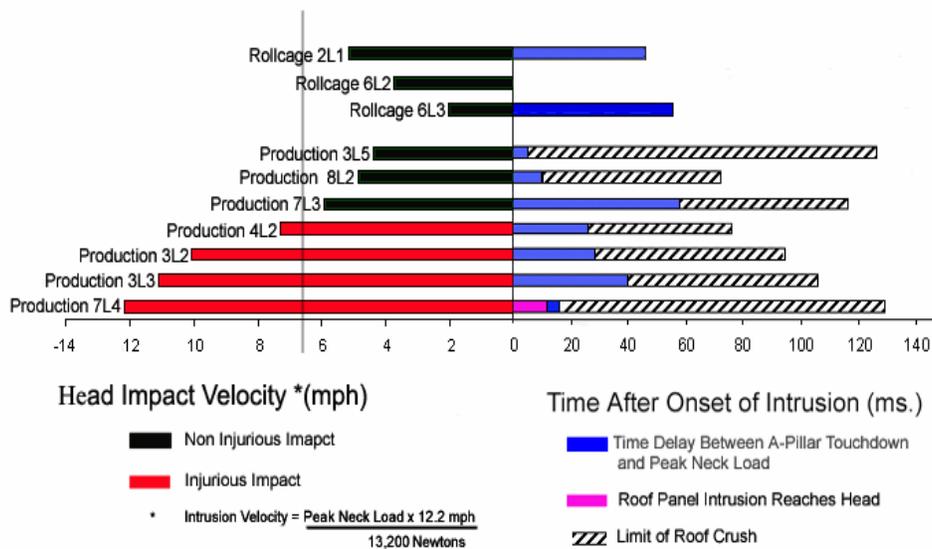
Figure 5. Head impact velocity and timing of GM selected impacts.

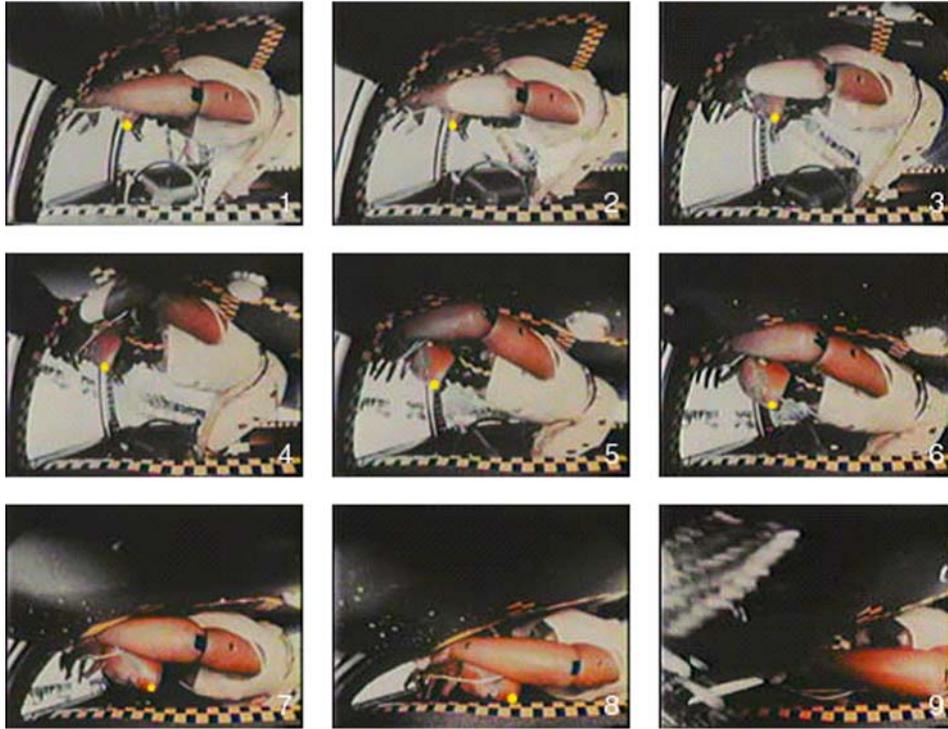
Figure 6 shows Malibu I Impact 1L3 in a sequence of interior views (at 4 ms timing per frame) of the driver dummy during roof intrusion of 12 inches at 20 mph velocity taking place over 32 ms. This roof intrusion produced a HIC of 2,820 to the dummy that is against the roof (from centrifugal force) and driven inward and towards the seat cushion. Notice the checkered seat back reference is stationary so that the path of the head can be followed by the sequence of yellow dots which locate the dummy's chin.

Figure 6. A sequence of frames from Malibu I, Impact 1L3.

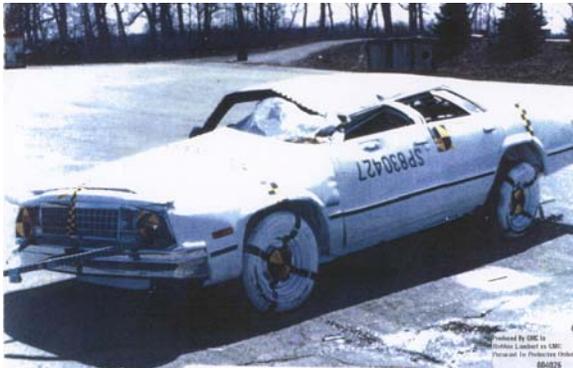
Shown below in Figures 8 and 9 are the vehicles at rest showing the extent of lateral roof crush to the vehicles in these tests.

Figure 8. Malibu I Test 1 vehicle at rest with residual driver side intrusion.

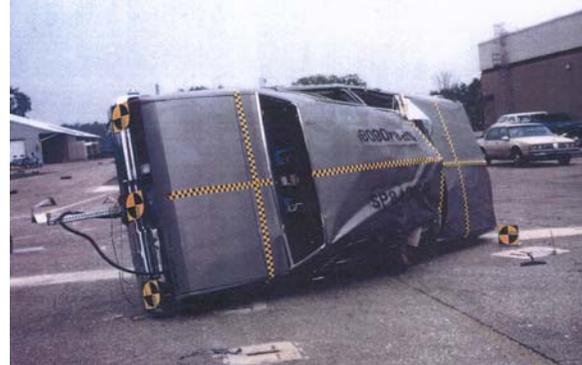
Figure 9. Malibu I Test 4 vehicle at rest with residual front seat intrusion and tenting.

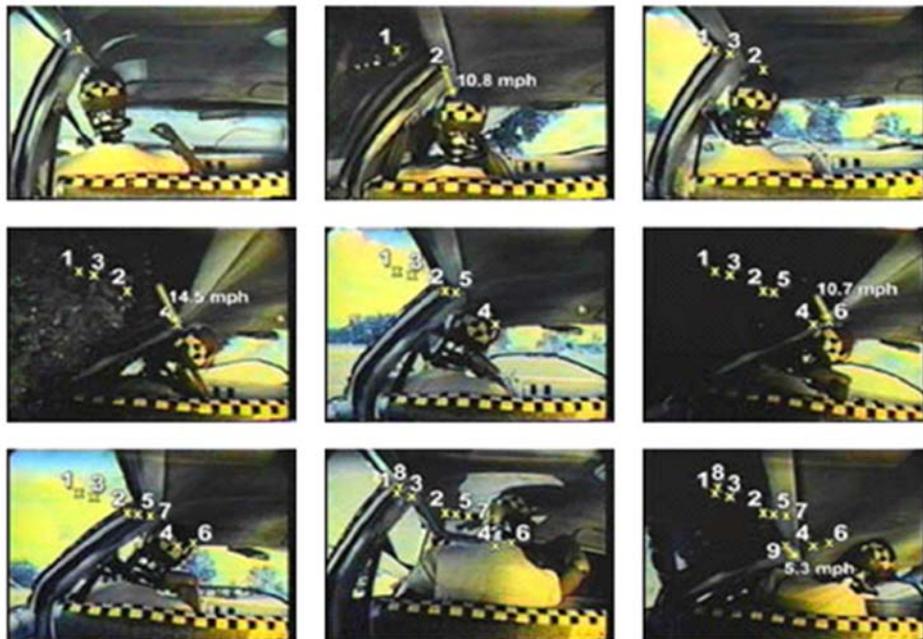
Figure 12. Malibu II Test 3 sequence of the intrusion position of the trailing side roof.

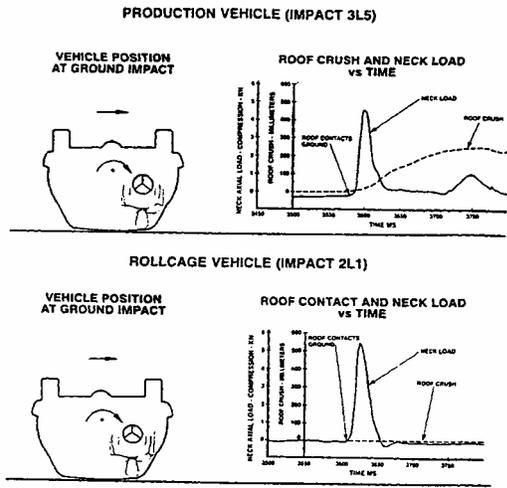
Figure 13. (Figure 12 in the Malibu II paper.) Roof Crush and Neck Loads versus Time from a GM Comparison between 3L5 (production) and 2L1 (roll caged).

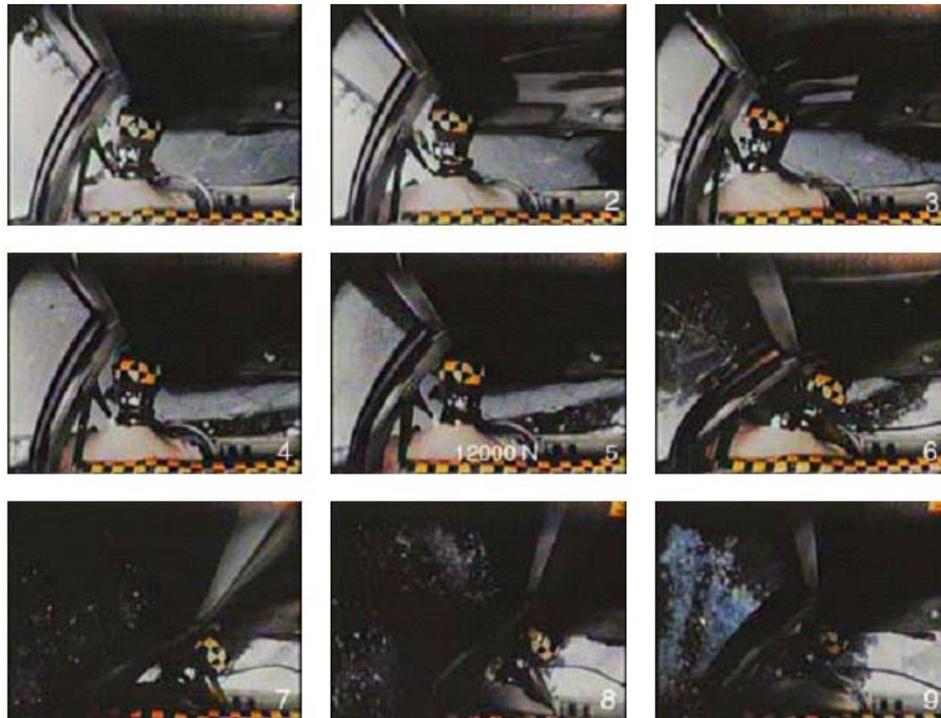
Figure 16. A sequence of frames from Malibu II Impact 3L3.

had an axial neck load of 12,000 N. In both instances the dummies were in very similar positions, the roof-to-ground impacts were of similar severity. The neck loads however were vastly different because of the difference in roof intrusion velocity which was 6.3 m/sec (14 mph as determined from the initial slope of the roof crush versus time graph) for test 3 but only 2.2 m/sec for test 2; and roof crush which was 23 cm (9 inches) for test 3 but less than 3 cm for test 6 (see Figure 16, 17, and 18).

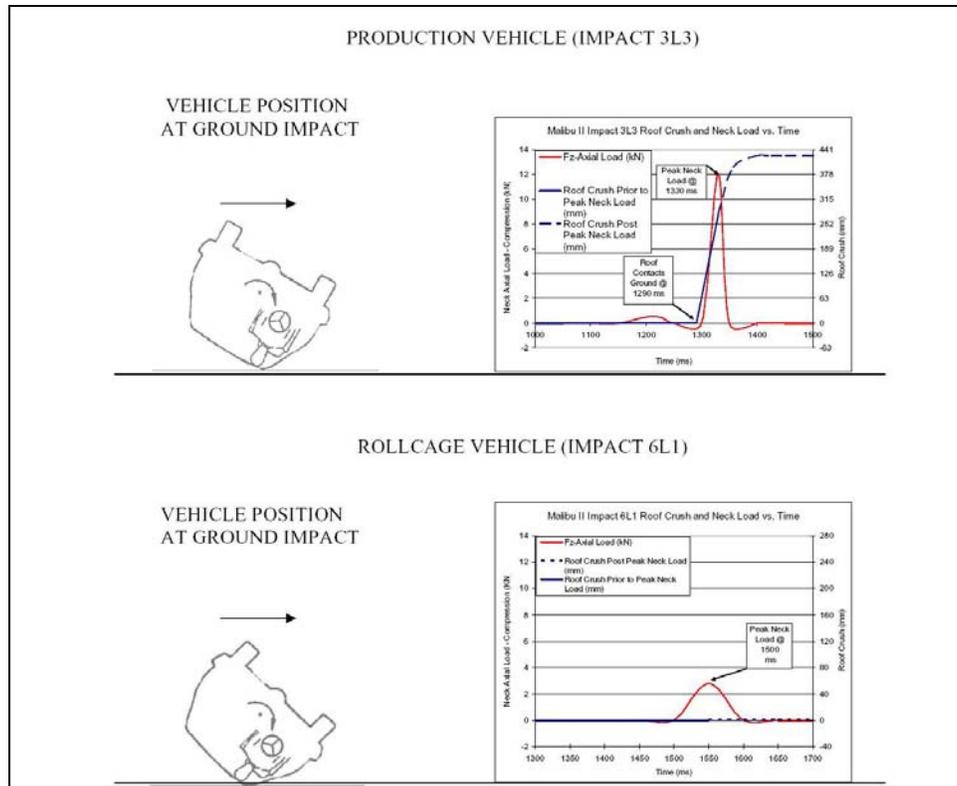
The load on the dummy neck is the result of the dummy head being contacted by the deformation of the roof panel from the near side ground contact and intrusion. That contact also forms a traveling buckle in the roof panel starting on the near side and traveling across the vehicle roof to merge with the trailing side contact and intrusion. The traveling buckle has an amplitude of about 4 inches and is off the ground and intrudes on the dummy head at 12 mph, causing the peak neck load over about 12 ms.

Figure 18. Roof Crush and Neck Loads v. Time for Impacts 3L3 (prod.) and 6L1 (roll caged).

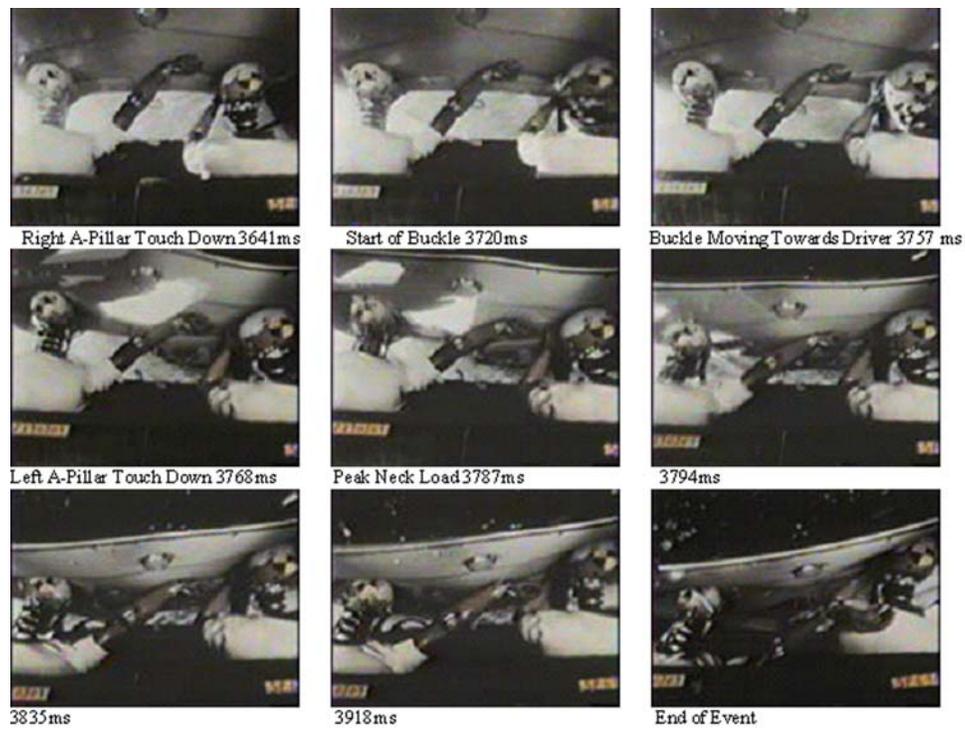
Figure 19. Nine frames from impact 7L4 with timing referenced.

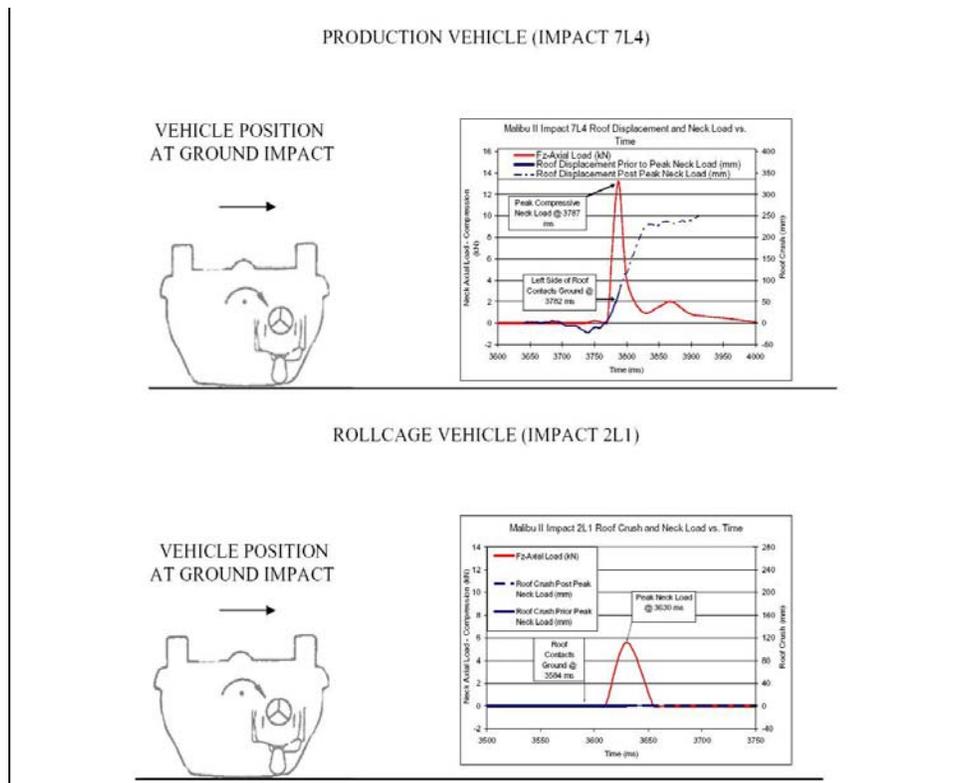
Figure 21. Roof Crush and Neck Loads v. Time for Impacts 7L4 (prod.) and 2L1 (roll caged). The roof displacement in 7L4 is measured over the driver dummy’s head.

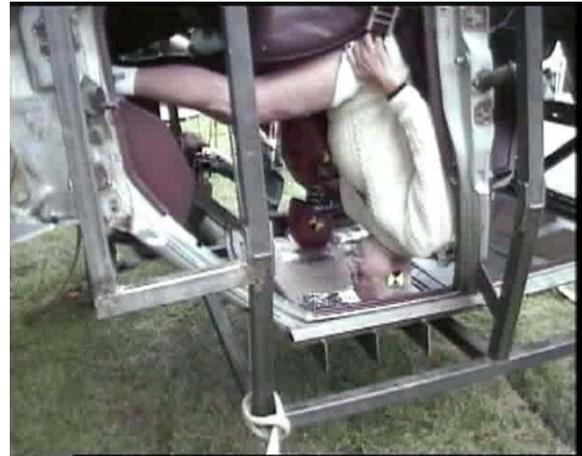
Figure 26. One of the authors (Friedman) and a Dummy in a 5.4 mph Malibu Drop Test in which roof crush was precluded.
