REPORT NO. 6525-V-43

NEW CAR ASSESSMENT AND STANDARDS
ENFORCEMENT INDICANT TESTING
FMVSS NOS. 212, 219 AND 301-75

1981 MERCURY LYNX 2-DOOR HATCHBACK
Rear Impact, 35 mph
NHTSA 308-43-506

FINAL REPORT

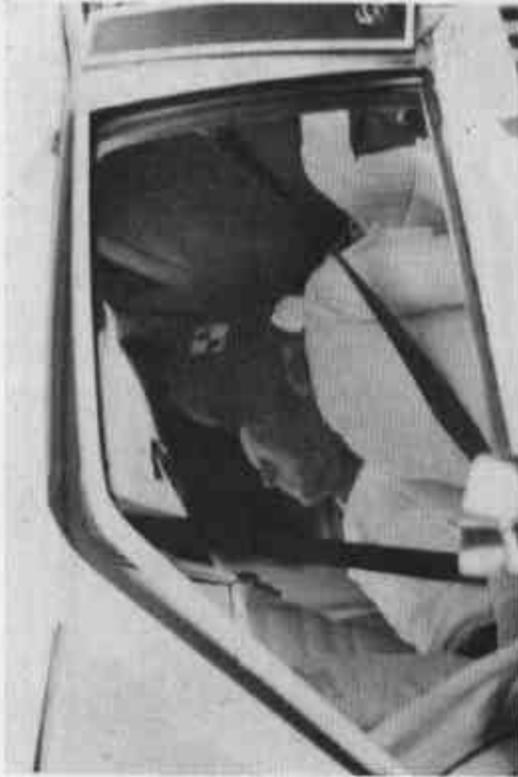
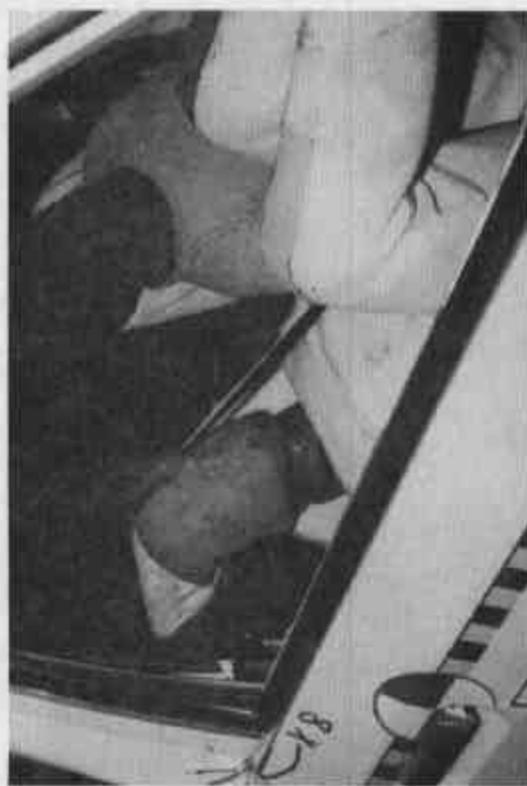
FIGURE A-11 POST-TEST VIEWS OF RIGHT FRONT PASSENGER'S POSITIONS

- Both front seat backs failed at impact and the passenger's seat right rail separated from the track.
- Both driver's and right front passenger's heads contacted the rear seat backs as indicated by the chalk marks, see Figure A-11.
- Both left and right rear side windows separated from the vehicle at the time of impact.
- Windshield has stress cracks on left side of vehicle.
- Rear tires remained inflated.
- The driver's door was operable but the right front passenger's door could not be opened after the test.
