Calspan Report No. YB-2987-V-17

# BASIC RESEARCH IN CRASHWORTHINESS II --- LOW SPEED IMPACT TESTS OF MODIFIED VEHICLES

CALSPAN CORPORATION  
TRANSPORTATION RESEARCH DEPARTMENT  
4455 GENESEE STREET  
BUFFALO, NEW YORK 14221

Interim Technical Report  
Contract No FH-11-7622

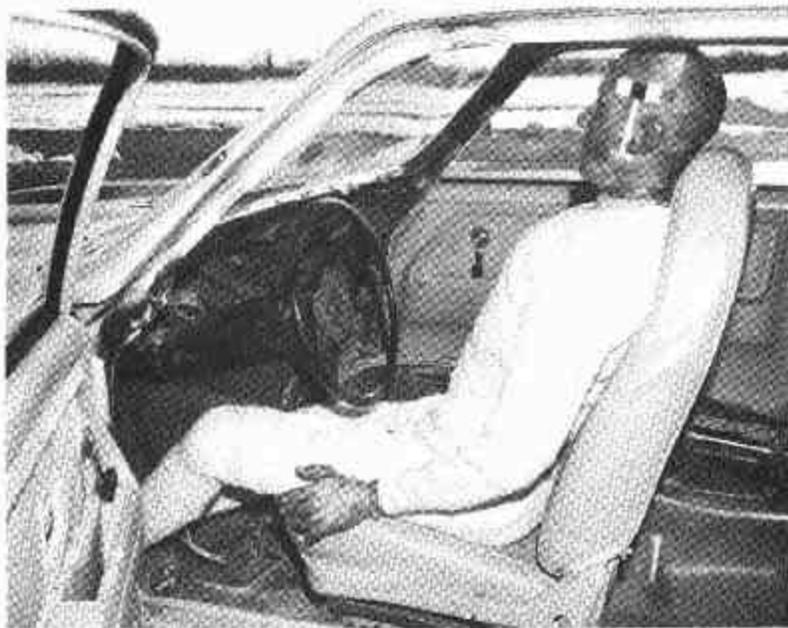
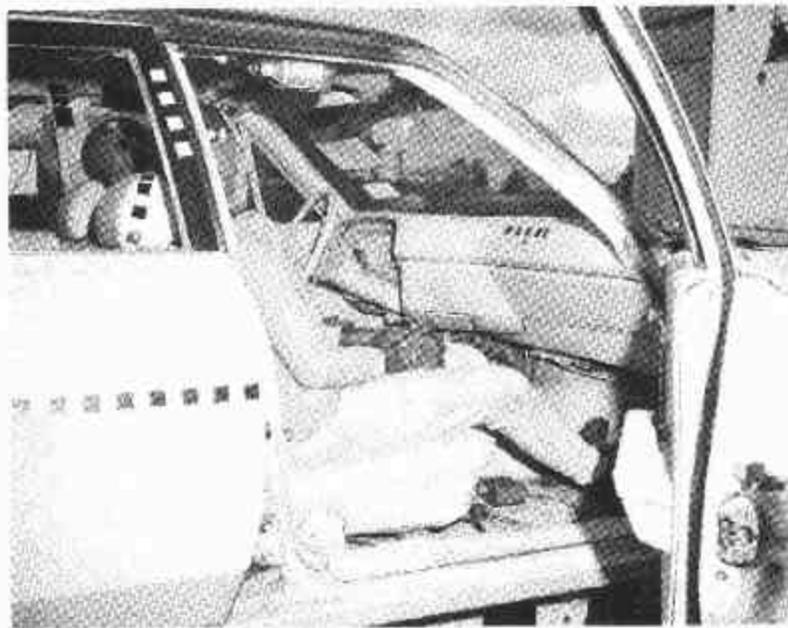
Figure 2-1 DUMMY TYPICAL PRE-TEST POSITIONS

LEFT FRONT SEAT

RIGHT FRONT SEAT

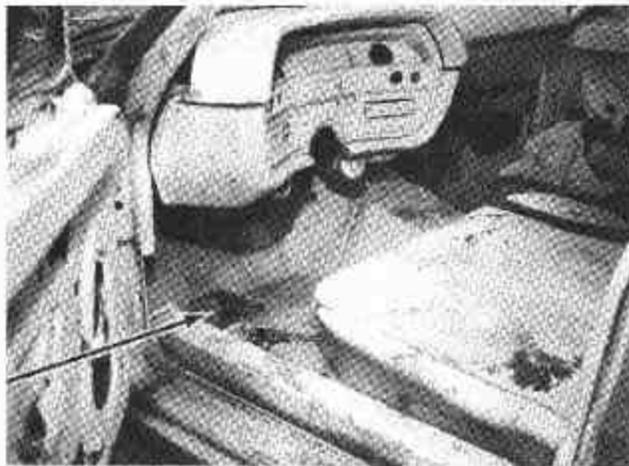
LEFT FRONT  
FLOOR MOUNT

Figure 2-3 ACCELEROMETER TYPICAL MOUNTING POSITIONS IN MODIFIED VEHICLES

Vehicle instrumentation consisted of triaxial accelerometers mounted on small reinforcing plates at different locations on the compartment floor. Figure 2-3 shows three typical placements of the accelerometers in the modified vehicles. Generally, the compartment tunnel accelerometer data were used to describe the deceleration response of the compartment.

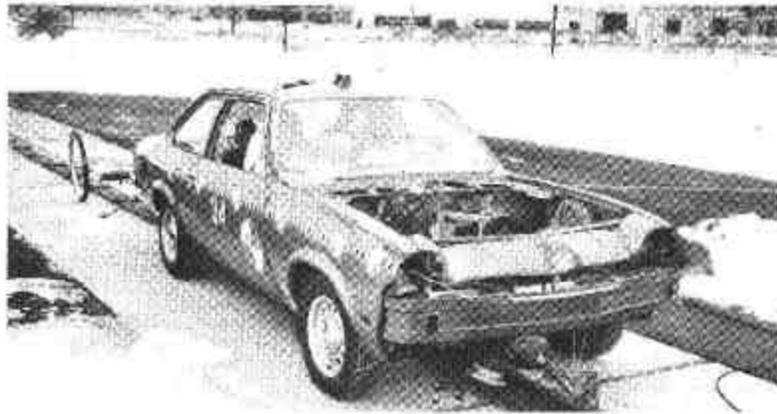
MOD. 6 VEGA

Figure 3-1 SUBCOMPACT MODIFIED VEHICLES,

The subcompact vehicles were modified 1971 Chevrolet Vega Sedans. The three modified cars, Mod. 6, Mod. 8, and Mod. 9, are shown before impact in Figure 3-1. The Mod. 6 design consisted of a built-up front bumper section of high strength steel and aluminum honeycomb, a truss type energy absorbing bumper support section, and tubular sections in each fender for additional energy absorption. A number of small urethane pads were situated between the front bumper and its supporting structure to provide some cushioning during low speed impacts. The Mod. 8 design contained basically the same bumper as the Mod. 6, plus a redesigned energy absorbing bumper support system, and an engine receiving box structure aft of the firewall. The drive shaft tunnel area was reinforced along with certain other critical reinforcement areas. The design of the Mod. 9 vehicle was very similar to the Mod. 8 except for small changes in reinforcing plates at the bumper connection points and thicker walled energy absorbing struts. A slight weight reduction was also achieved with the Mod. 9 design, which showed a test weight of 2380 lbs. compared to 2580 lbs. for the Mod. 8. The specific design details of these subcompact vehicles are presented in Reference 4.

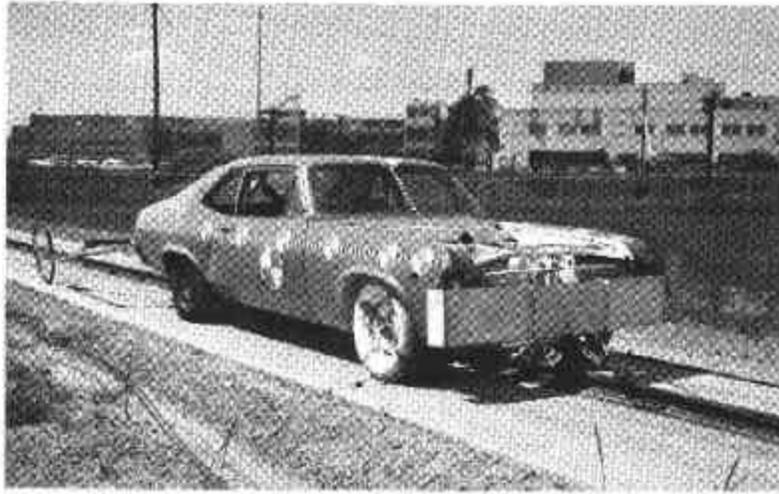
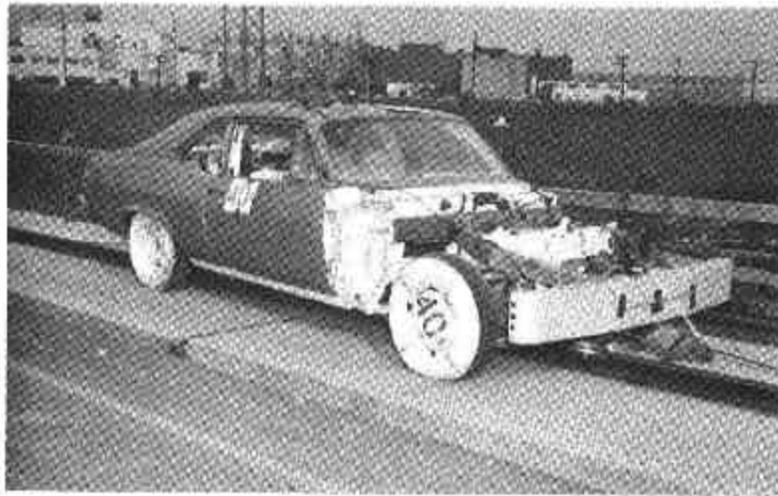
Figure 3-2 COMPACT MODIFIED VEHICLES

MOD. 2G NOVA

MOD. 2H1 NOVA

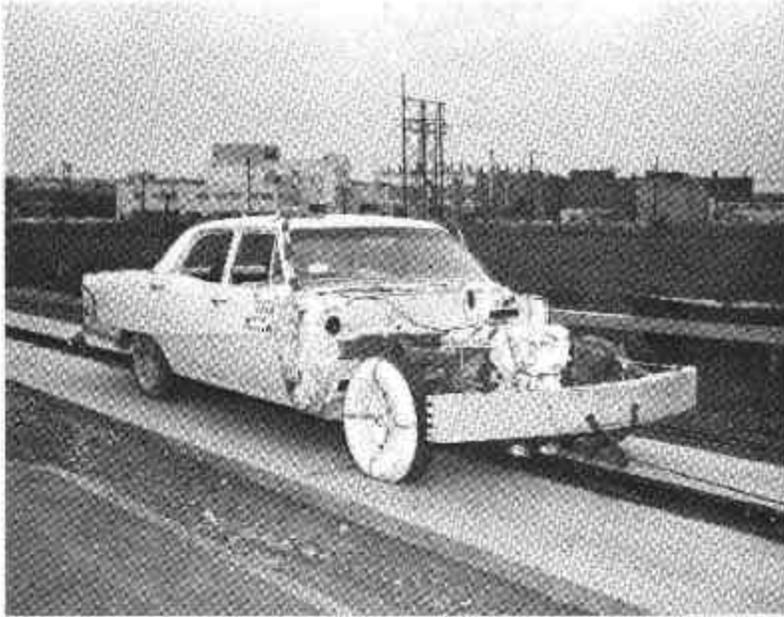
Figure 3-4 LARGE SIZE MODIFIED VEHICLE

The Mod. 1F design, shown in Figure 3-4, contained the same basic structural elements as used on the standard size Mod. 1D1 vehicle. These consisted of a rigid front bumper bar connected through small cushioning pads to four separate energy absorbing steel tubes and an engine-compartment separating mechanism mounted at the firewall. One major change from previous vehicle designs was in the use of aluminum in the firewall reinforcing beam and in the engine deflection ramp. The specific design details of the Mod. 1F car can be found in Reference 7.

MOD. 1F BUICK

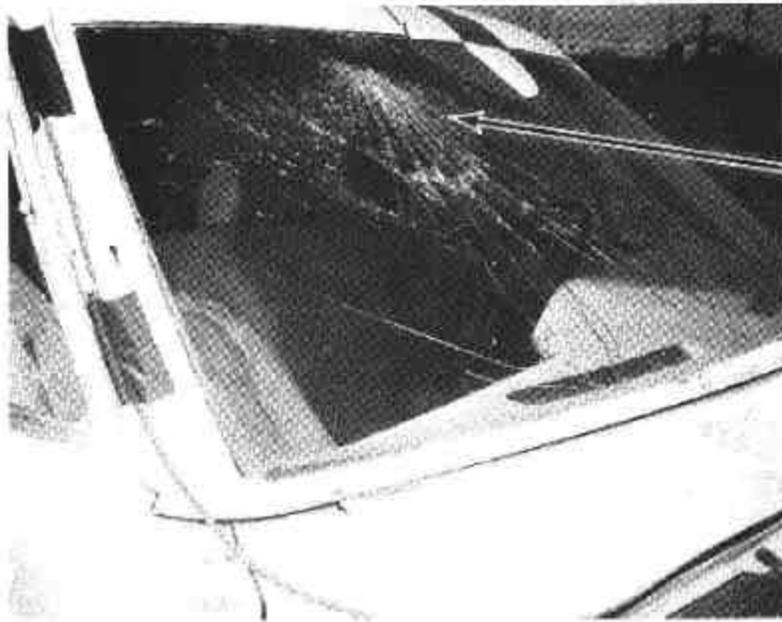
CRACKED  
WINDSHIELD

ROOF  
HEADER AREA

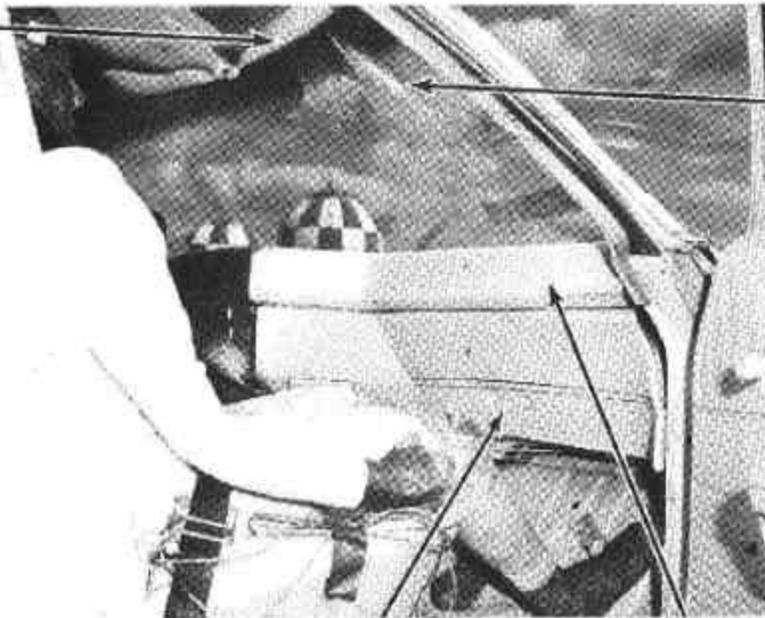
WINDSHIELD  
CRACKED FROM  
HEAD IMPACT

LOWER  
DASHBOARD
