DOT HS 807 441

Final Report

Final Report of 270° Contoured Moving Barrier Impact into a 1983 Honda Prelude 2-Door Coupe in Support of Crash III Damage Algorithm Reformation

The purpose of the four 270° contoured moving barrier impact tests was for research and development in support of the CRASH III damage algorithm reformulation.

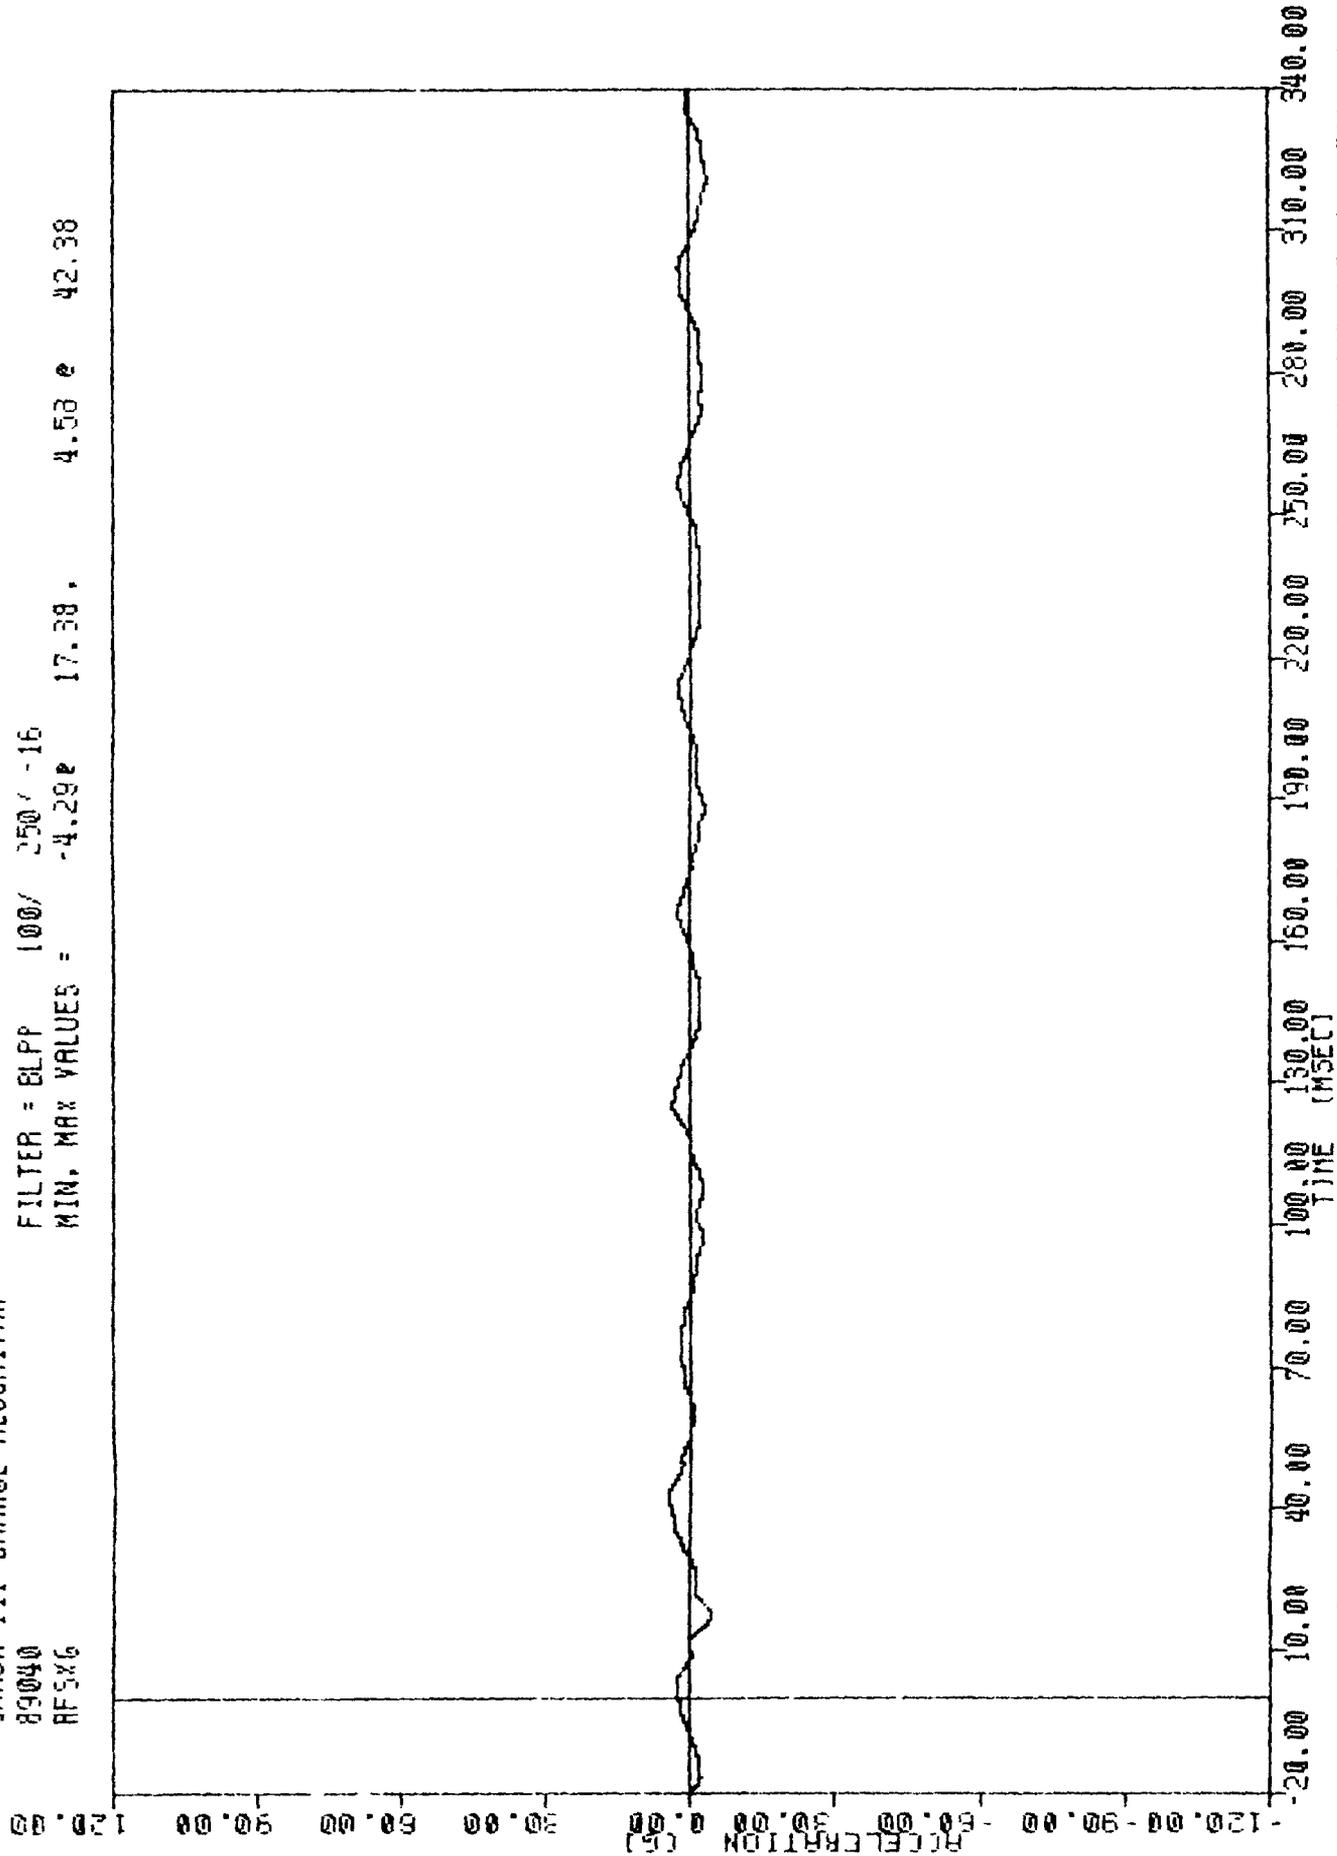
FILTER = BLPP 100/ 250 / -16
MIN. MAX VALUES = -4.292 4.58 e 42.38

CUNTOURED MOVING BARRIER INTO 90 DEG 1983 HONDA PRELUDE AT 18.1 MPH #1
RIGHT FRONT SILL X AXIS ACCELERATION

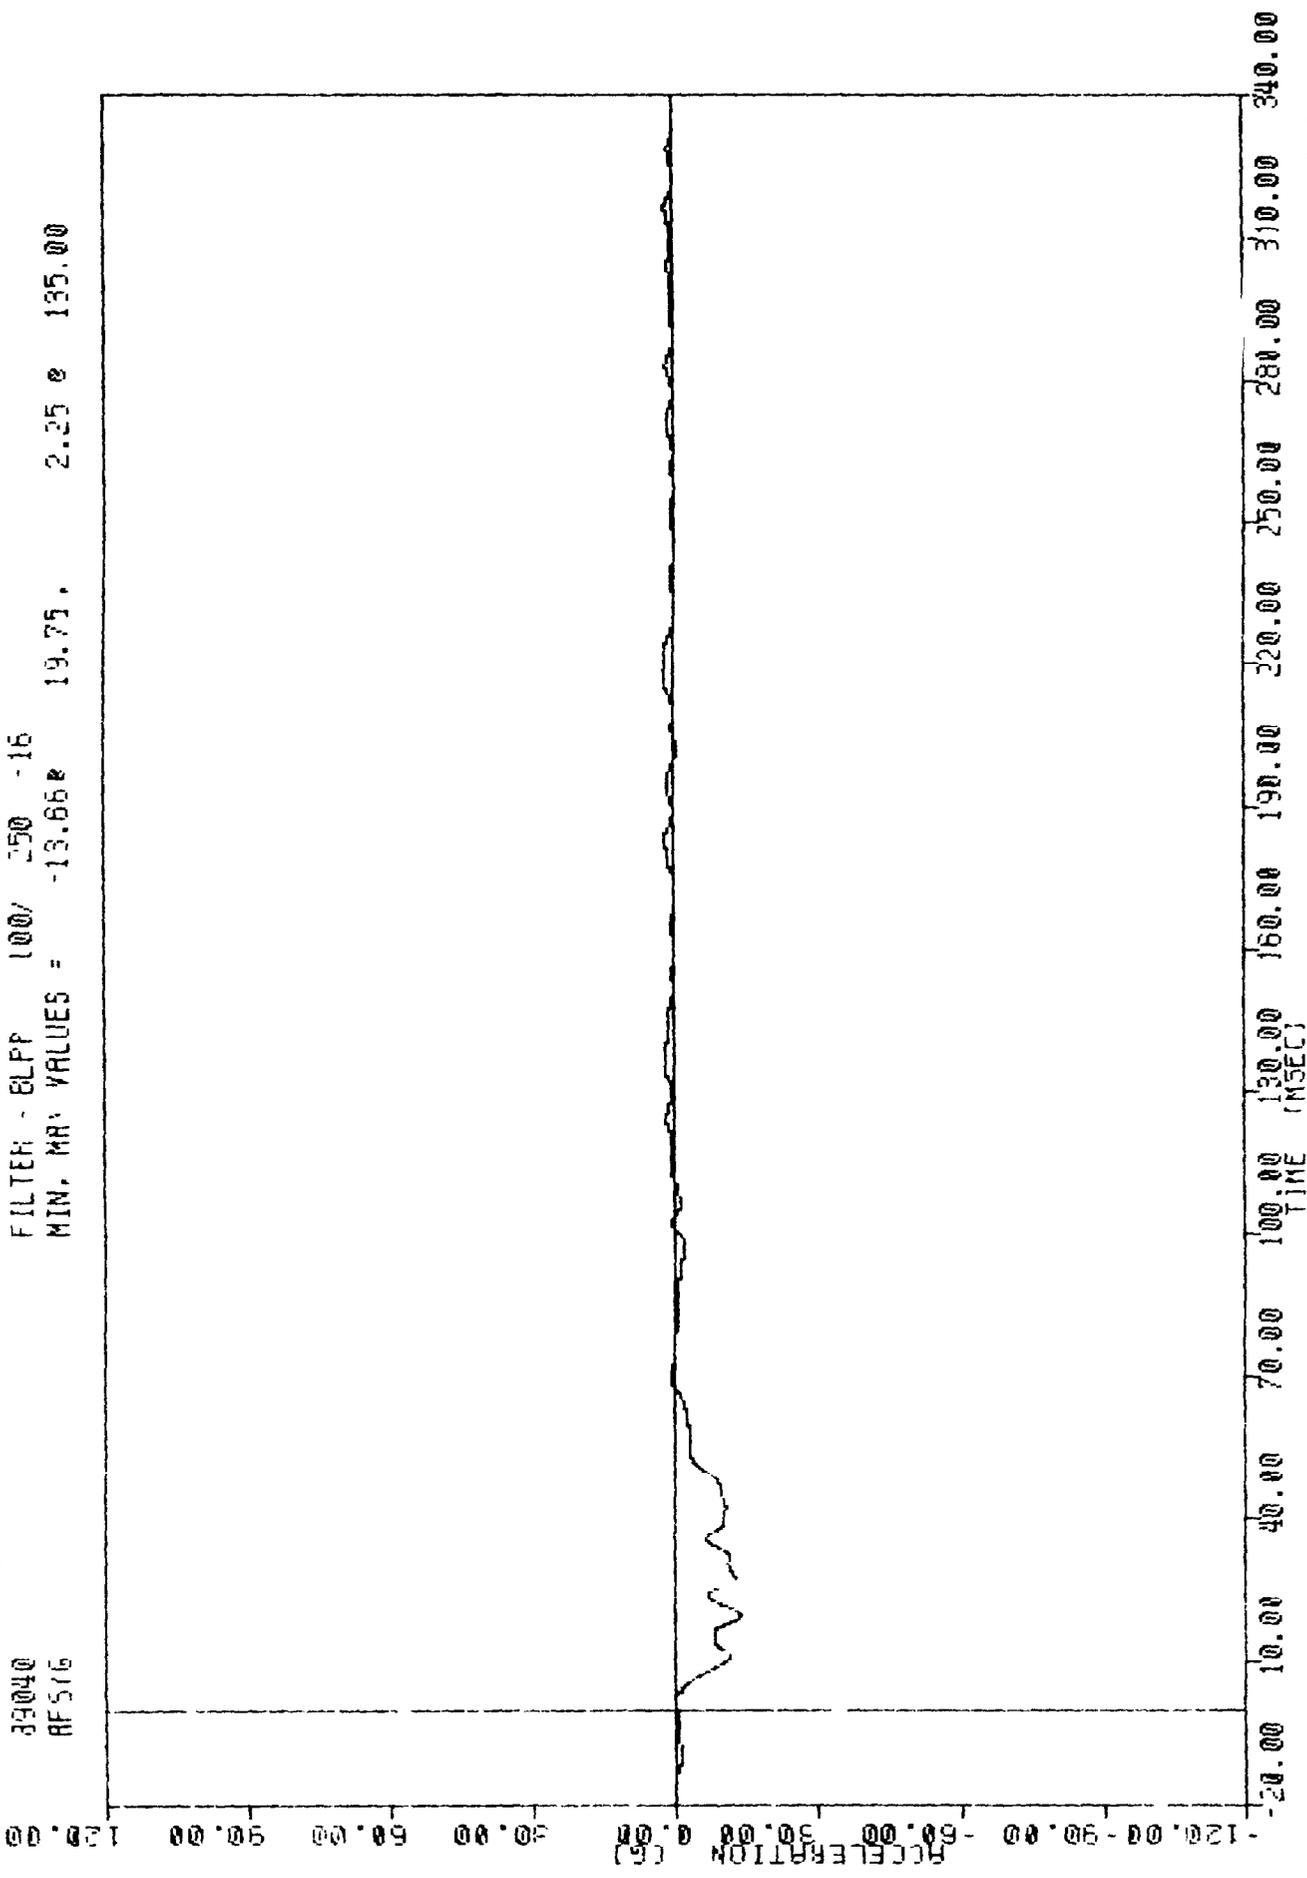
FILTER - BLPP 100/ 250 -16
 MIN. MAX VALUES = -13.66 19.75 2.25 135.00

COUNTERED MOVING BARRIER INTO 90 DEG HONDA PRELUDE AT 18.1 MPH *1
 RIGHT FRONT SILL Y AXIS ACCELERATION

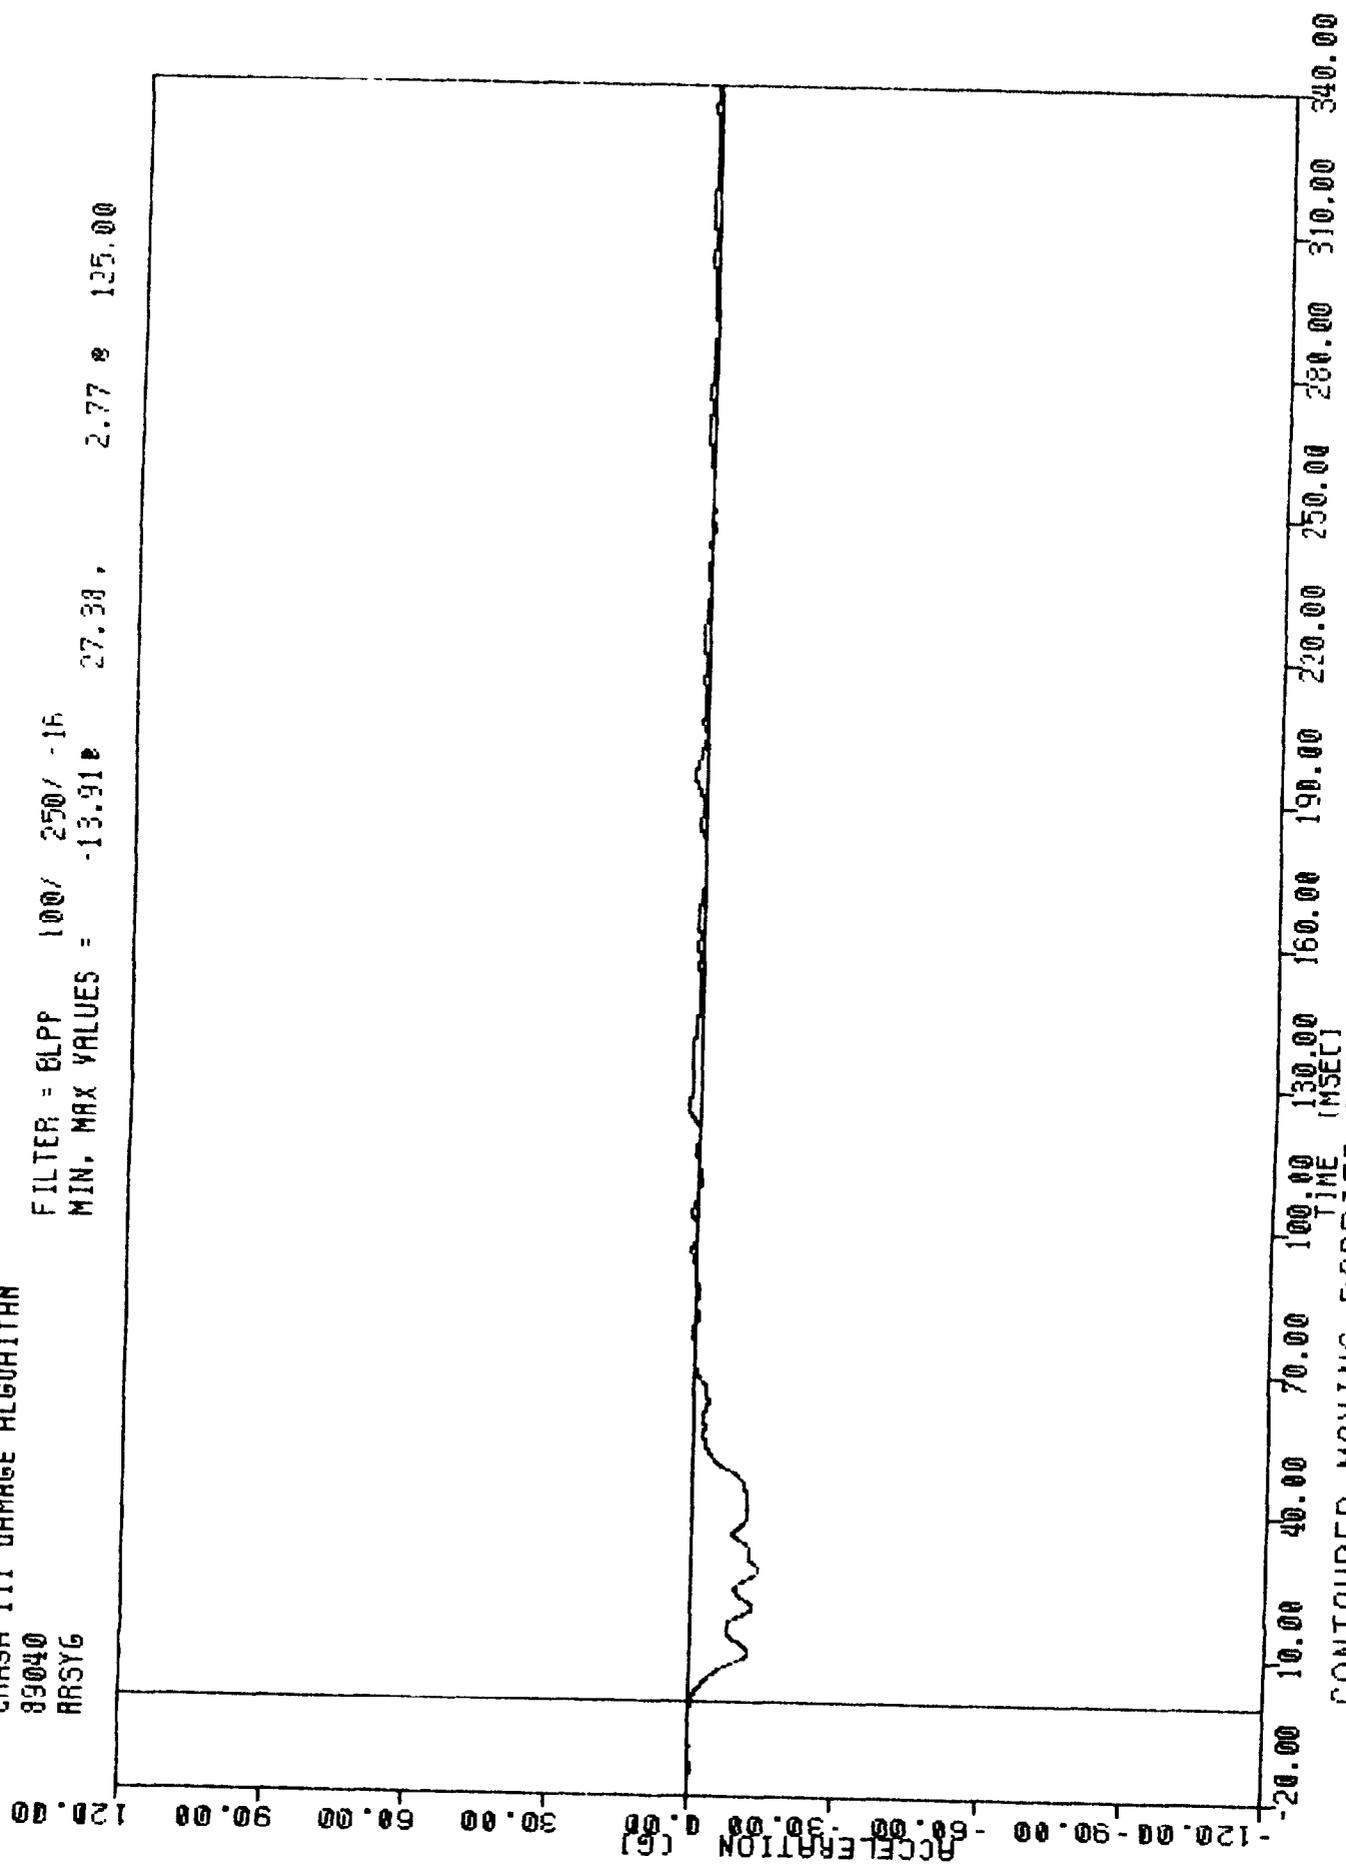
FILTER = 6LPP 100/ 250/ -15
MIN. MAX VALUES = -13.91 27.38 2.77 125.00

CONTOURED MOVING BARRIER INTO 30 DEG 1983 HONDA PRELUDE AT 18.1 MPH
RIGHT REAR SILL Y AXIS ACCELERATION

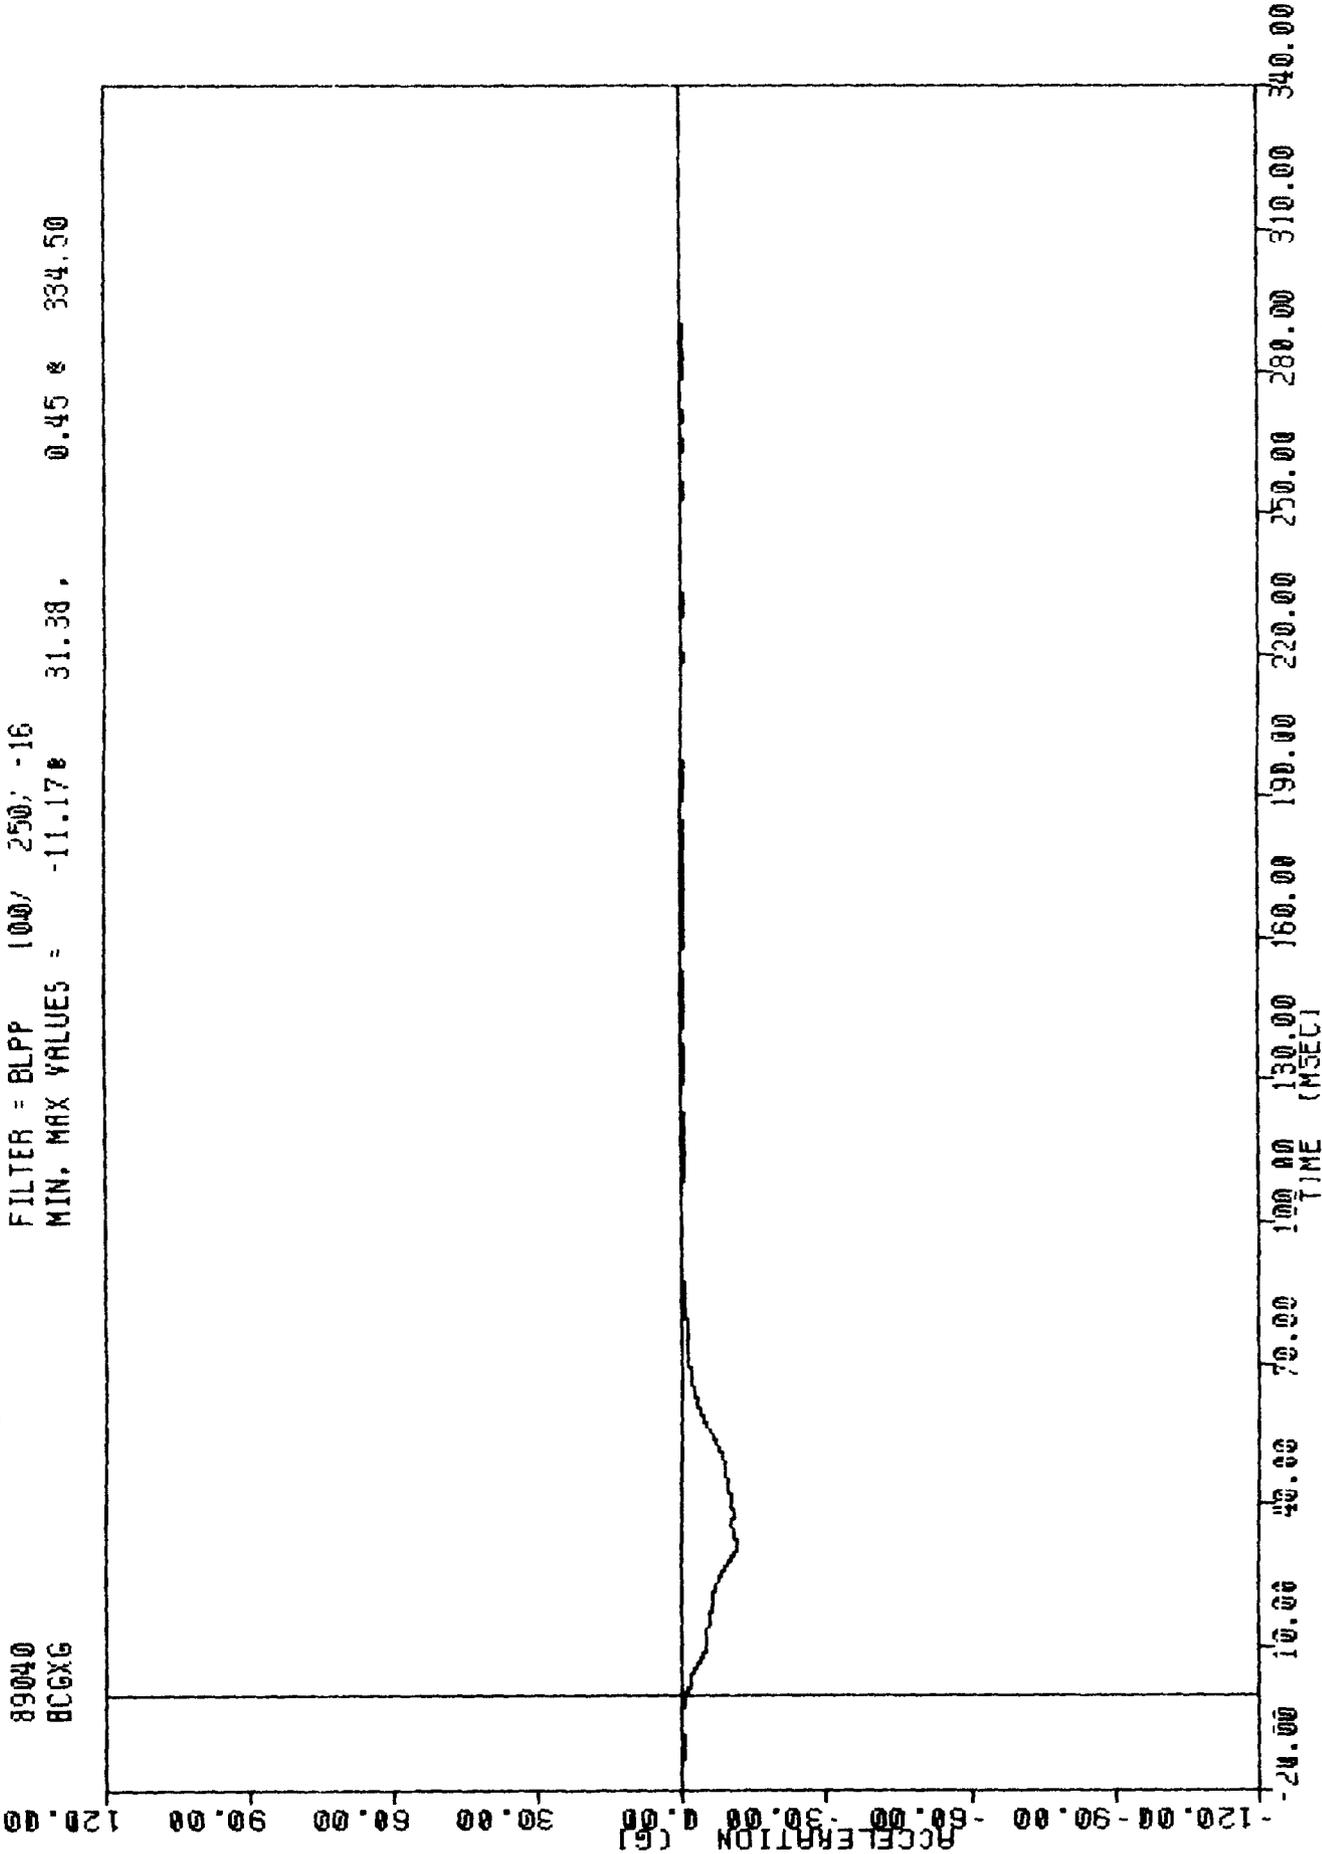
FILTER = BLPP 100/ 250, -16
MIN. MAX VALUES = -11.17 e 31.38 , 0.45 e 334.50

CONTOURED MOVING BARRIER INTO 90 DEG HONDA PRELUDE AT 18.1 MPH #1
CONTOURED MOVING BARRIER CENTER OF GRAVITY X AXIS ACCELERATION

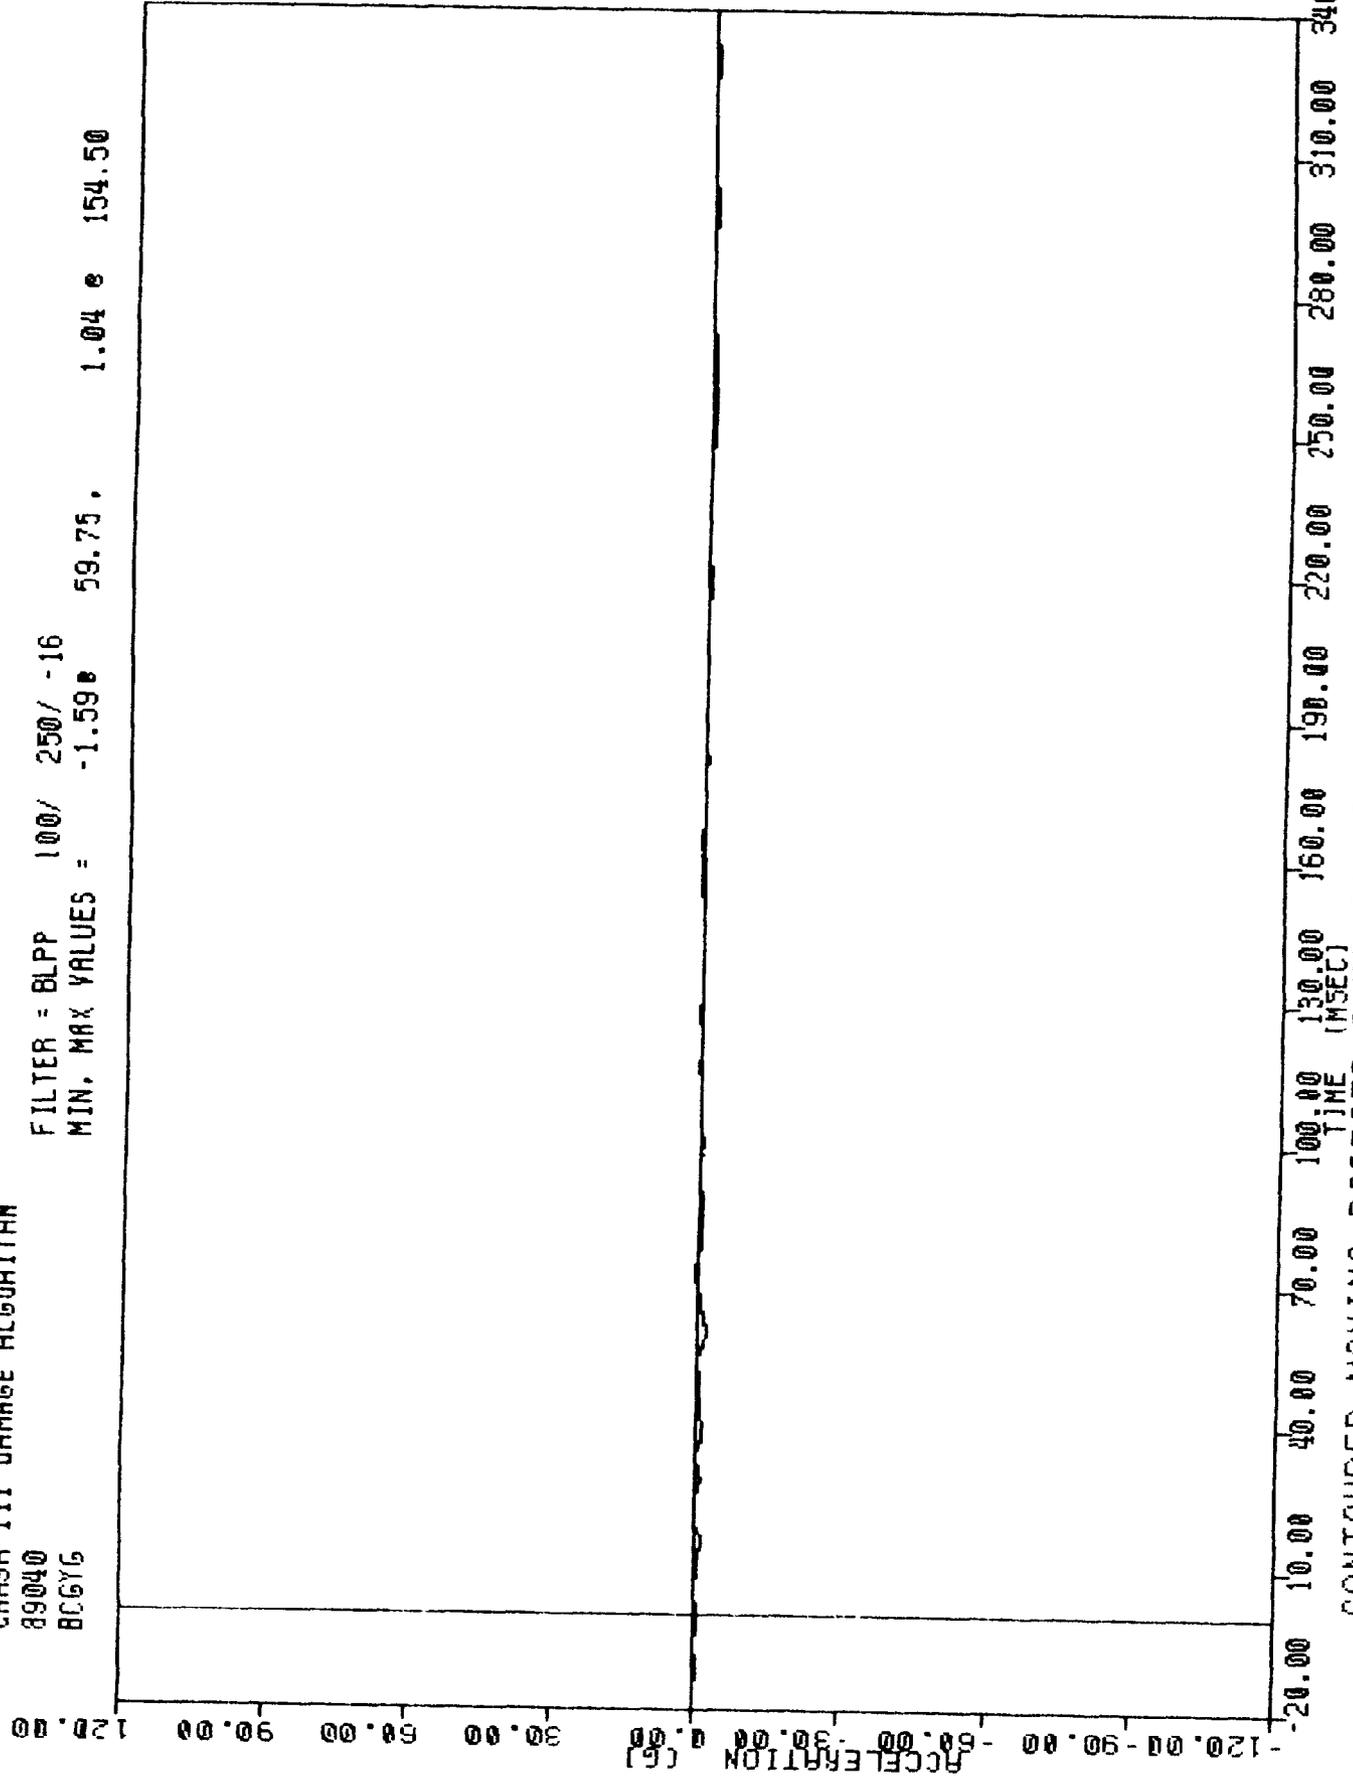
FILTER = BLPP 100/ 250/ -16
 MIN. MAX VALUES = -1.59e 59.75, 1.04 e 154.50

CONTOURED MOVING BARRIER INTO 90 DEG 1983 HONDA PRELUDE AT 18.1 MPH #1
 CONTOURED MOVING BARRIER CENTER OF GRAVITY Y AXIS ACCELERATION

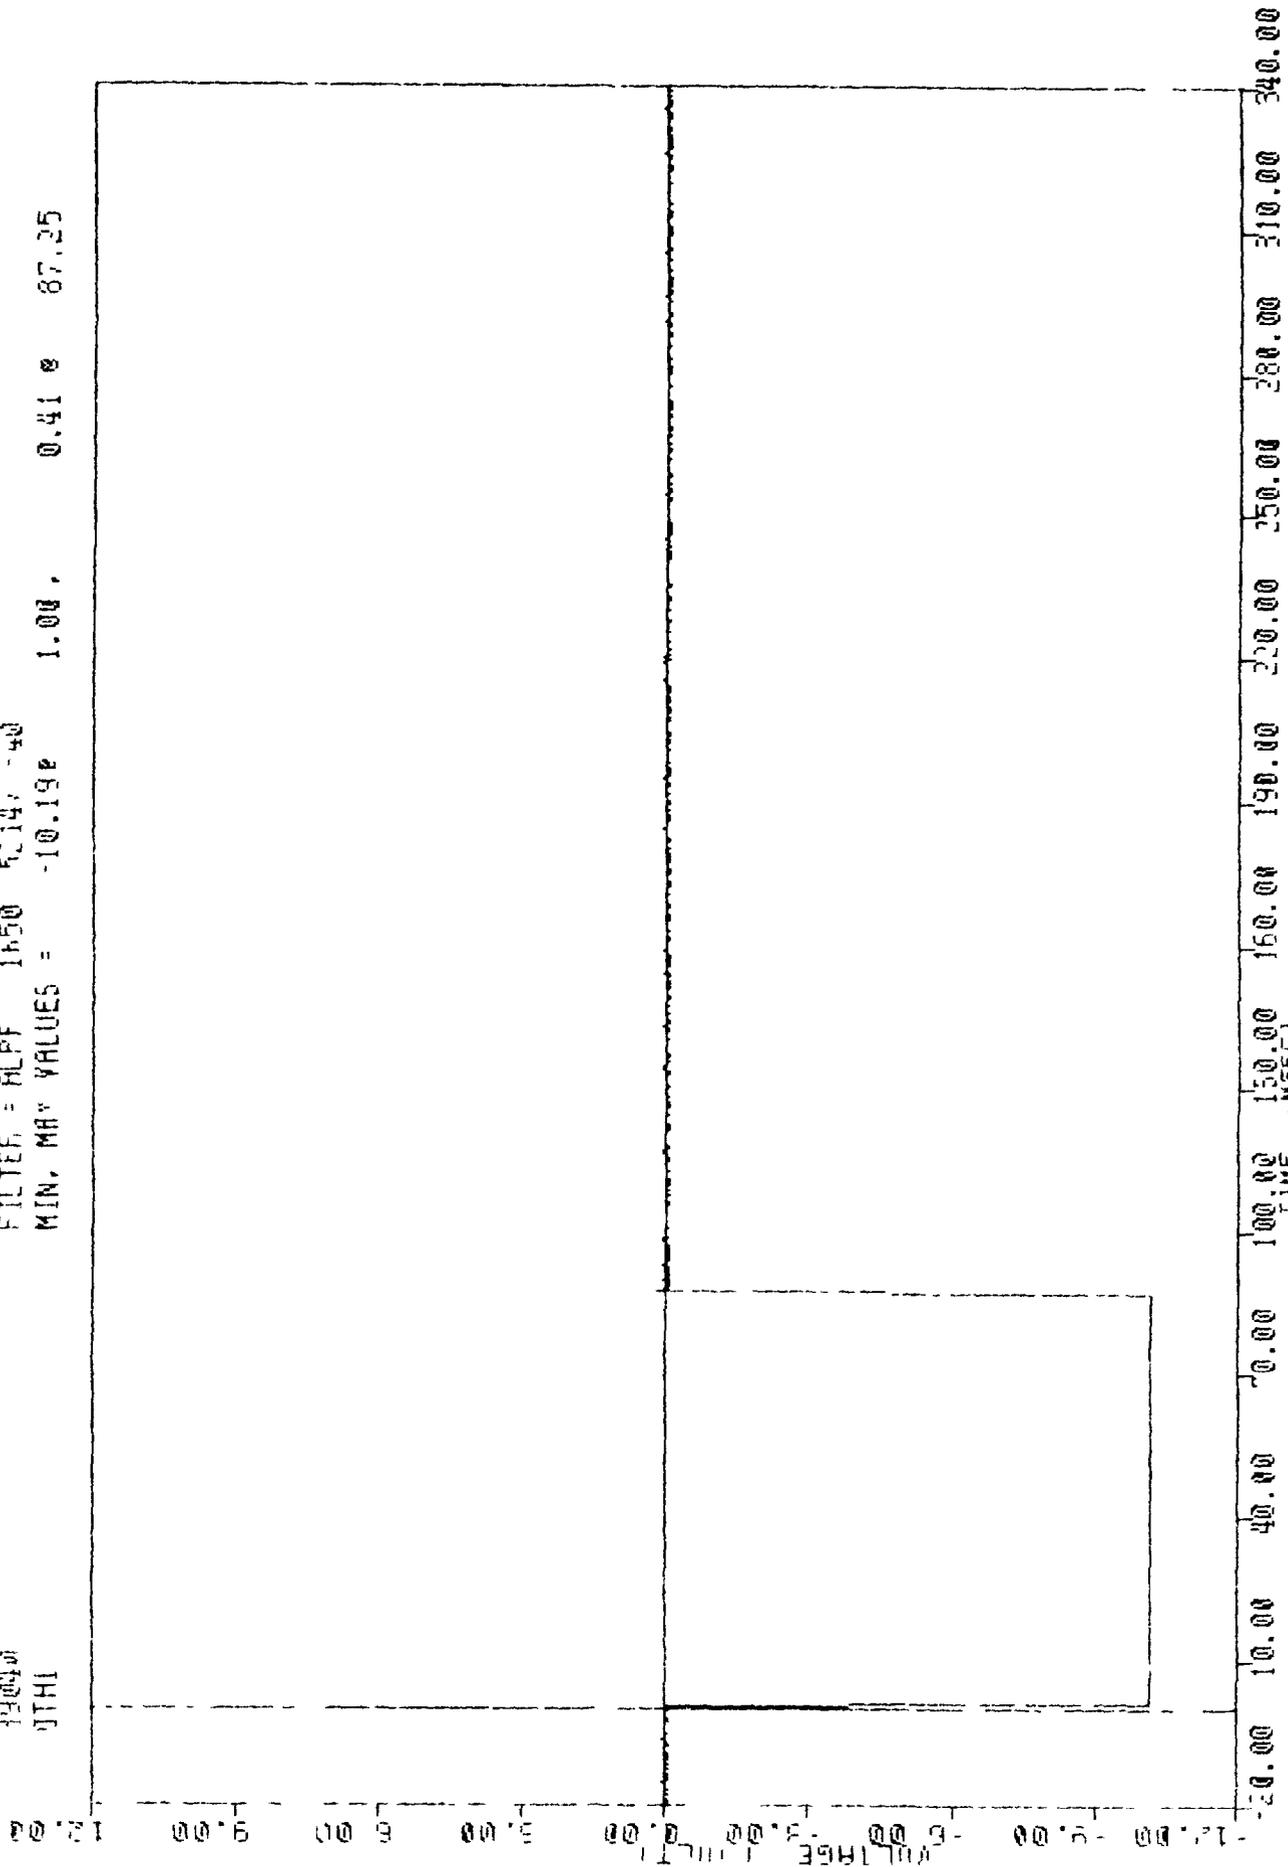
FILTER = ALPF 1650 52147 -40
 MIN. MAX VALUES = -10.198 1.00 0.41 87.25

CONToured MOVING BARRIER INTO 90 DEG 1983 HONDA PRELUDE AT 18.1 MPH *1
 VEHICLE CONTACT SWITCH - LEFT

Noise in the form of spikes was observed in the plots for the contact switches OTH1, OTH2, OTH3, OTH4. * The switches were used to record the time of vehicle contact with the moving barrier, as well as the time of vehicle separation from the barrier. The switches were damaged by the crush of the moving contoured barrier against the vehicle. The switches were replaced following each test which contained spikes. This is not the standard use of such switches.

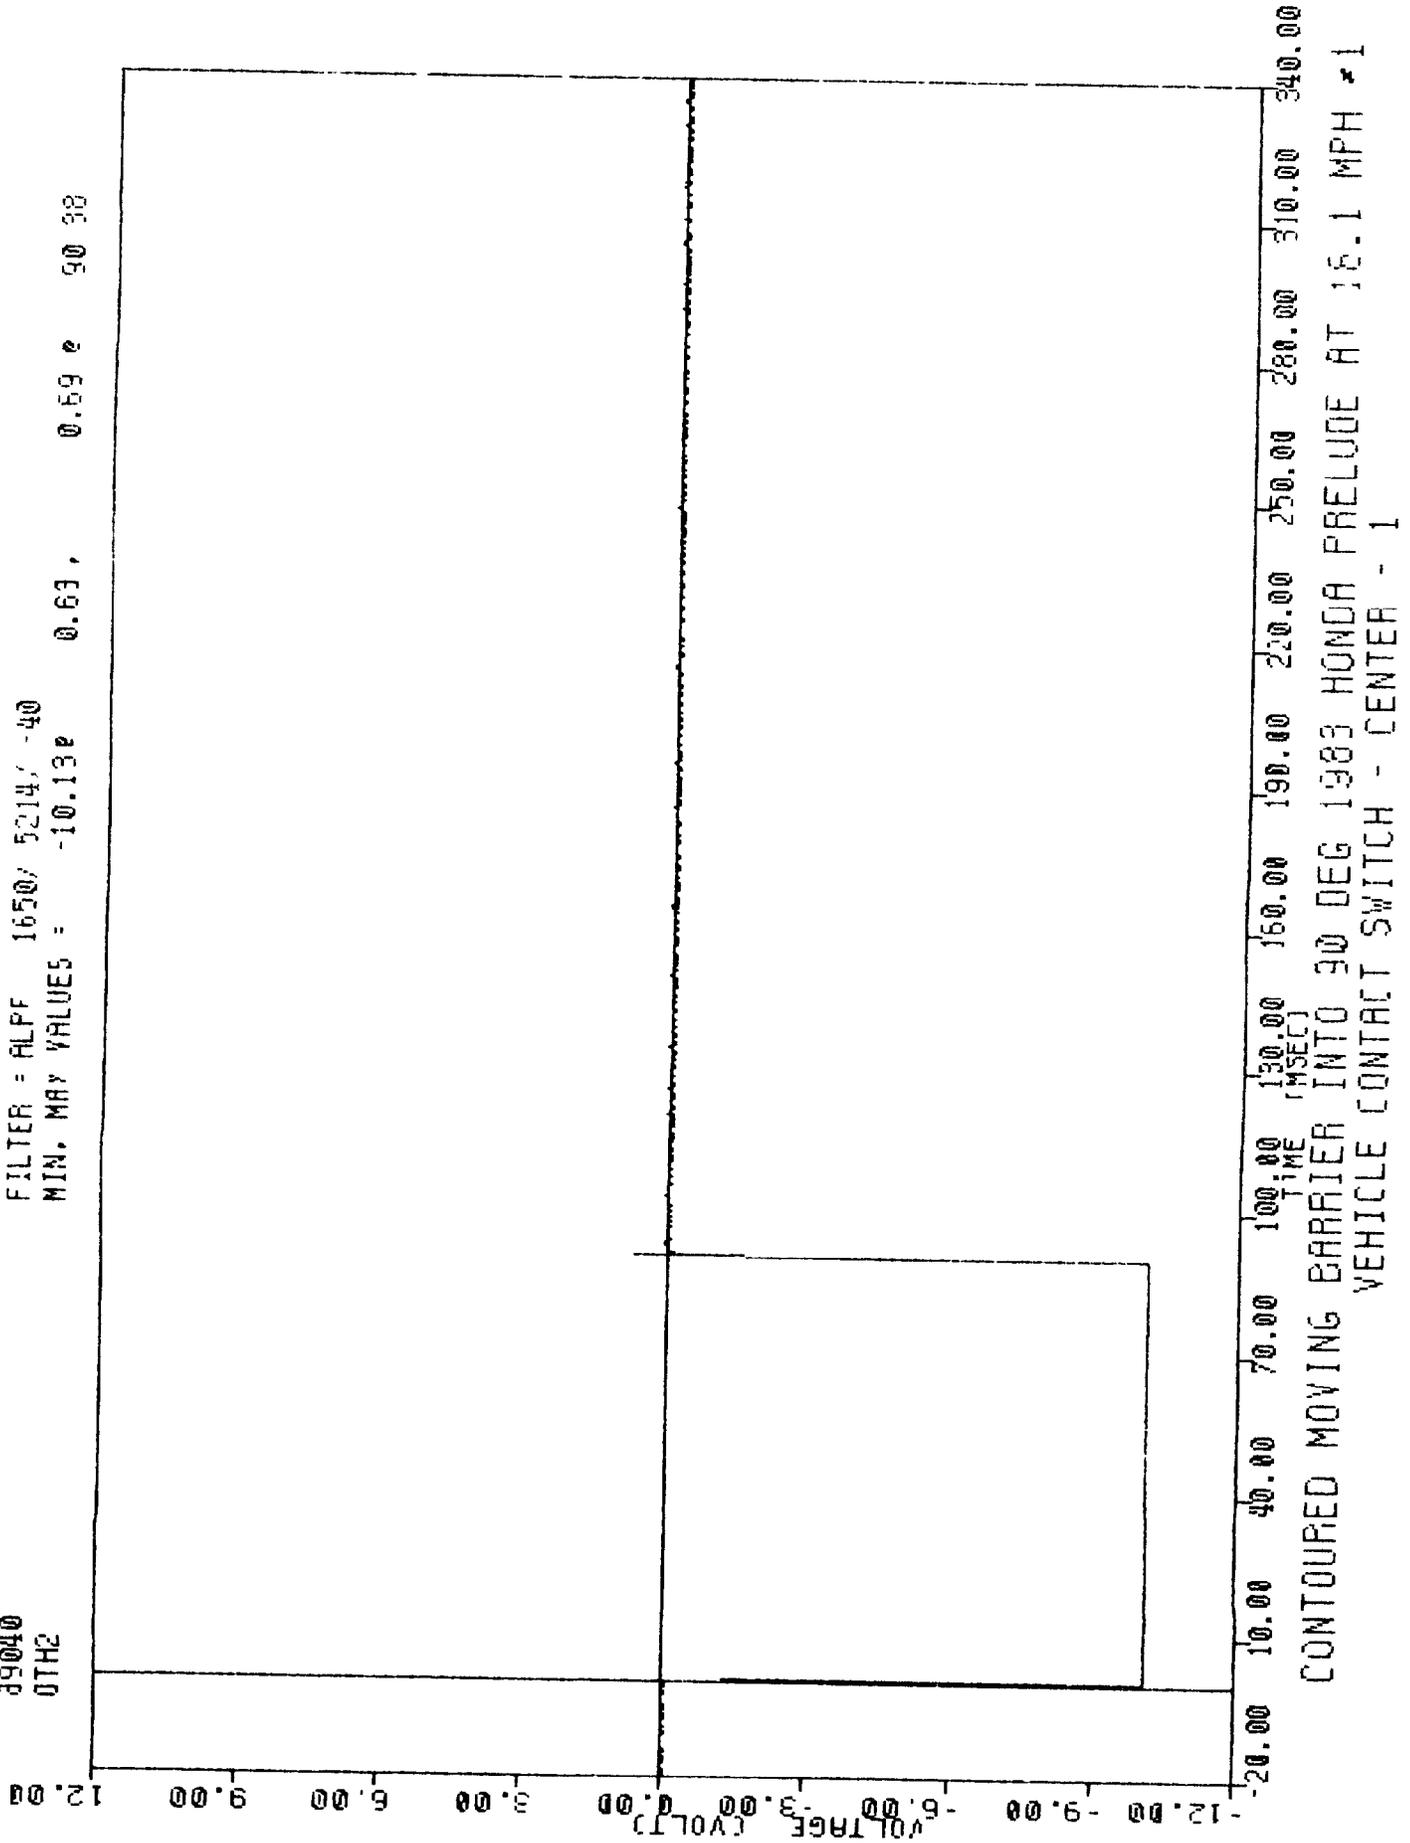
FILTER = ALPF 1650/ 5214, -40
MIN. MAX VALUES = -10.13e 0.69, 0.59 e 90 38

CONToured MOVING BARRIER INTO 90 DEG 1983 HONDA PRELUDE AT 16.1 MPH *1
VEHICLE CONTACT SWITCH - CENTER - 1

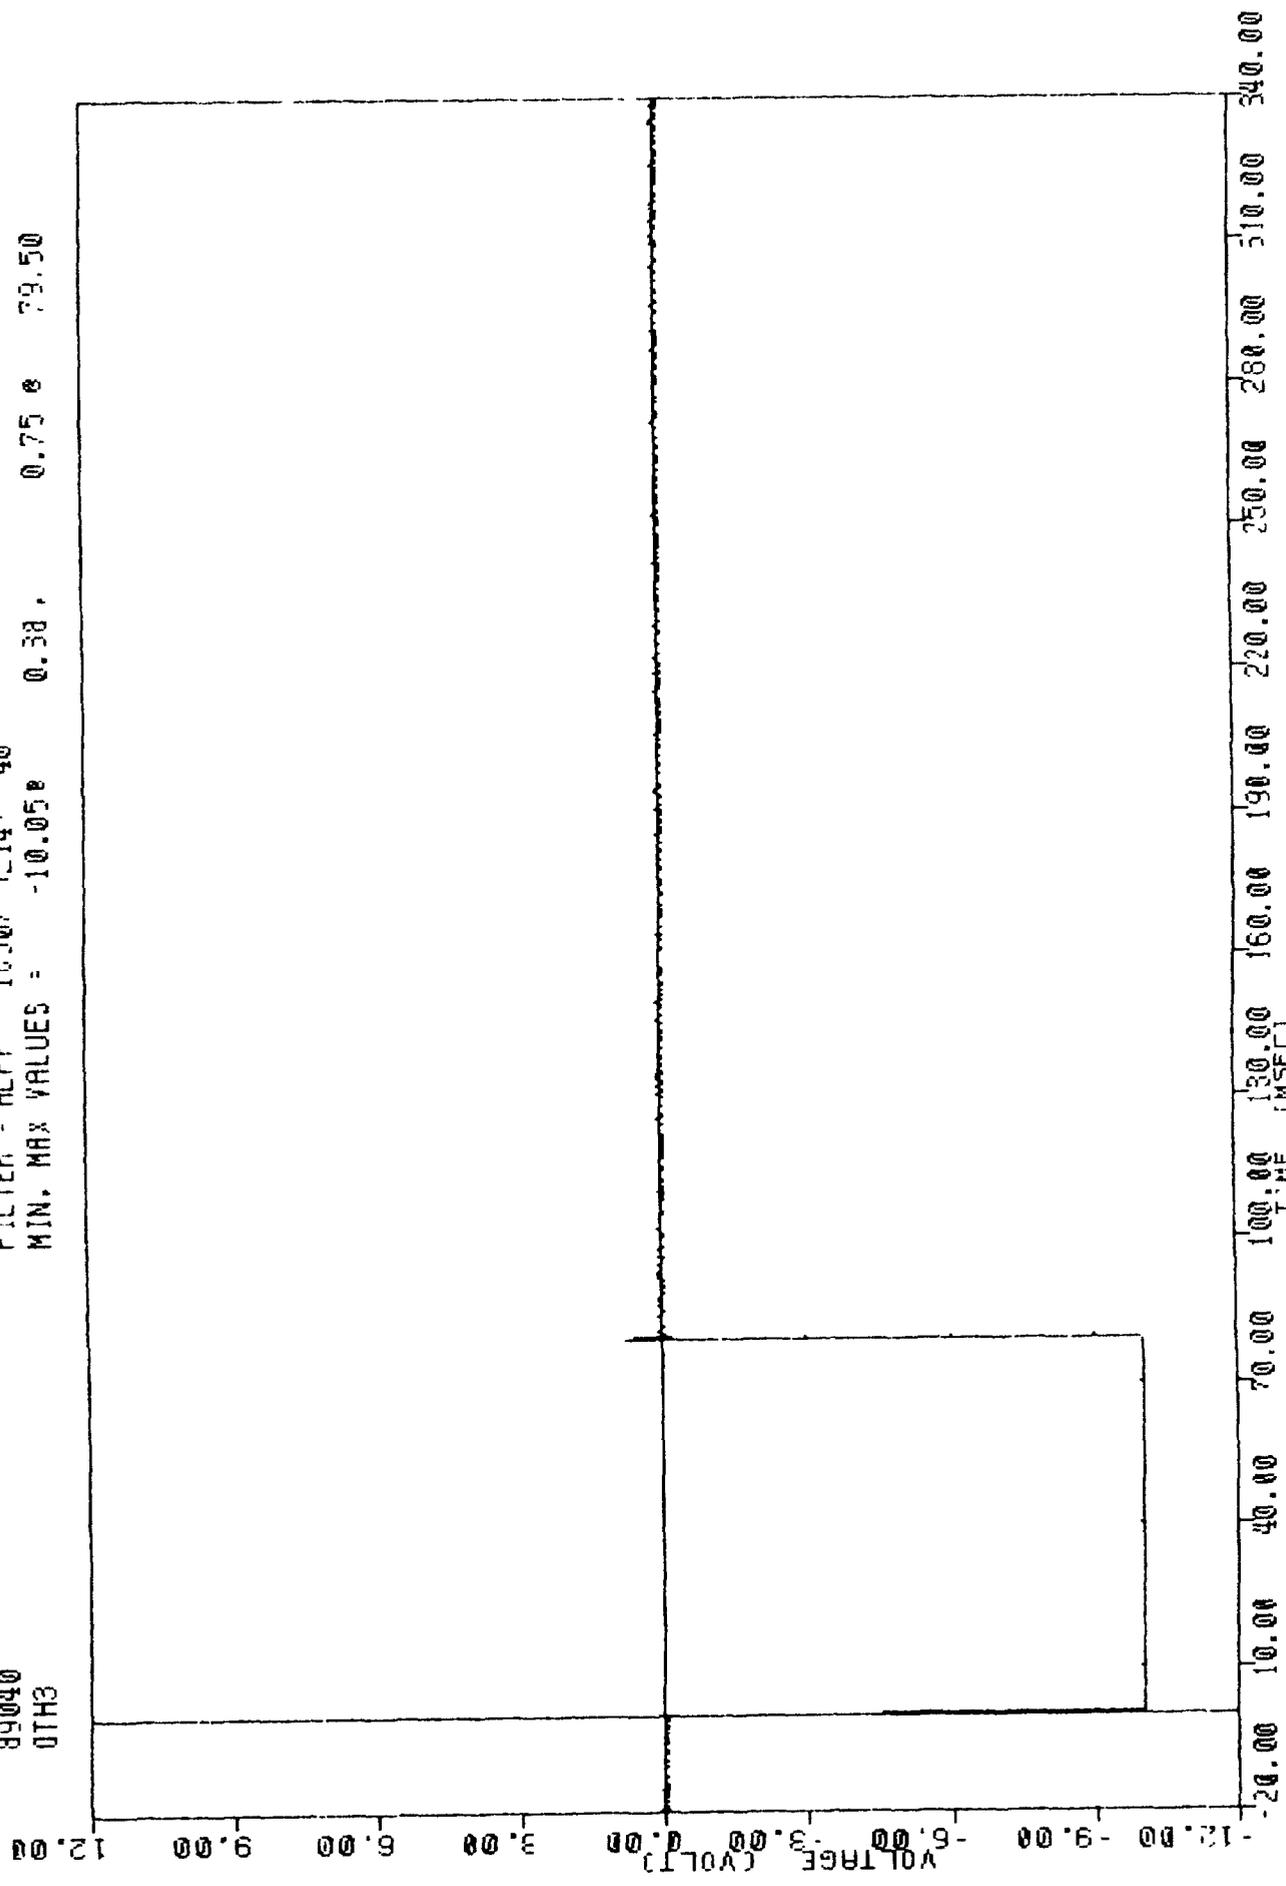
FILTER = ALPF 1650/ 5214/ -40
 MIN. MAX VALUES = -10.05e 0.38 , 0.75 e 79.50

CONToured MOVING BARRIER INTO 90 DEG 1983 HONDA PRELUDE AT 18.1 MPH #1
 VEHICLE CONTACT SWITCH - CENTER - 2

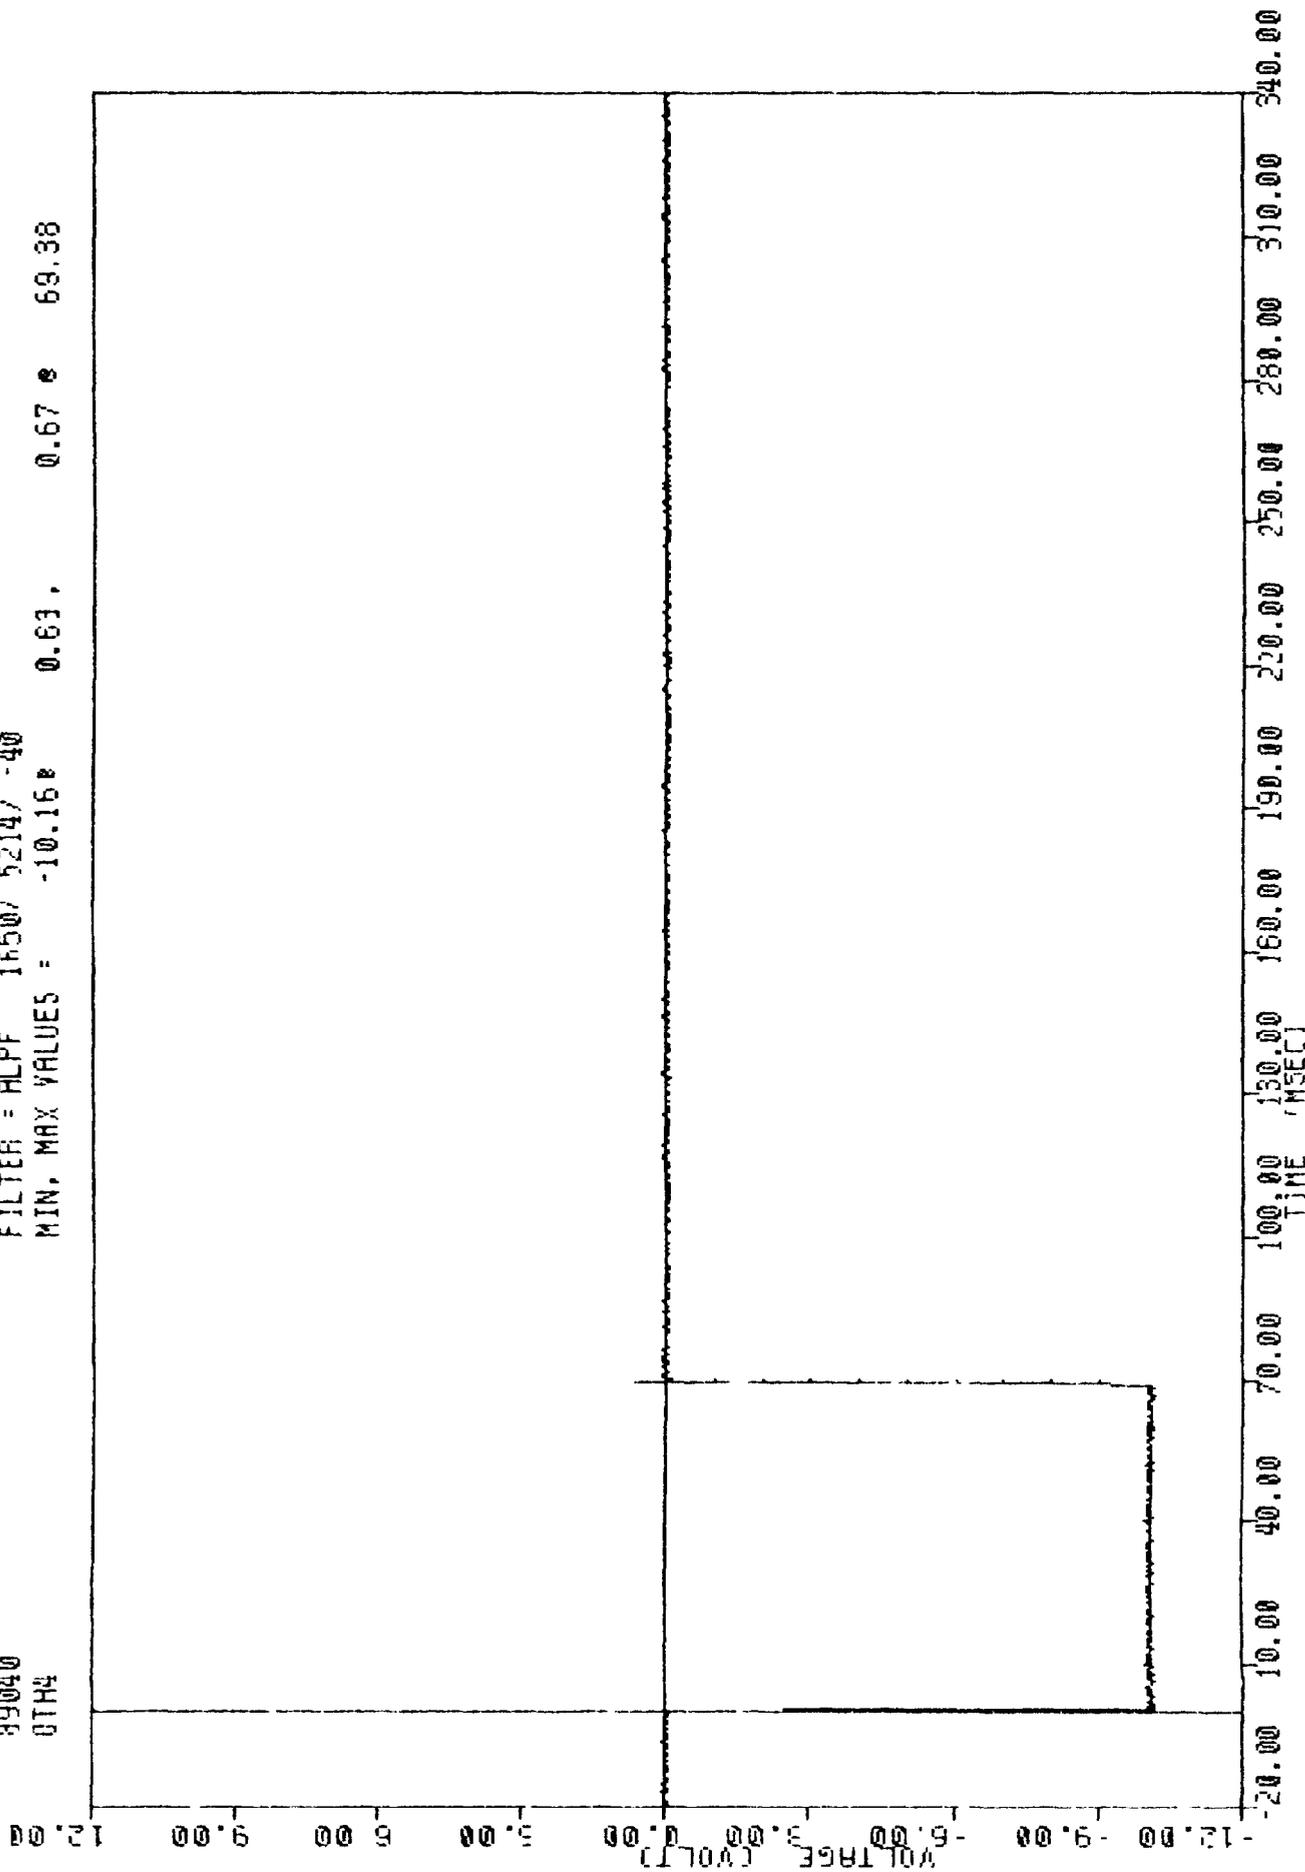
FILTER = ALPF 1650/ 5214/ -40
MIN, MAX VALUES = -10.16 0.63, 0.67 e 69.38

CONToured MOVING BARRIER INTO 90 DEG 1983 HONDA PRELUDE AT 18.1 MPH #1
VEHICLE CONTACT SWITCH - RIGHT
