DOT HS 807 441

Final Report

Final Report of 270° Contoured Moving Barrier Impact into a 1983 Honda Prelude 2-Door Coupe in Support of Crash III Damage Algorithm Reformation

The purpose of the four 270° contoured moving barrier impact tests was for research and development in support of the CRASH III damage algorithm reformulation.

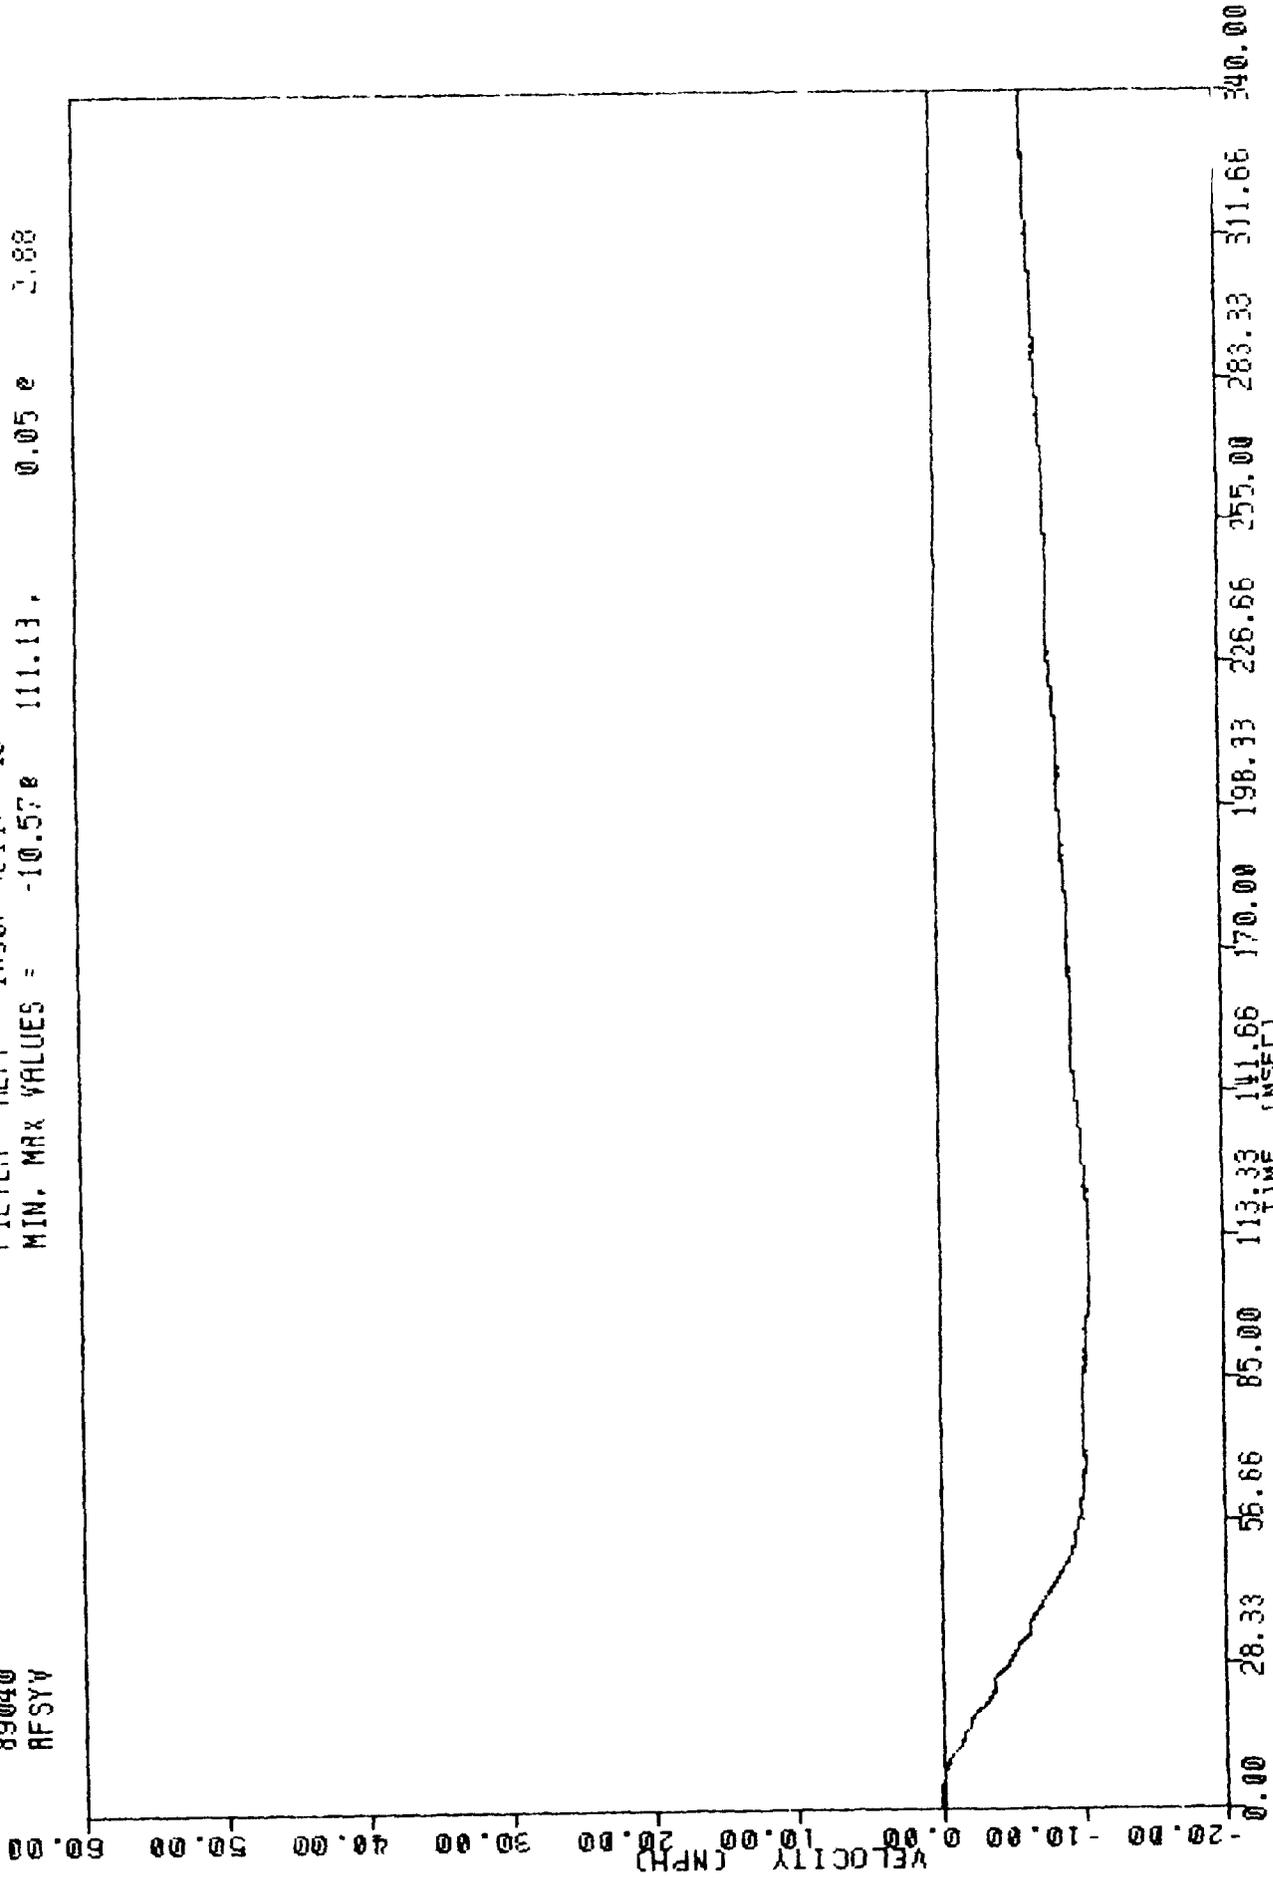
FILTER = ALPF 1650/ 5214/ -40
 MIN. MAX VALUES = -10.57 111.13 0.05 e 2.88

CONTOURED MOVING BARRIER INTO 90 DEG HONDA PRELUDE AT 18.1 MPH *1
 RIGHT FRONT SILL Y AXIS VELOCITY

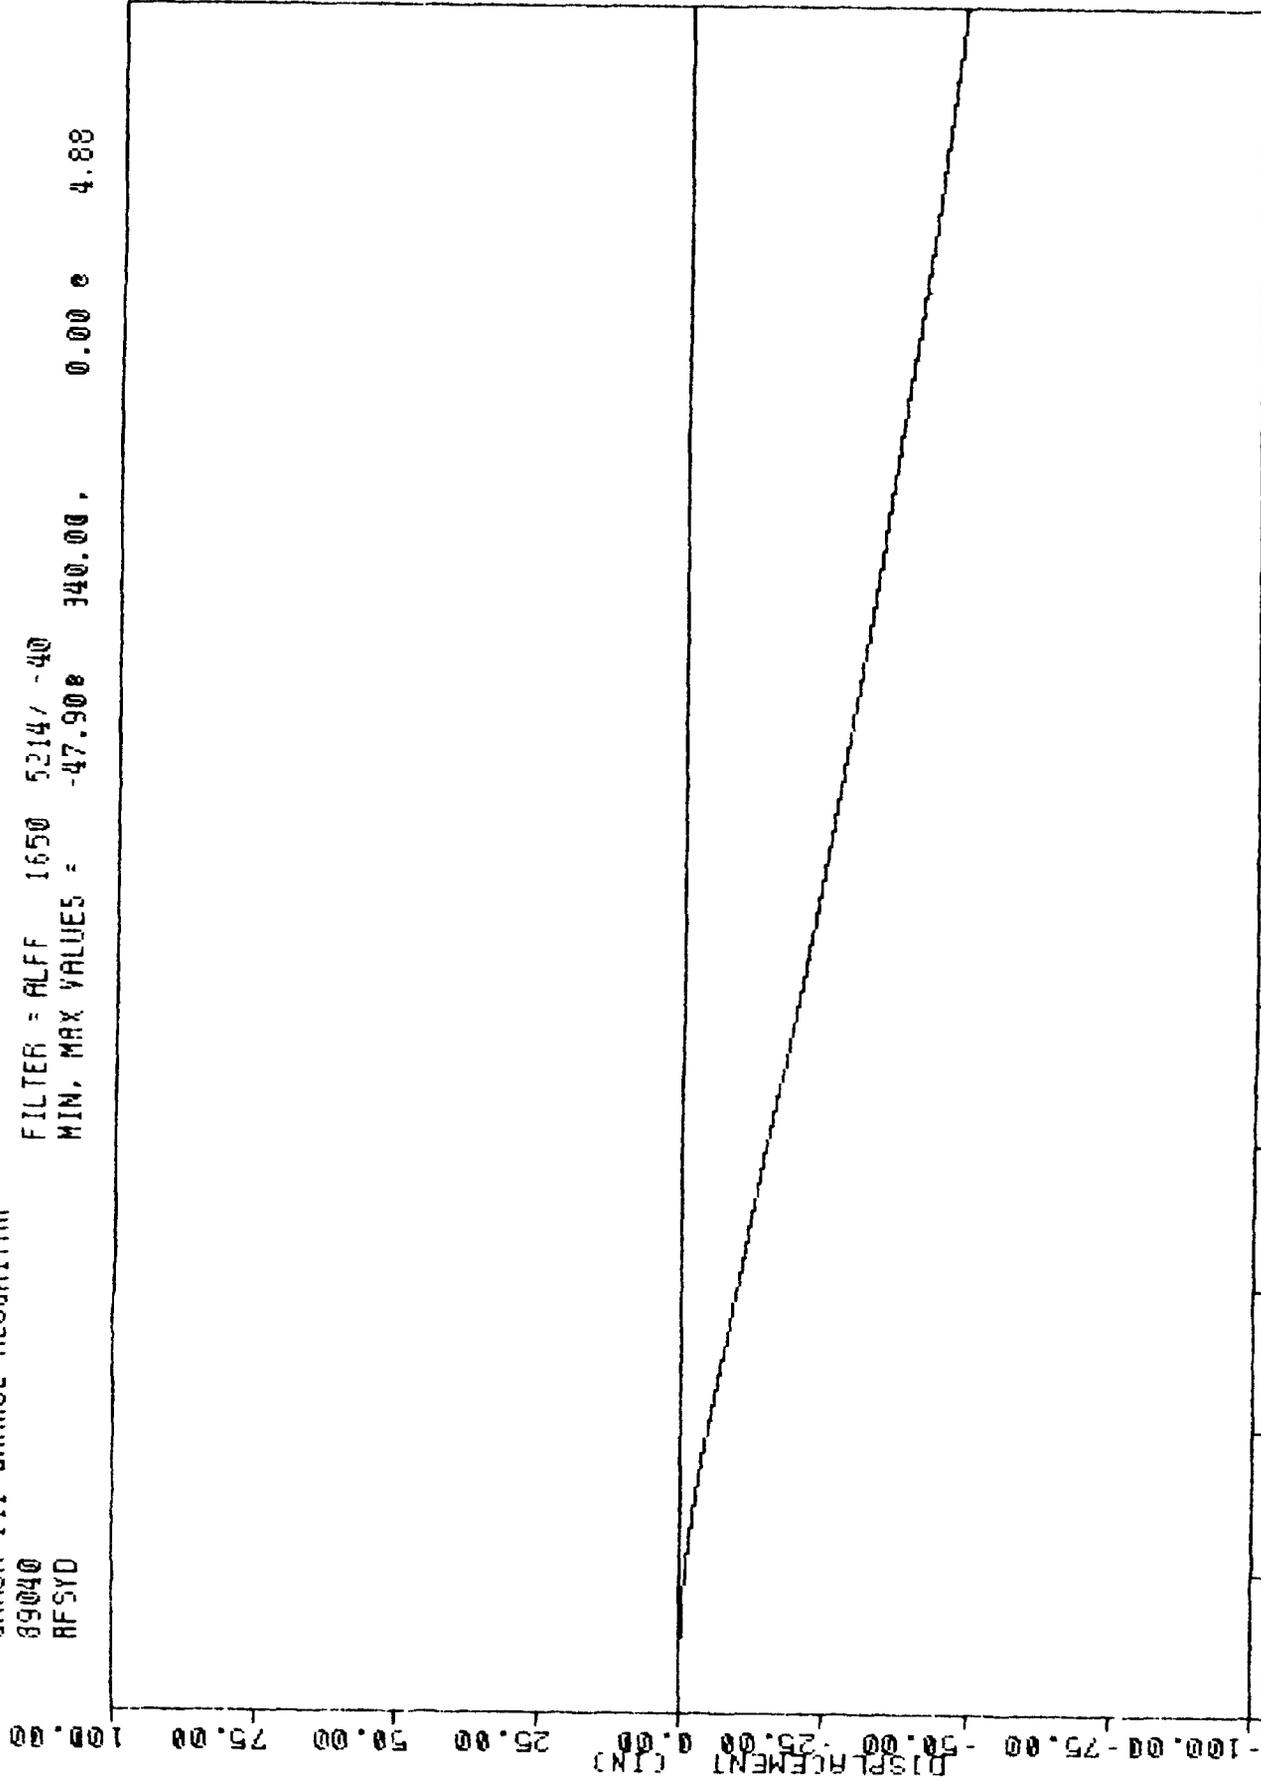
FILTER = ALFF 1650 5214 / -40
 MIN, MAX VALUES = -47.90e 340.00, 0.00 e 4.88

CONTOURED MOVING BARRIER INTO 90 DEG HONDA PRELUDE AT 18.1 MPH = 1
 RIGHT FRONT SILL Y AXIS DISPLACEMENT

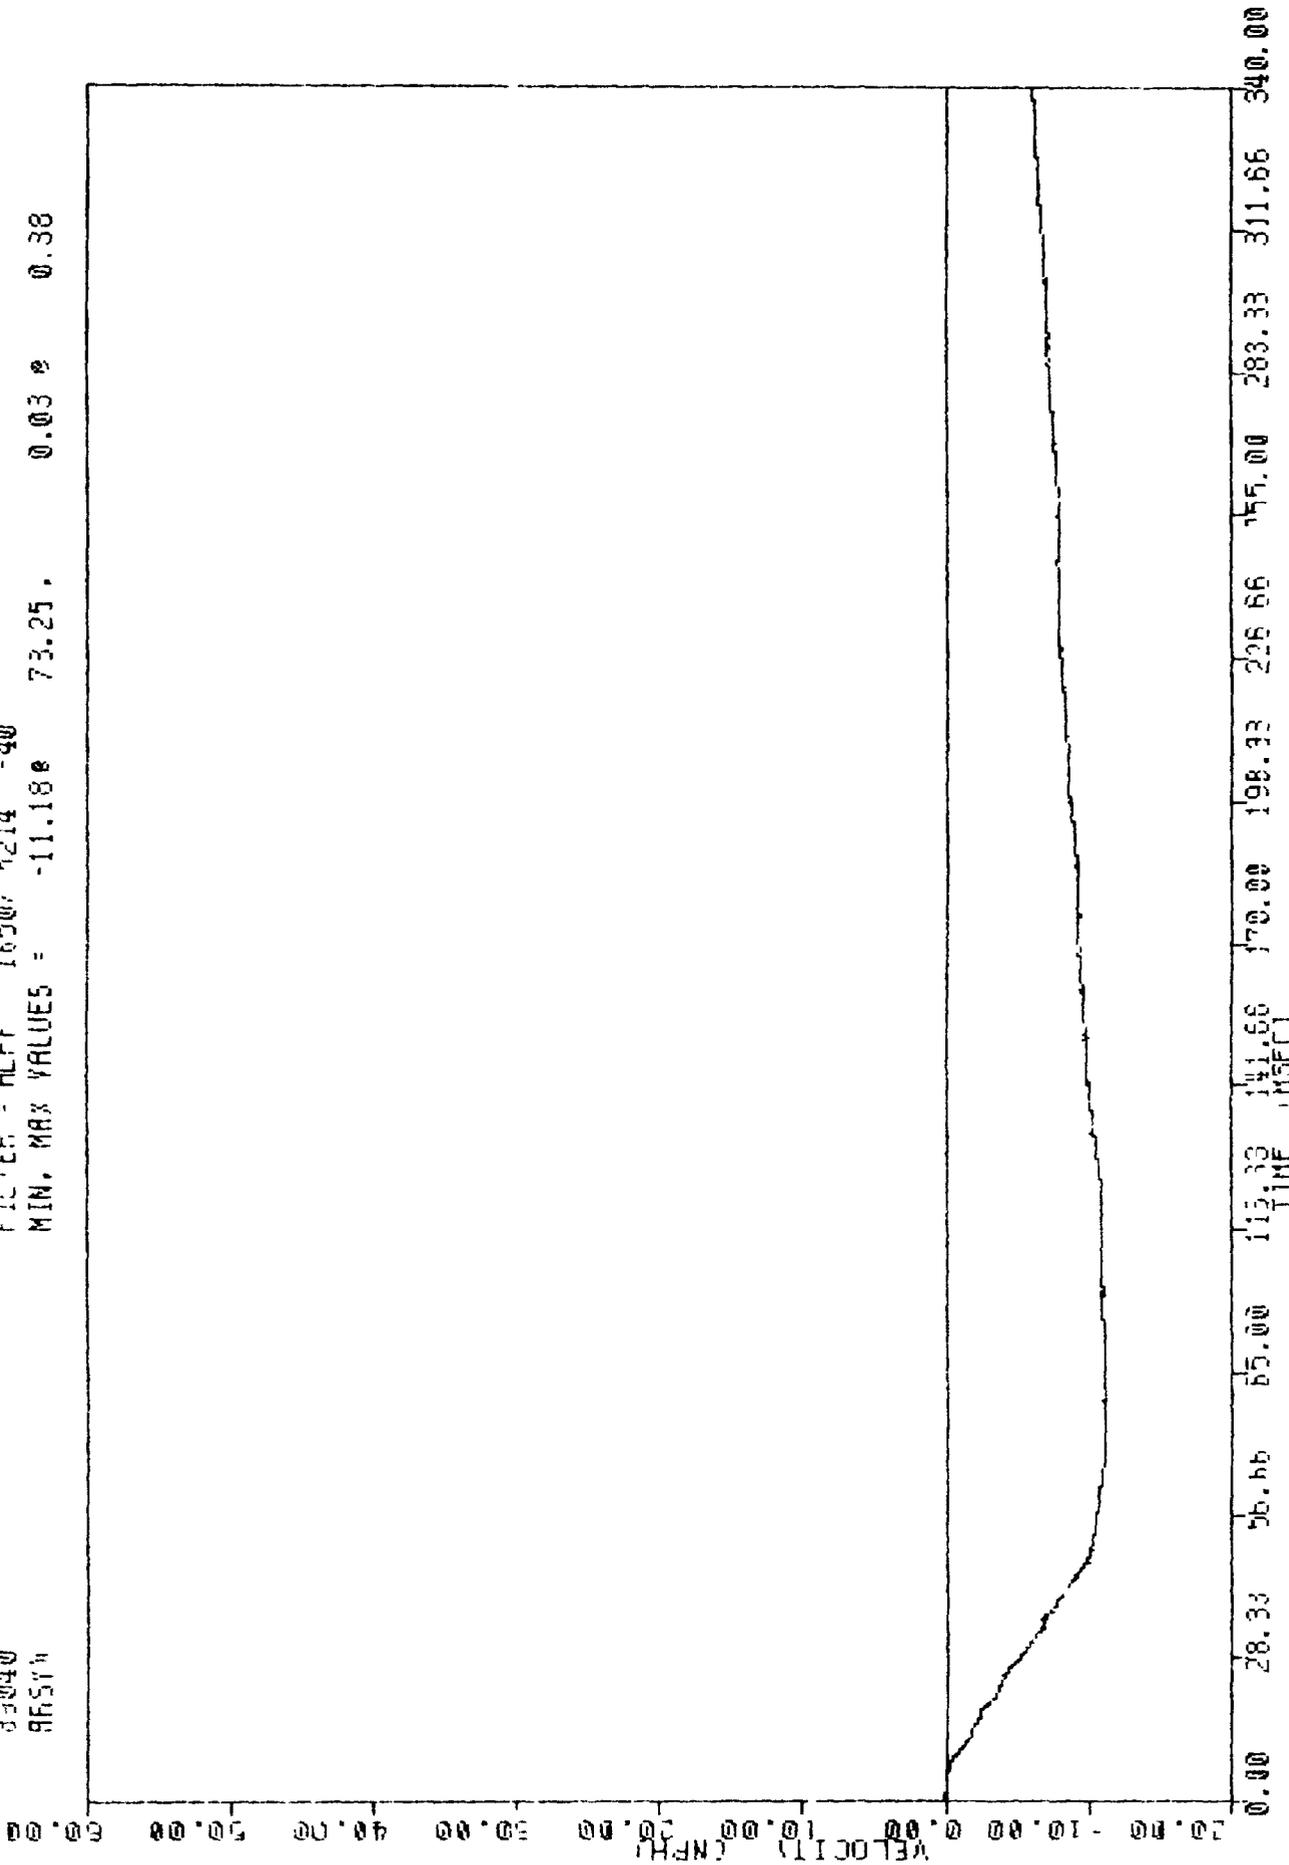
35040
RESYN
FILTER = ALFF 1650, 5214 -40
MIN, MAX VALUES = -11.18e 73.25, 0.03 e 0.38

CUNTOURED MOVING BARRIER INTO 90 DEG 1983 HONDA PRELUDE AT 18.1 MPH *1
RIGHT PEAR SILL Y AXIS VELOCITY

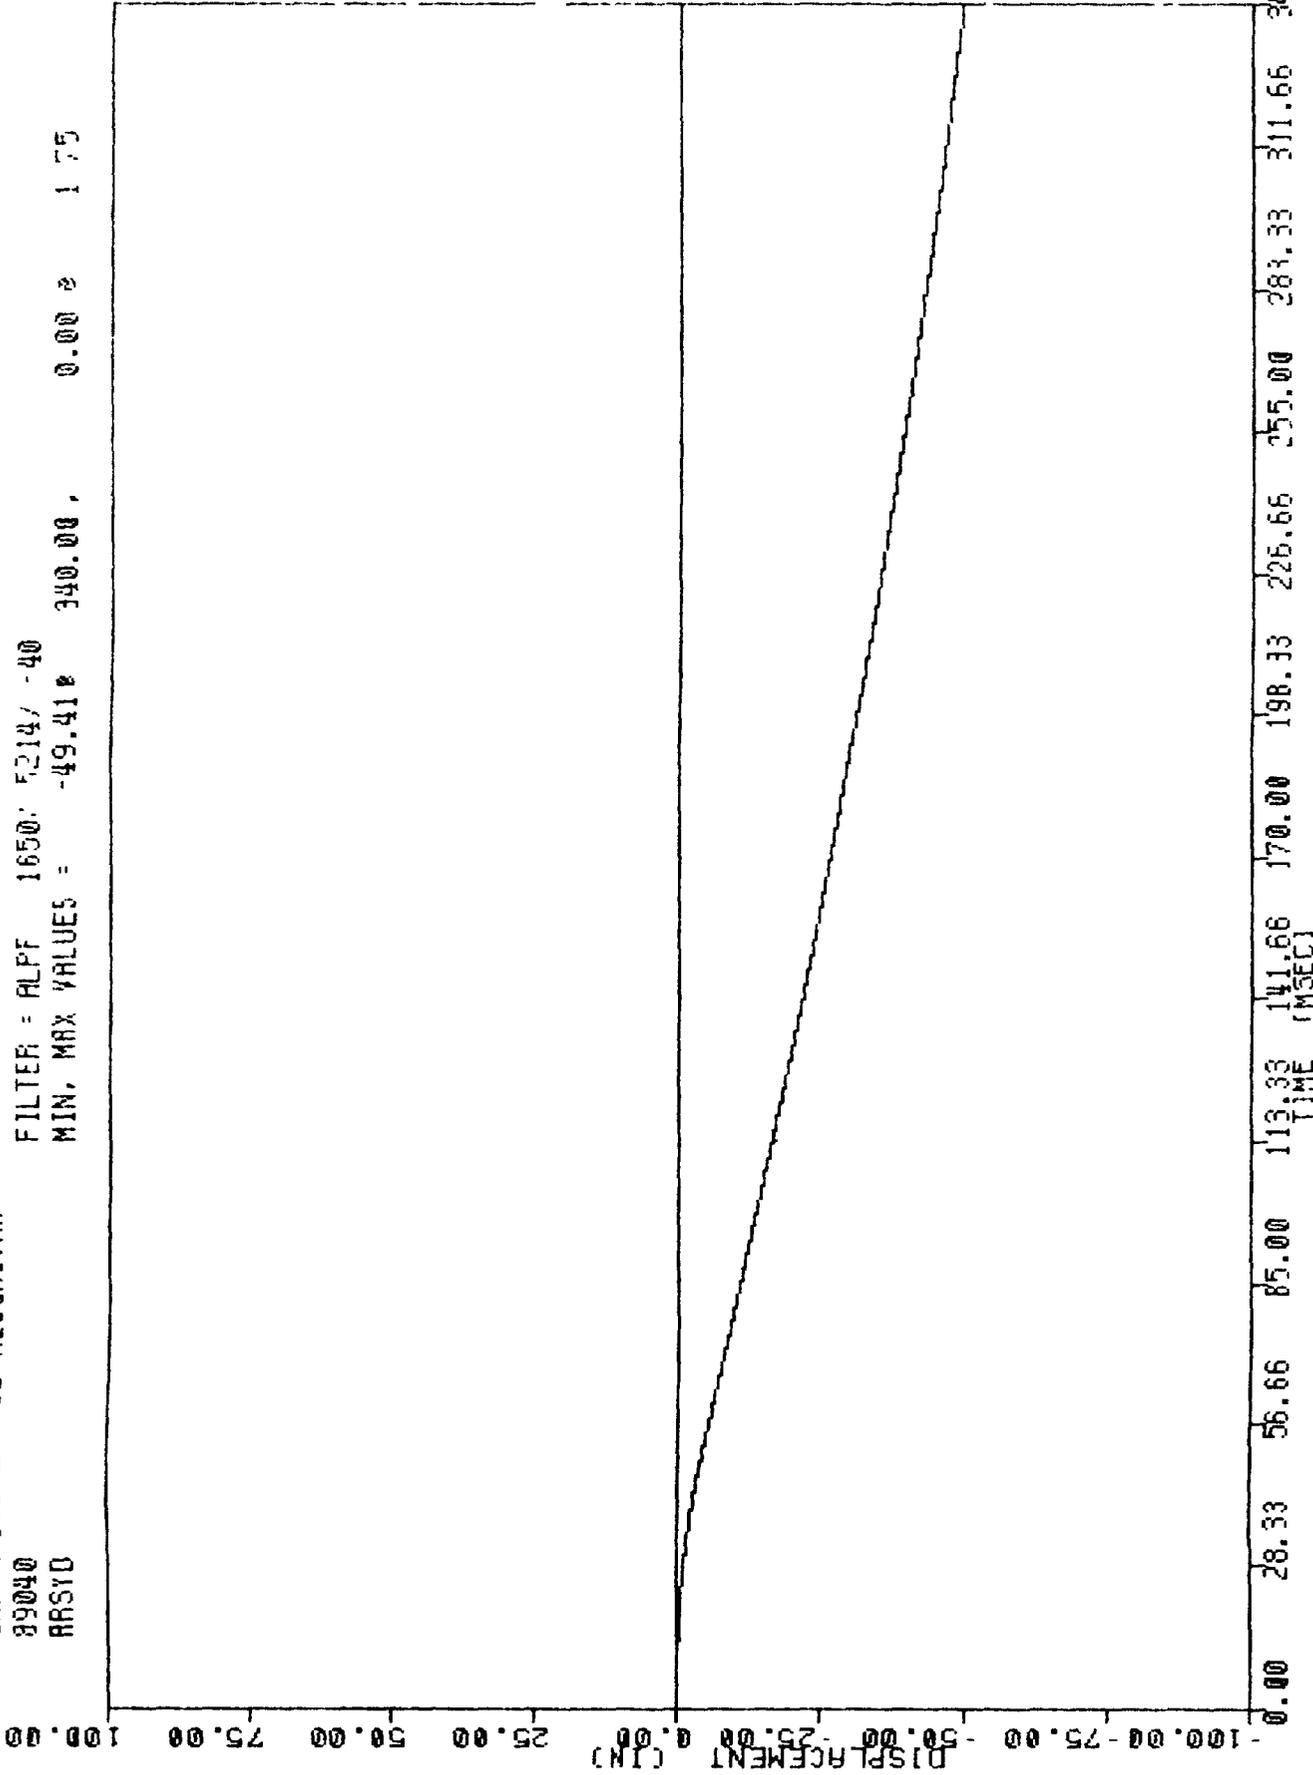
MIN. MAX VALUES = -49.41# 340.00 , 0.00# 1.75

CONTOURED MOVING BARRIER INTO 90 DEG 1983 HONDA PRELUDE AT 18.1 MPH #1
RIGHT REAR SILL Y AXIS DISPLACEMENT

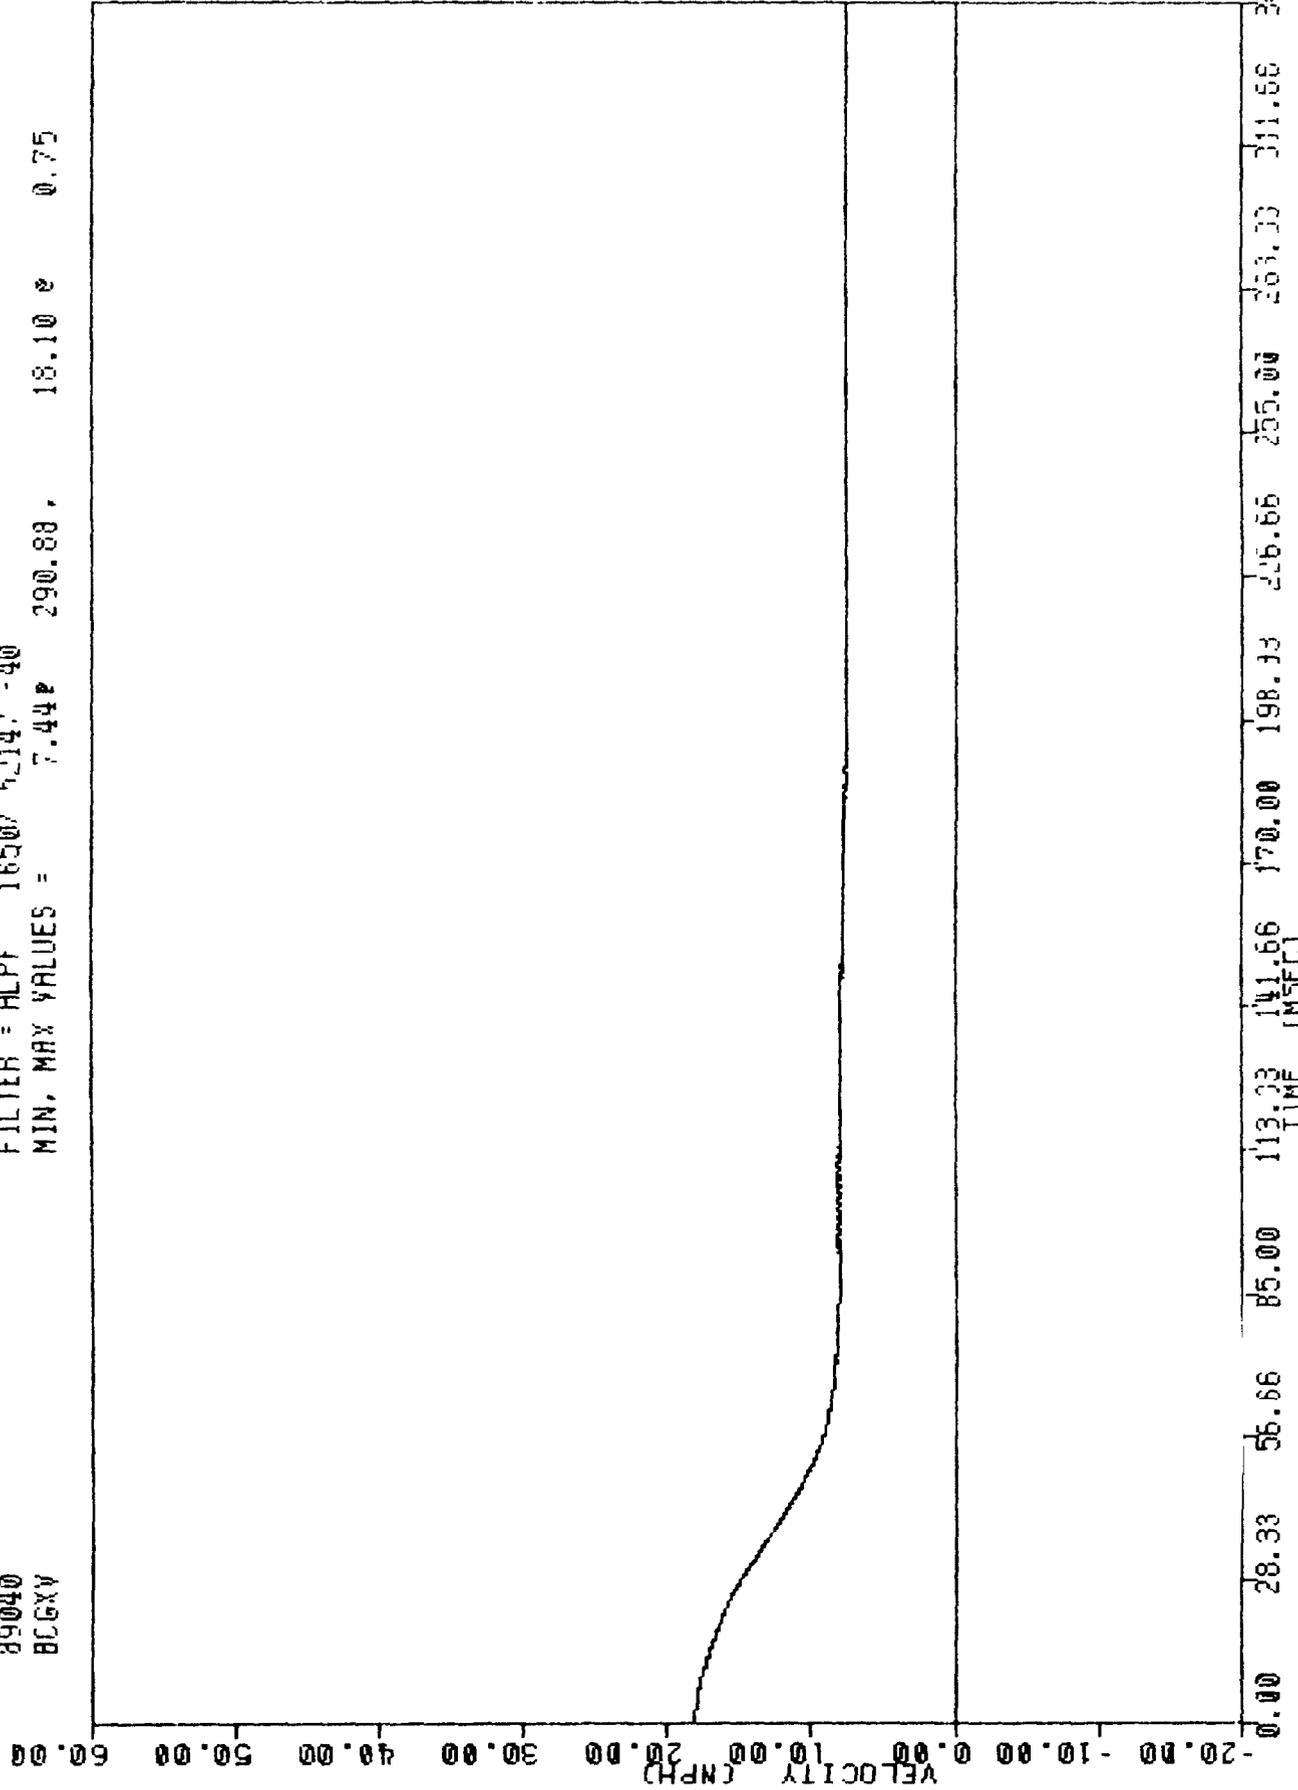
MIN. MAX VALUES = 7.44 290.88 18.10 0.75

CONTOURED MOVING BARRIER INTO 90 DEG HONDA PRELUDE AT 18.1 MPH *1
CONTOURED MOVING BARRIER CENTER OF GRAVITY X AXIS VELOCITY

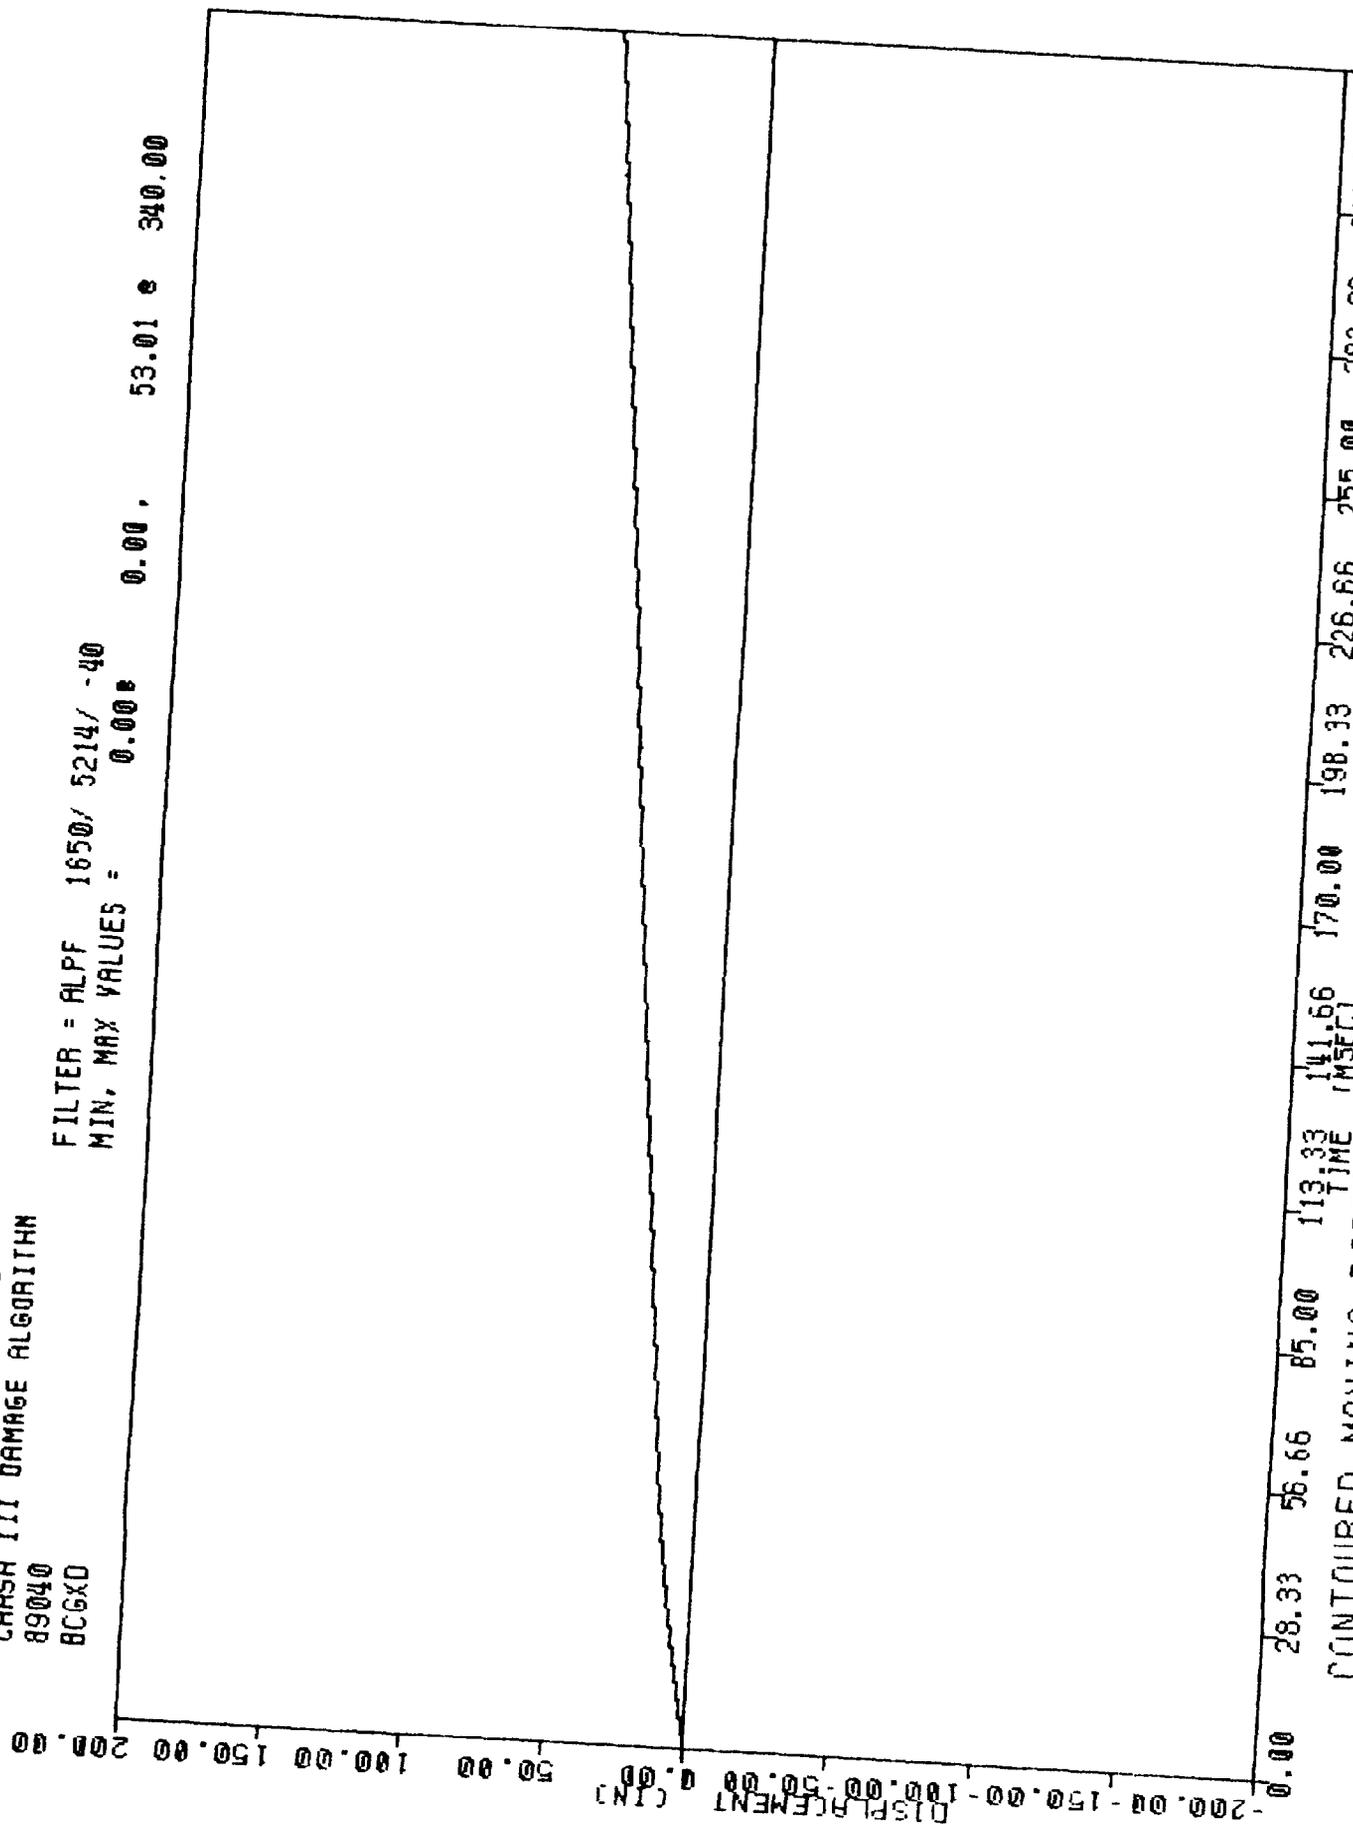
FILTER = ALPF 1650/ 5214/ -40
 MIN, MAX VALUES = 0.00 53.01 e 340.00

28.33 56.66 85.00 113.33 141.66 170.00 198.33 226.66 255.00 283.33 311.66 340.00
 TIME (MSEC)
 CONTOURED MOVING BARRIER INTO 90 DEG 1983 HONDA PRELUDE AT 18.1 MPH ± 1
 CONTOURED MOVING BARRIER CENTER OF GRAVITY X AXIS DISPLACEMENT

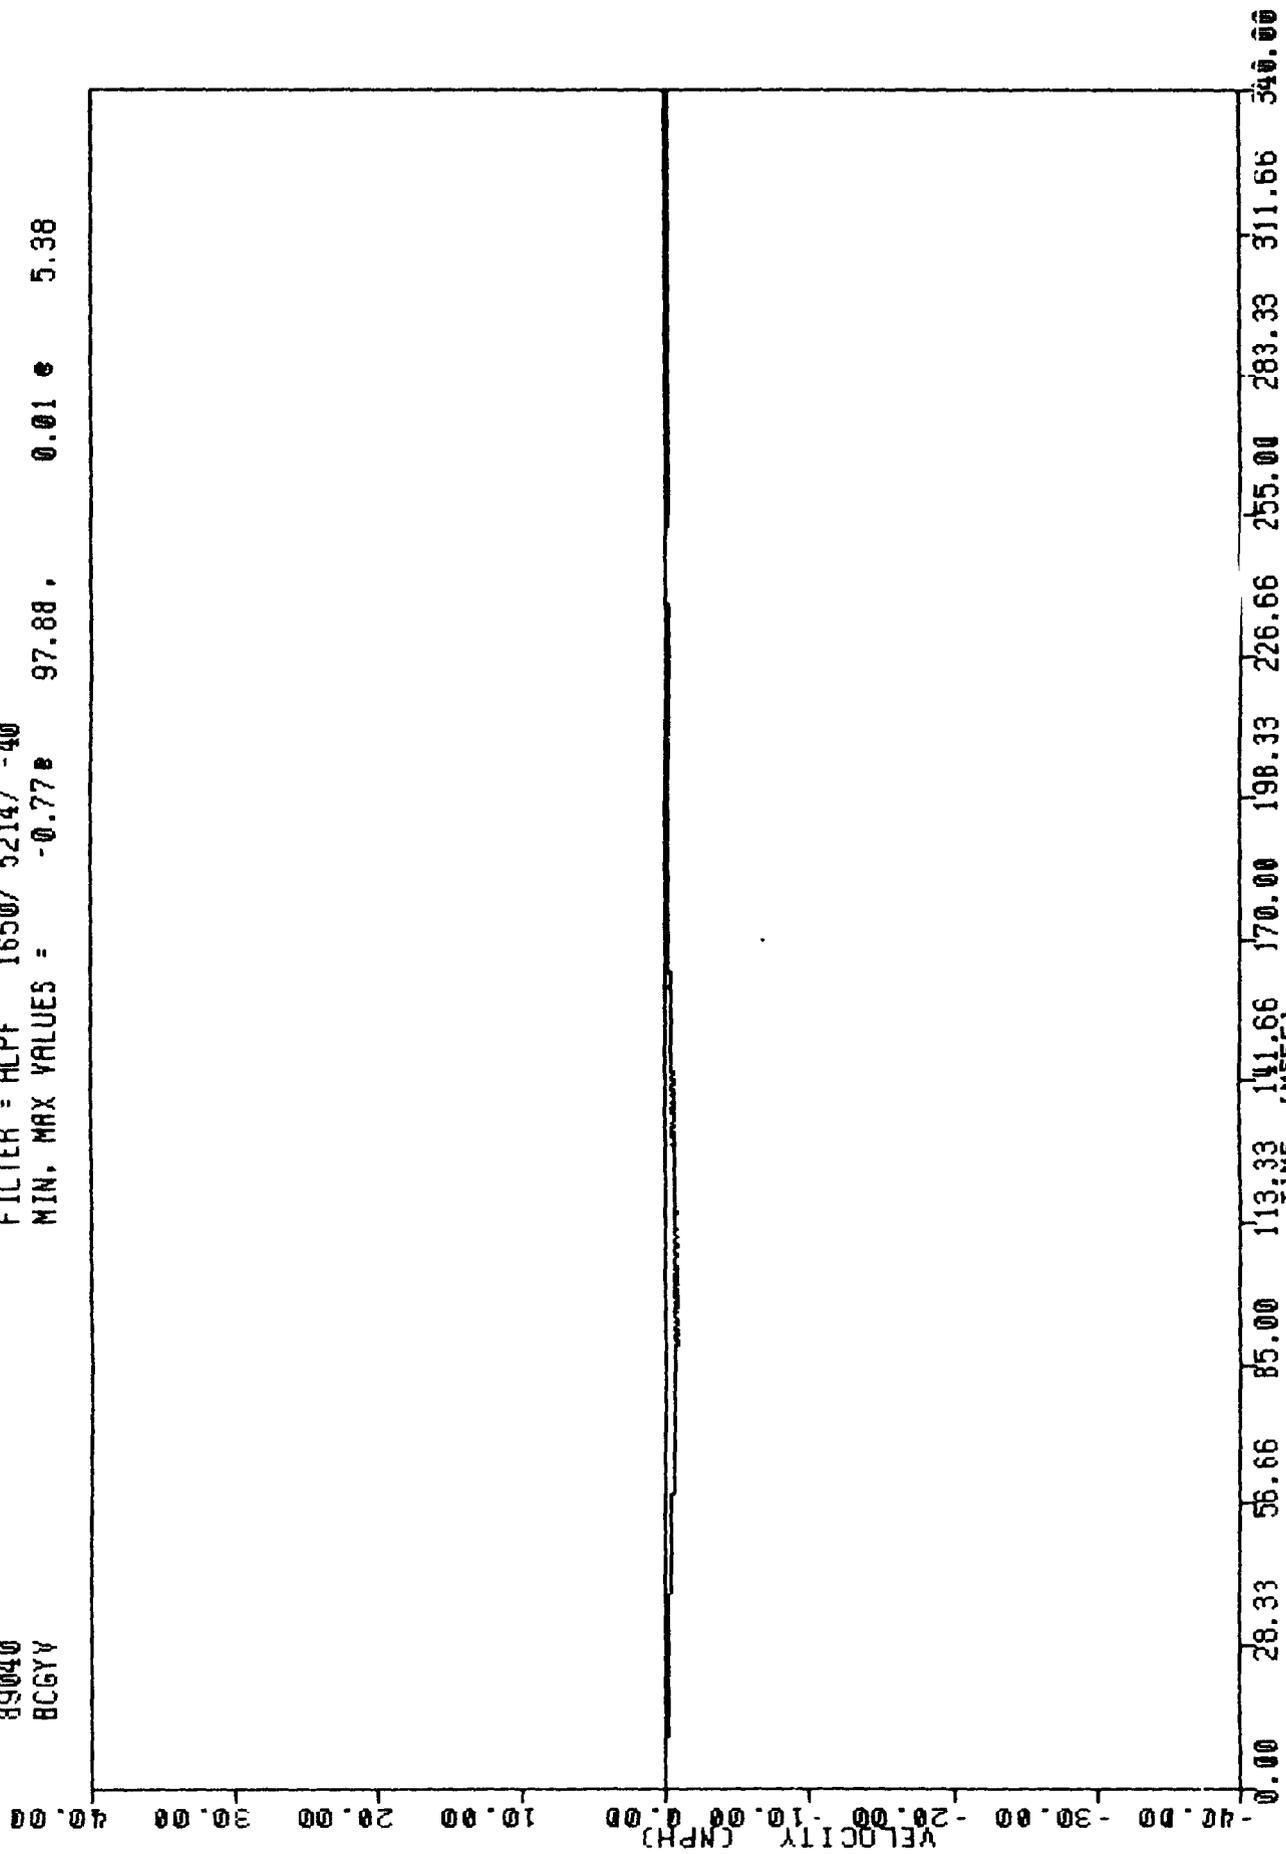
FILTER = ALPF 1650/ 5214/ -40
 MIN. MAX VALUES = -0.77 97.88 , 0.01 5.38

CONTOURED MOVING BARRIER INTO 90 DEG 1983 HONDA PRELUDE AT 18.1 MPH *1
 CONTOURED MOVING BARRIER CENTER OF GRAVITY Y AXIS VELOCITY

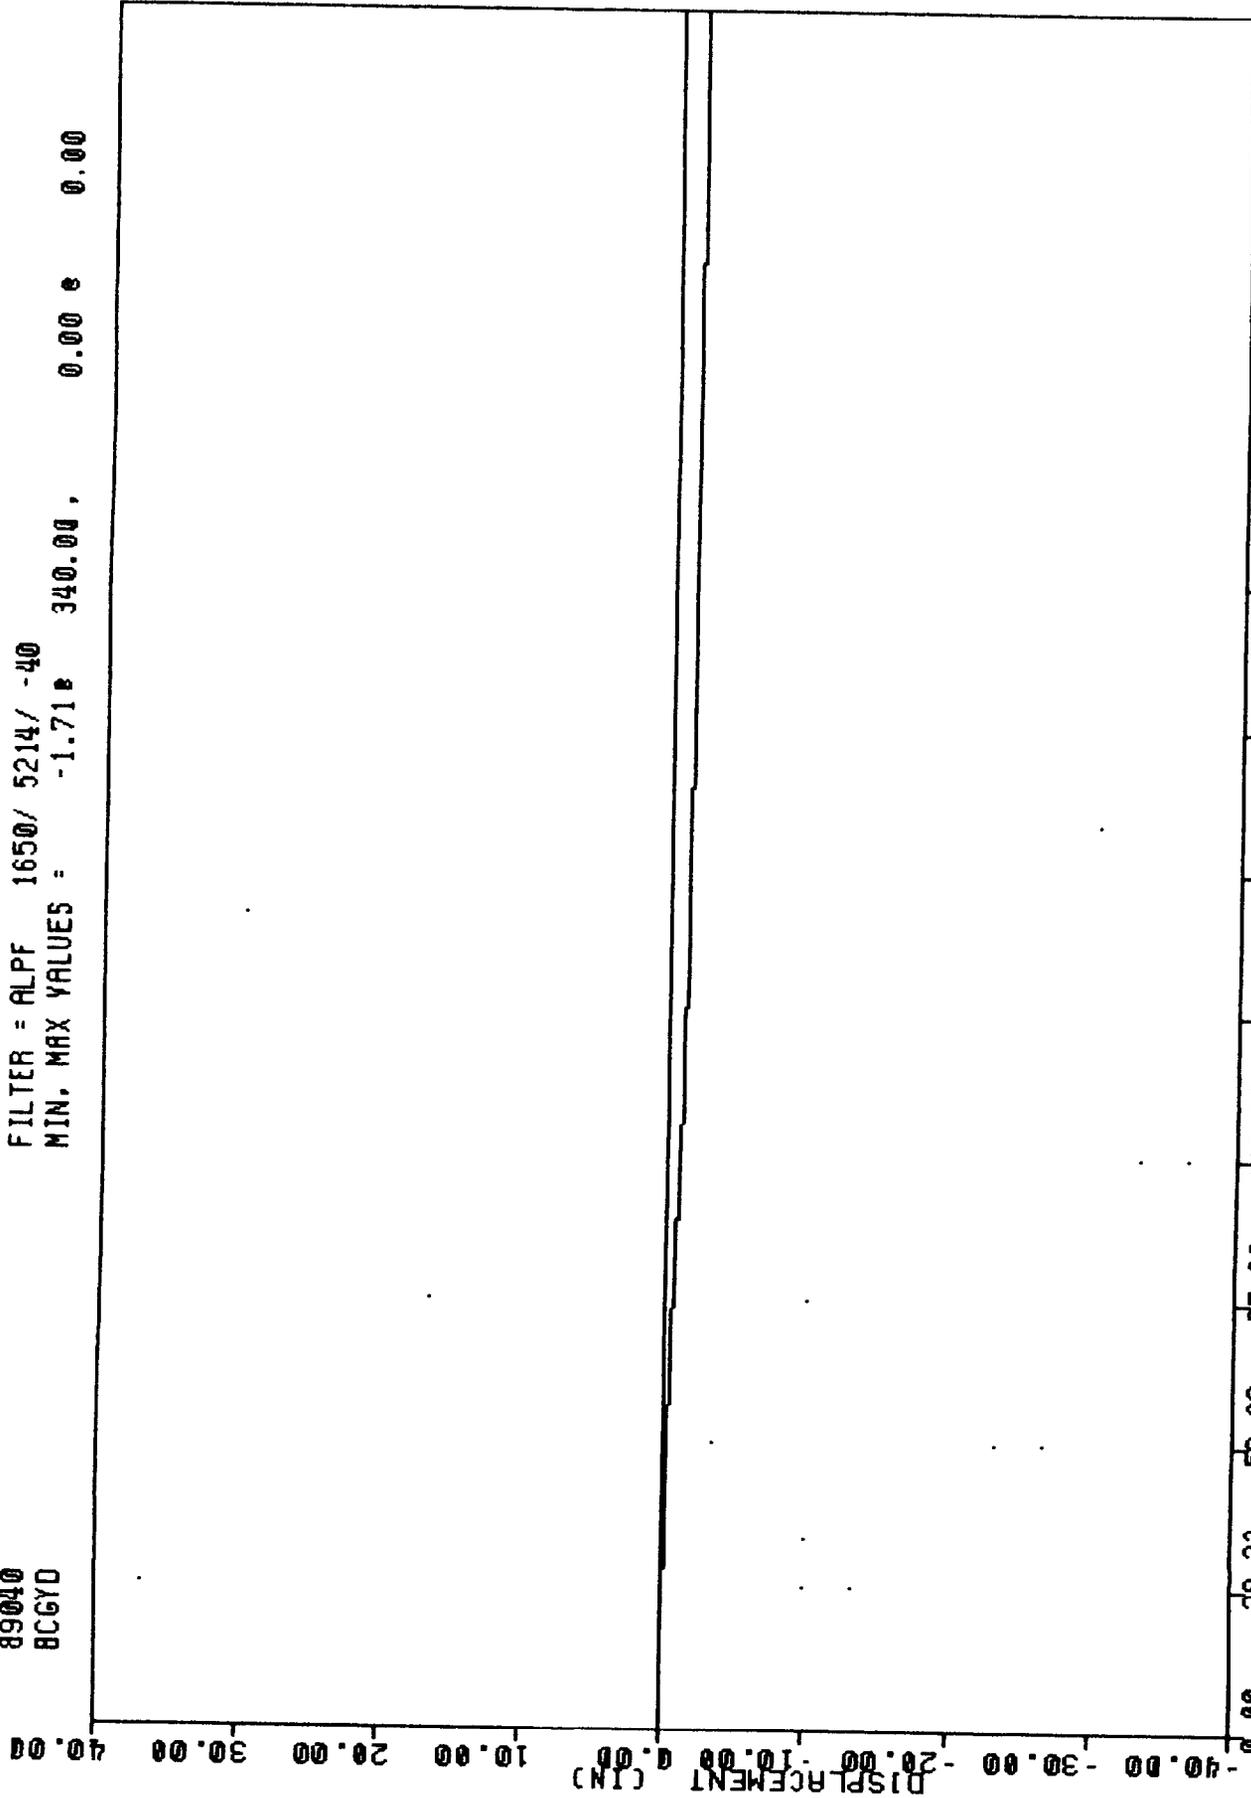
FILTER = ALPF 1650/ 5214/ -40
 MIN. MAX VALUES = -1.71 340.00 , 0.00 e 0.00

0.00 28.33 56.66 85.00 113.33 141.66 170.00 198.33 226.66 255.00 283.33 311.66 340.00
 TIME (MSEC)
 CONTOURED MOVING BARRIER INTO 90 DEG 1983 HONDA PRELUDE AT 18.1 MPH #1
 CONTOURED MOVING BARRIER CENTER OF GRAVITY Y AXIS DISPLACEMENT

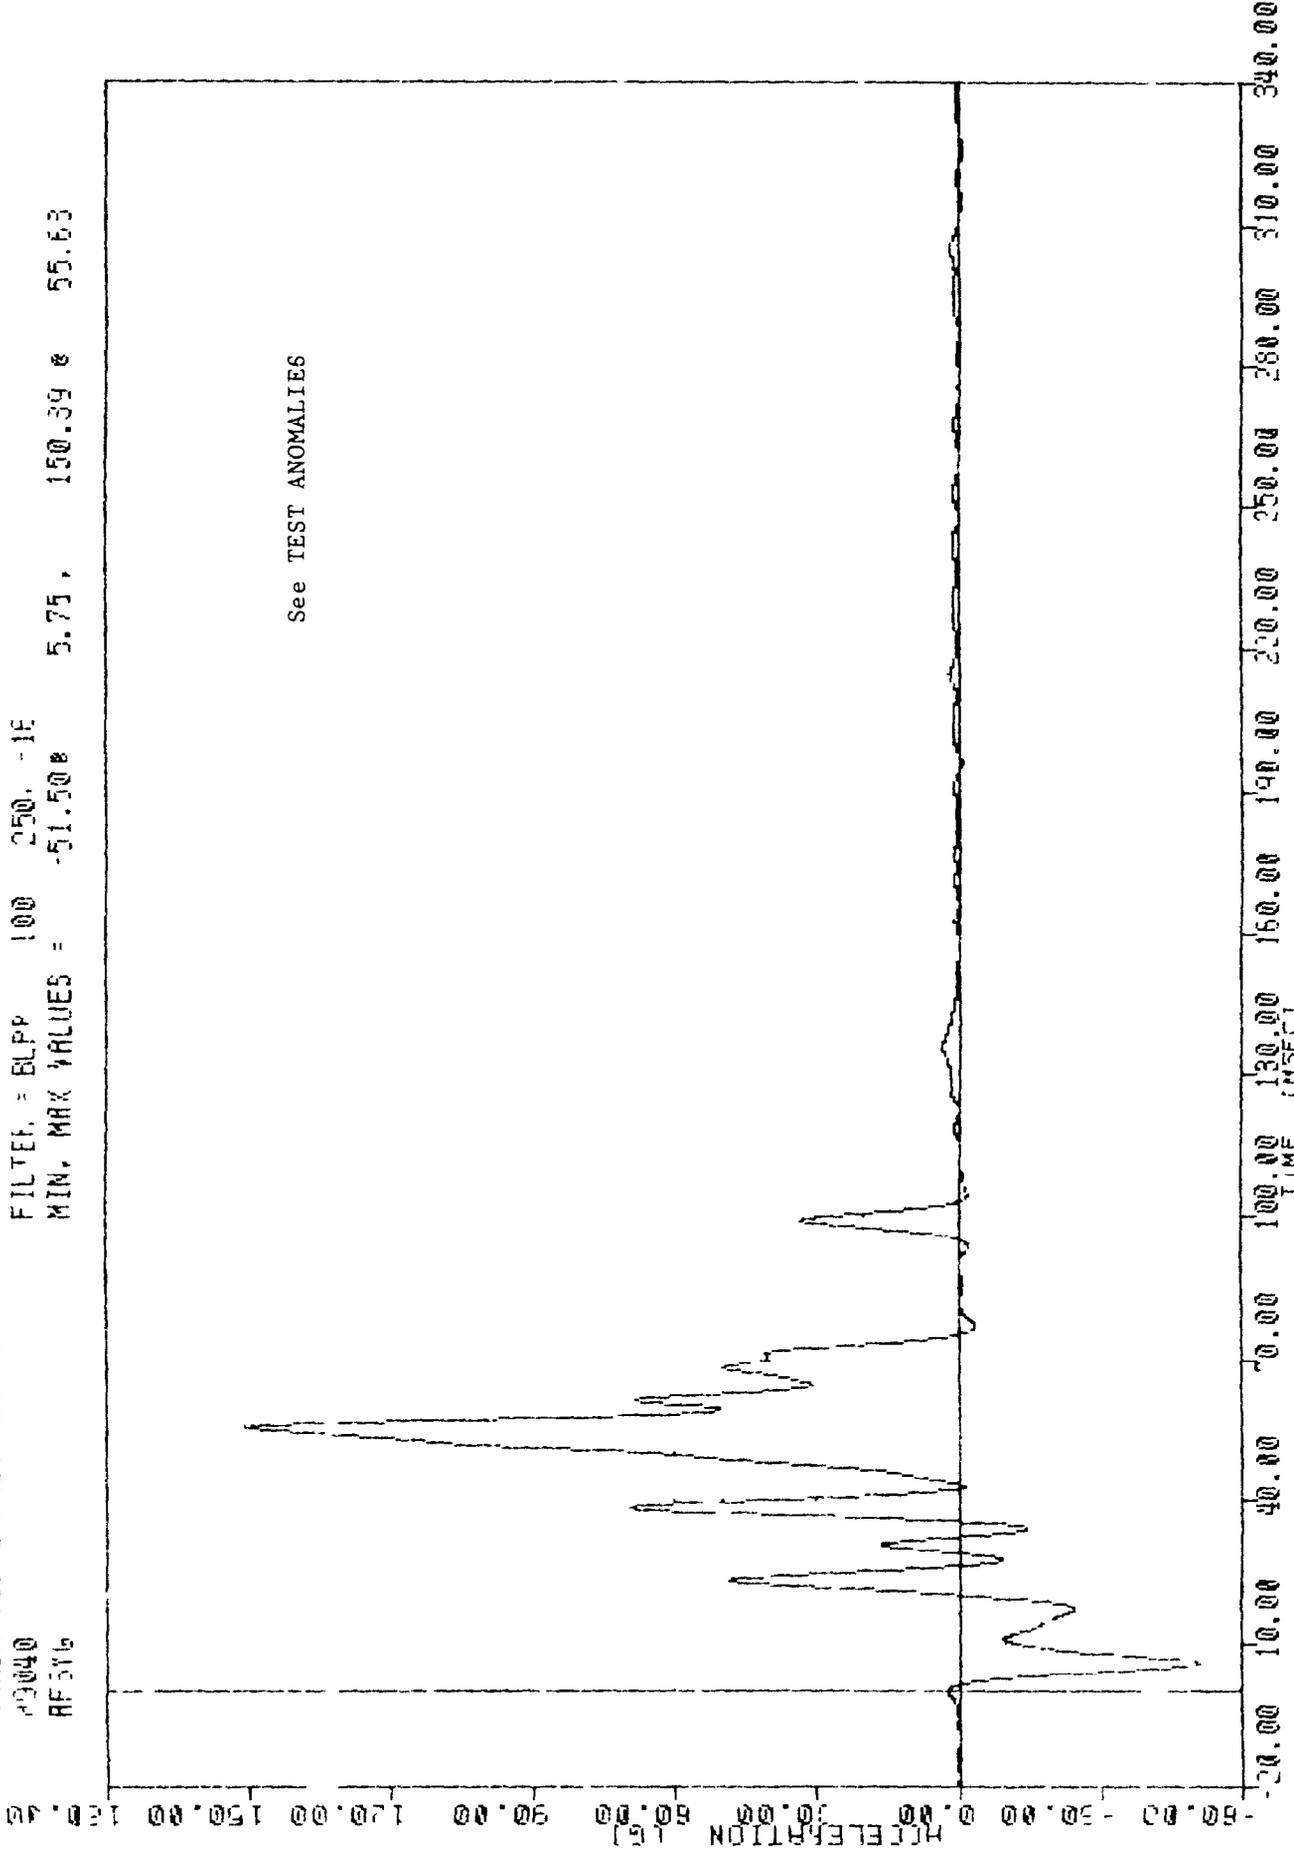
FILTER = BLP 100 250. -1E
 MIN. MAX VALUES = -51.50 150.39 55.63

-20.00 10.00 40.00 70.00 100.00 130.00 160.00 190.00 220.00 250.00 280.00 310.00 340.00
 TIME (MSEC)
 CONTOURED MOVING BARRIER INTO 90 DEG 1963 HONDA PRELUDE AT 27.0 MPH #2
 RIGHT FRONT SILL, AXIS ACCELERATION
