DOT HS 807 441

Final Report

Final Report of 270° Contoured Moving Barrier Impact into a 1983 Honda Prelude 2-Door Coupe in Support of Crash III Damage Algorithm Reformation

The purpose of the four 270° contoured moving barrier impact tests was for research and development in support of the CRASH III damage algorithm reformulation.

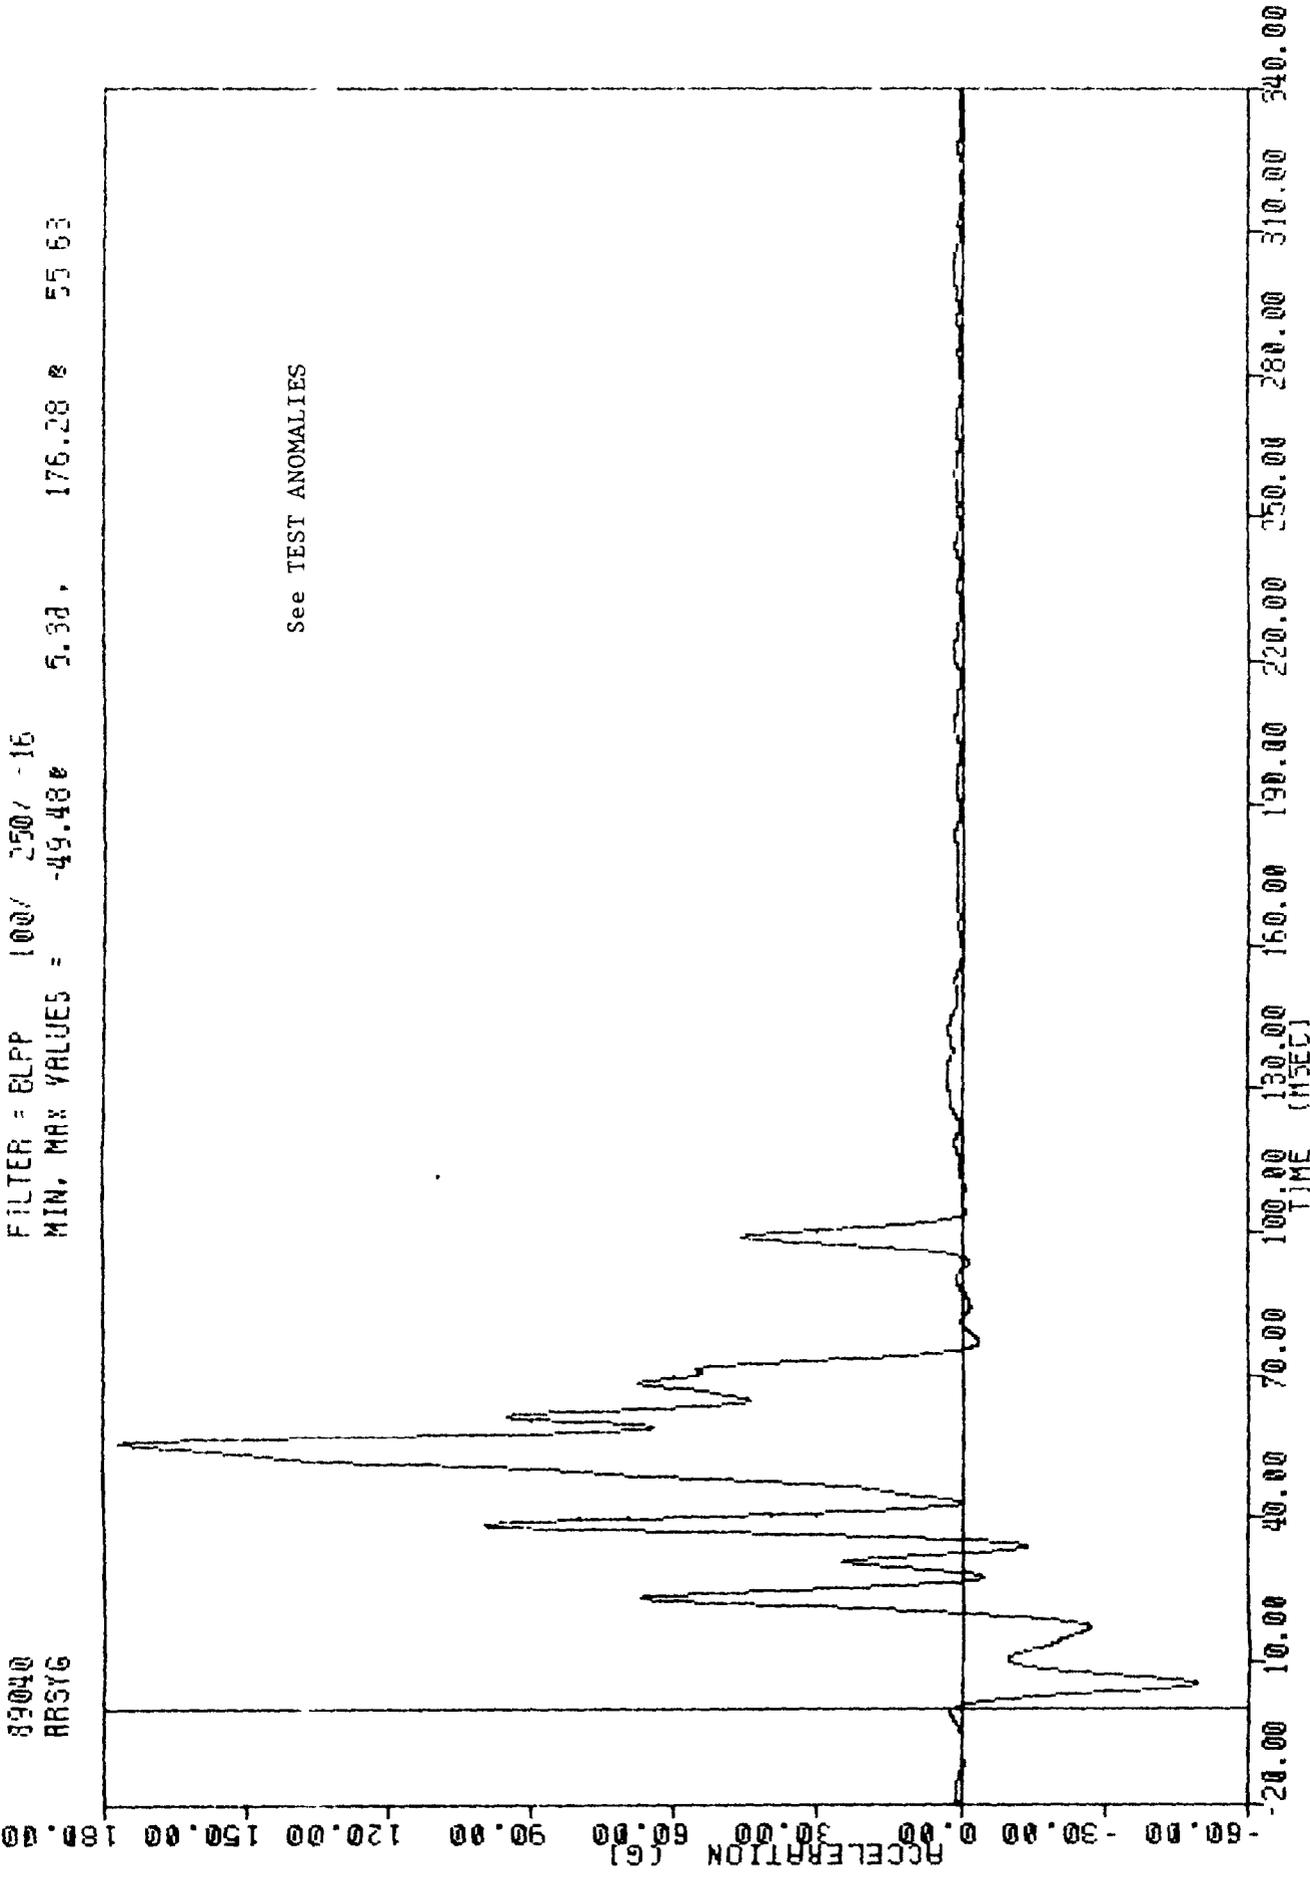
FILTER = BLPP 100/ 250/ -16
MIN. MAX VALUES = -49.480 5.30 176.28 55 63

CONTOURED MOVING BARRIER INTO 90 DEG HONDA PRELUDE AT 27.0 MPH #2
RIGHT REAR SILL Y AXIS ACCELERATION

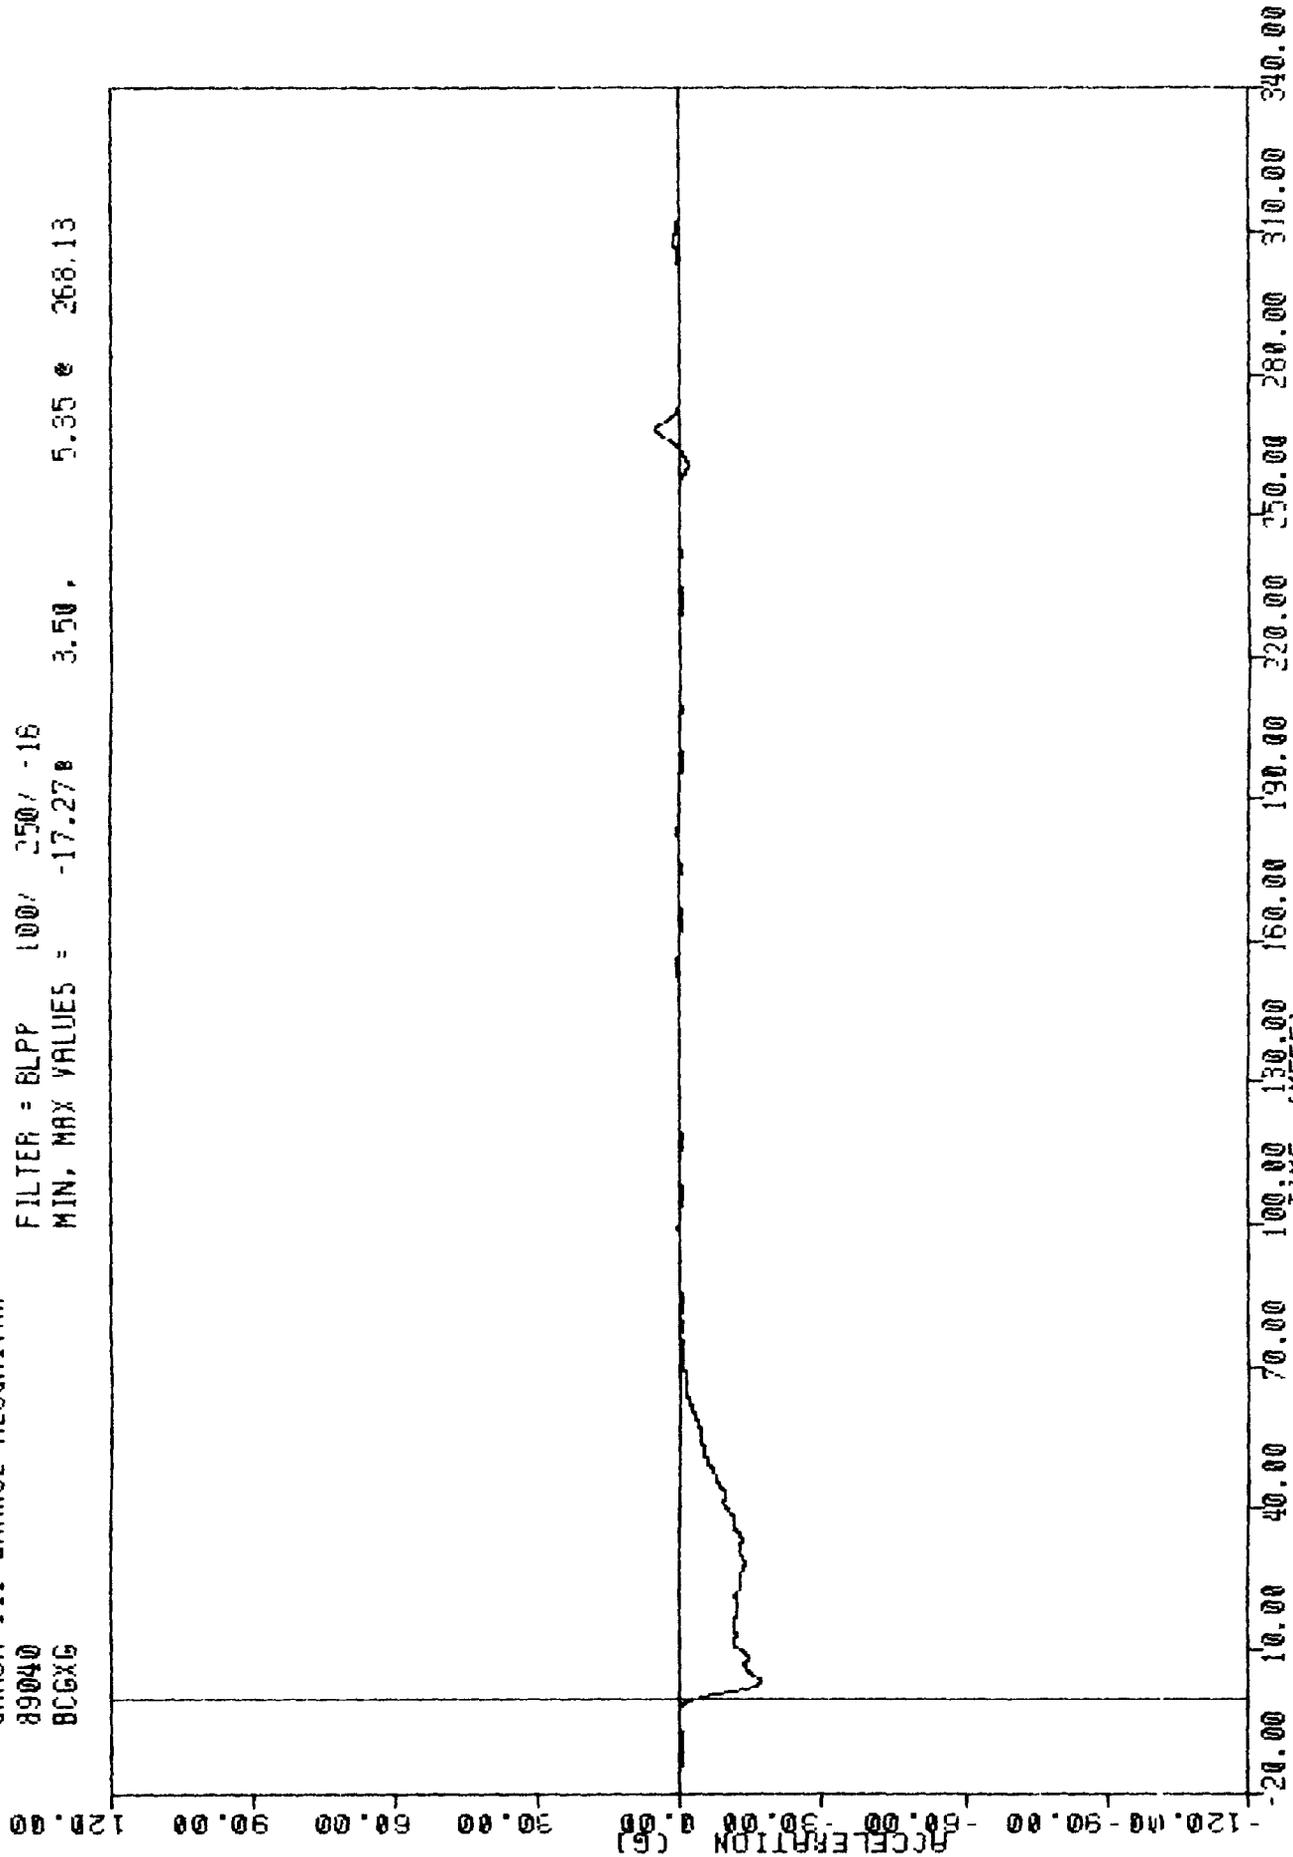
MIN, MAX VALUES = -17.27 3.50 5.35 e 268.13

COUNTROUDED MOVING BARRIER INTO 90 DEG HONDA PRELUDE AT 27.0 MPH #2
COUNTROUDED MOVING BARRIER CENTER OF GRAVITY X AXIS ACCELERATION

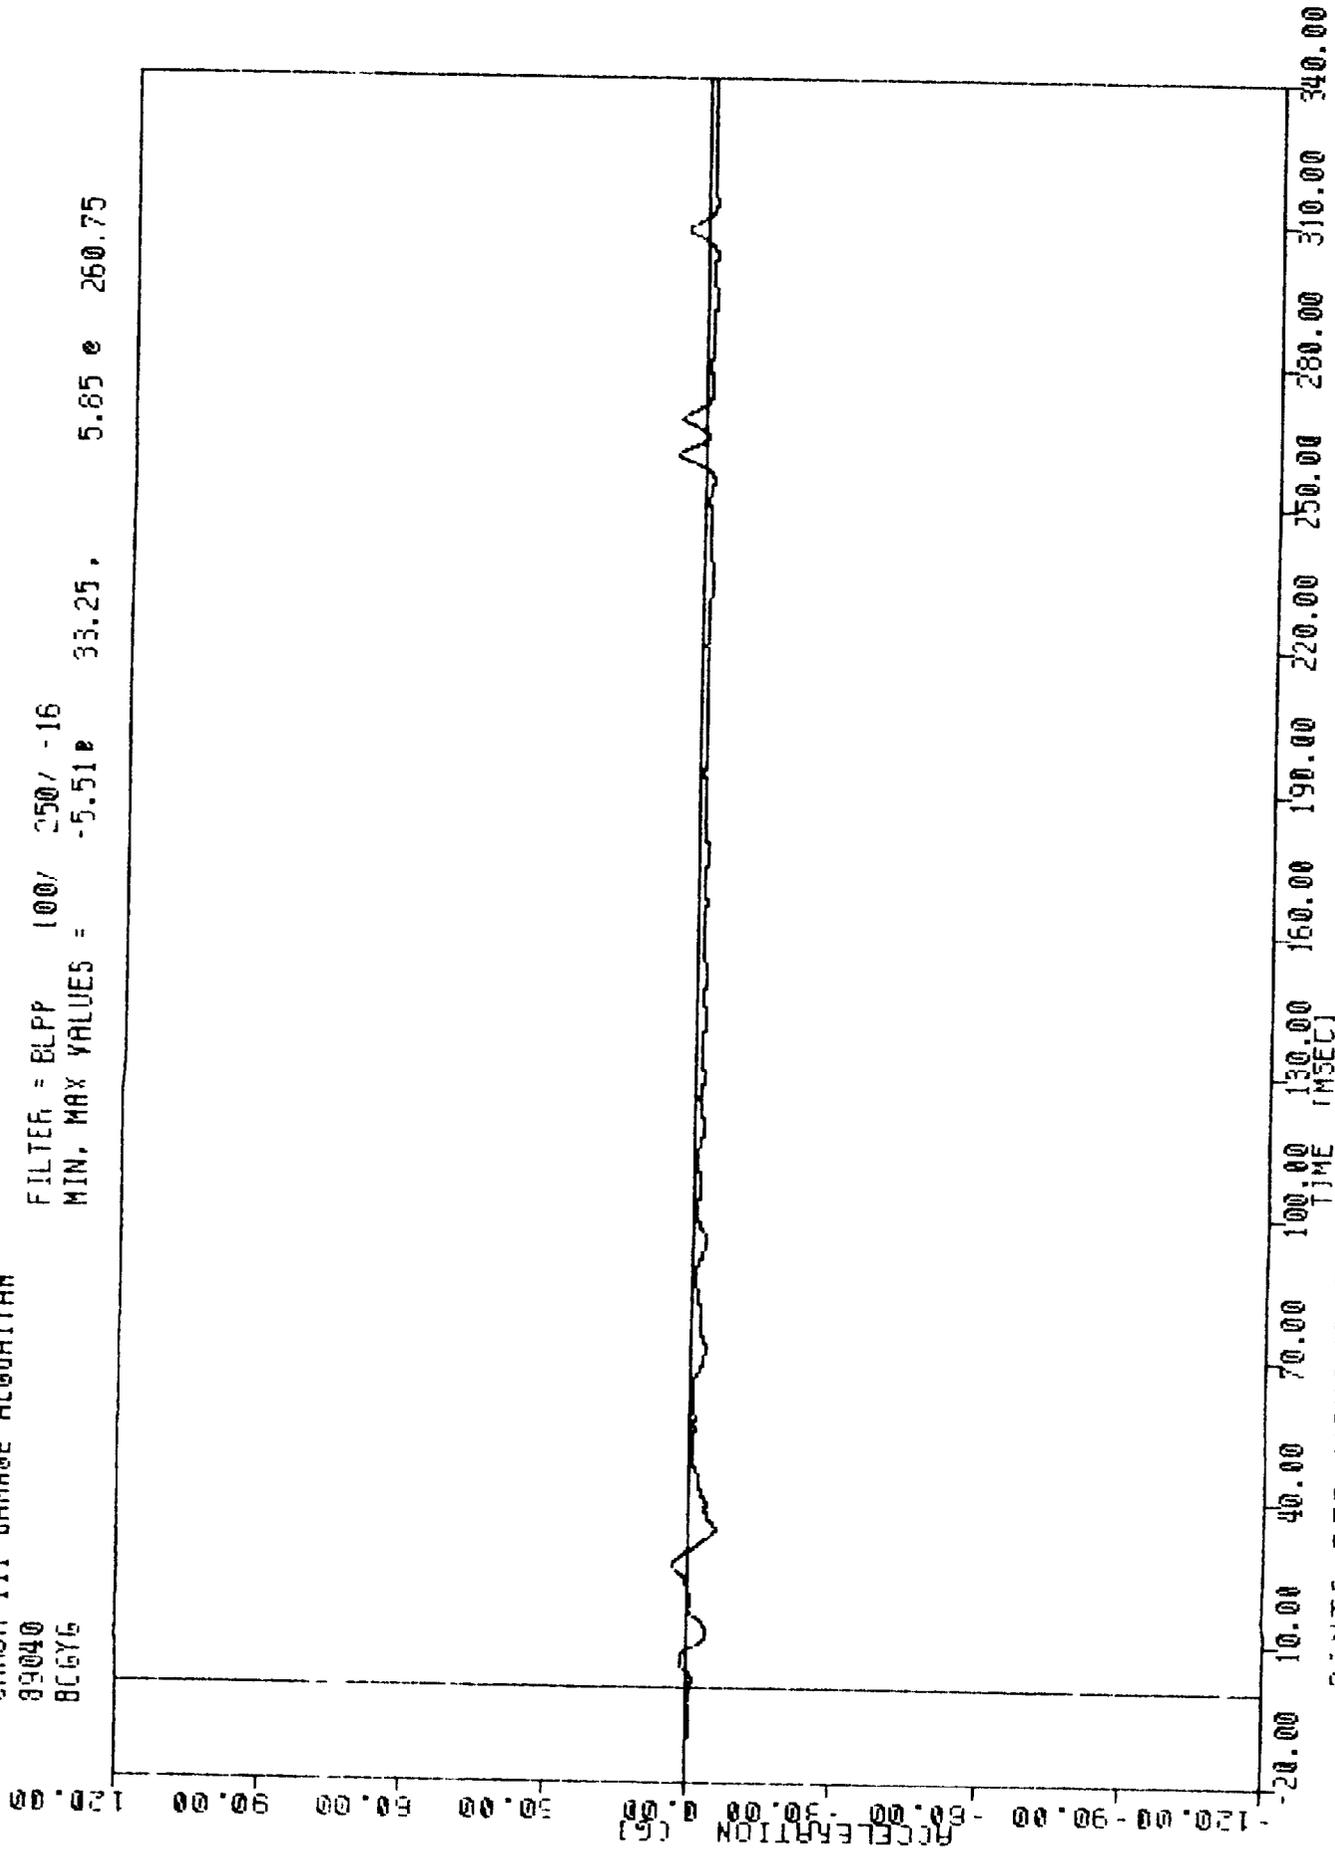
FILTER = BLPP 100/ 250/ -16
MIN, MAX VALUES = -5.51 33.25, 5.85 e 260.75

CONToured MOVING BARRIER INTO 90 DEG 1983 HONDA PRELUDE AT 27.0 MPH #2
CONToured MOVING BARRIER CENTER OF GRAVITY Y AXIS ACCELERATION

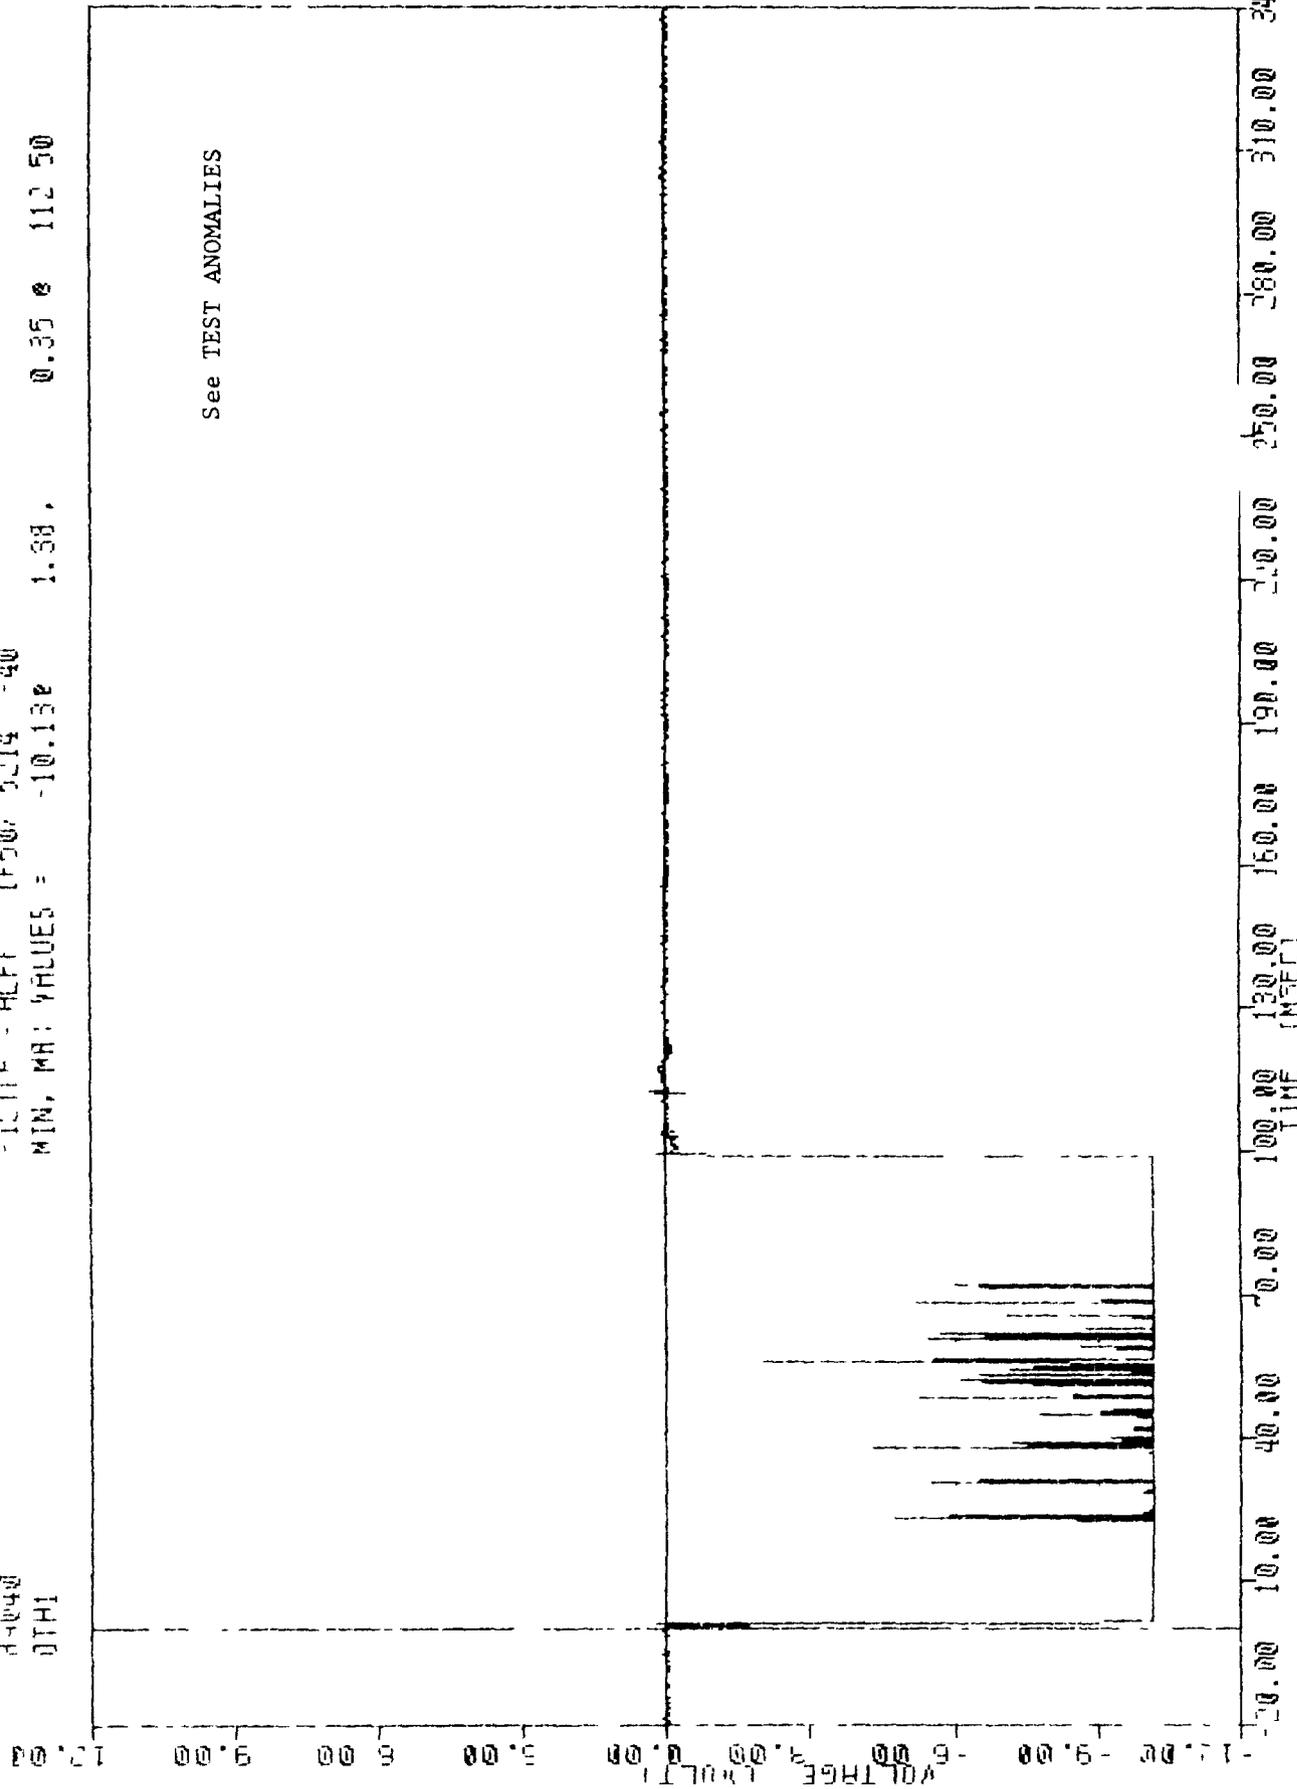
-LUFF - RUFF 1150 5214 -40
 MIN, MA: VALUES = -10.130 1.38 0.35 0 112 50

20.00 10.00 40.00 70.00 100.00 130.00 160.00 190.00 220.00 250.00 280.00 310.00 340.00
 TIME (MSEC)
 CONToured MOVING BARRIER INTO 30 DEG 1993 HONDA PRELUDE AT 27.0 MPH *2
 VEHICLE CONTACT SWITCH - LEFT

Noise in the form of spikes was observed in the plots for the contact switches OTH1, OTH2, OTH3, OTH4. * The switches were used to record the time of vehicle contact with the moving barrier, as well as the time of vehicle separation from the barrier. The switches were damaged by the crush of the moving contoured barrier against the vehicle. The switches were replaced following each test which contained spikes. This is not the standard use of such switches.

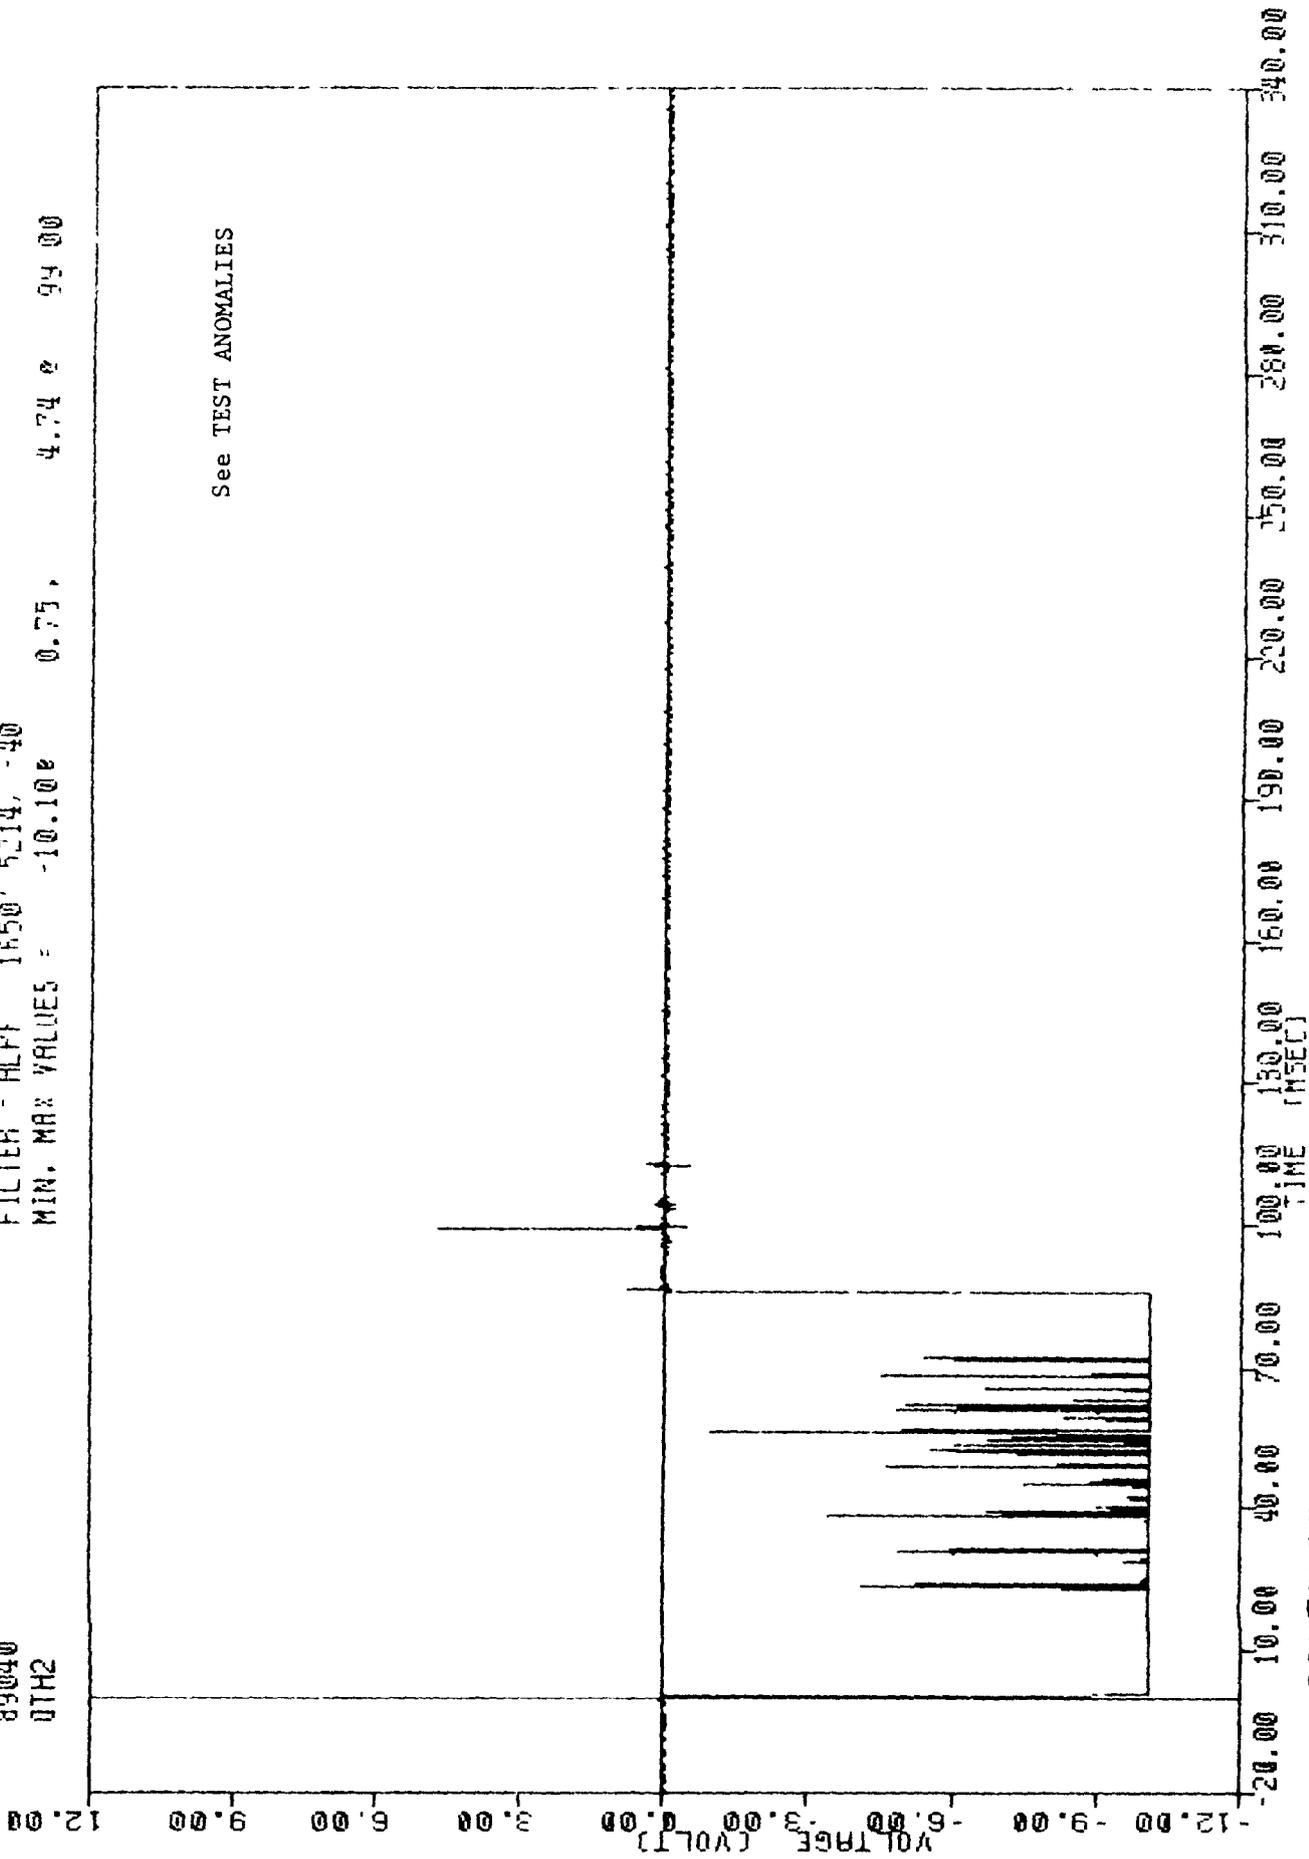
FILTER - HLFF 1650 5214, -40
MIN. MAX VALUES = -10.10e 0.75, 4.74 e 94 00

CONToured MOVING BARRIER INTO 90 DEG 1983 HONDA PRELUDE AT 27.0 MPH *2
VEHICLE CONTACT SWITCH - CENTER - 1

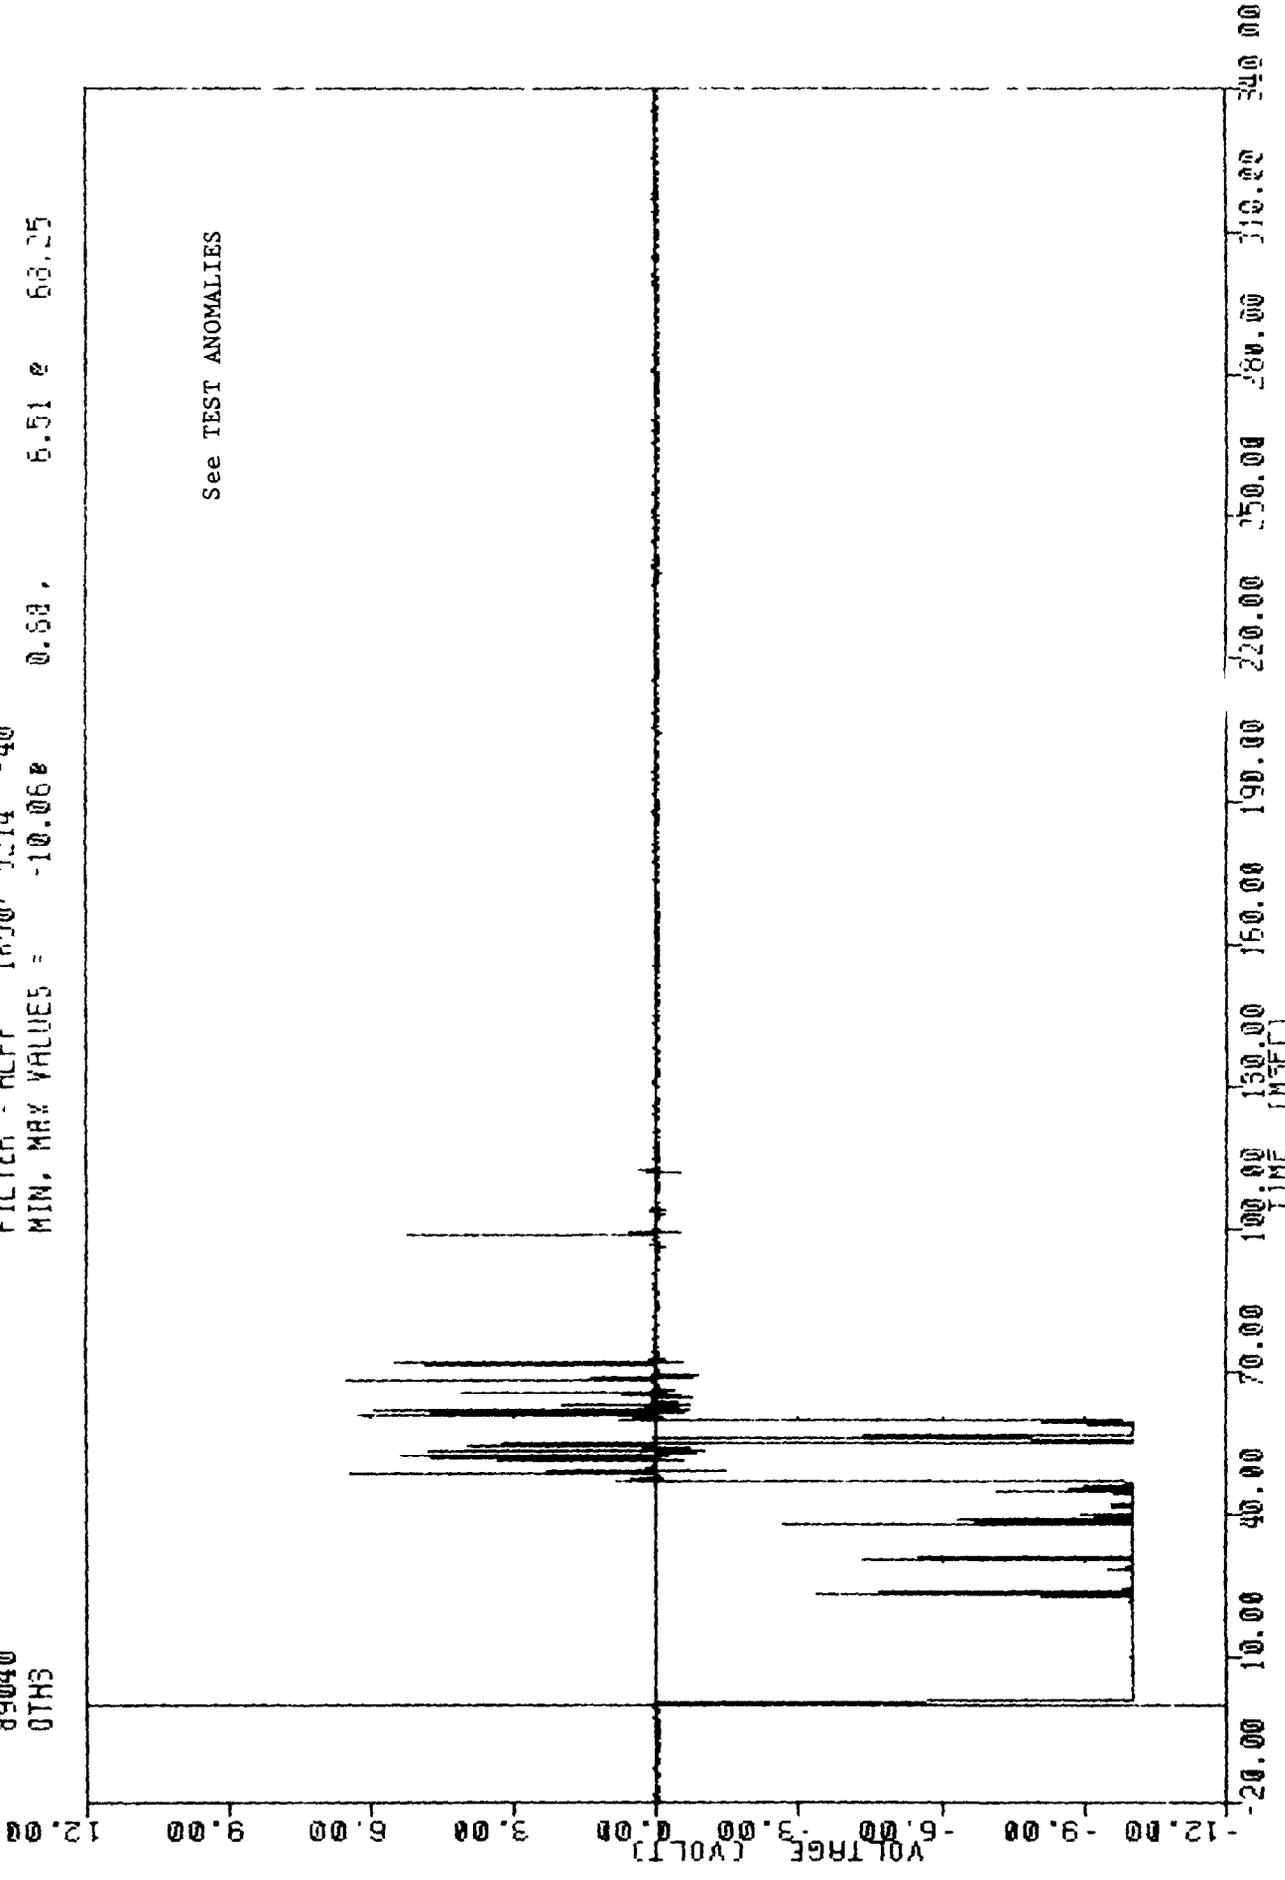
FILTER = ALFF 1650' 5214 -40
MIN, MAX VALUES = -10.068 0.58 , 6.51 e 63.25

CONToured MOVING BARRIER INTO 90 DEG 1983 HONDA PRELUDE AT 27.0 MPH #2
VEHICLE CONTACT SWITCH - CENTER - 2

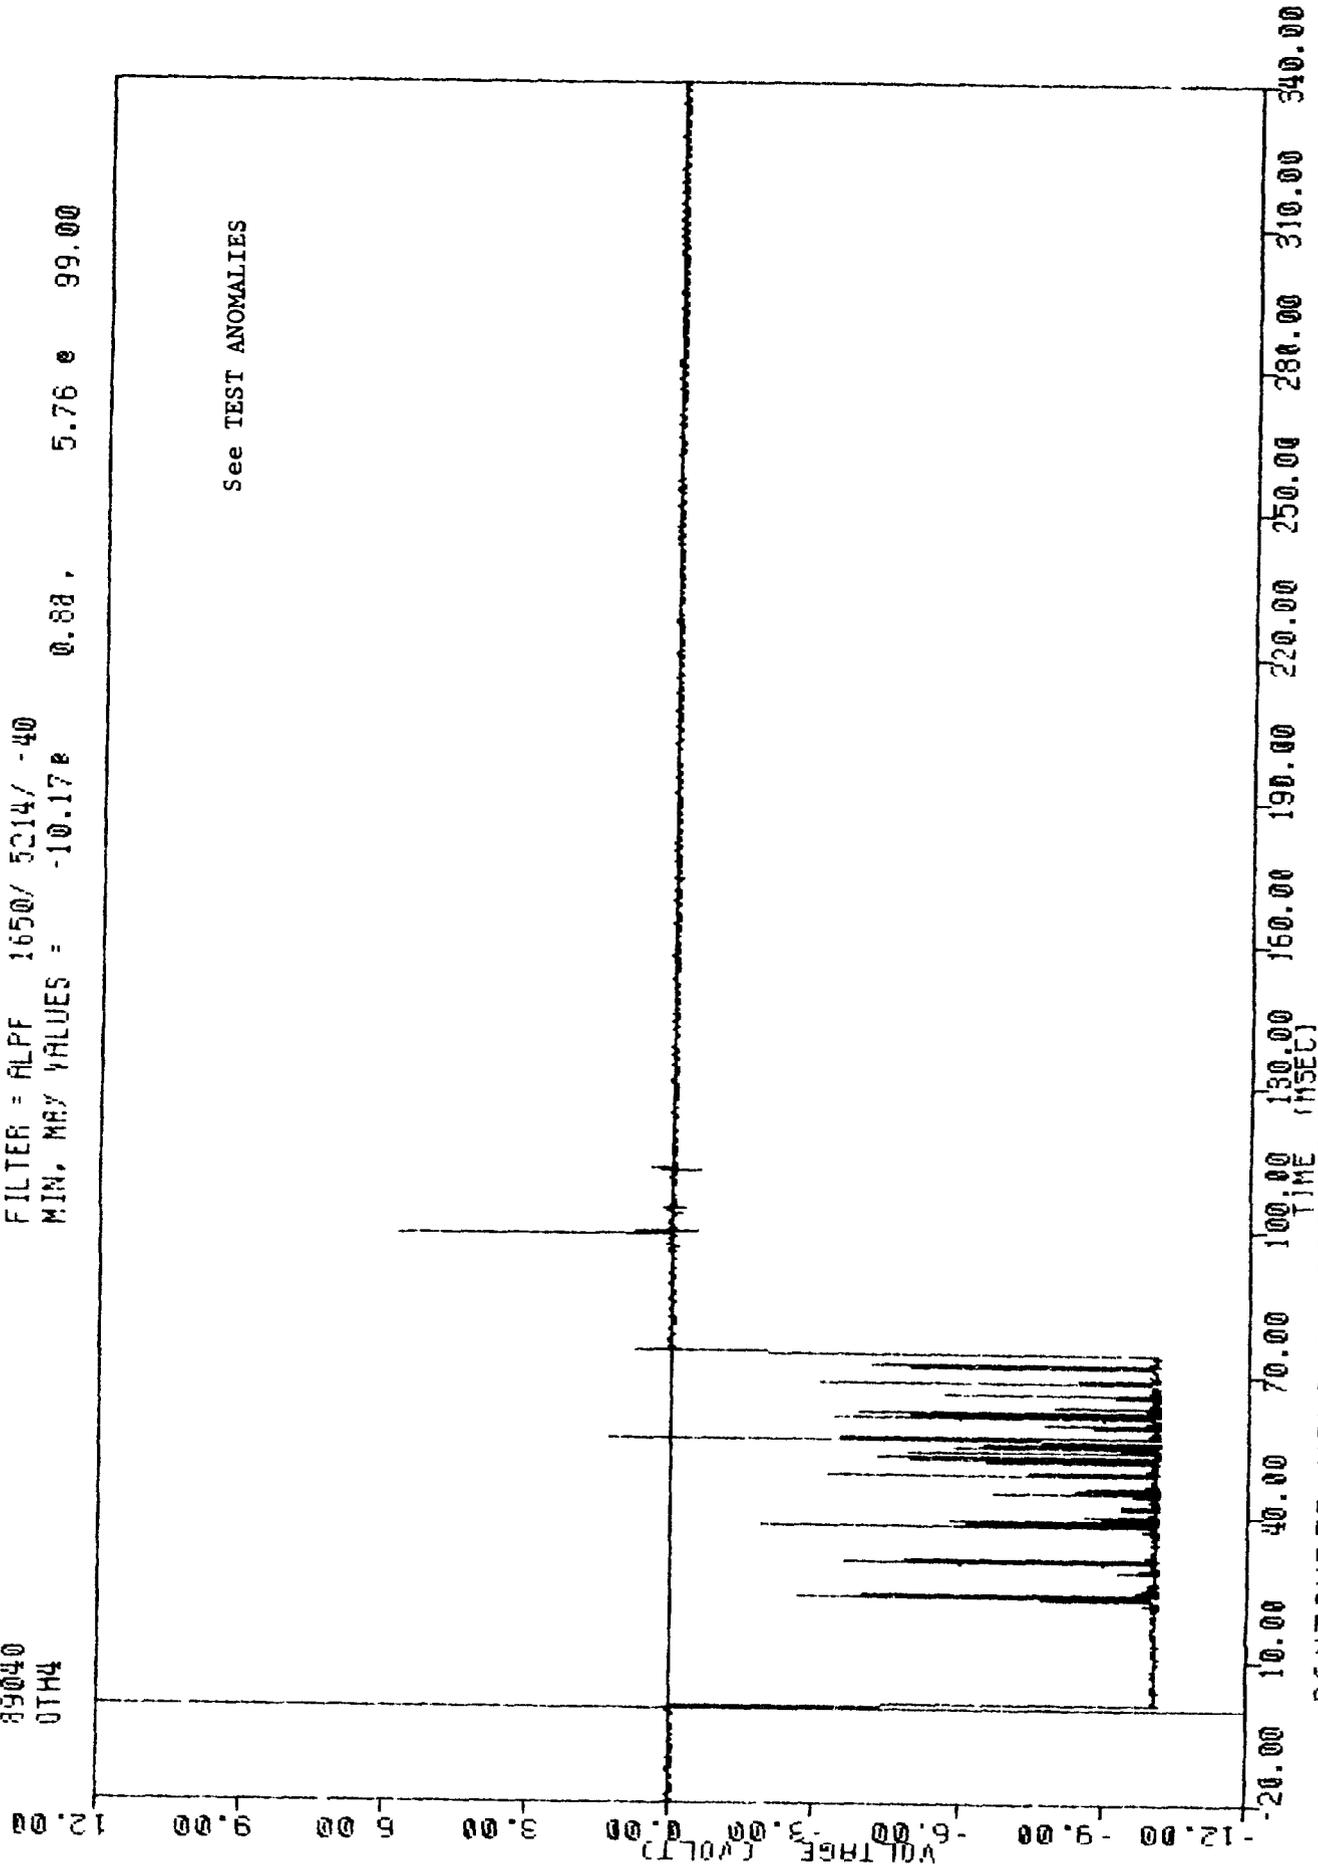
FILTER = ALPF 1650/ 5214/ -40
MIN, MAX VALUES = -10.17e 0.88 , 5.76 e 99.00

CONTOURED MOVING BARRIER INTO 90 DEG HONDA PRELUDE AT 27.0 MPH #2
VEHICLE CONTACT SWITCH - RIGHT

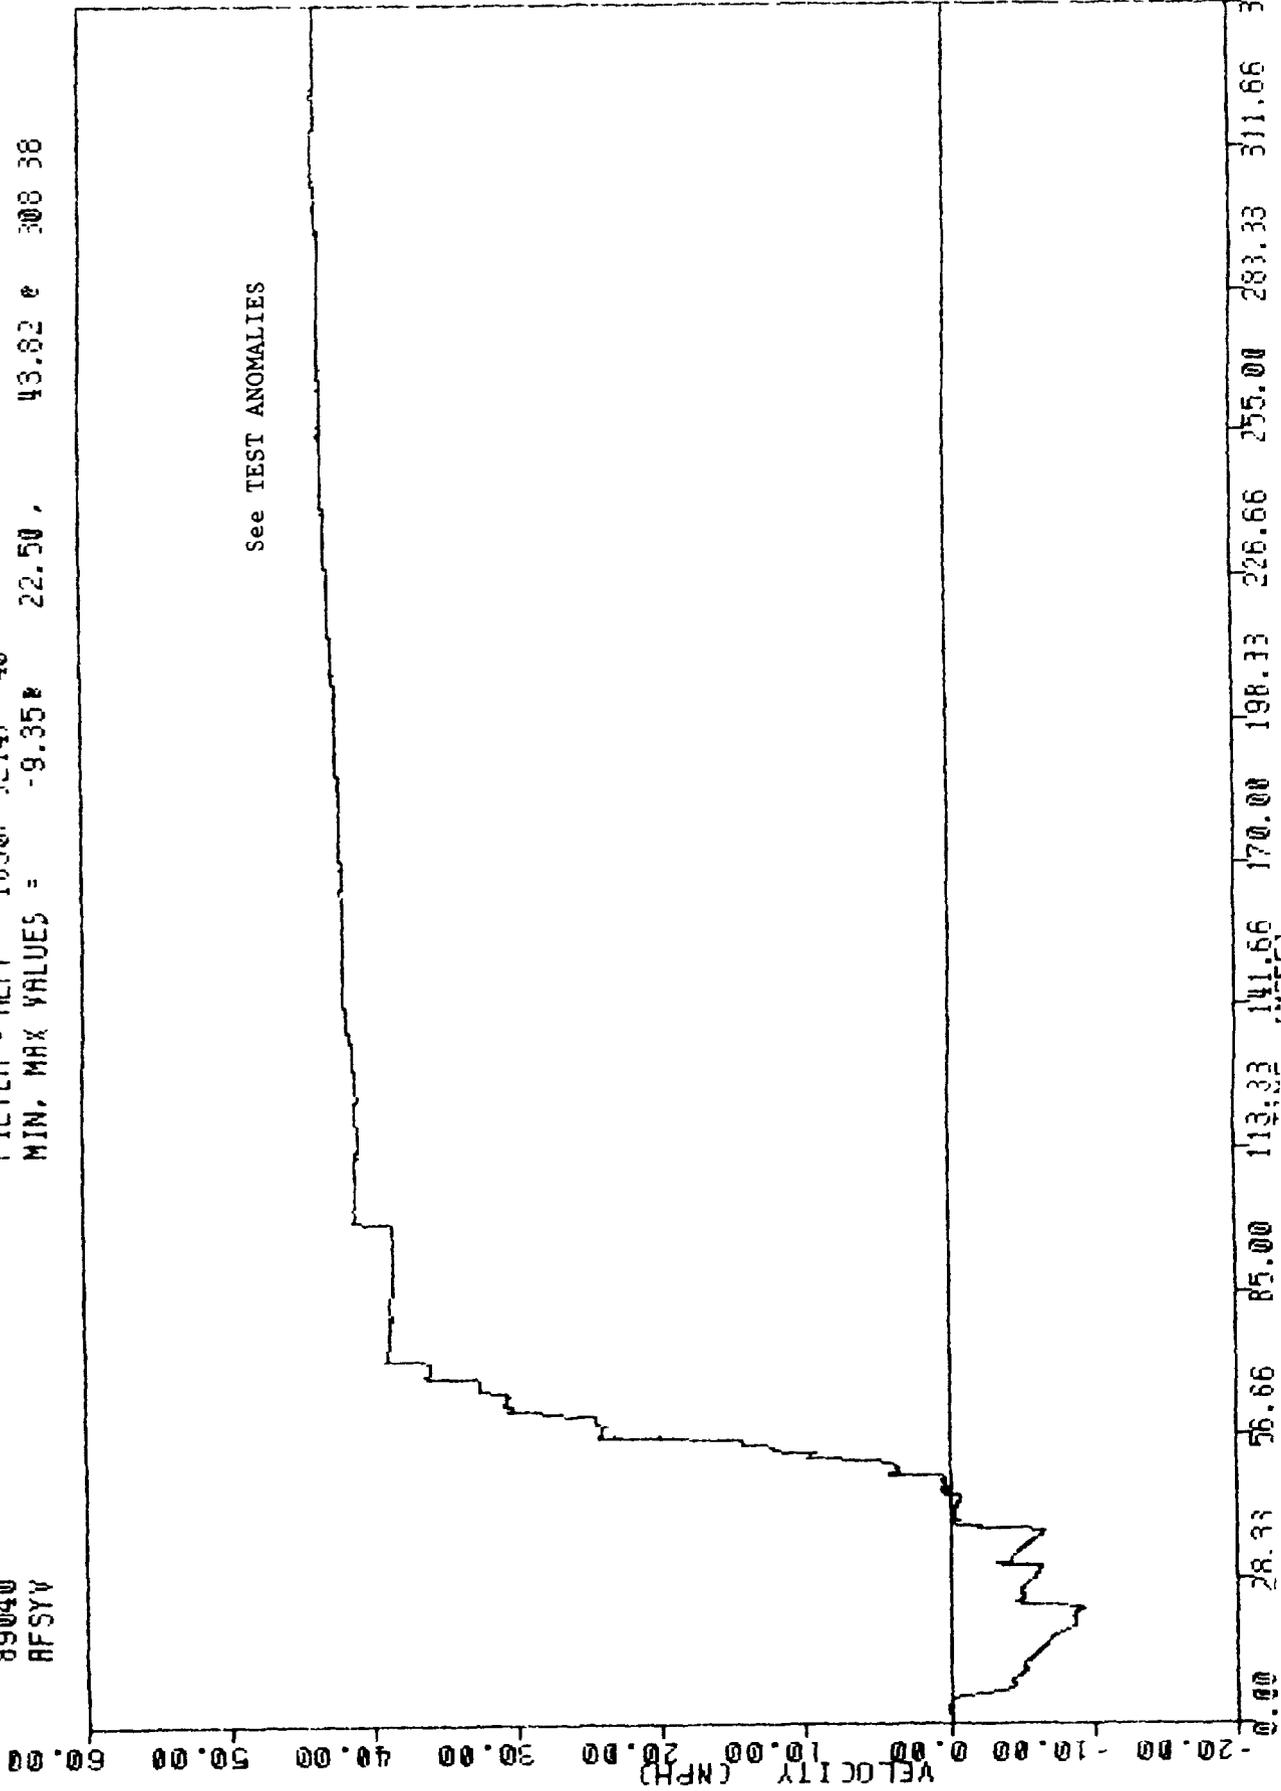
FILTER = ALPF 1650/ 5214/ -40
 MIN, MAX VALUES = -9.35 43.82 e 308 38

CONTOURED MOVING BARRIER INTO 90 DEG 1983 HONDA PRELUDE AT 27.0 MPH #2
 RIGHT FRONT SILL Y AXIS VELOCITY

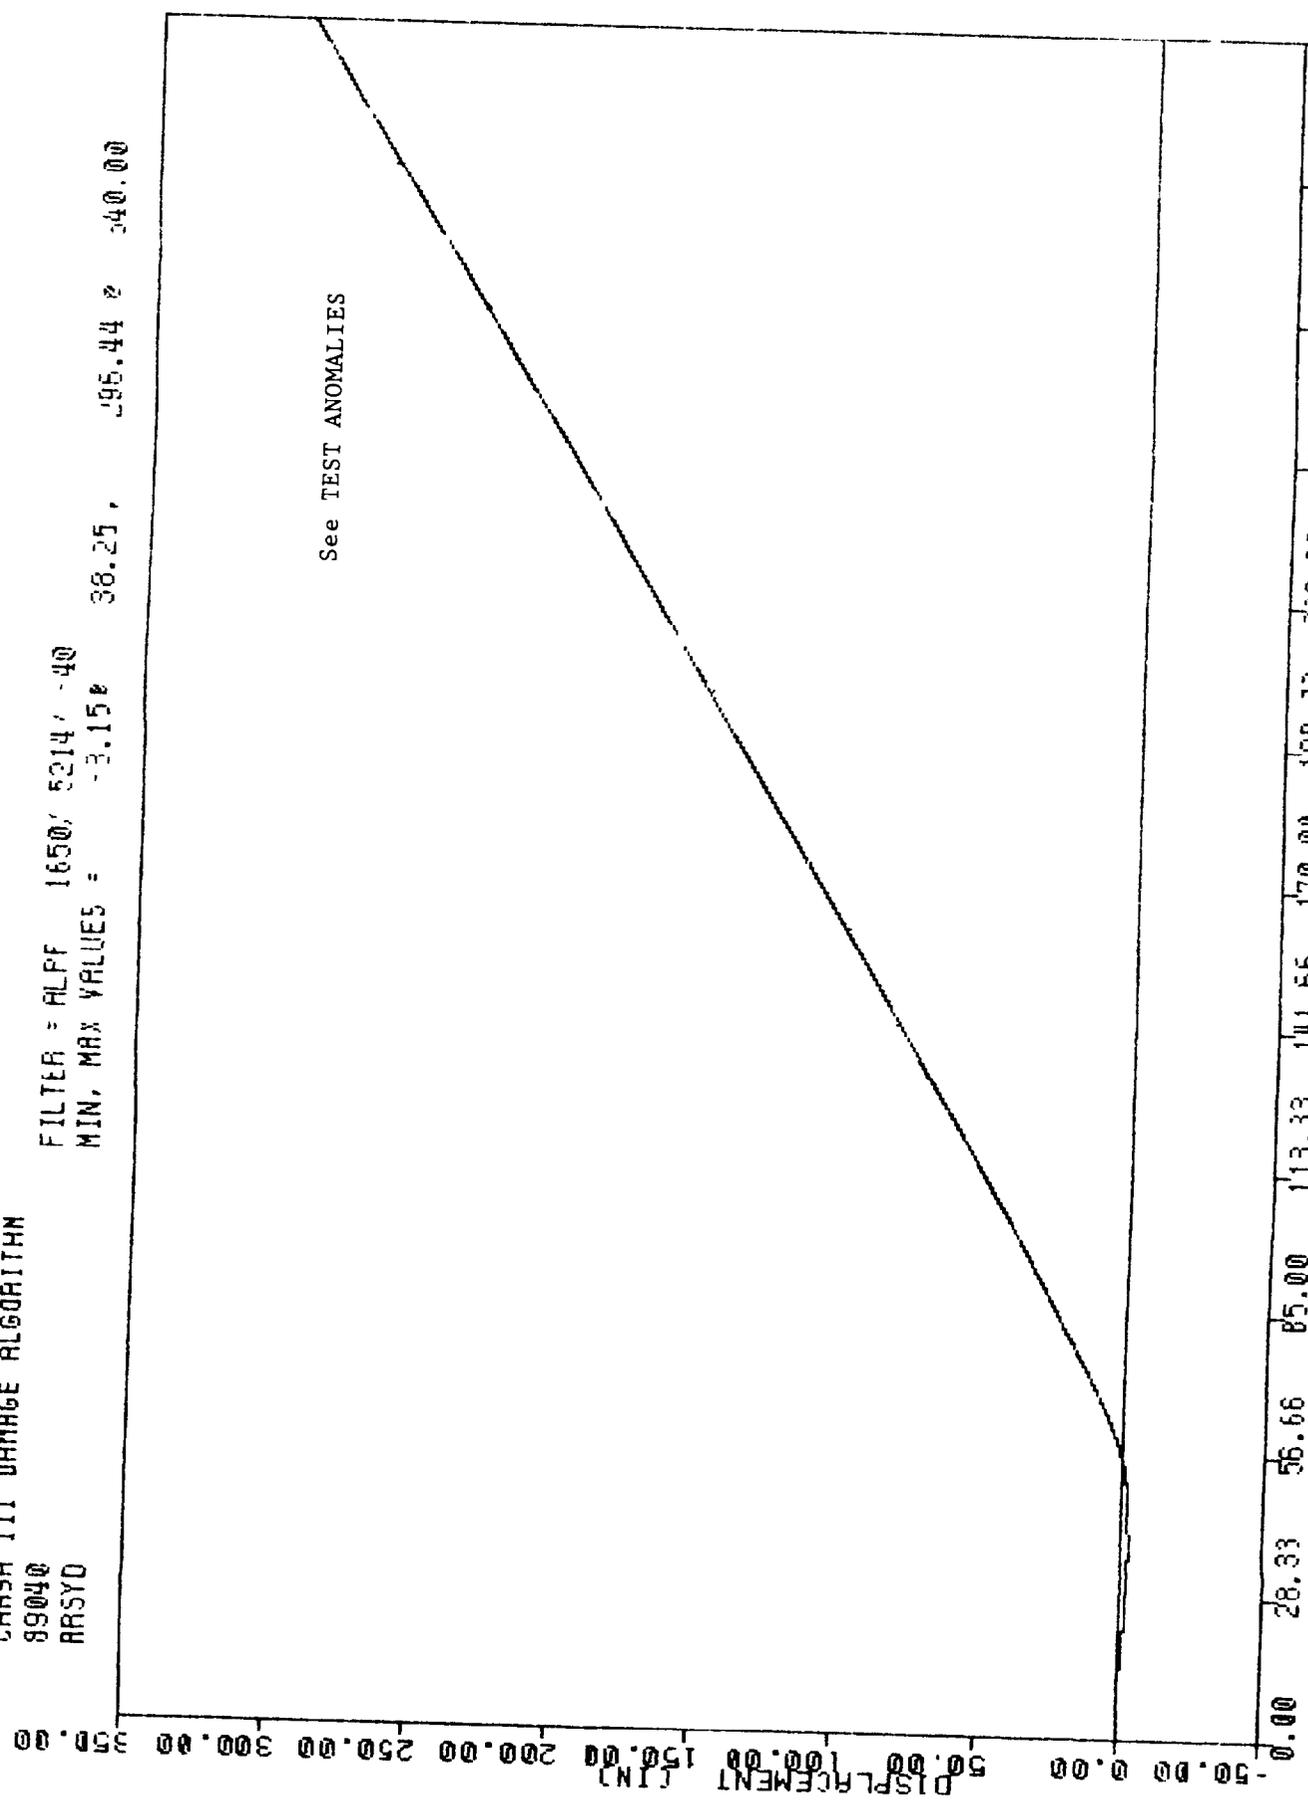
CONTOURED MOVING BARRIER INTO 90 DEG HONDA PRELUDE AT 27.0 MPH #2
 RIGHT REAR SILL Y AXIS DISPLACEMENT
