DOT HS 807 441

Final Report

Final Report of 270° Contoured Moving Barrier Impact into a 1983 Honda Prelude 2-Door Coupe in Support of Crash III Damage Algorithm Reformation

The purpose of the four 270° contoured moving barrier impact tests was for research and development in support of the CRASH III damage algorithm reformulation.

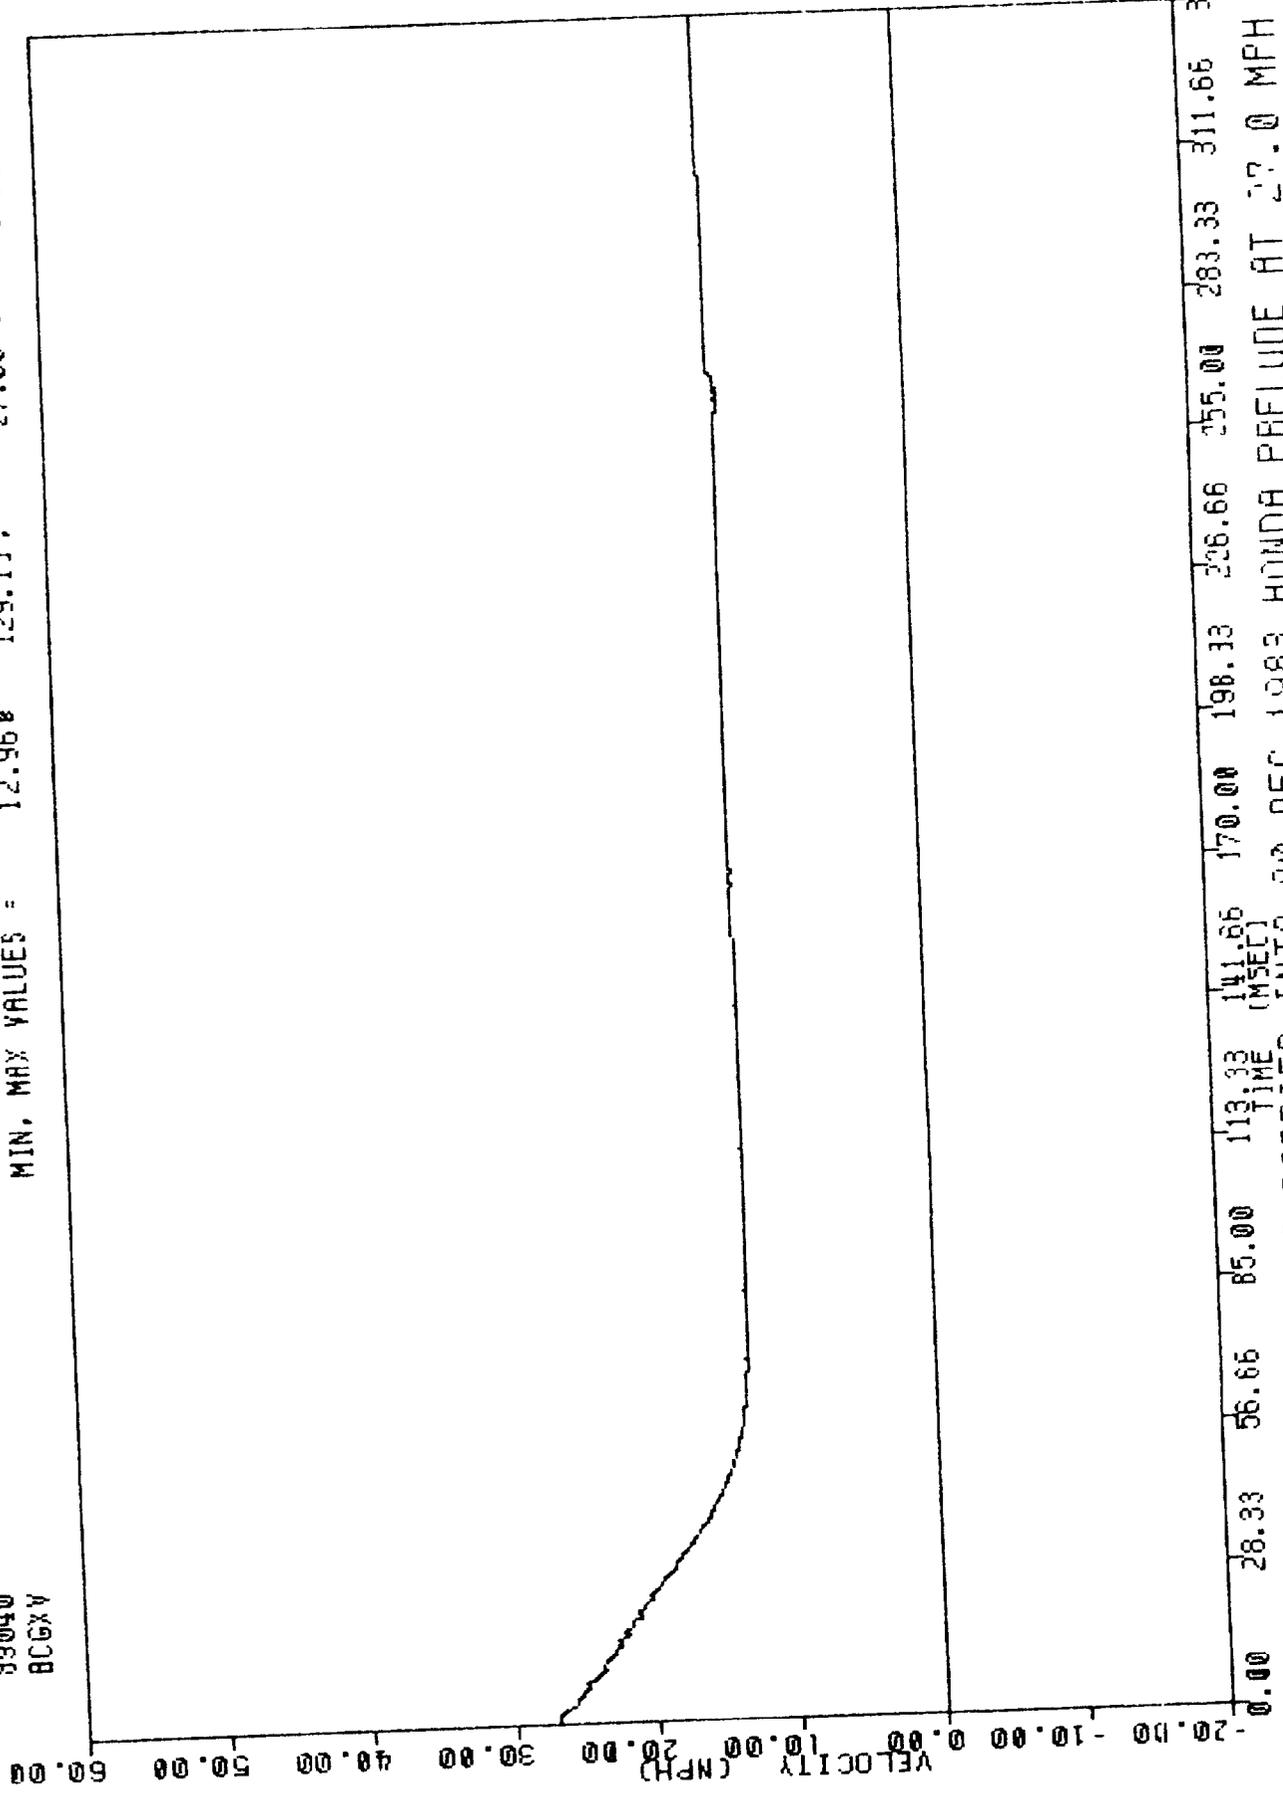
FILTER = ALPF 1650, 5214, -40
 MIN. MAX VALUES = 12.96 129.13, 27.00 0.00

CONTOURED MOVING BARRIER INTO 90 DEG 1983 HONDA PRELUDE AT 27.0 MPH #2
 CONTOURED MOVING BARRIER CENTER OF GRAVITY X AXIS VELOCITY

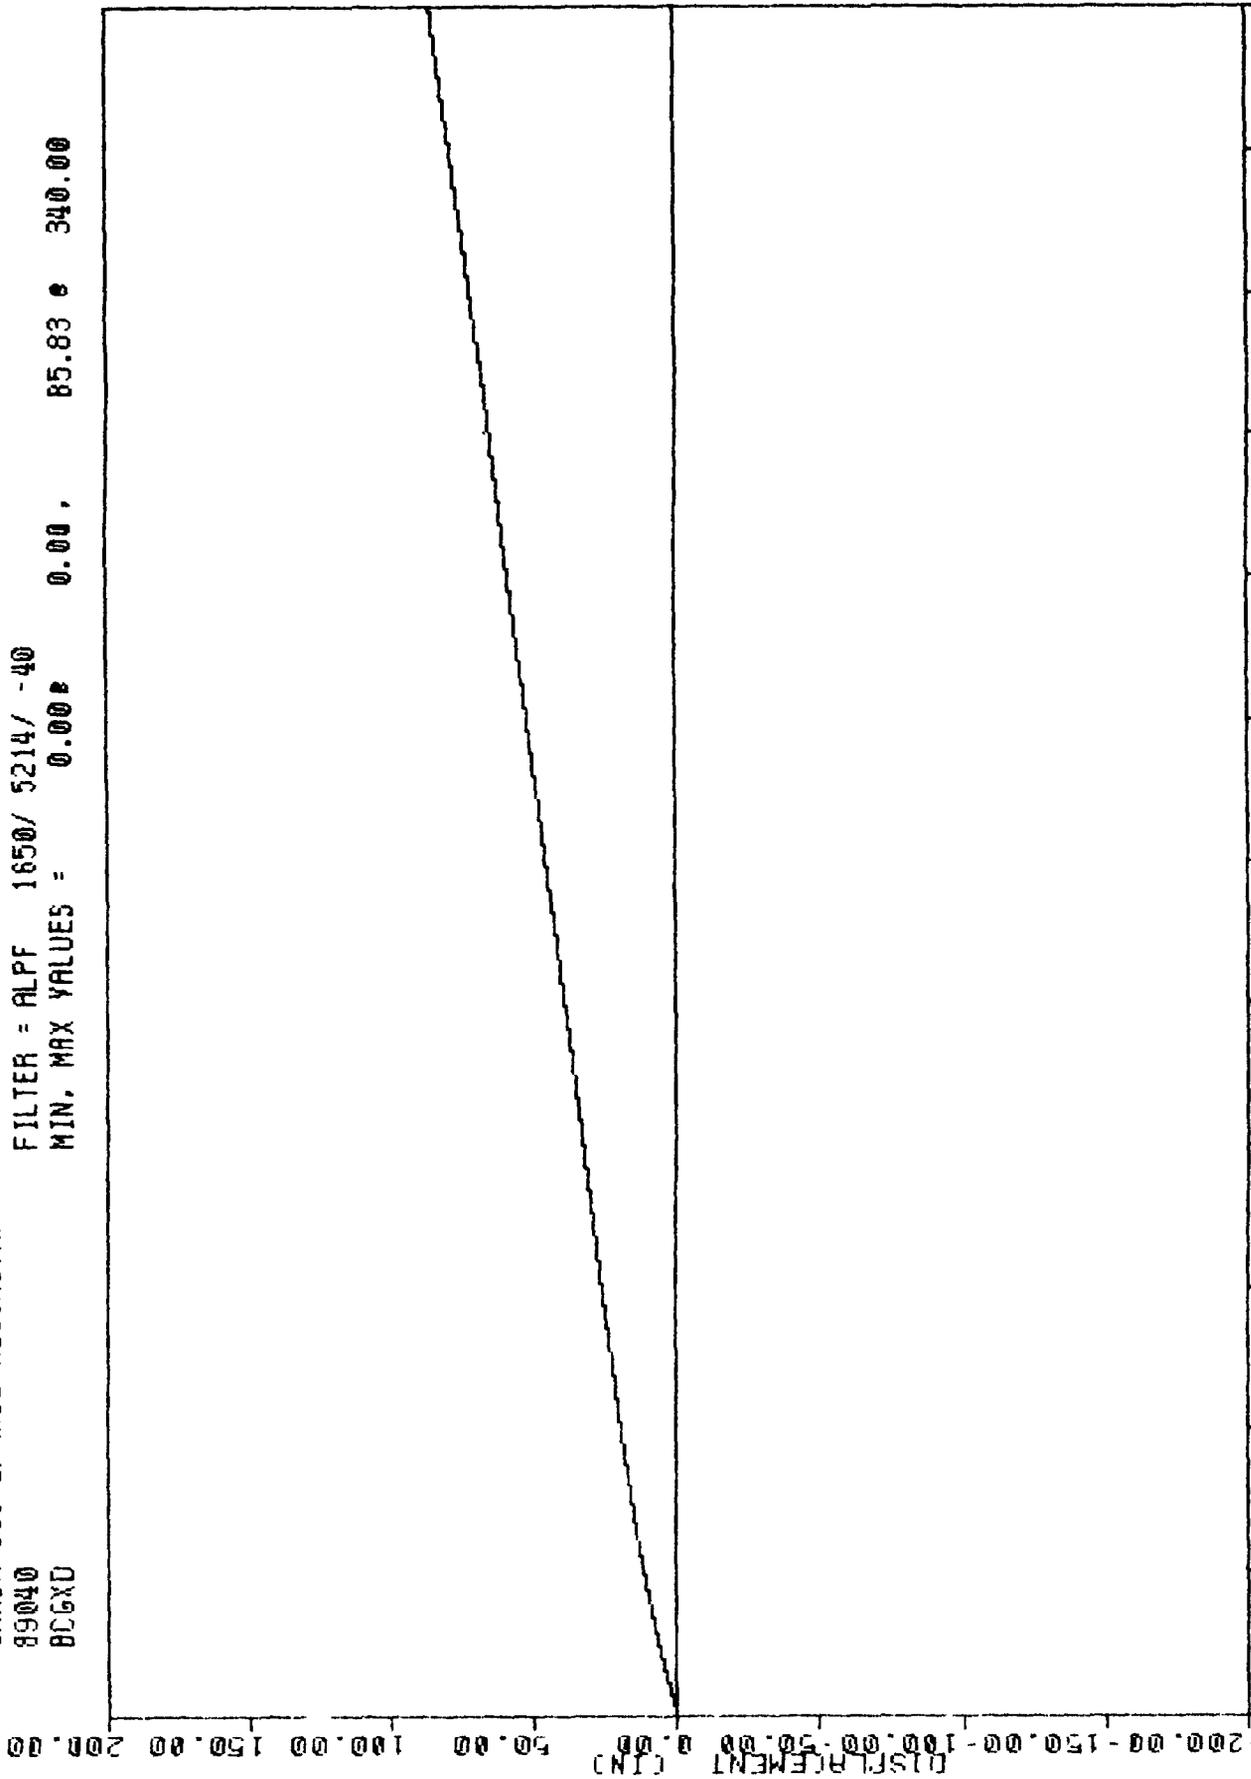
FILTER = ALPF 1650/ 5214/ -40
 MIN. MAX VALUES = 0.00 0.00 , 85.83 340.00

CONToured MOVING BARRIER INTO 90 DEG HONDA PRELUDE AT 27.0 MPH *2
 CONToured MOVING BARRIER CENTER OF GRAVITY X AXIS DISPLACEMENT

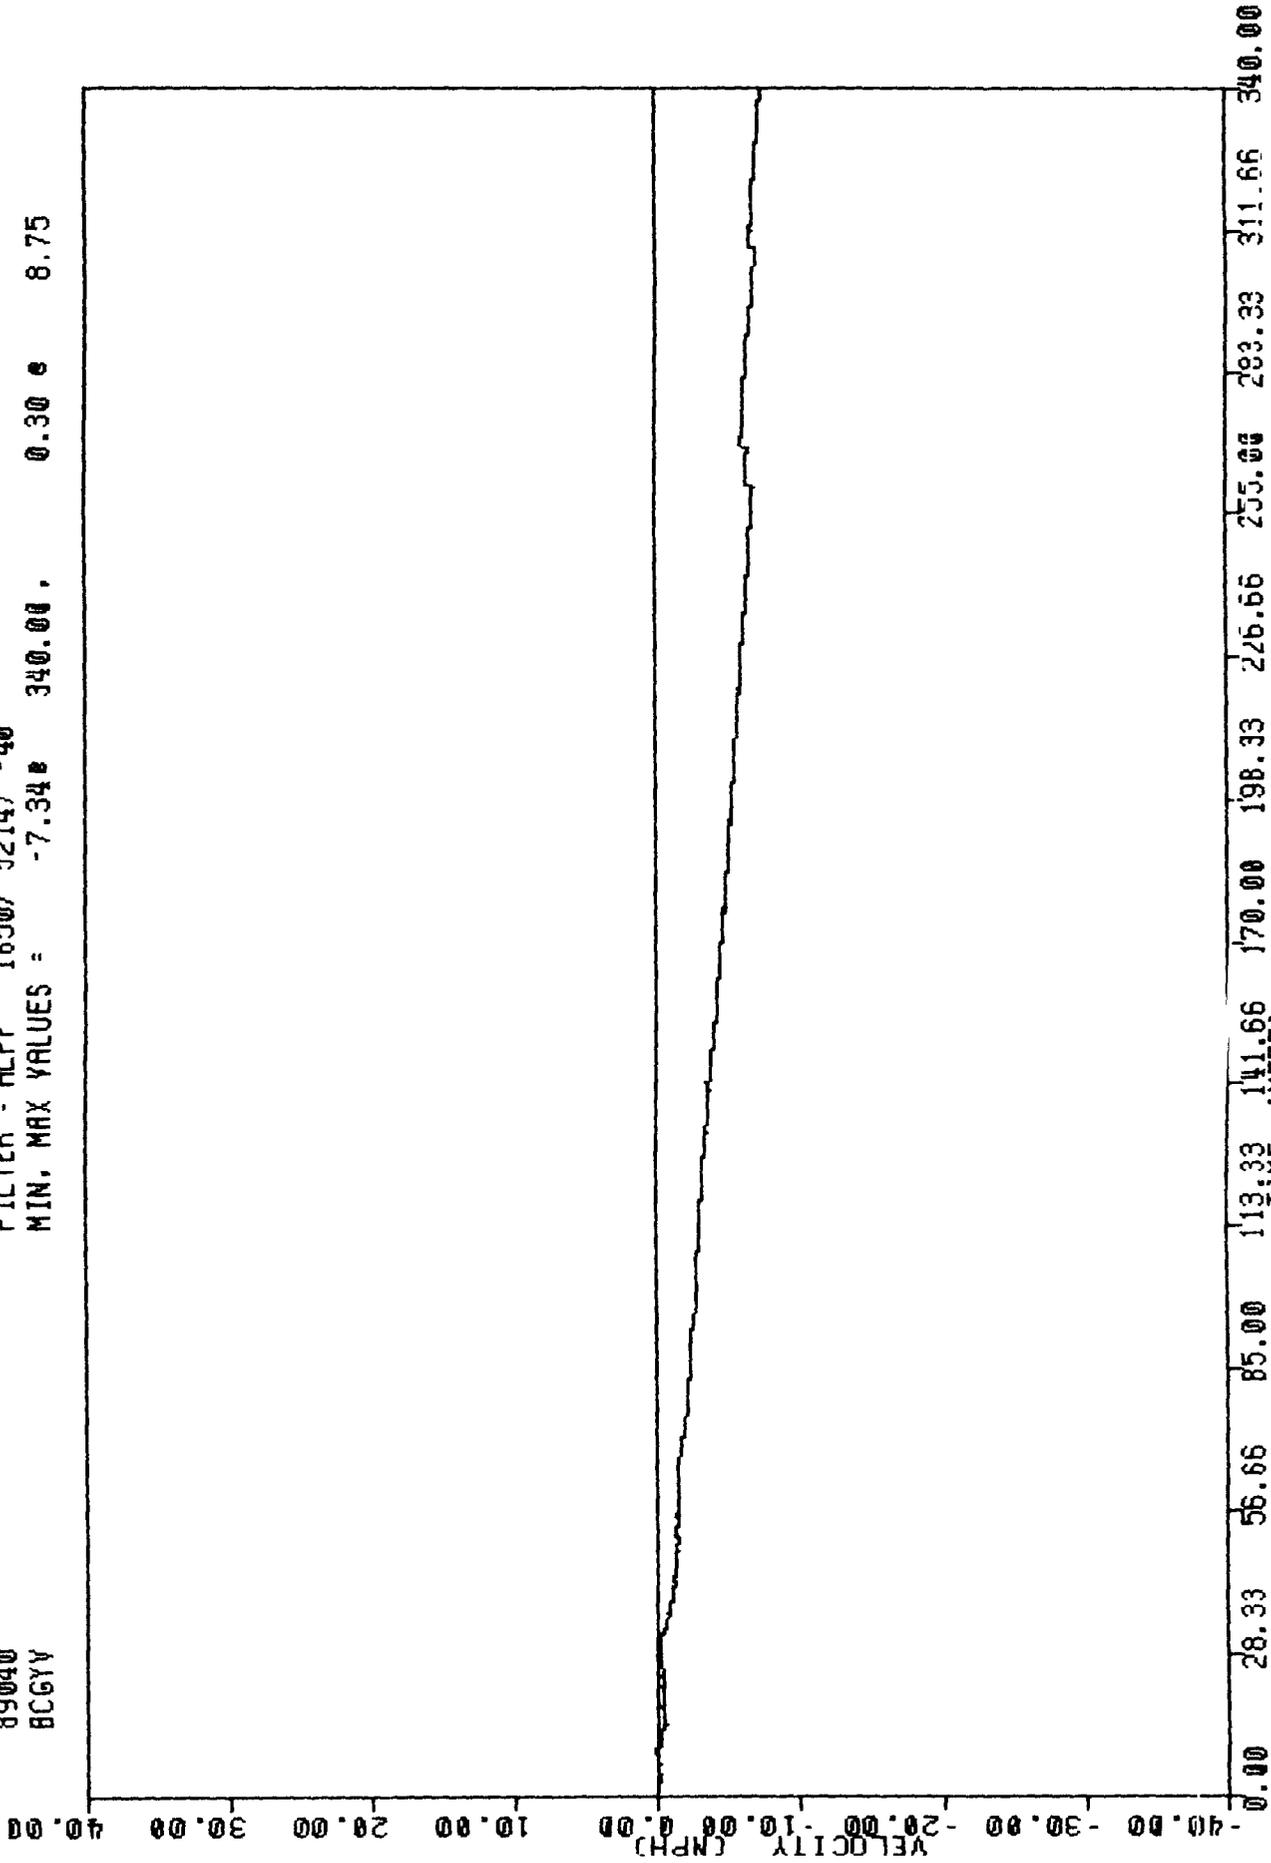
FILTER = ALPF 1650/ 5214/ -40
MIN. MAX VALUES = -7.34 340.00 , 0.30 8.75

CONTOURED MOVING BARRIER INTO 90 DEG 1983 HONDA PRELUDE AT 27.0 MPH #2
CONTOURED MOVING BARRIER CENTER OF GRAVITY Y AXIS VELOCITY

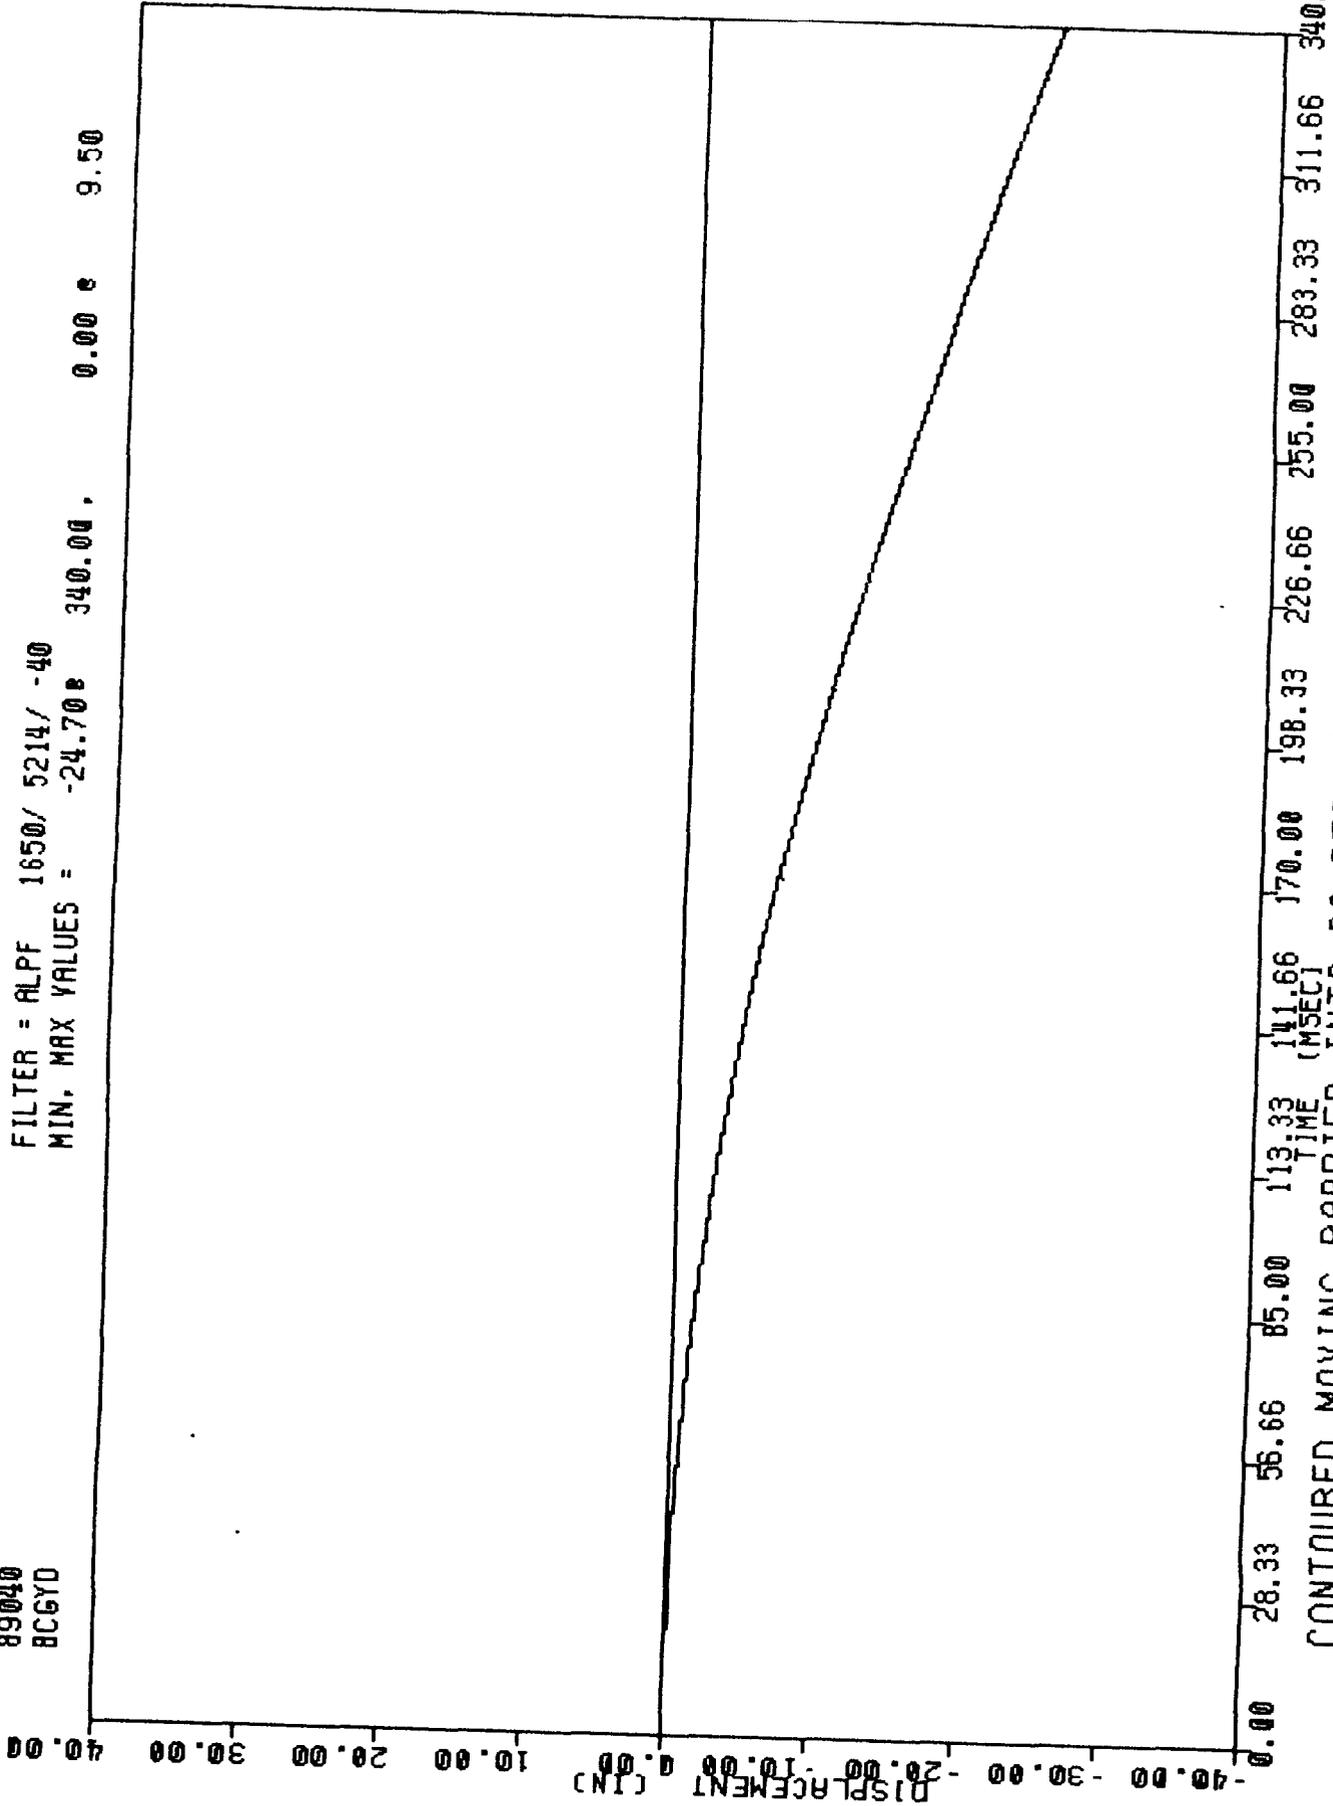
FILTER = ALPF 1650/ 5214/ -40
 MIN, MAX VALUES = -24.70 340.00 0.00 9.50

CONTOURED MOVING BARRIER INTO 90 DEG 1983 HONDA PRELUDE AT 27.0 MPH #2
 CONTOURED MOVING BARRIER CENTER OF GRAVITY Y AXIS DISPLACEMENT

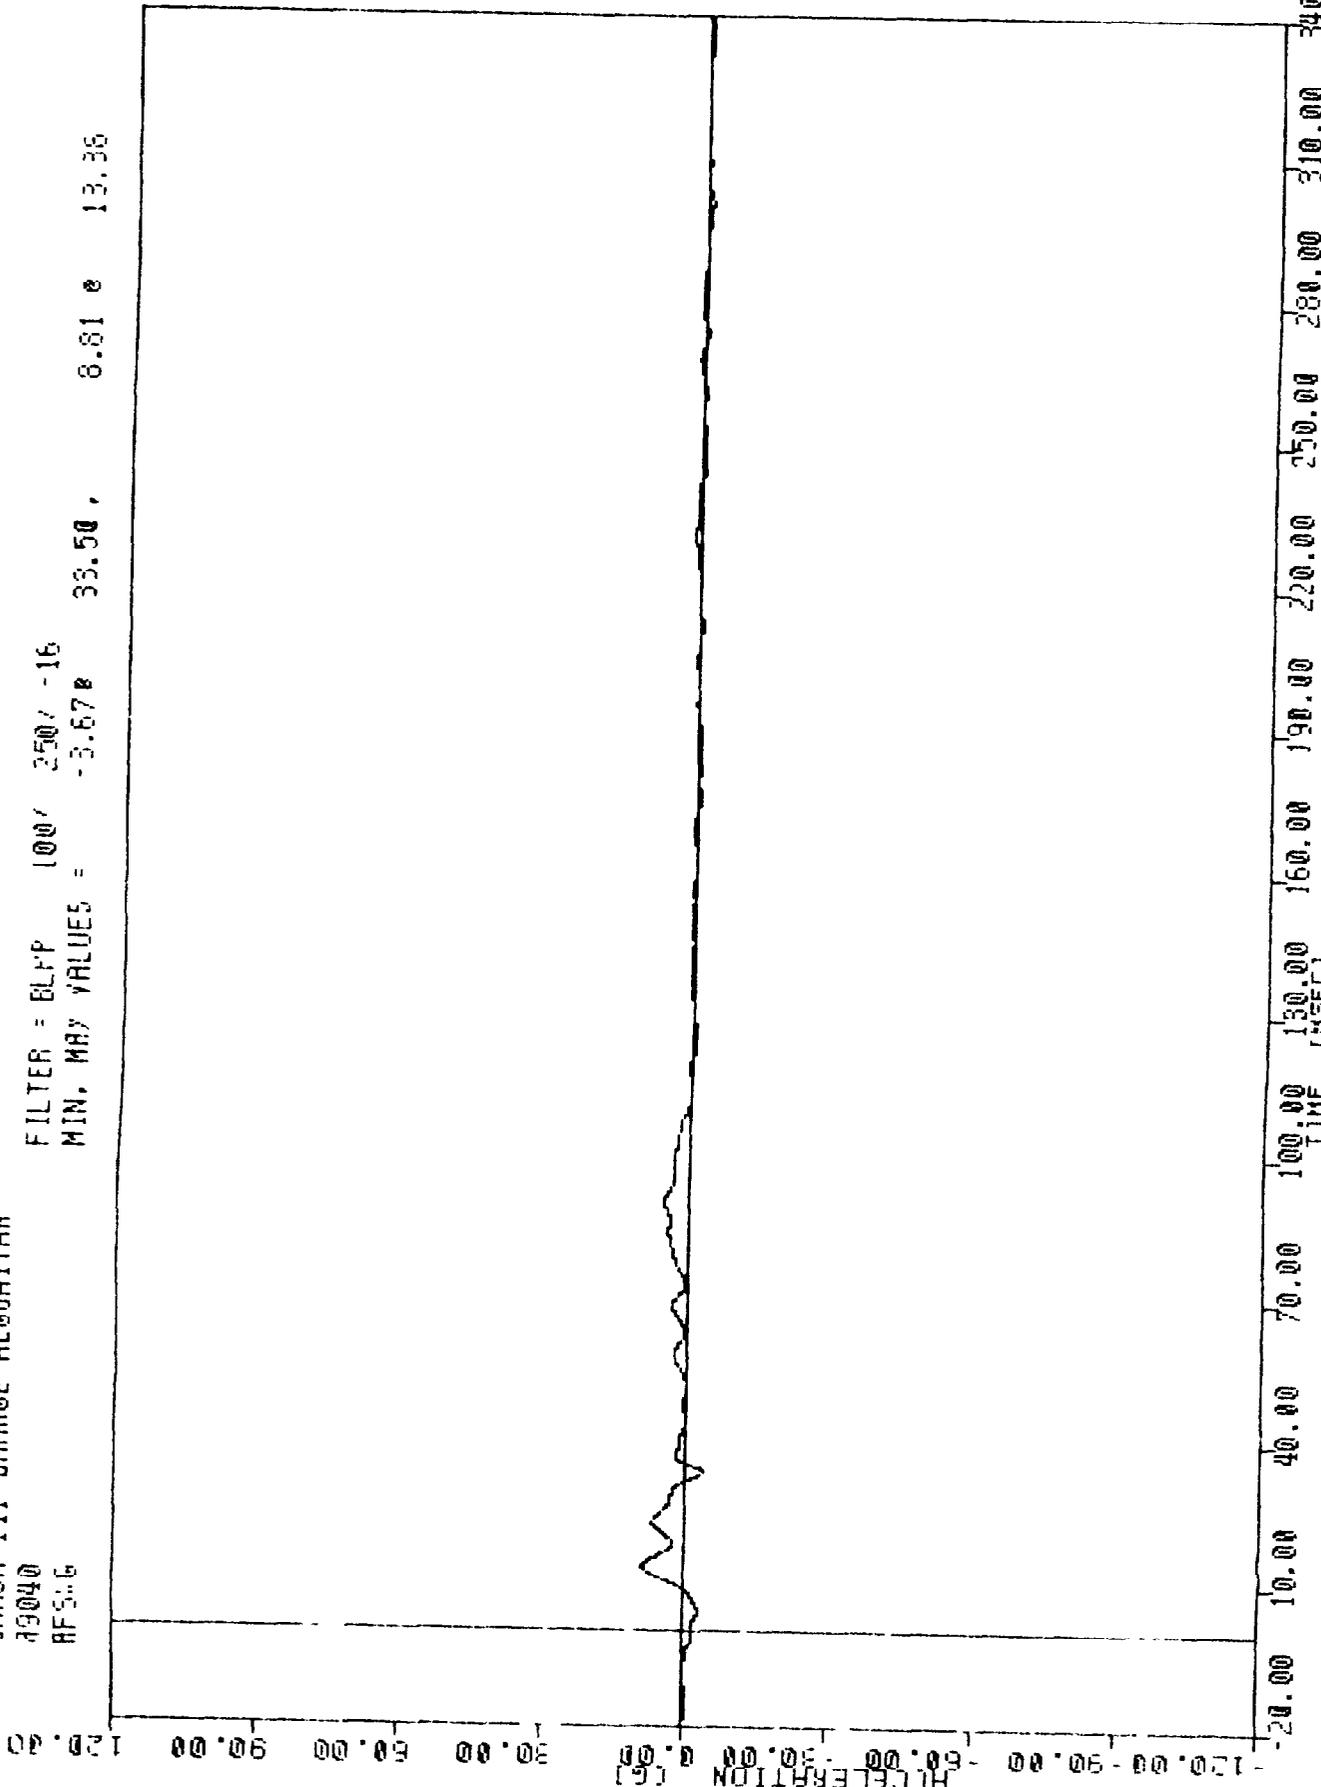
FILTER = BLFP 100% 250% -16
MIN. MAX VALUES = -3.67 8.81 e 13.36

COUNTROUDED MOVING BARRIER INTO 90 DEG HONDA PRELUDE AT 27.1 MPH #3
RIGHT FRONT SILL Y AXIS ACCELERATION

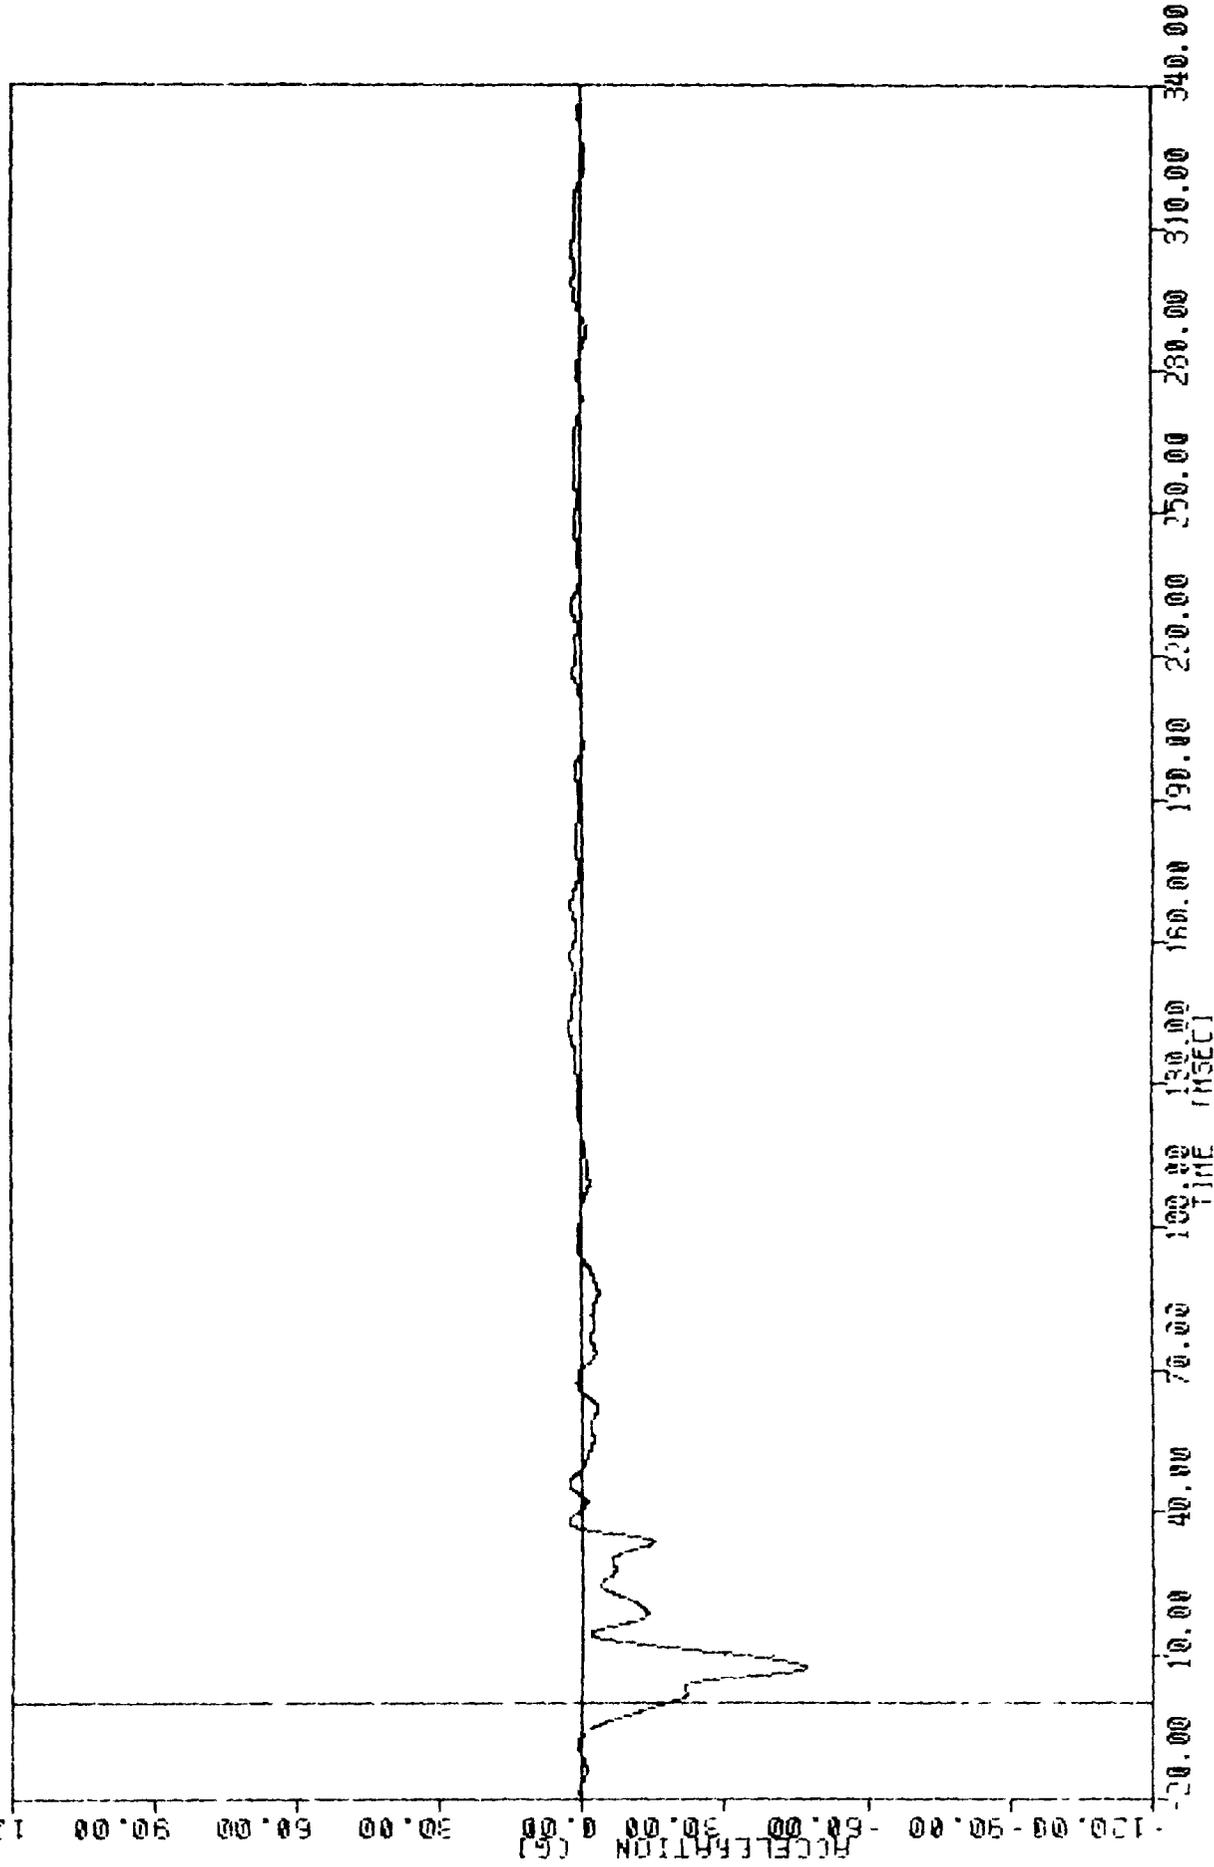
FILTER - RLPF 100' 250' -16
MIN. MAX VALUES = -47.04 e 7.50 . 2.98 e 37.63

CONToured MOVING BARRIER INTO 90 DEG 1983 HONDA PRELUDE AT 27.1 MPH #3
RIGHT FRONT SILL Y AXIS ACCELERATION

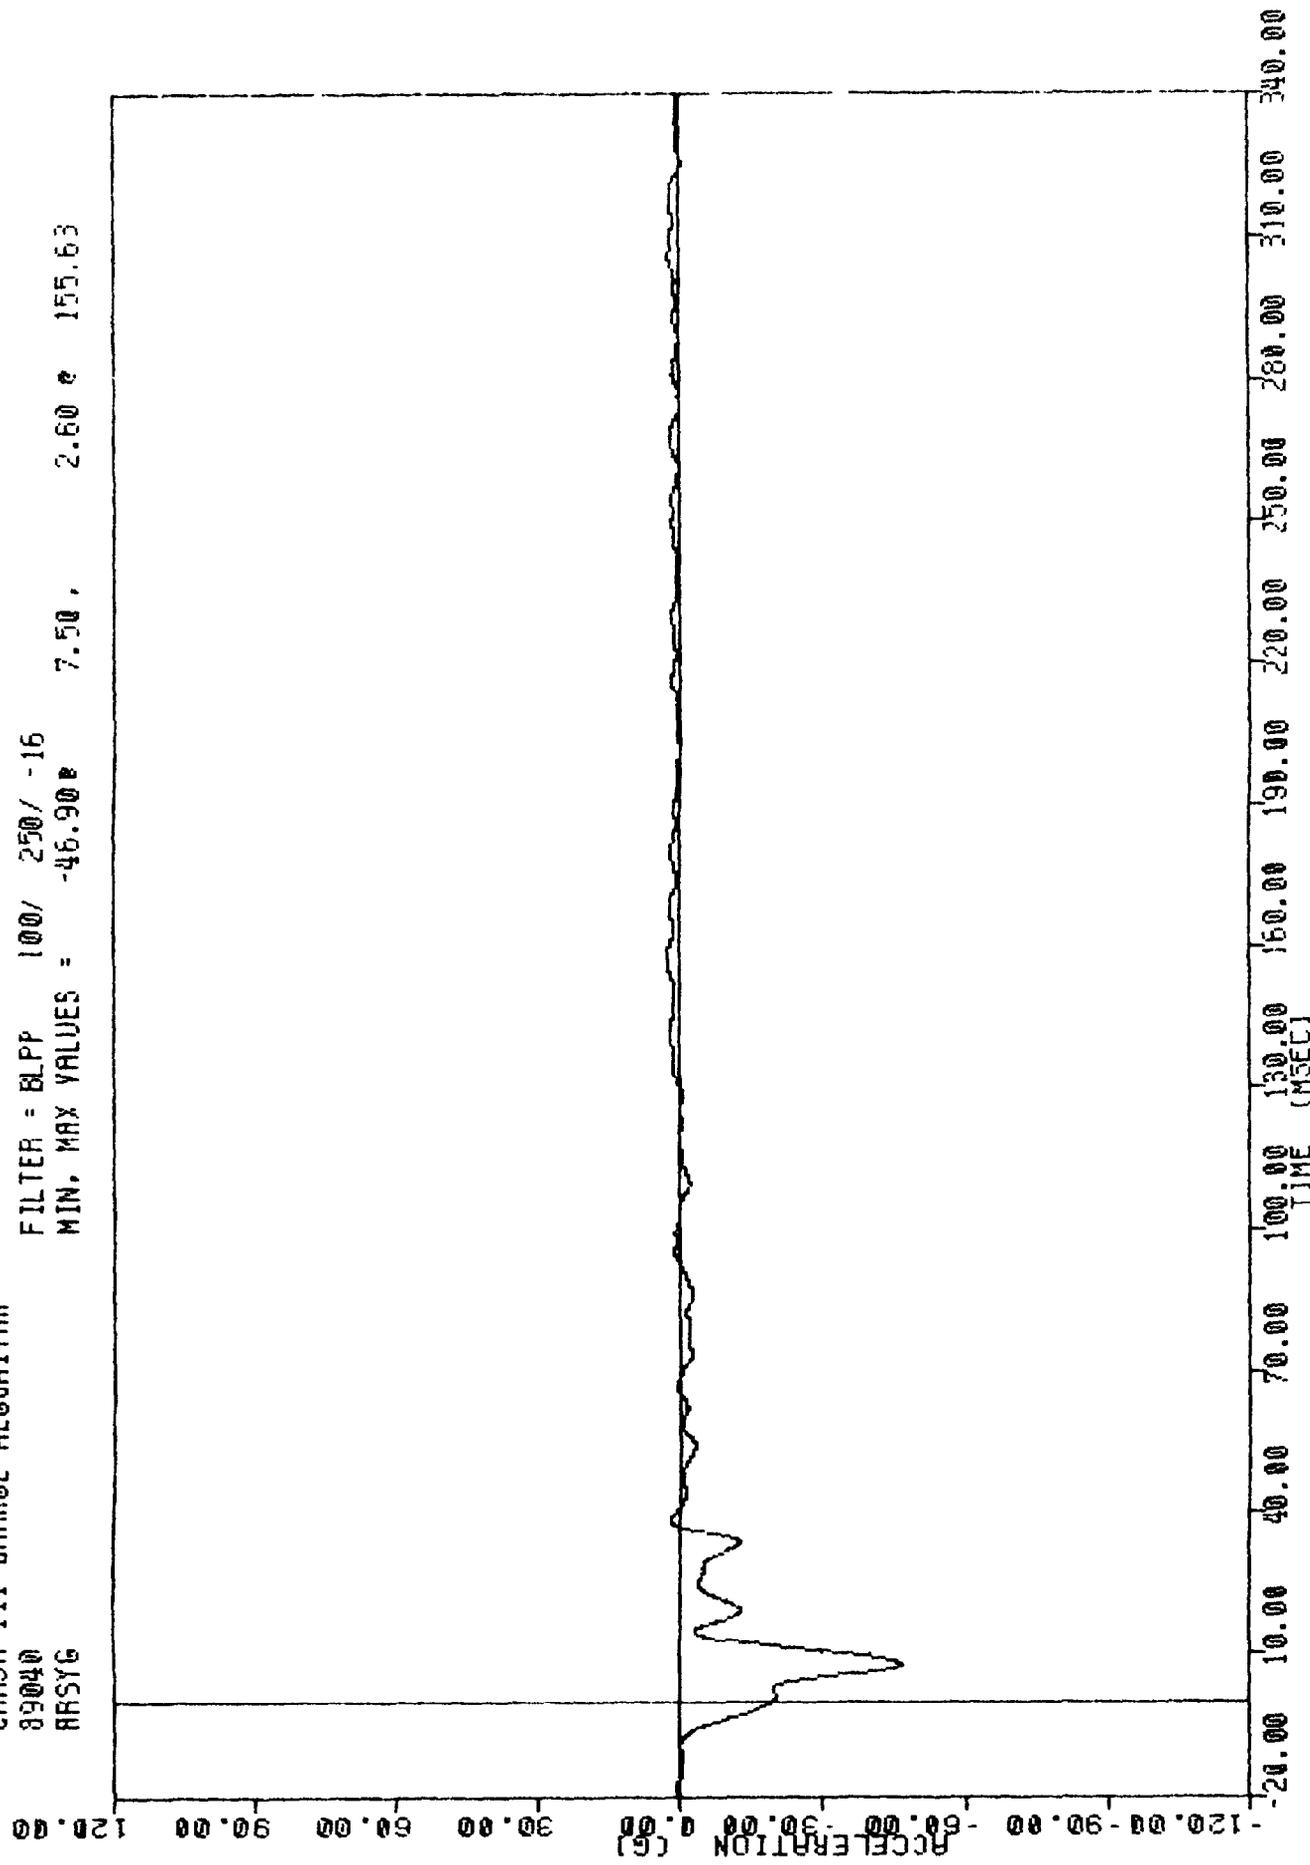
CONTOURED MOVING BARRIER INTO 90 DEG HONDA PRELUDE AT 27.1 MPH #3
RIGHT REAR SILL Y AXIS ACCELERATION

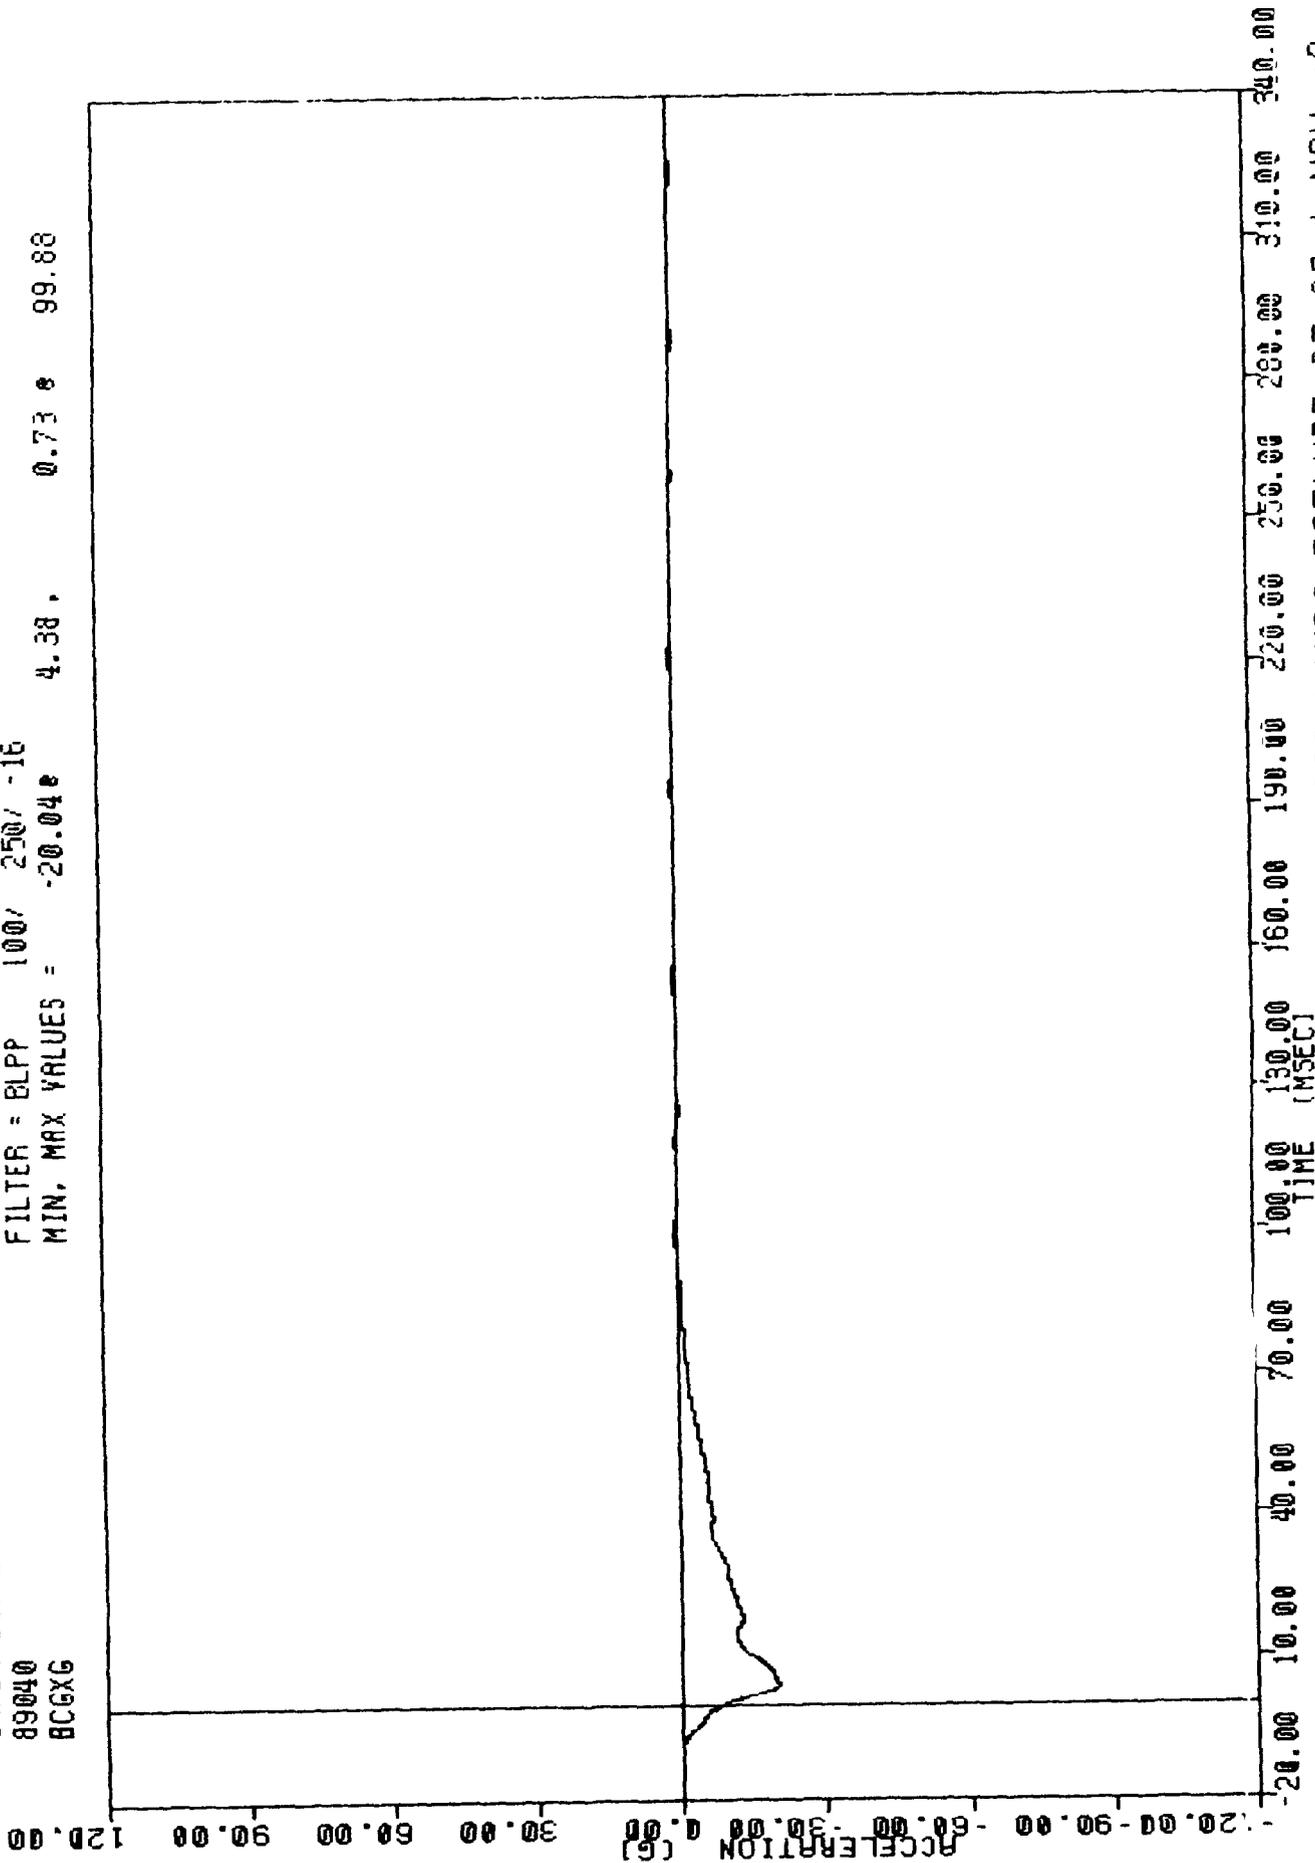
CONTOURED MOVING BARRIER INTO 90 DEG HONDA PRELUDE AT 27.1 MPH #3
CONTOURED MOVING BARRIER CENTER OF GRAVITY X AXIS ACCELERATION

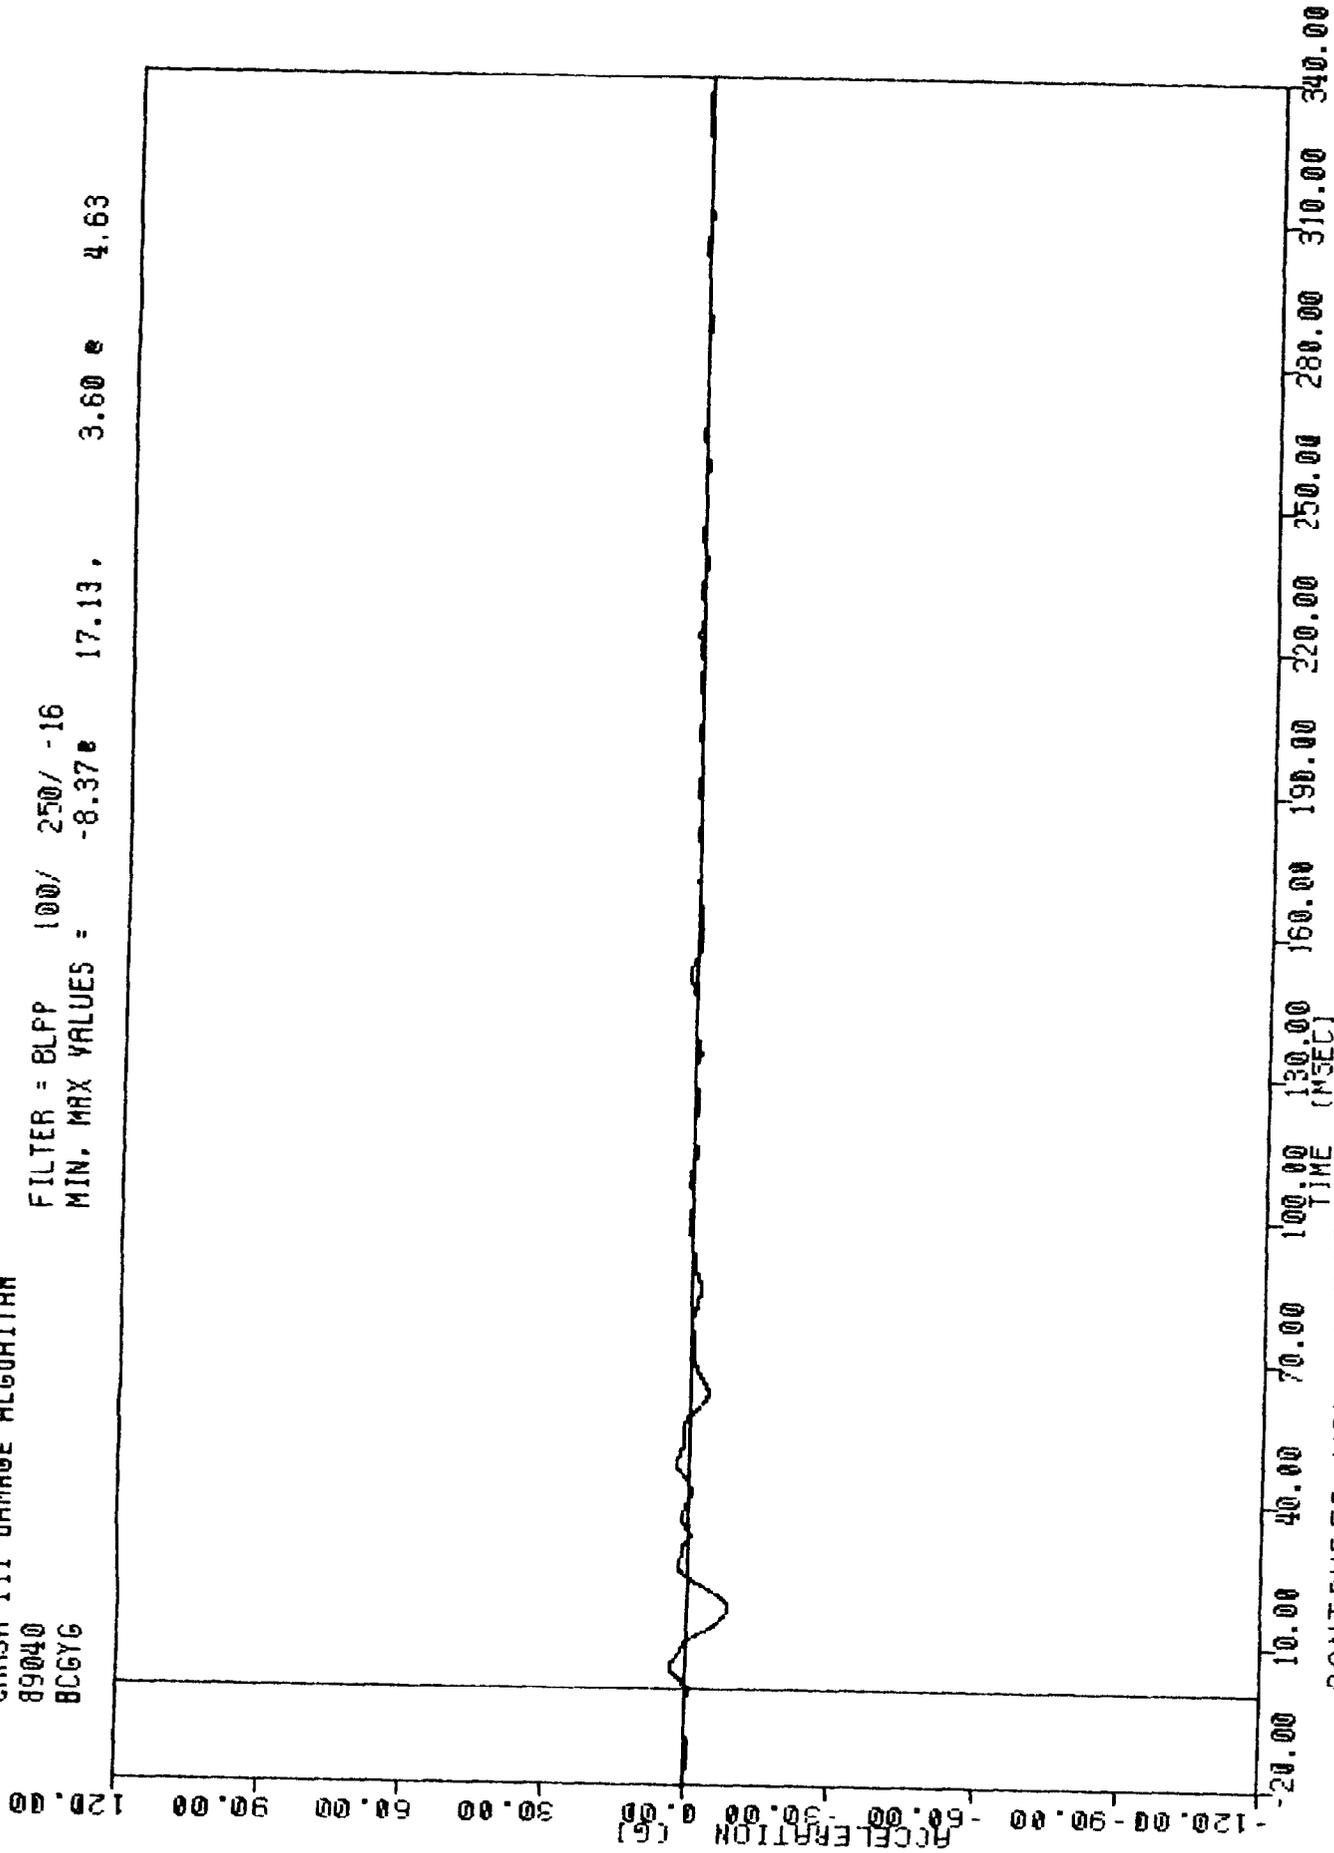
CONTOURED MOVING BARRIER INTO 90 DEG HONDA PRELUDE AT 27.1 MPH #3
CONTOURED MOVING BARRIER CENTER OF GRAVITY Y AXIS ACCELERATION
