DOT HS 807 441

Final Report

Final Report of 270° Contoured Moving Barrier Impact into a 1983 Honda Prelude 2-Door Coupe in Support of Crash III Damage Algorithm Reformation

The purpose of the four 270° contoured moving barrier impact tests was for research and development in support of the CRASH III damage algorithm reformulation.

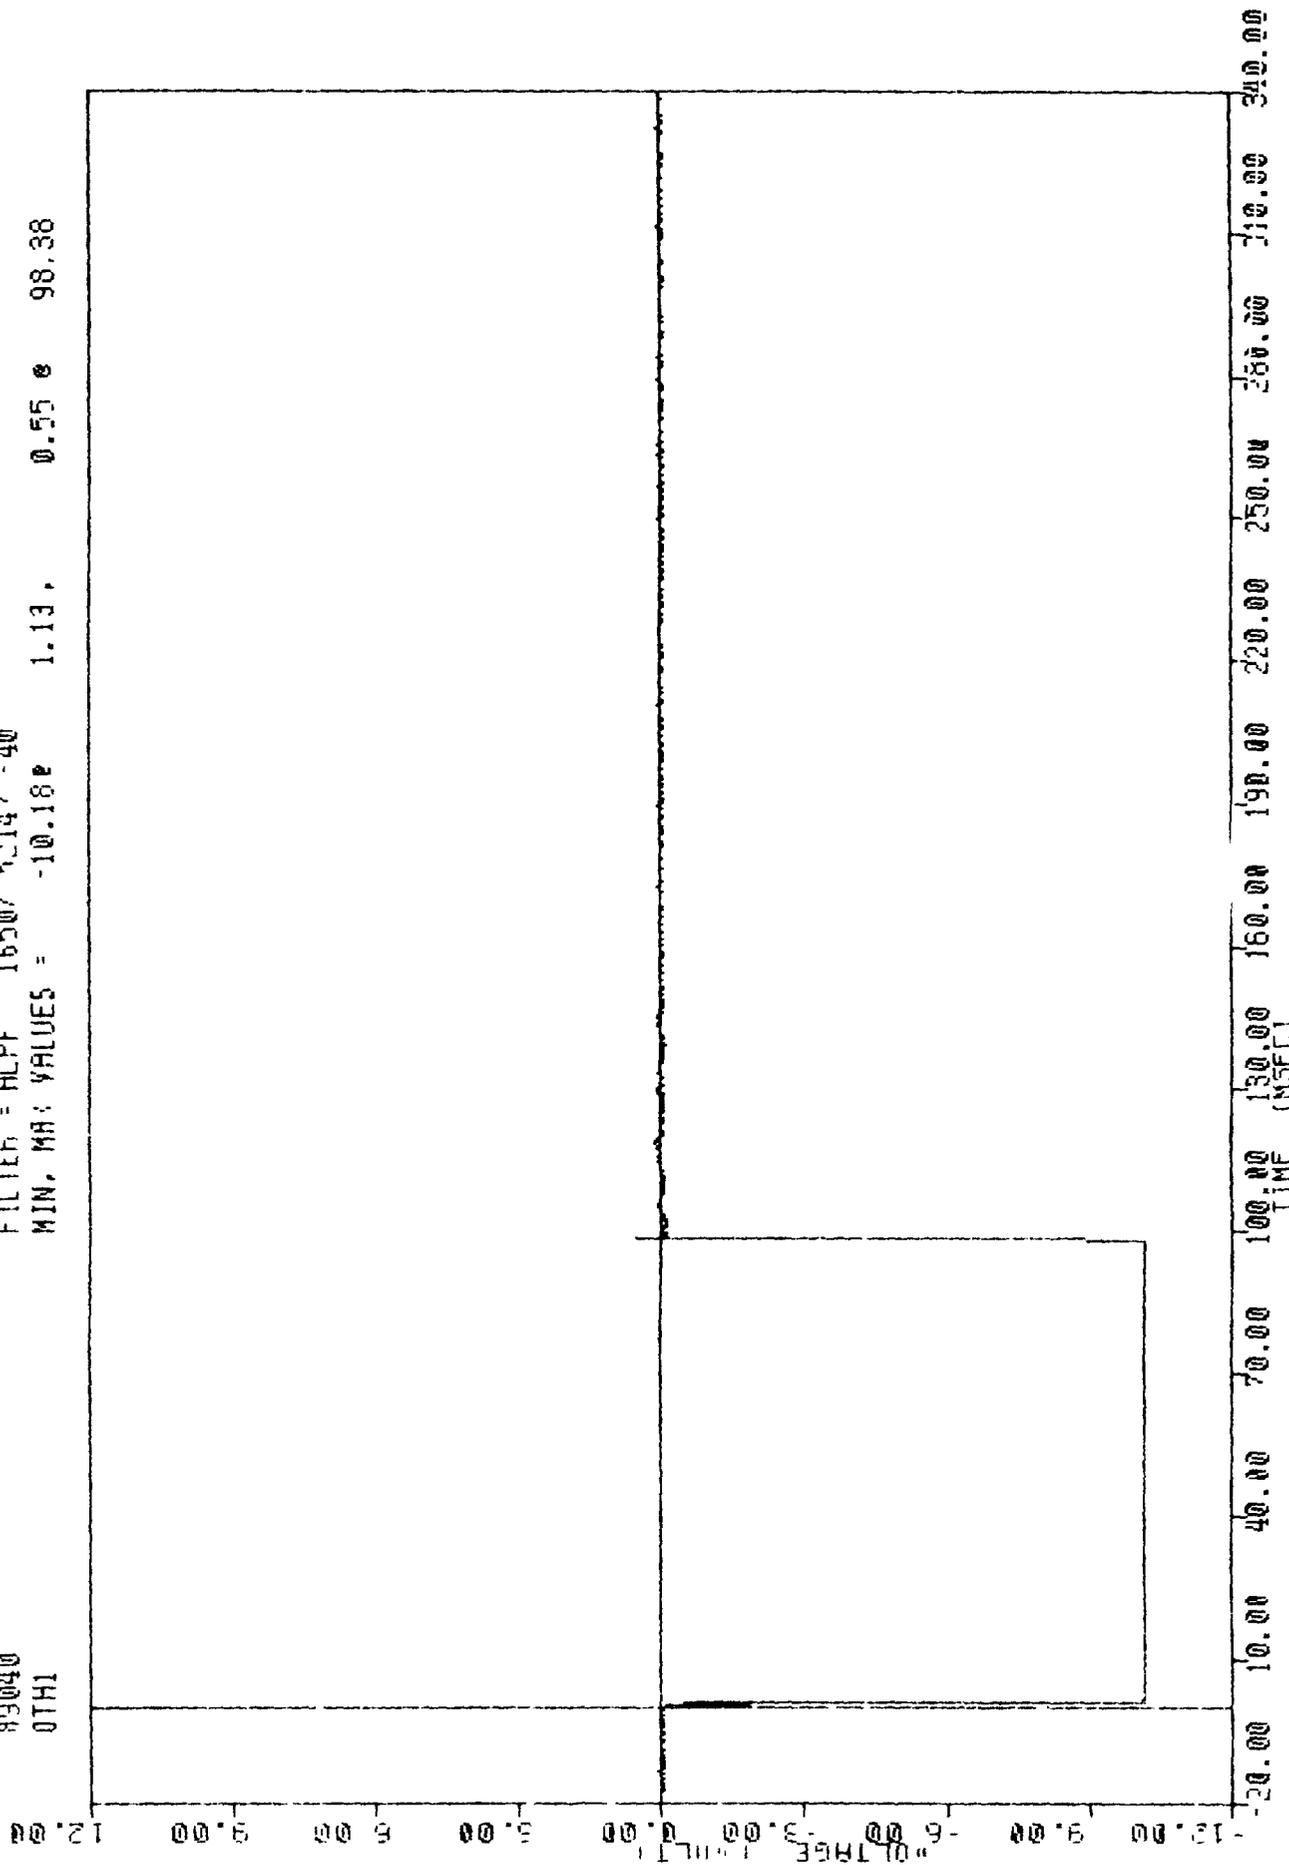
CONToured MOVING BARRIER INTO 90 DEG 1983 HONDA PRELUDE AT 27.1 MPH #3
 VEHICLE CONTACT SWITCH - LEFT

Noise in the form of spikes was observed in the plots for the contact switches OTH1, OTH2, OTH3, OTH4. * The switches were used to record the time of vehicle contact with the moving barrier, as well as the time of vehicle separation from the barrier. The switches were damaged by the crush of the moving contoured barrier against the vehicle. The switches were replaced following each test which contained spikes. This is not the standard use of such switches.

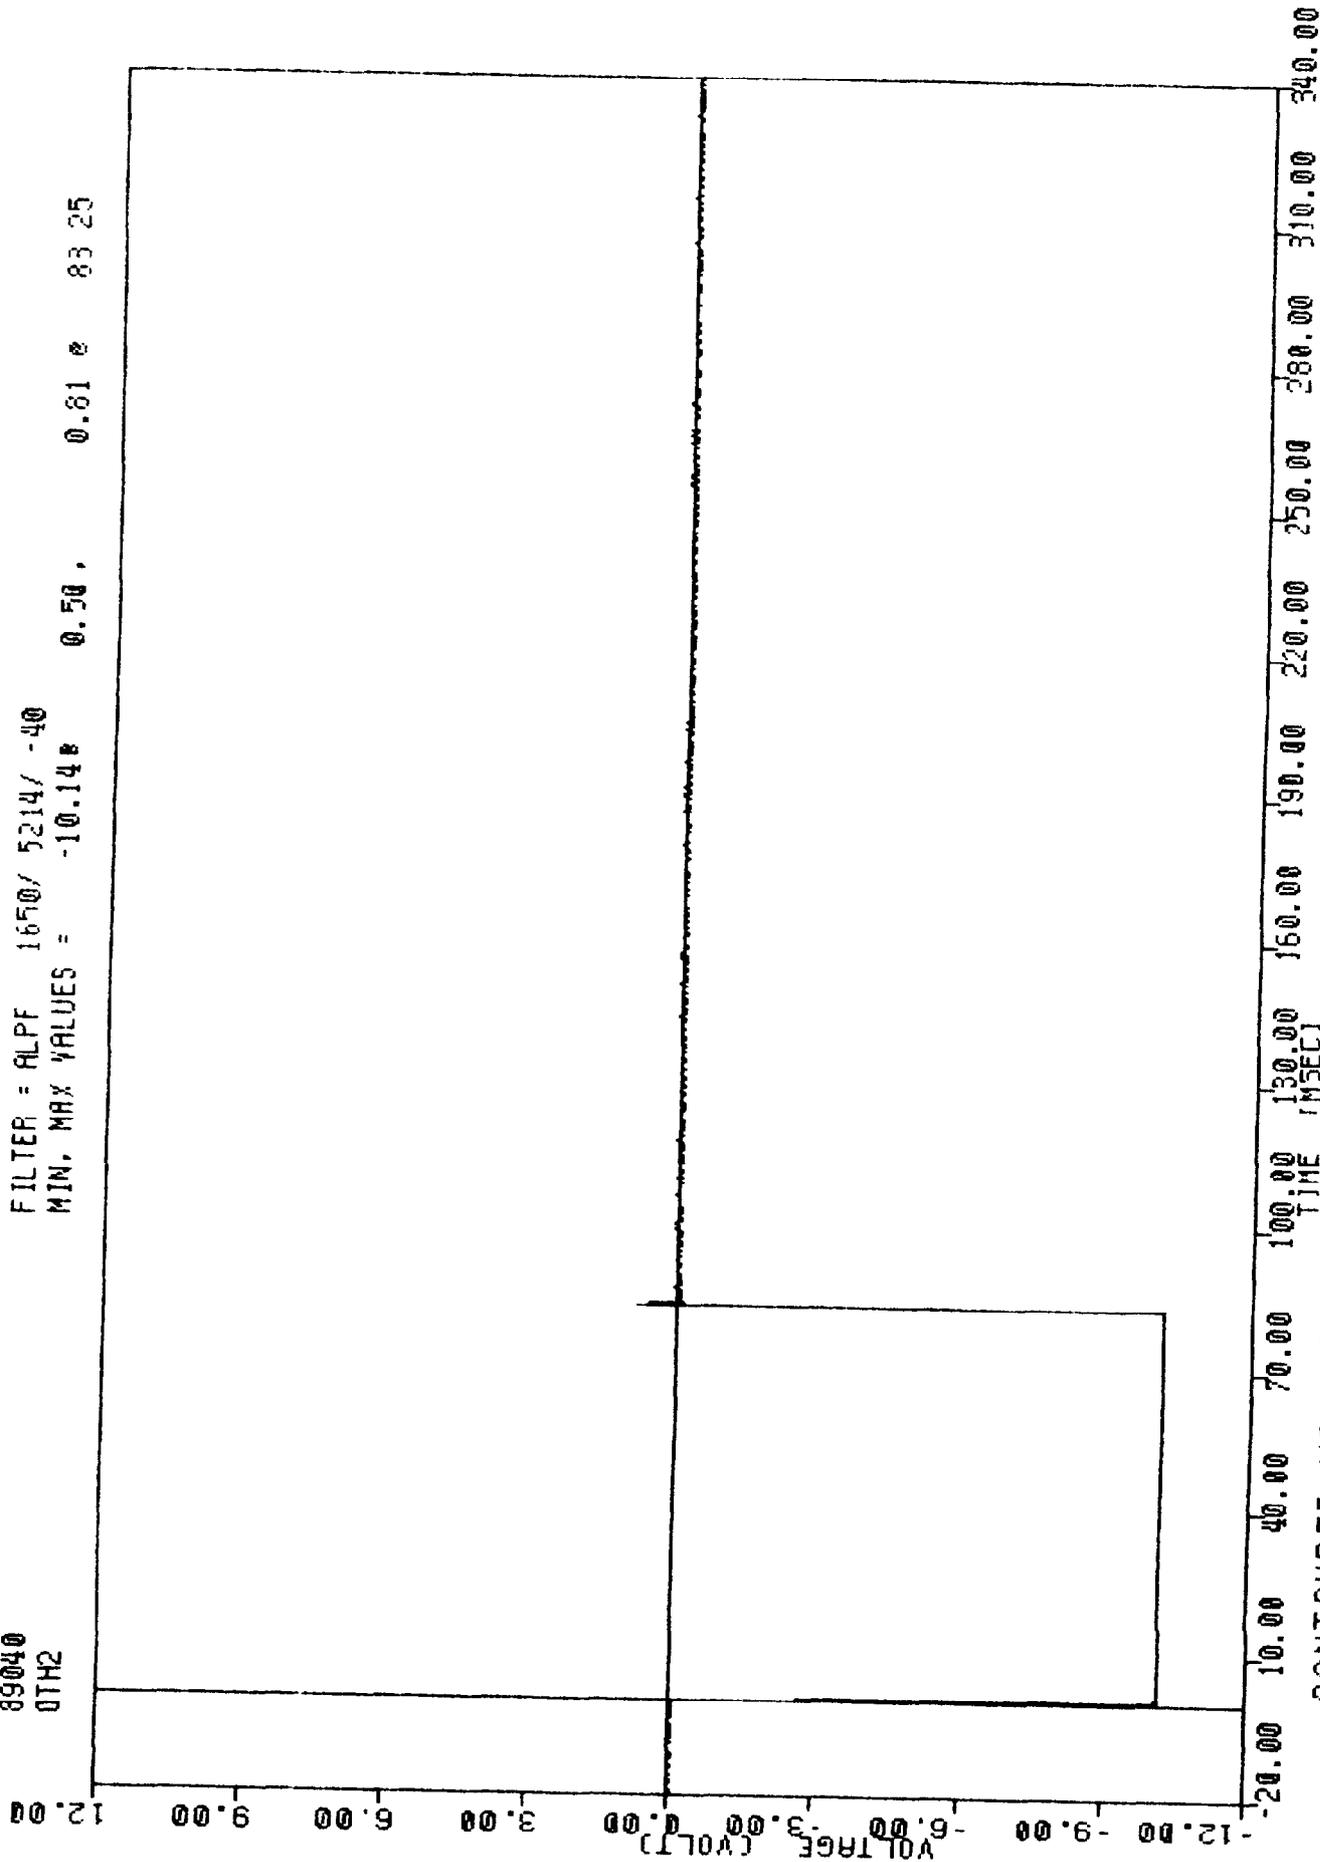
CONToured MOVING BARRIER INTO 90 DEG 1983 HONDA PRELUDE AT 27.1 MPH #3
VEHICLE CONTACT SWITCH - CENTER - 1

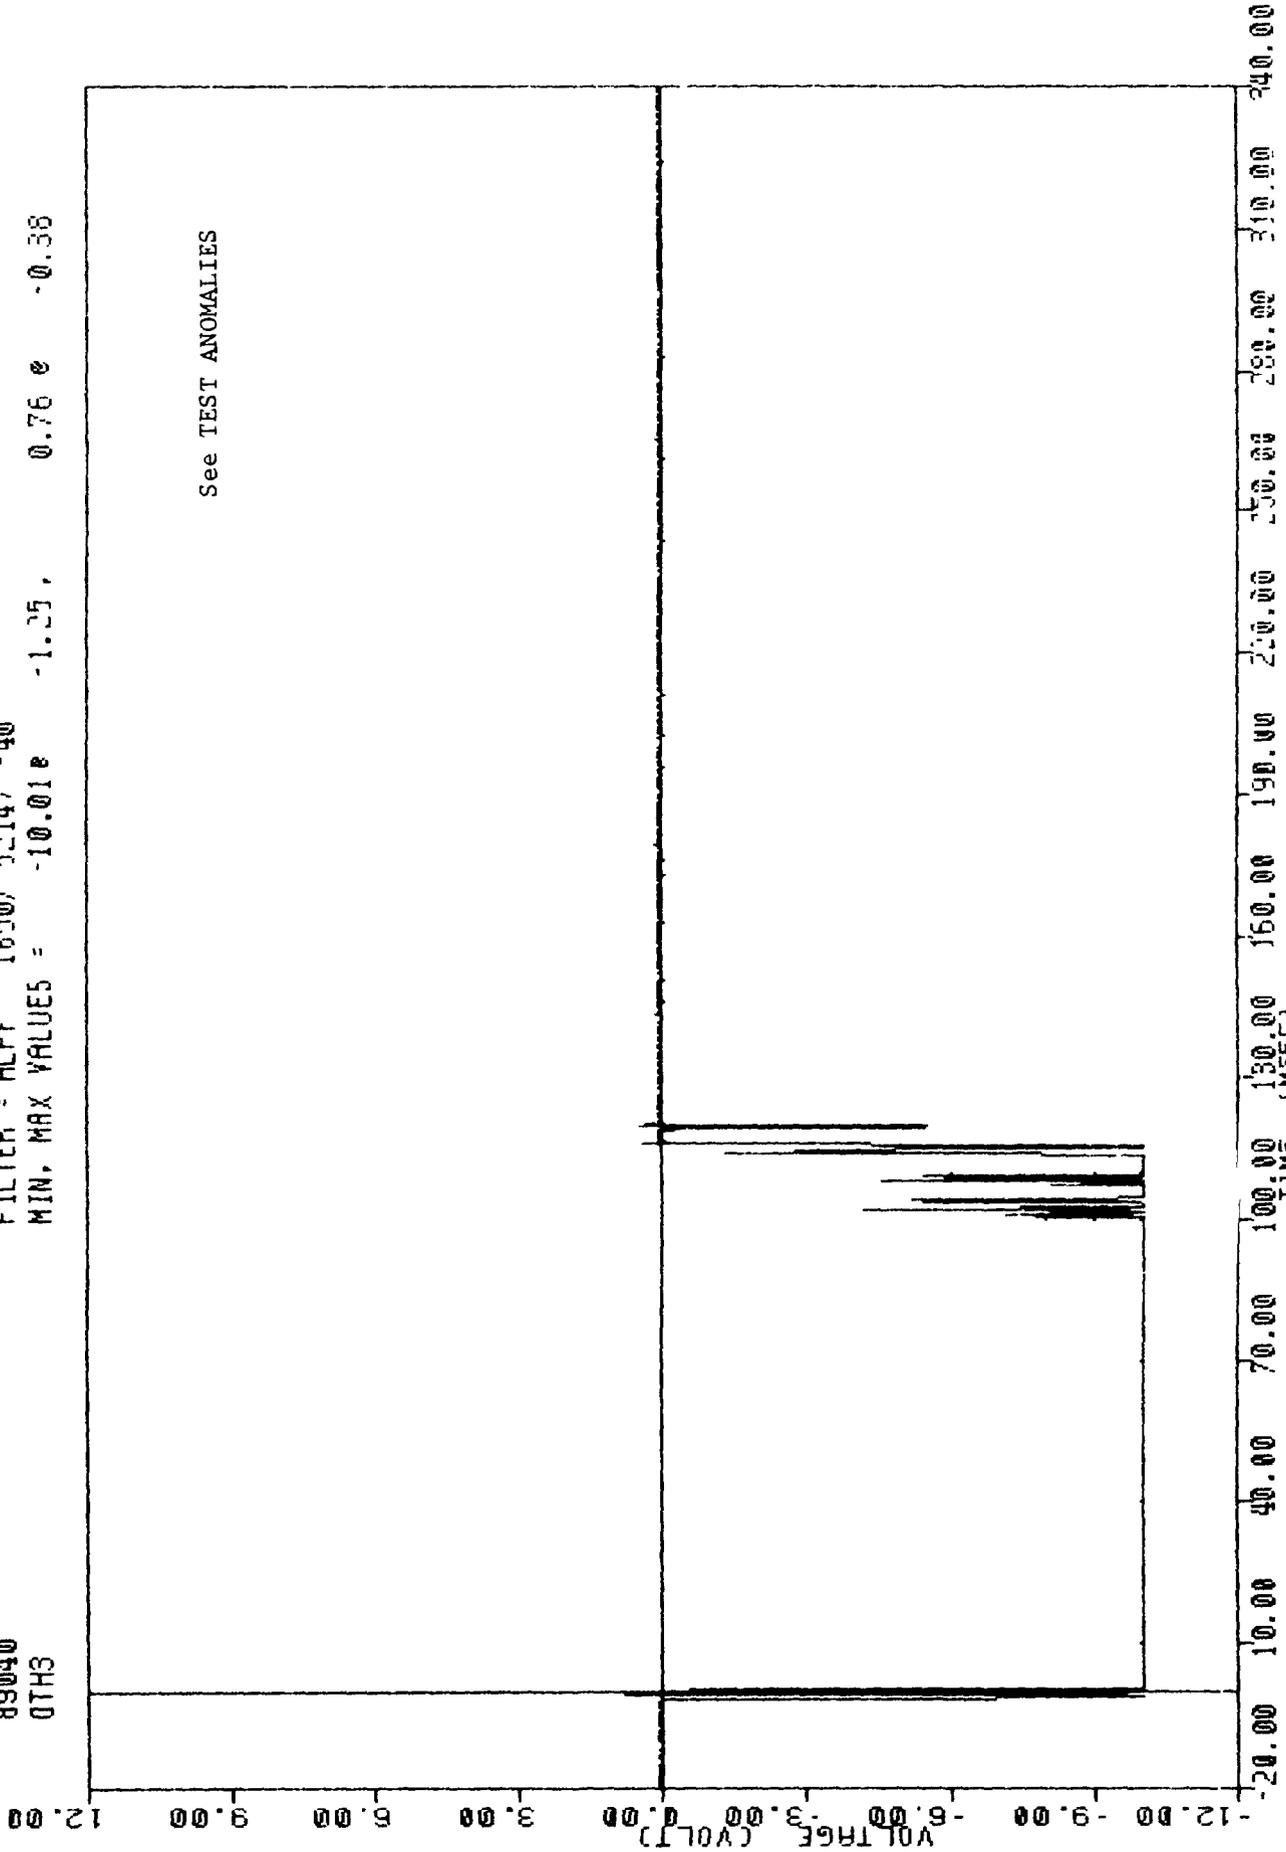
CONToured MOVING BARRIER INTO 90 DEG 1983 HONDA PRELUDE AT 27.1 MPH #3
VEHICLE CONTACT SWITCH - CENTER - 2

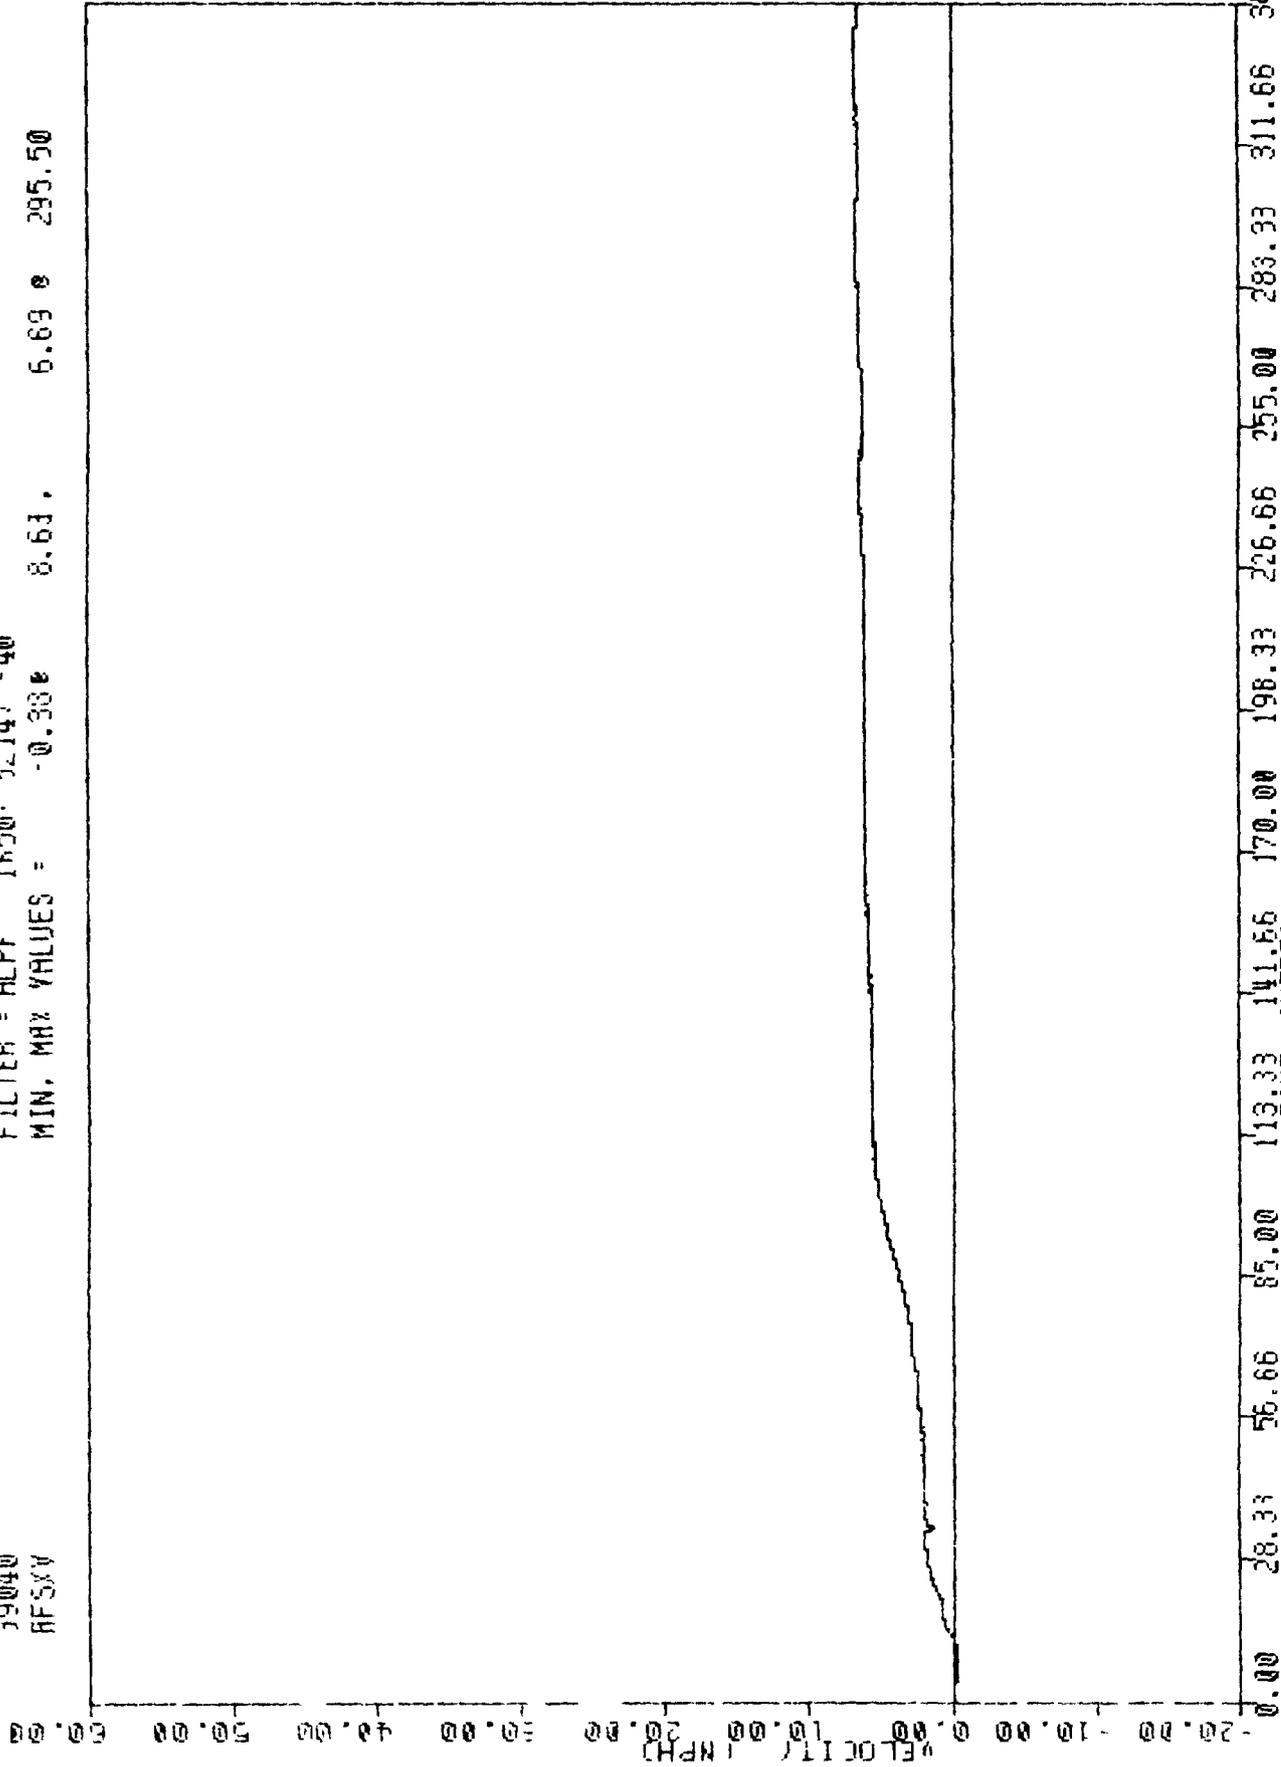
COUNTERED MOVING BARRIER INTO 90 DEG 1983 HONDA PRELUDE AT 27.1 MPH #3
 RIGHT FRONT SILL X AXIS VELOCITY

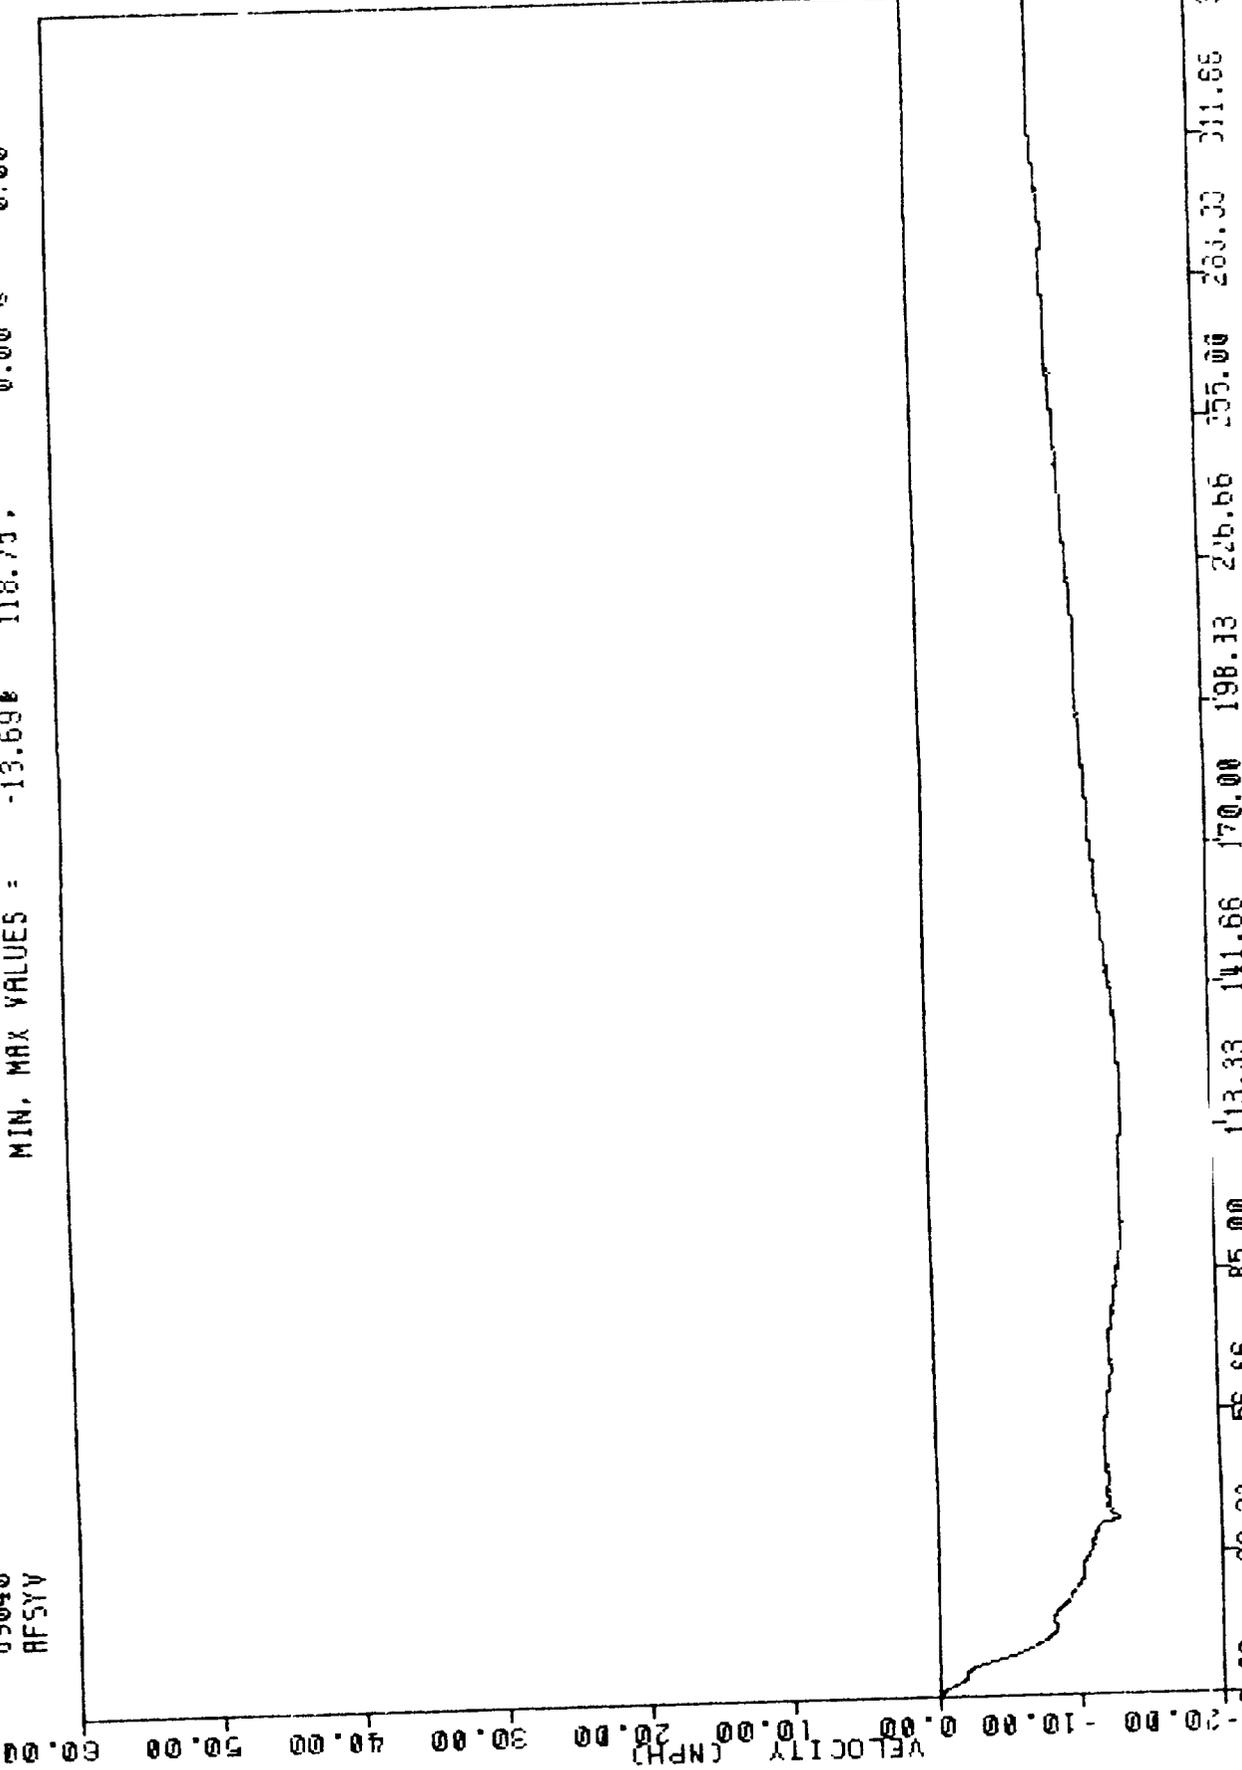
CONTOURED MOVING BARRIER INTO 90 DEG 1983 HONDA PRELUDE AT 27.1 MPH * 3
RIGHT FRONT SILL Y AXIS VELOCITY

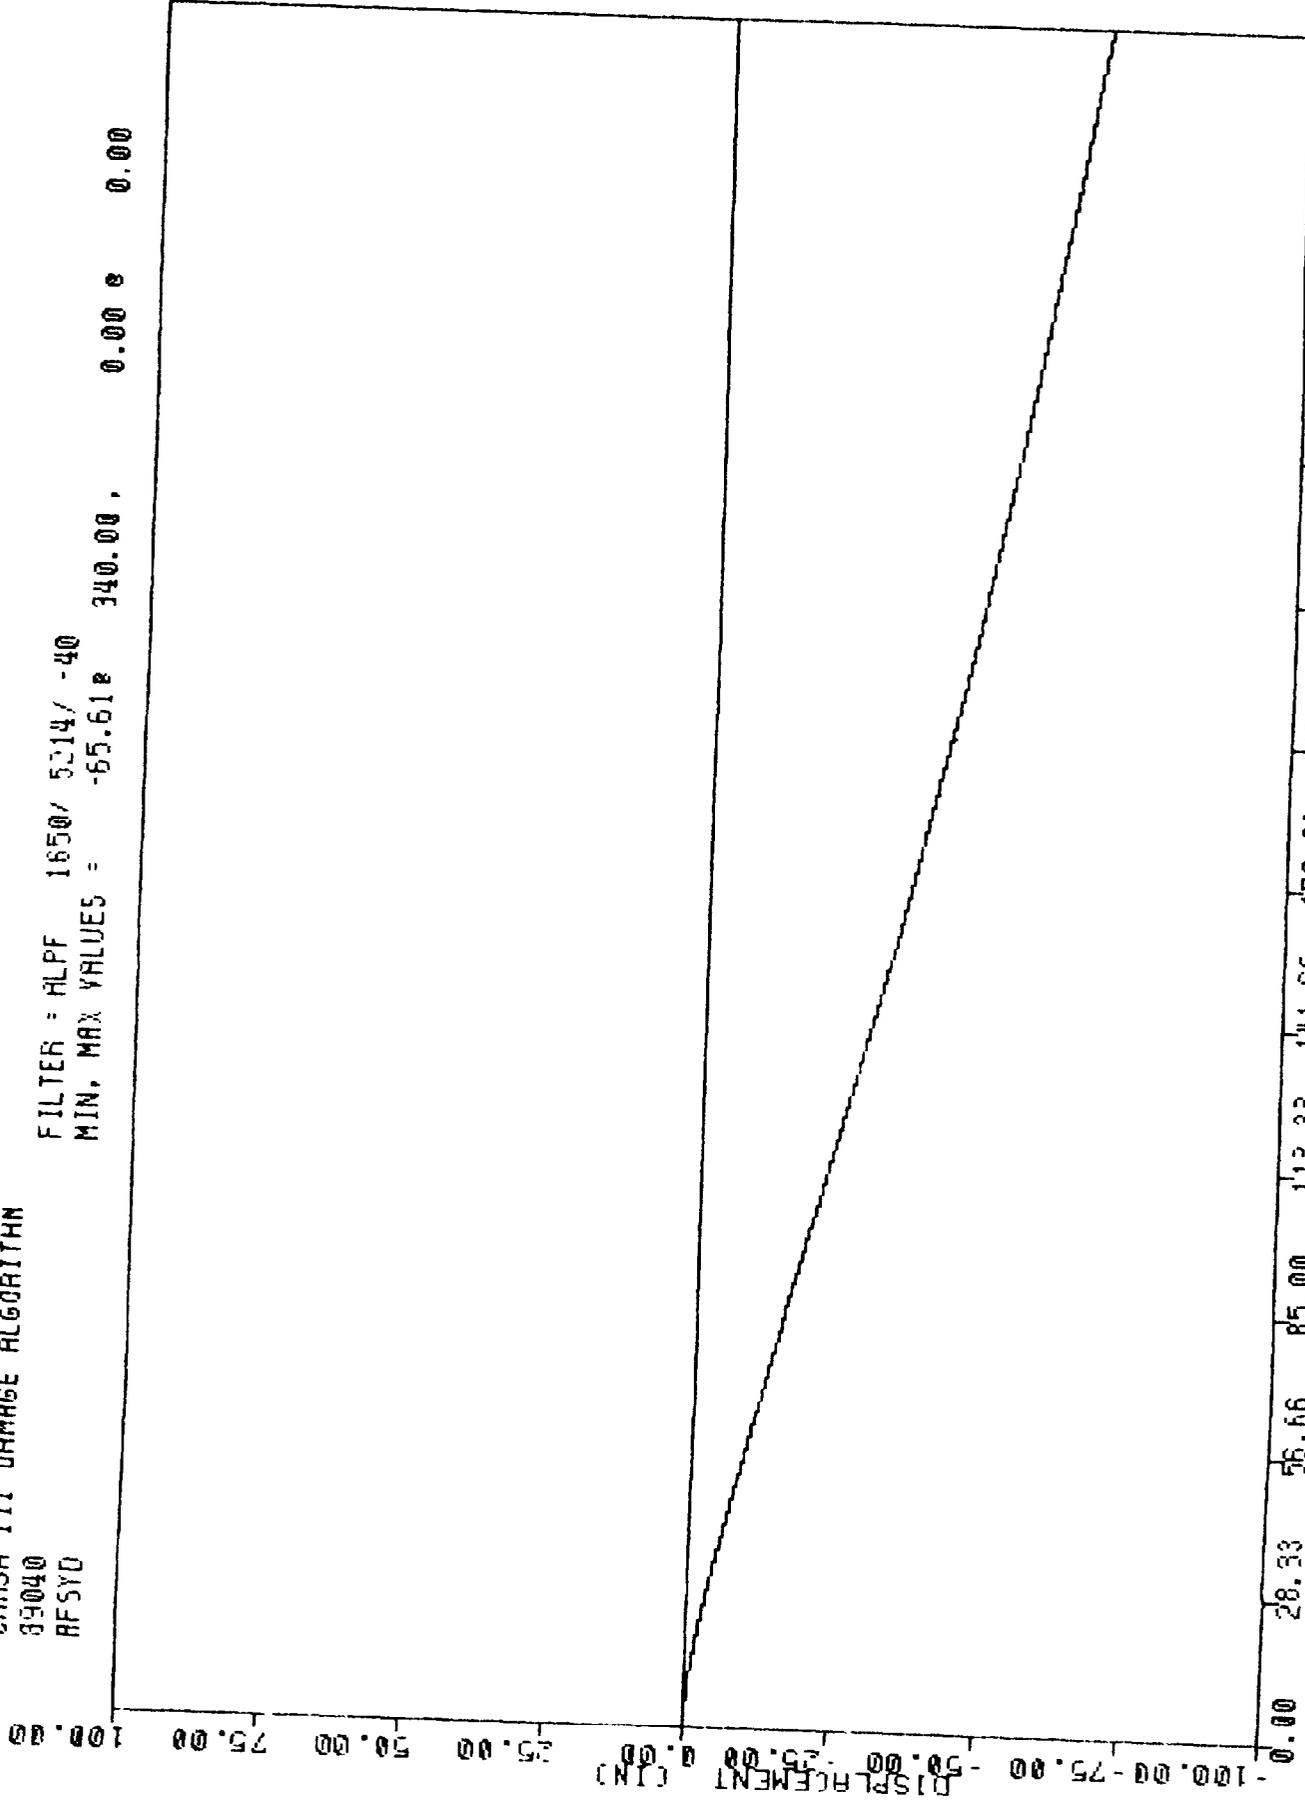
CONTOURED MOVING BARRIER INTO 90 DEG 1983 HUNDA PRELUDE AT 27.1 MPH #3
 RIGHT FRONT SILL Y AXIS DISPLACEMENT

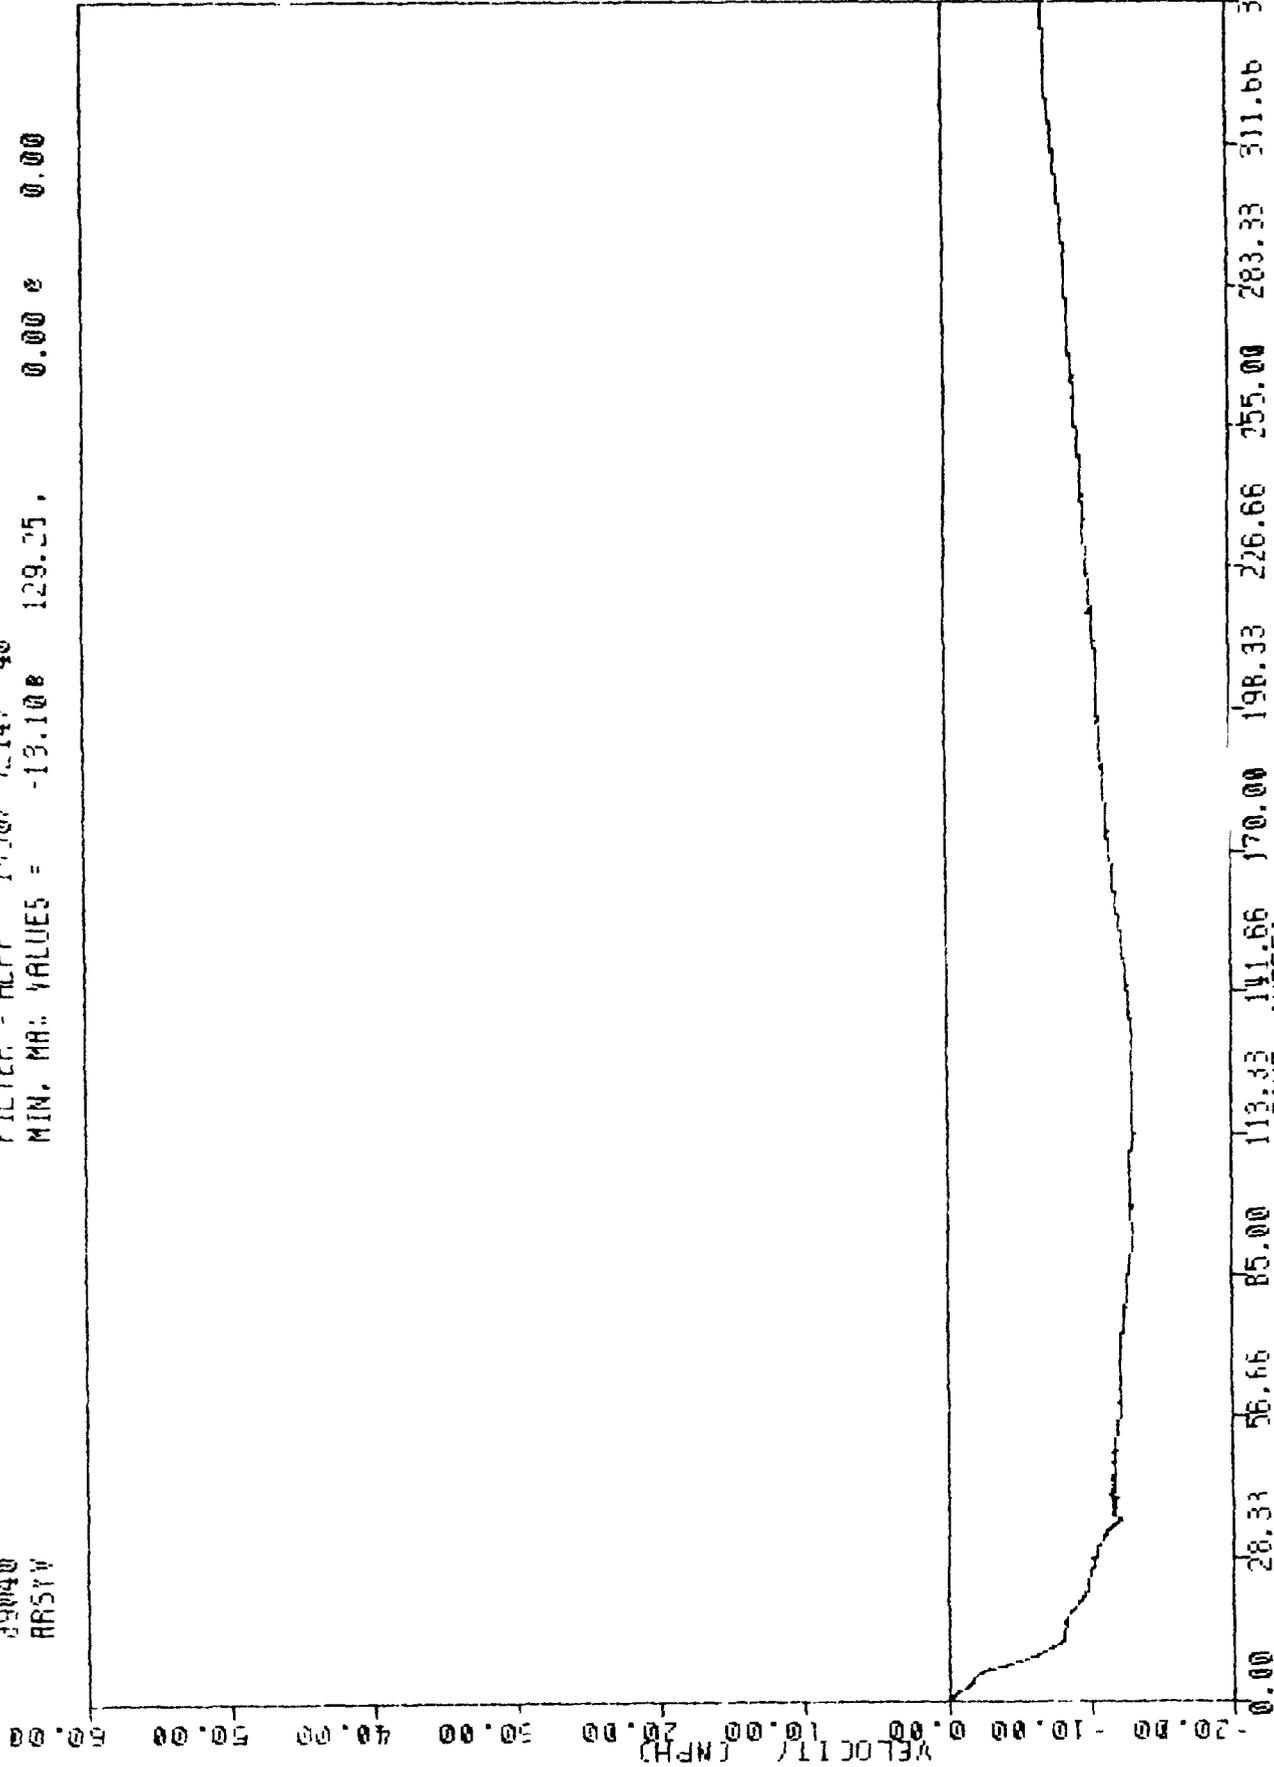
CONTOURED MOVING BARRIER INTO 90 DEG HONDA PRELUDE AT 27.1 MPH #3
 RIGHT REAR SILL Y AXIS VELOCITY

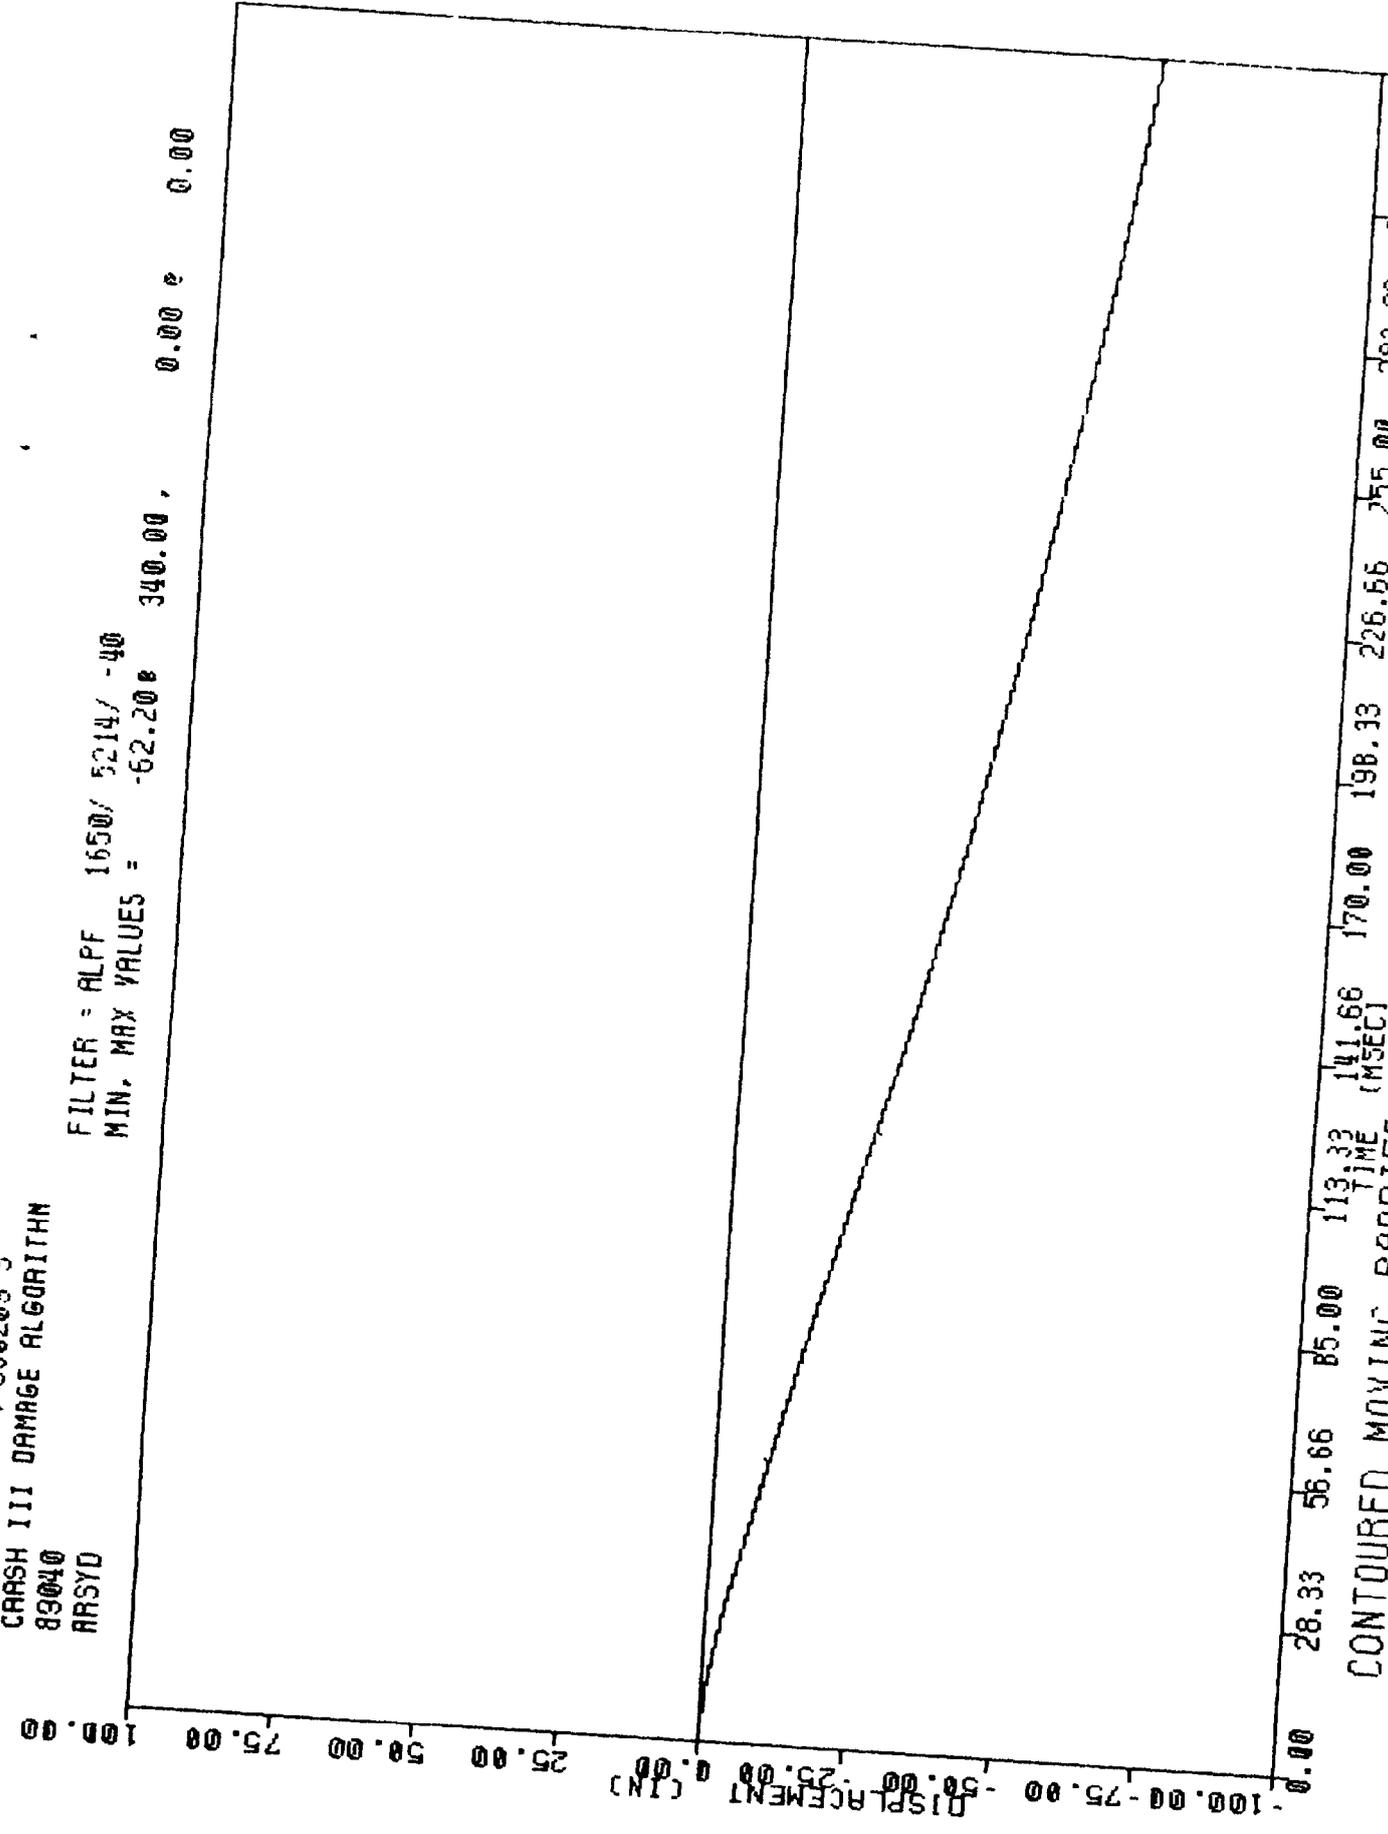
CONTOURED MOVING BARRIER INTO 90 DEG 1983 HONDA PRELUDE AT 27.1 MPH * 3
 RIGHT REAR SILL Y AXIS DISPLACEMENT

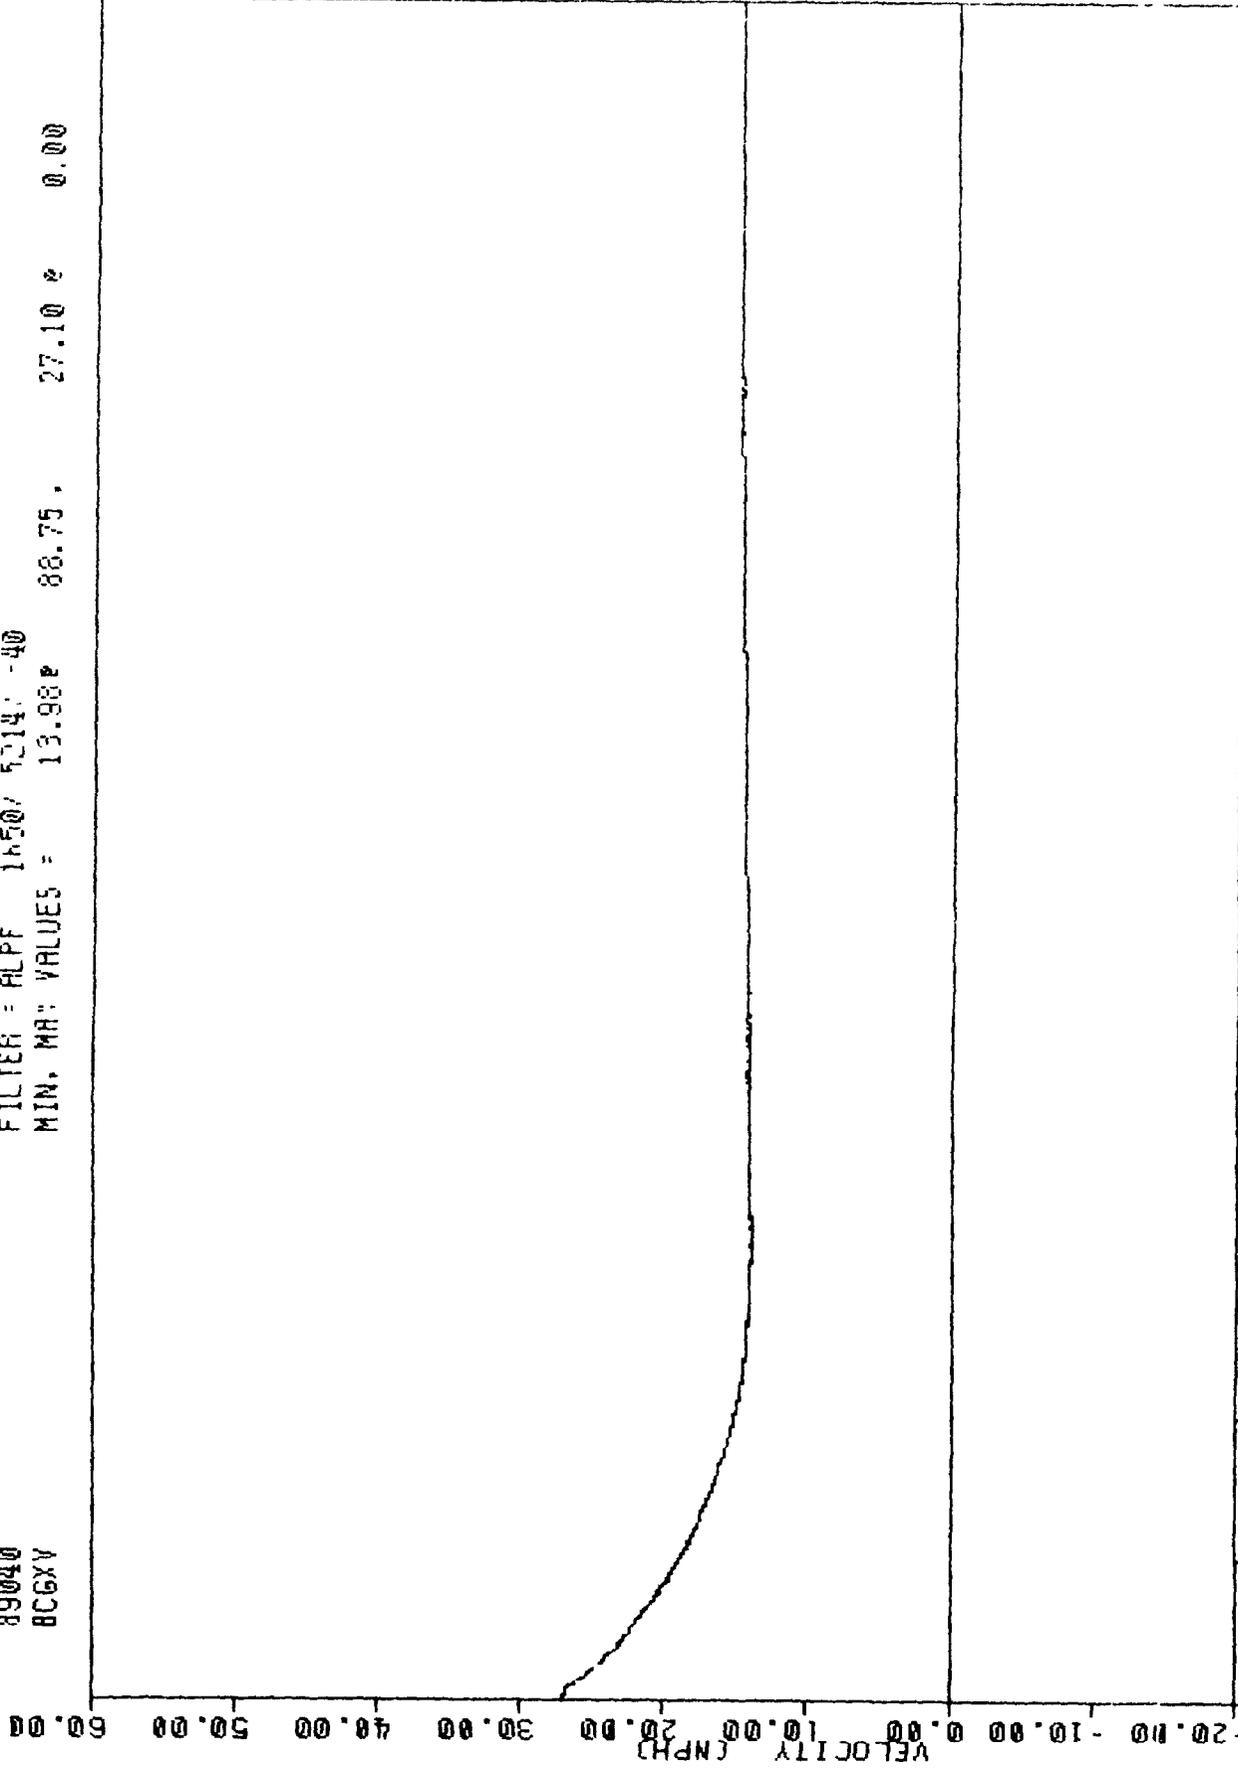
CONToured MOVING BARRIER INTO 90 DEG 1983 HONDA PRELUDE AT 27.1 MPH *3
 CONToured MOVING BARRIER CENTER OF GRAVITY * AXIS VELOCITY
