DOT HS 807 441

Final Report

Final Report of 270° Contoured Moving Barrier Impact into a 1983 Honda Prelude 2-Door Coupe in Support of Crash III Damage Algorithm Reformation

The purpose of the four 270° contoured moving barrier impact tests was for research and development in support of the CRASH III damage algorithm reformulation.

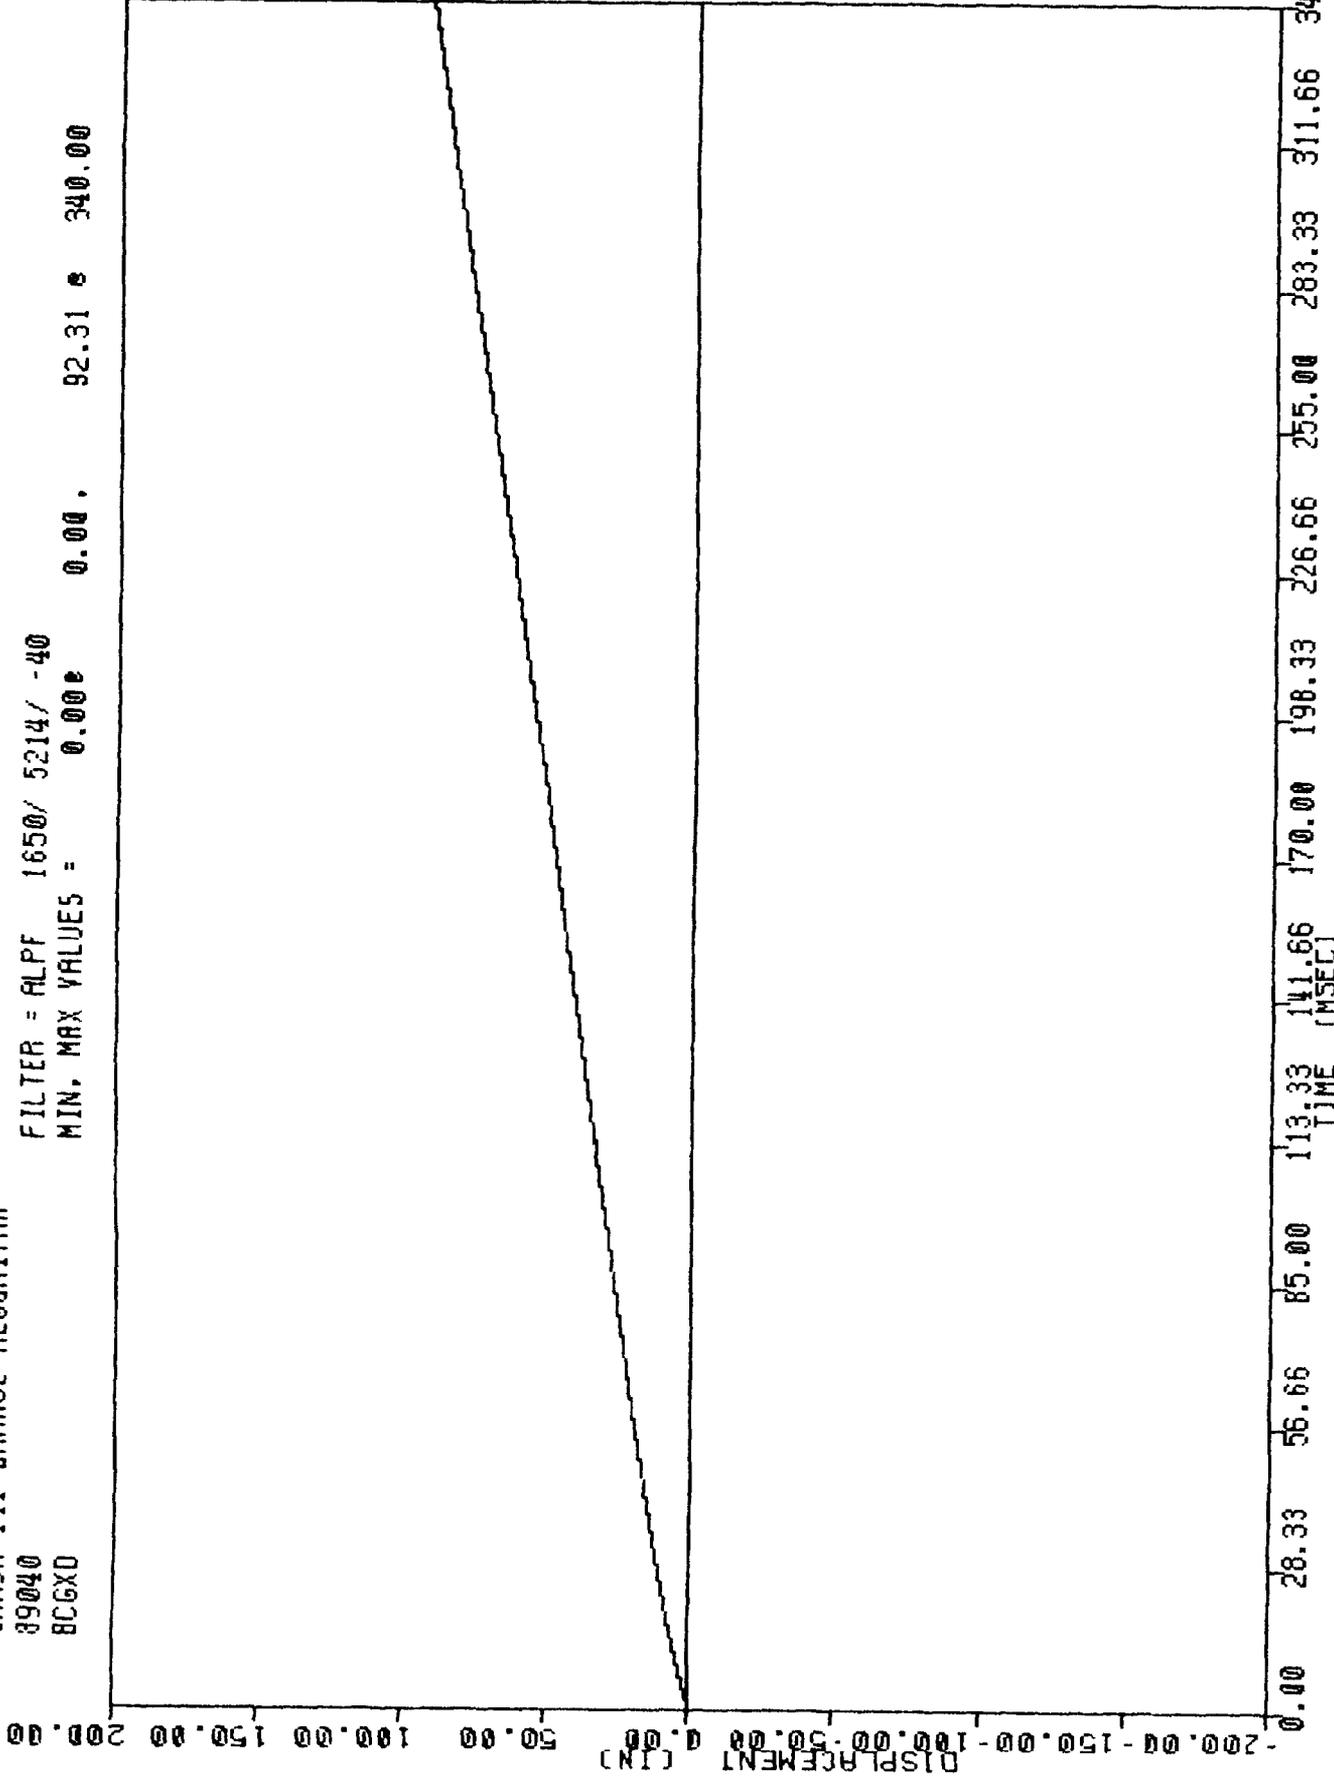
CONTOURED MOVING BARRIER INTO 90 DEG 1983 HONDA PRELUDE AT 27.1 MPH #3
CONTOURED MOVING BARRIER CENTER OF GRAVITY X AXIS DISPLACEMENT

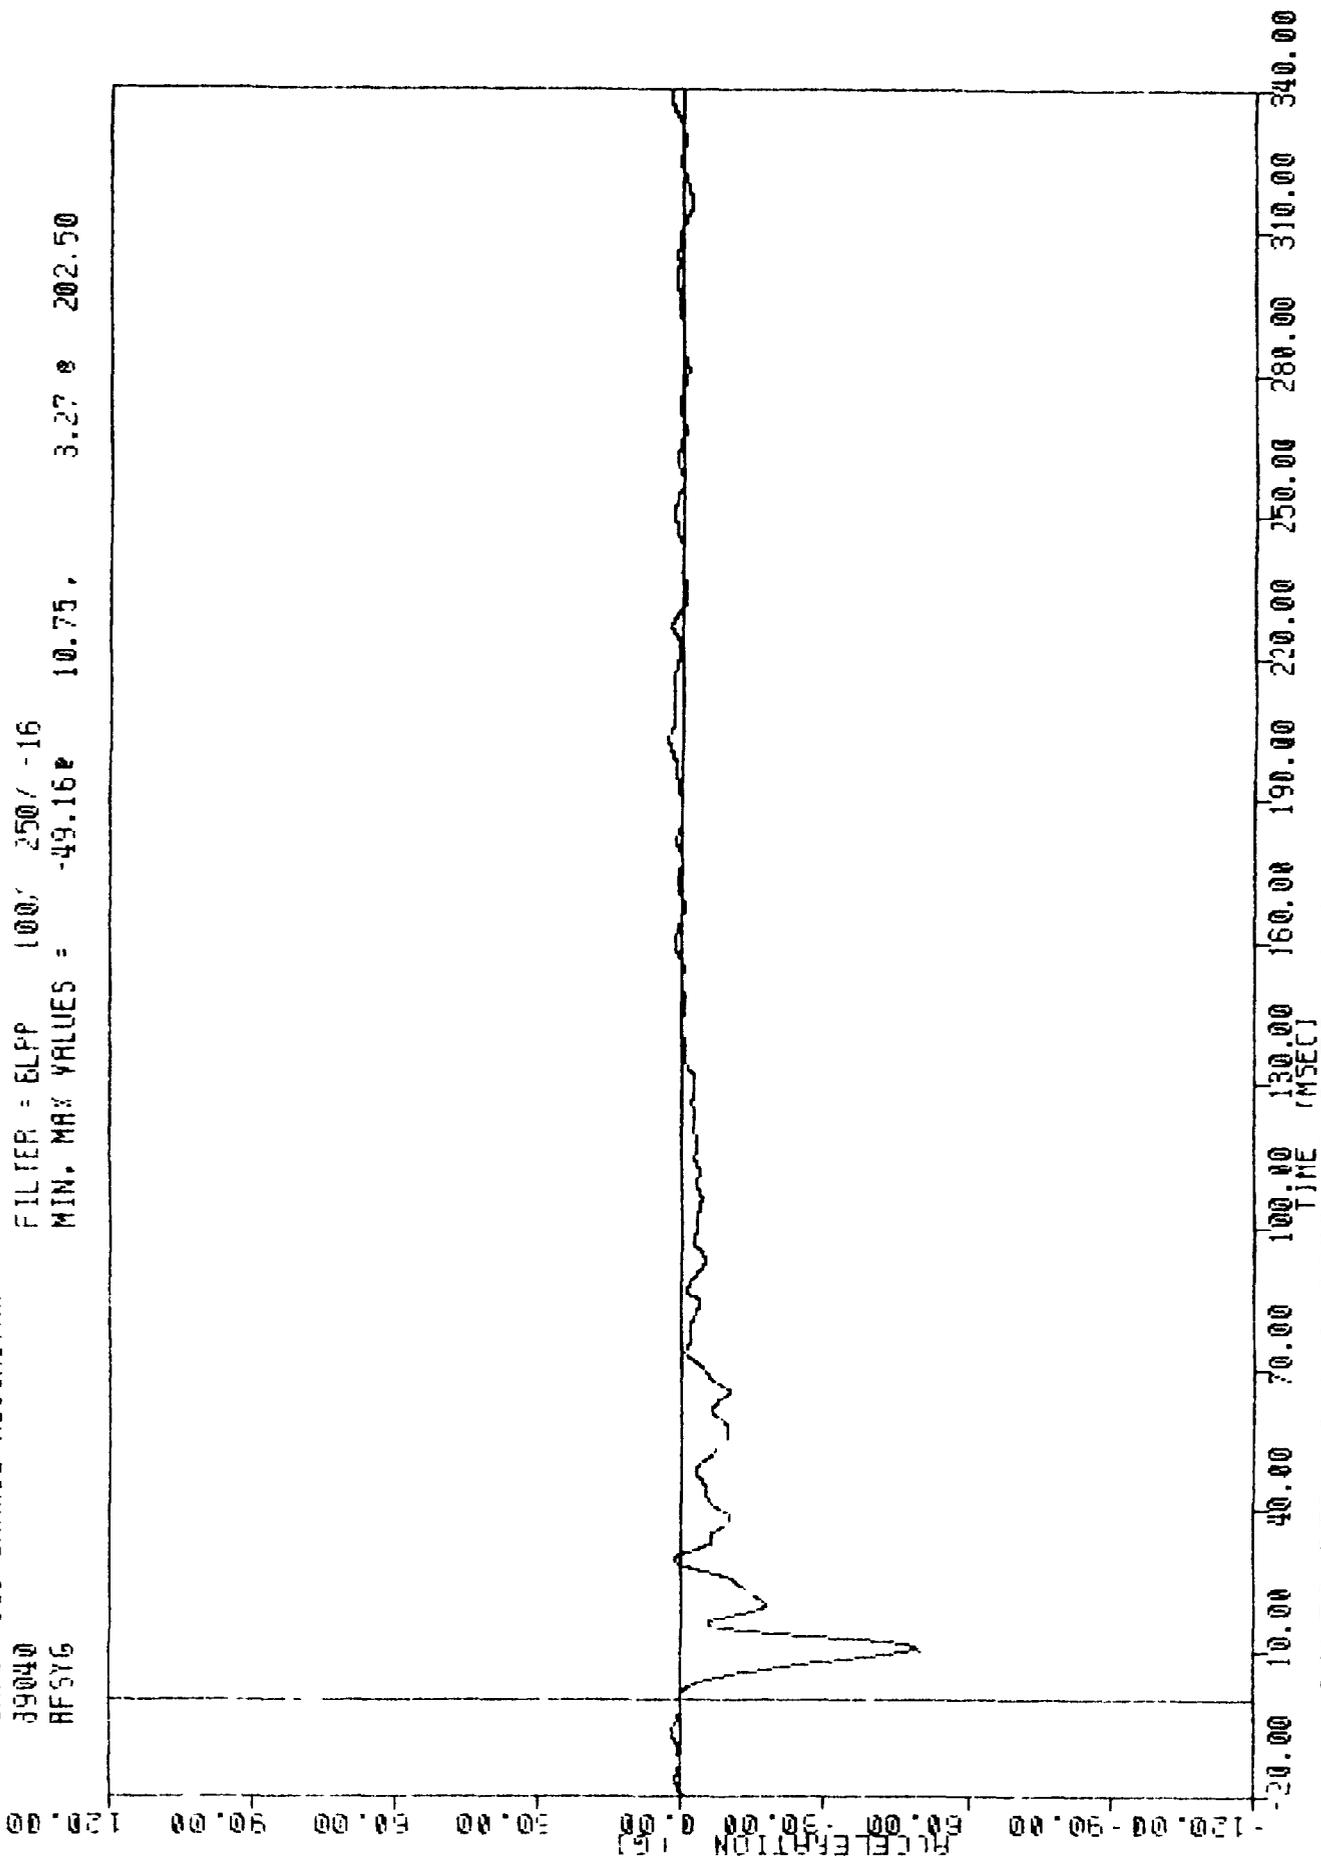
CONTOURED MOVING BARRIER INTO 90 DEG 1983 HONDA PRELUDE AT 35.9 MPH #4
RIGHT FRONT SILL Y AXIS ACCELERATION

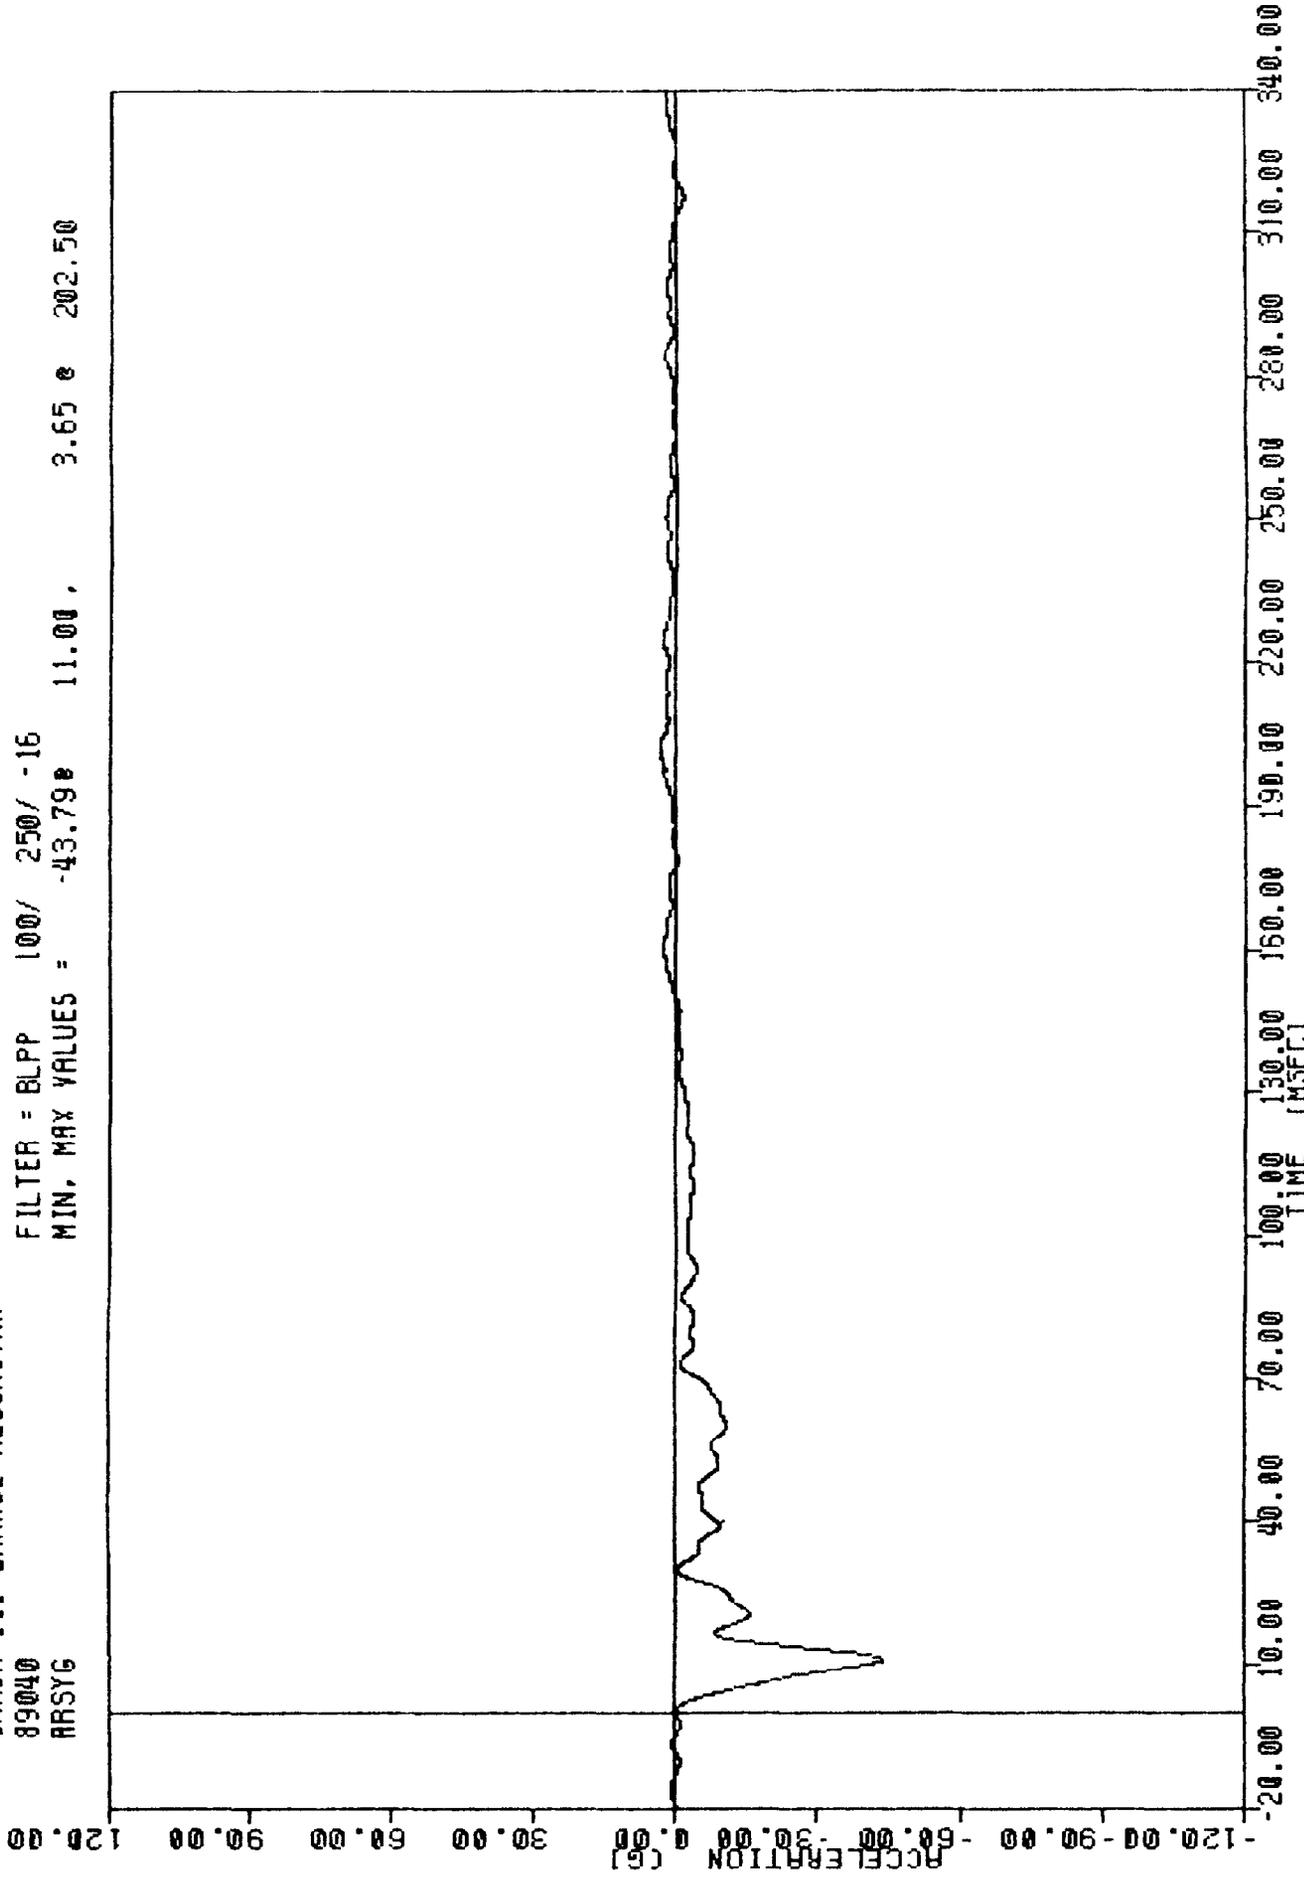
CONToured MOVING BARRIER INTO 90 DEG HONDA PRELUDE AT 35.9 MPH #4
RIGHT REAR SILL Y AXIS ACCELERATION

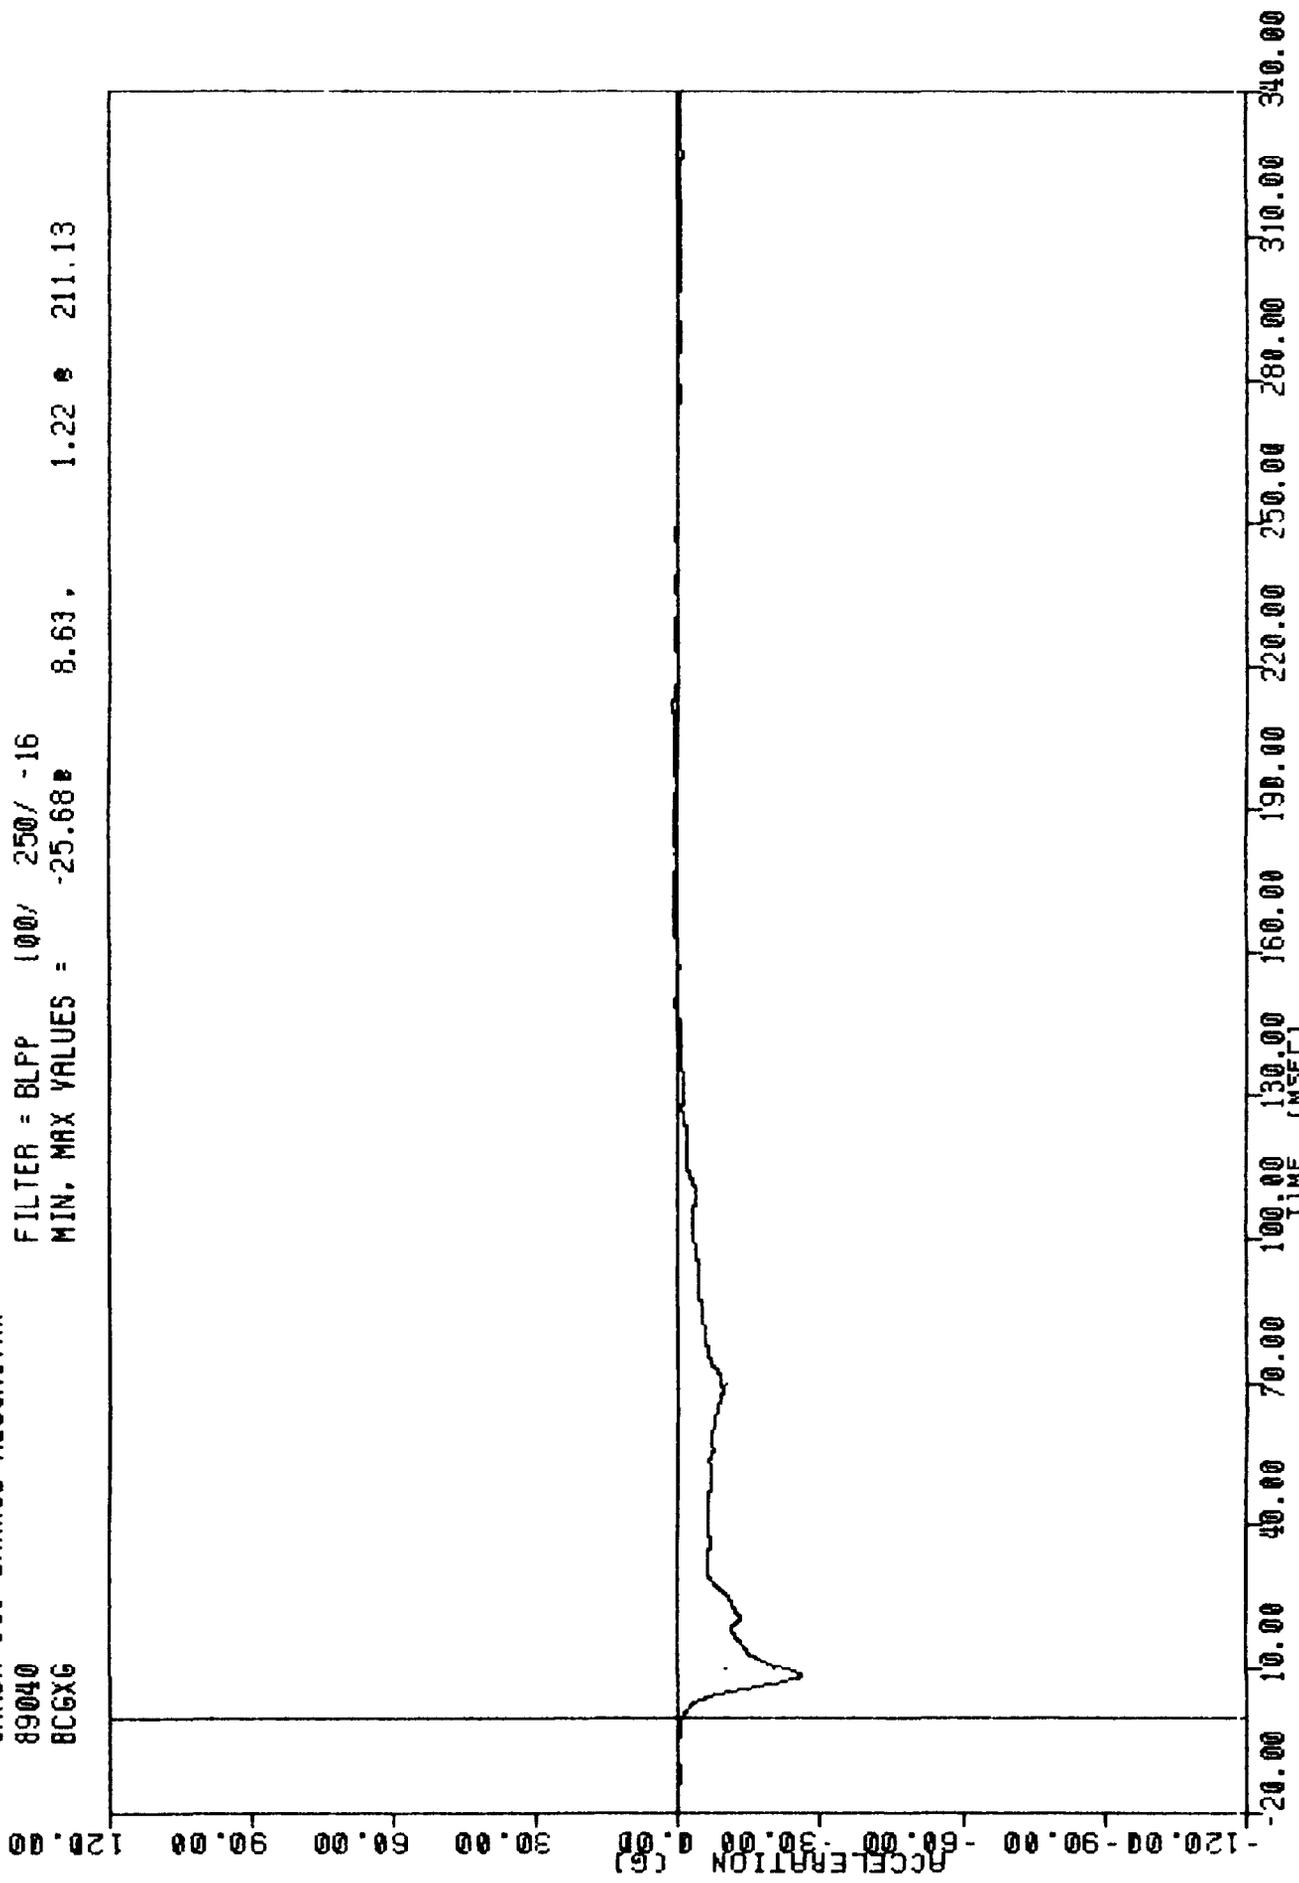
CONTOURED MOVING BARRIER INTO 90 DEG 1983 HONDA PRELUDE AT 35.9 MPH #4
CONTOURED MOVING BARRIER CENTER OF GRAVITY X AXIS ACCELERATION

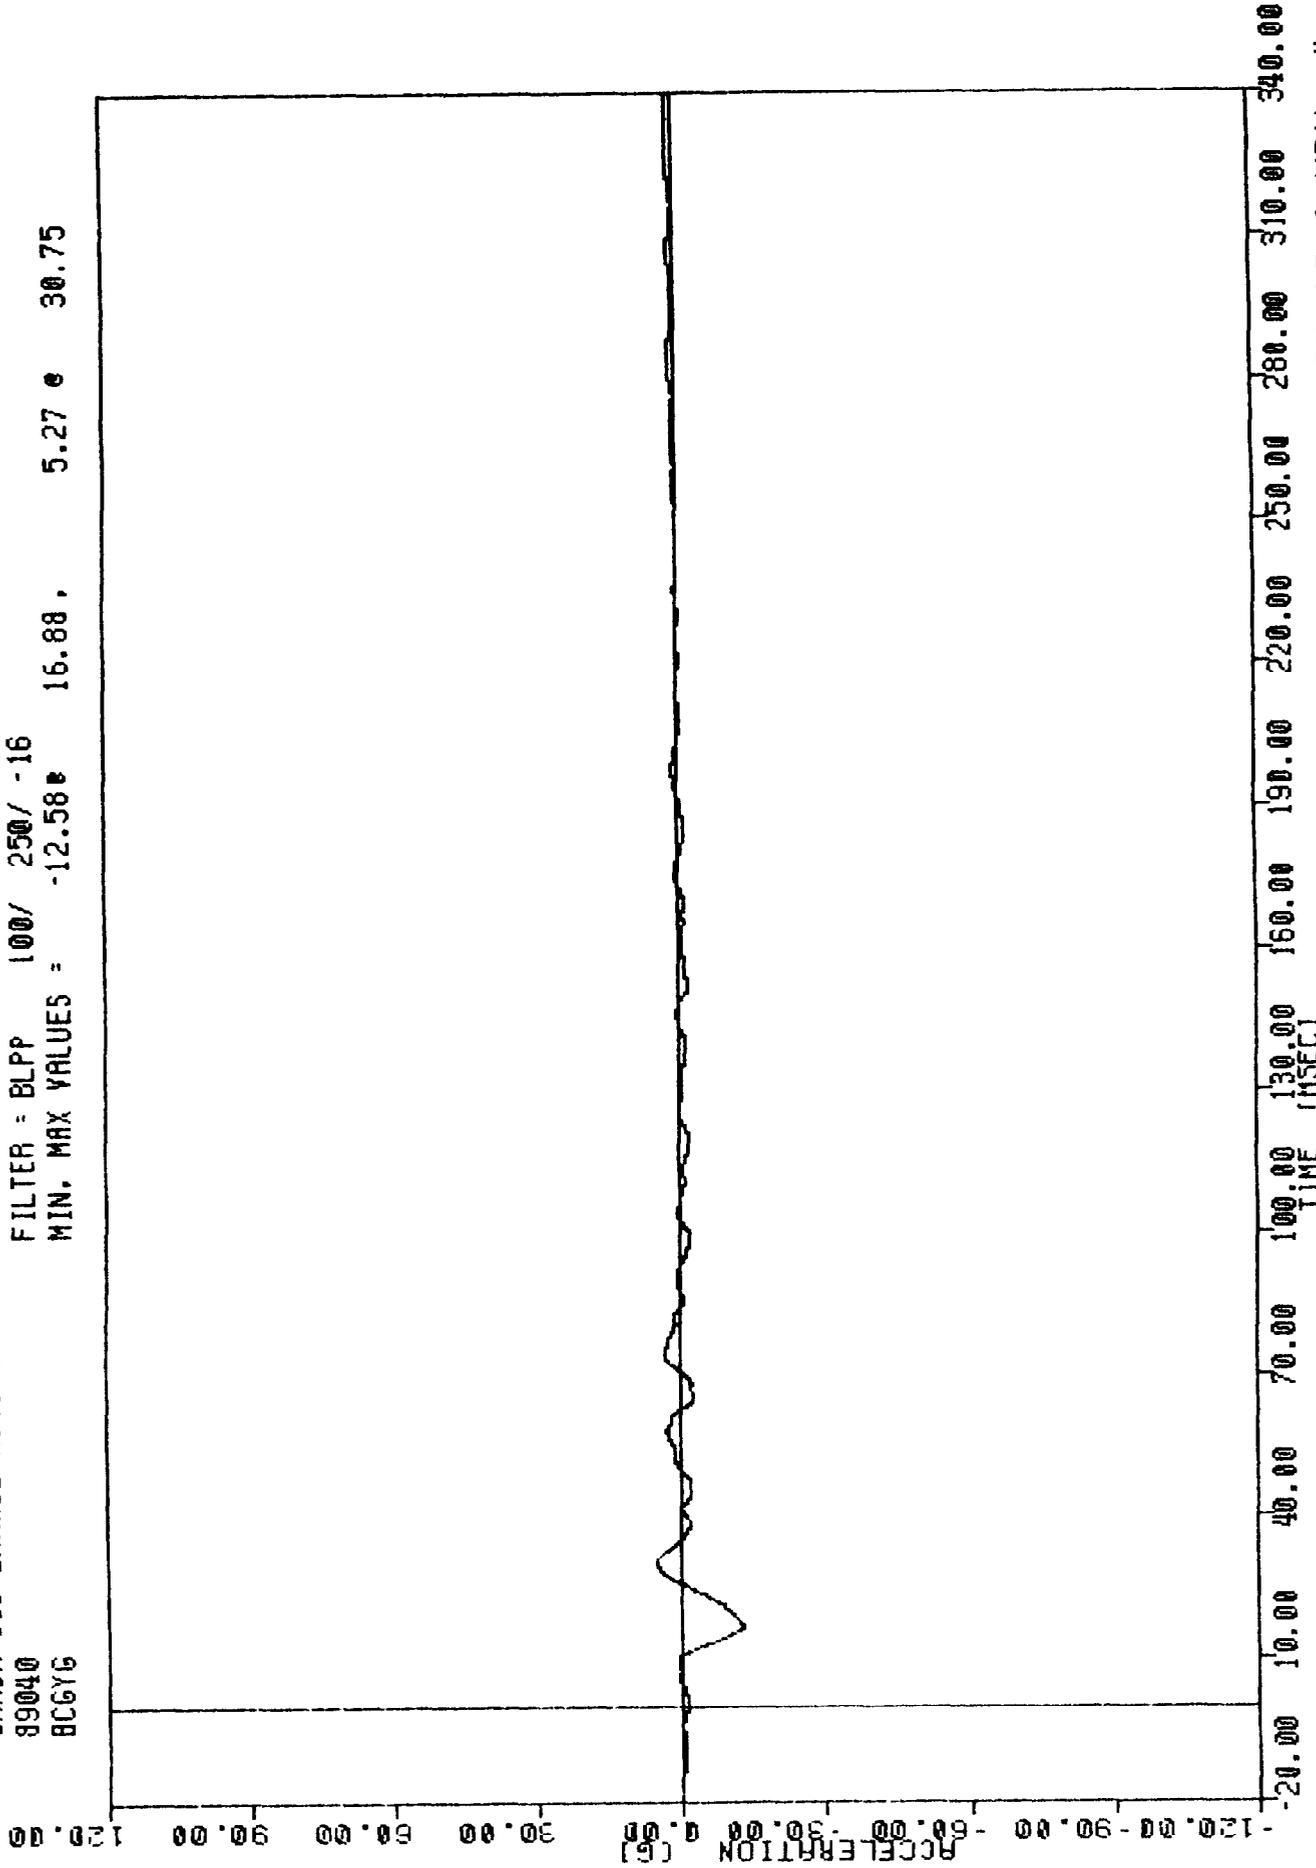
CONTOURED MOVING BARRIER INTO 90 DEG 1983 HONDA PRELUDE AT 35.9 MPH #4
CONTOURED MOVING BARRIER CENTER OF GRAVITY Y AXIS ACCELERATION

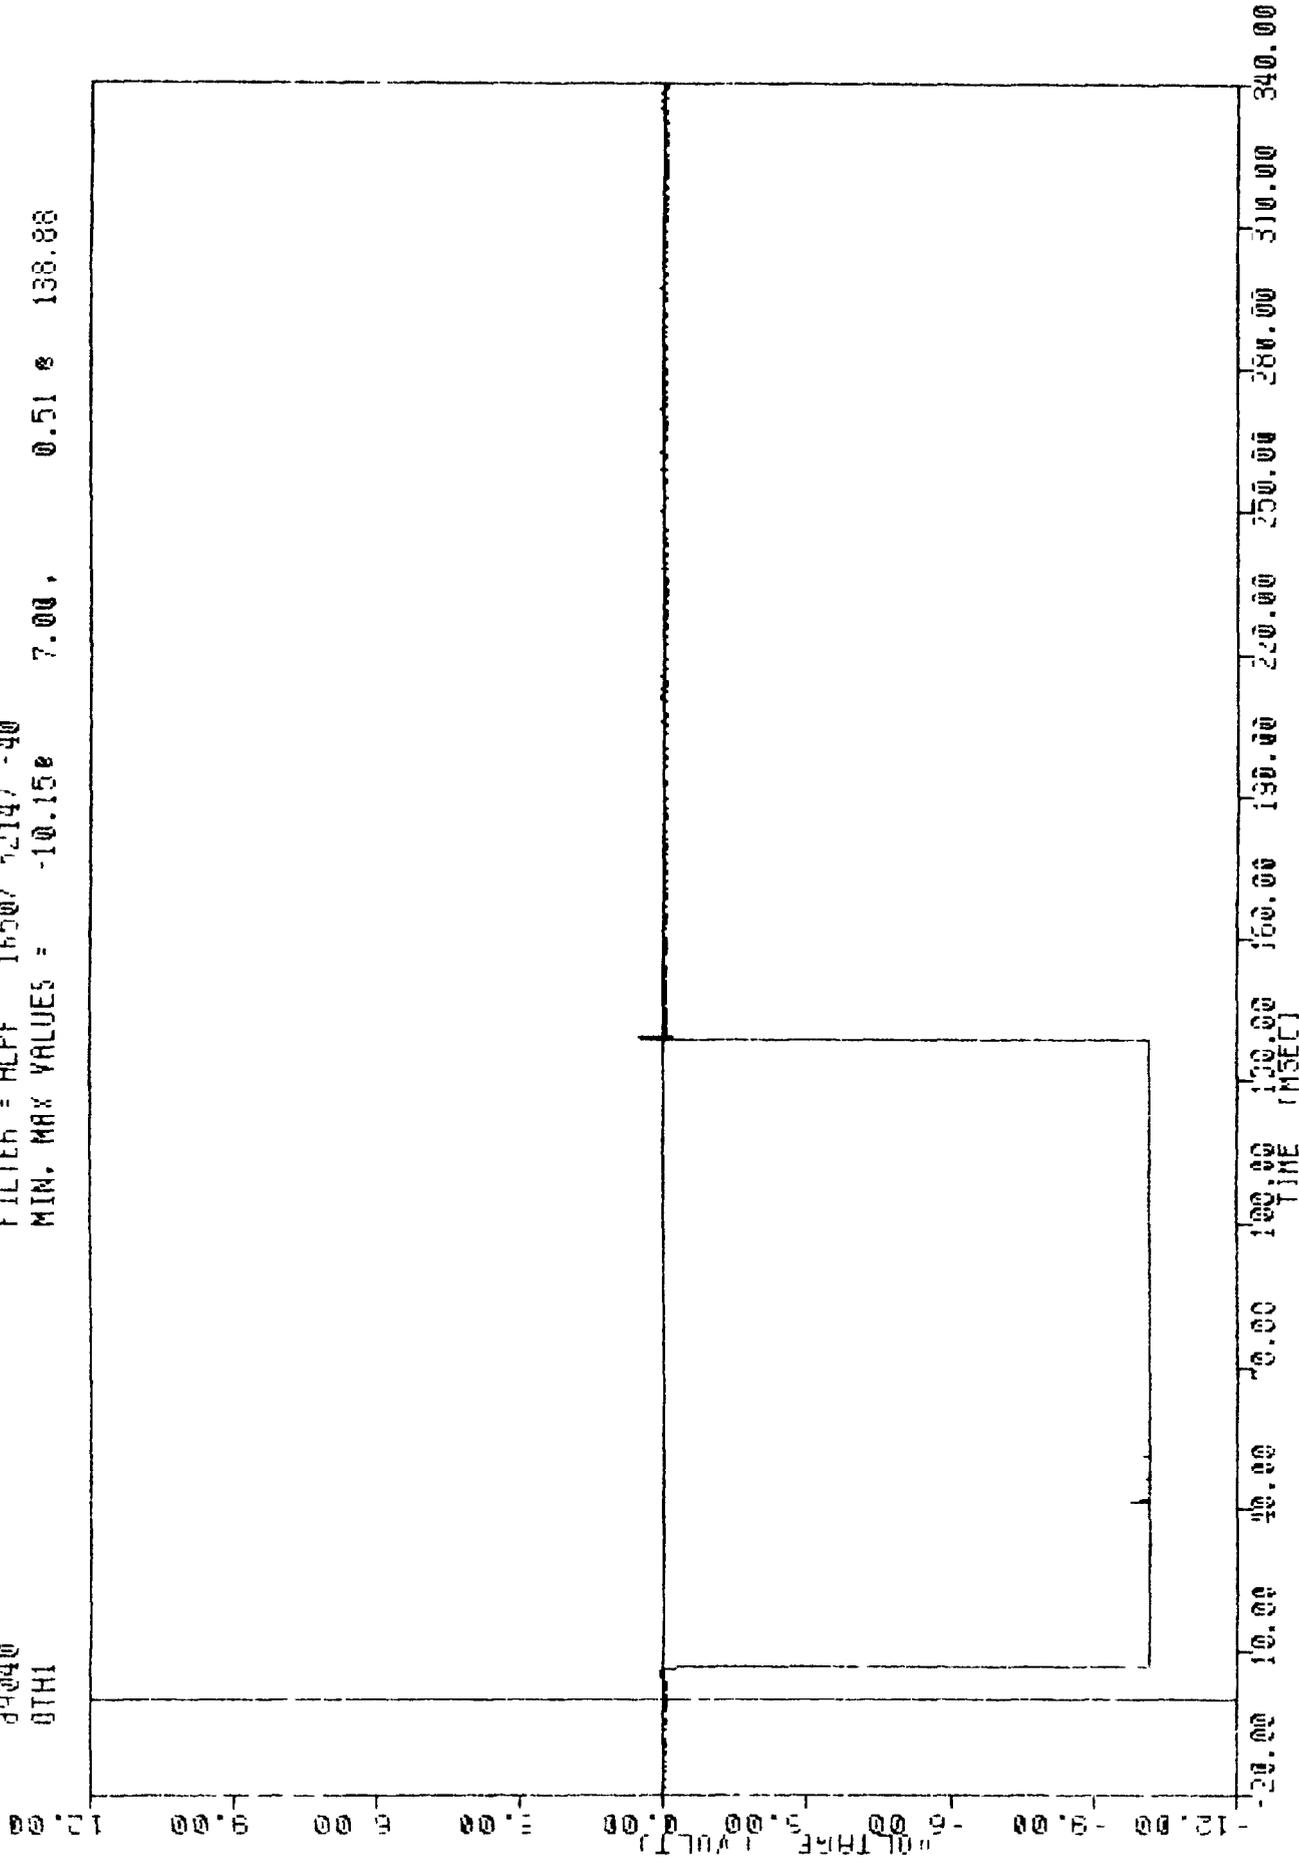
CONToured MOVING BARRIER INTO 90 DEG 1983 HONDA PRELUDE AT 35.9 MPH #4
 VEHICLE CONTACT SWITCH - LEFT

Noise in the form of spikes was observed in the plots for the contact switches OTH1, OTH2, OTH3, OTH4. * The switches were used to record the time of vehicle contact with the moving barrier, as well as the time of vehicle separation from the barrier. The switches were damaged by the crush of the moving contoured barrier against the vehicle. The switches were replaced following each test which contained spikes. This is not the standard use of such switches.

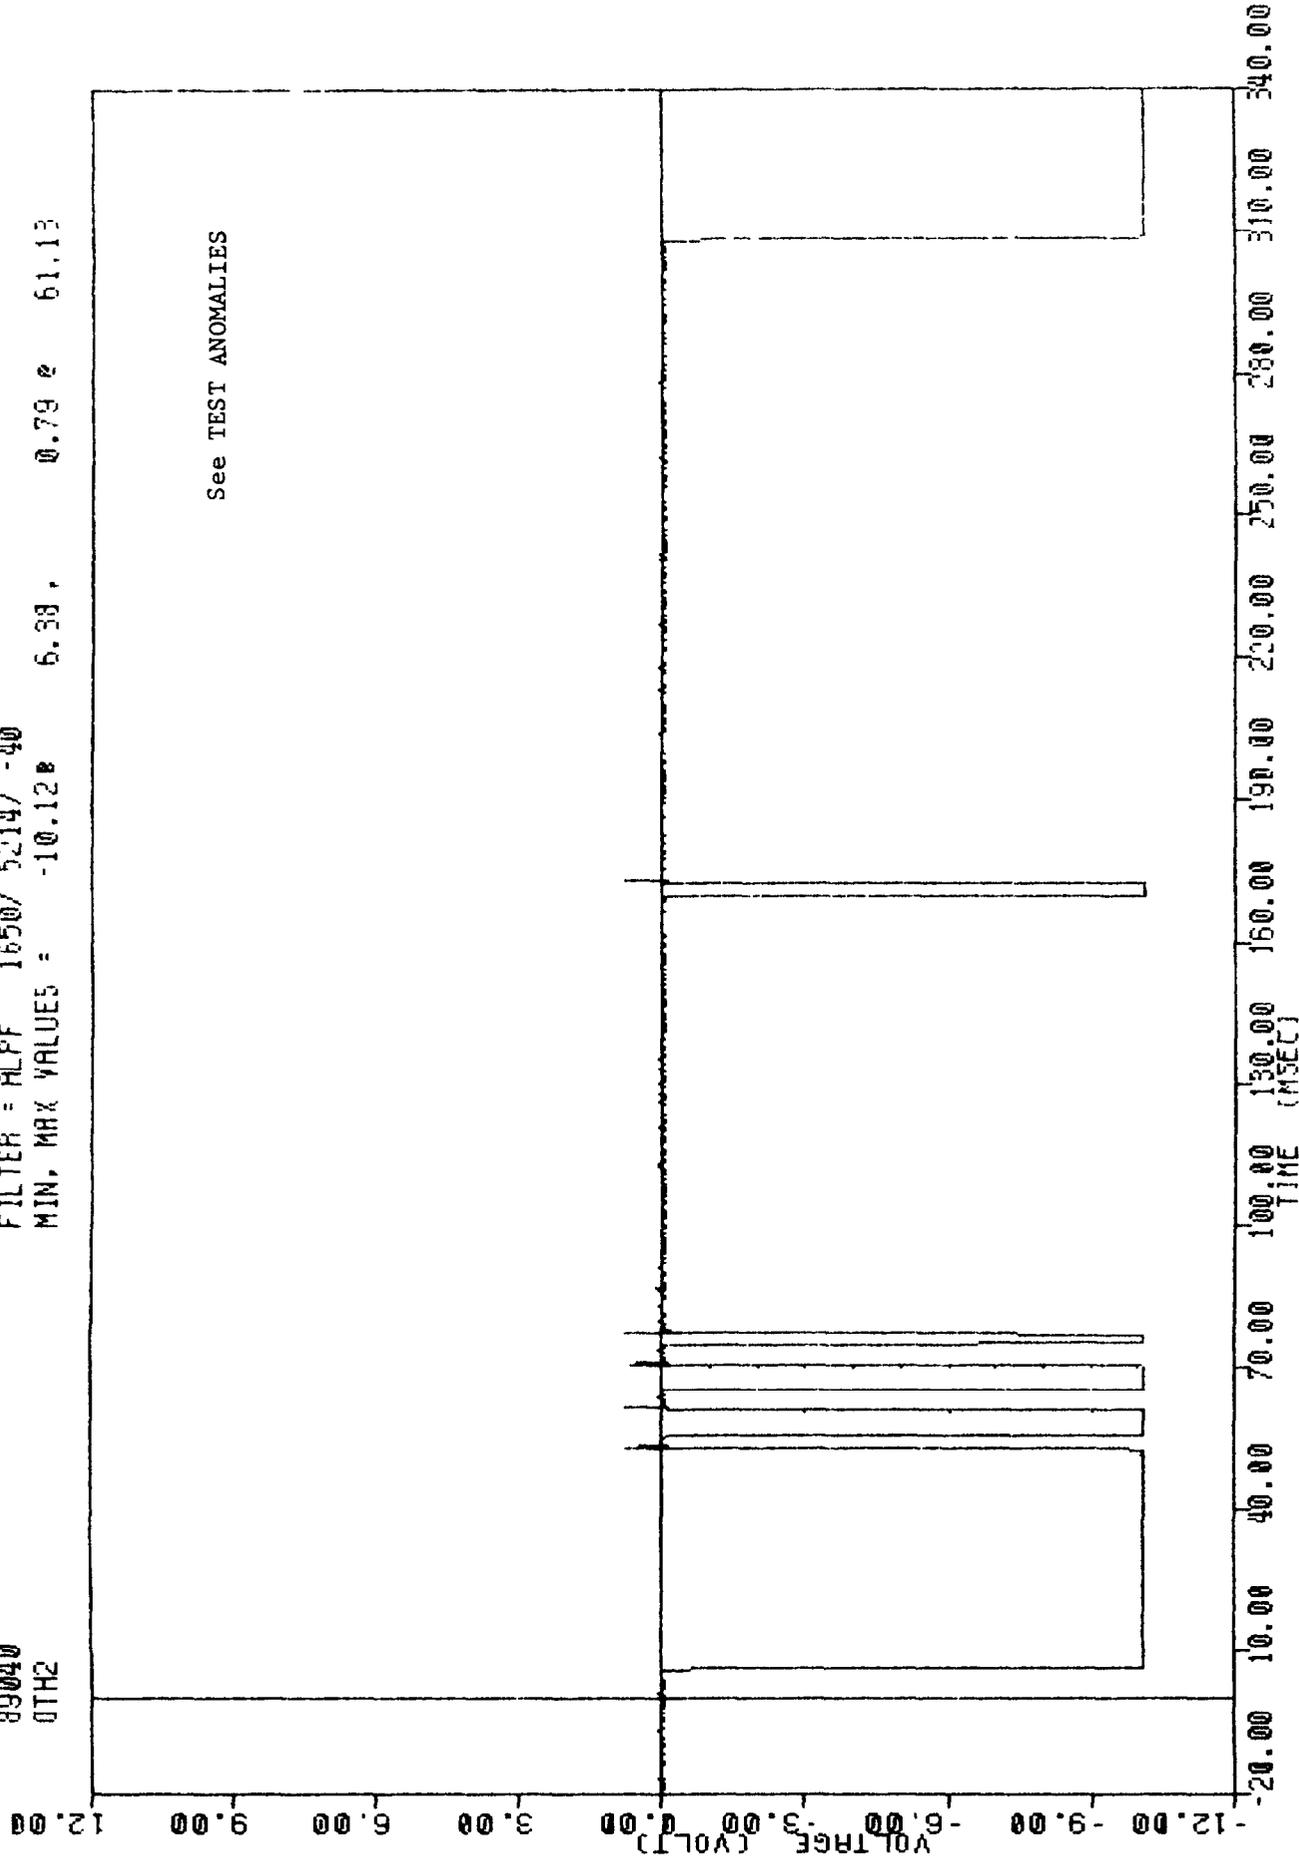
CONToured MOVING BARRIER INTO 90 DEG 1983 HONDA PRELUDE AT 35.9 MPH #4
VEHICLE CONTACT SWITCH - CENTER - 1

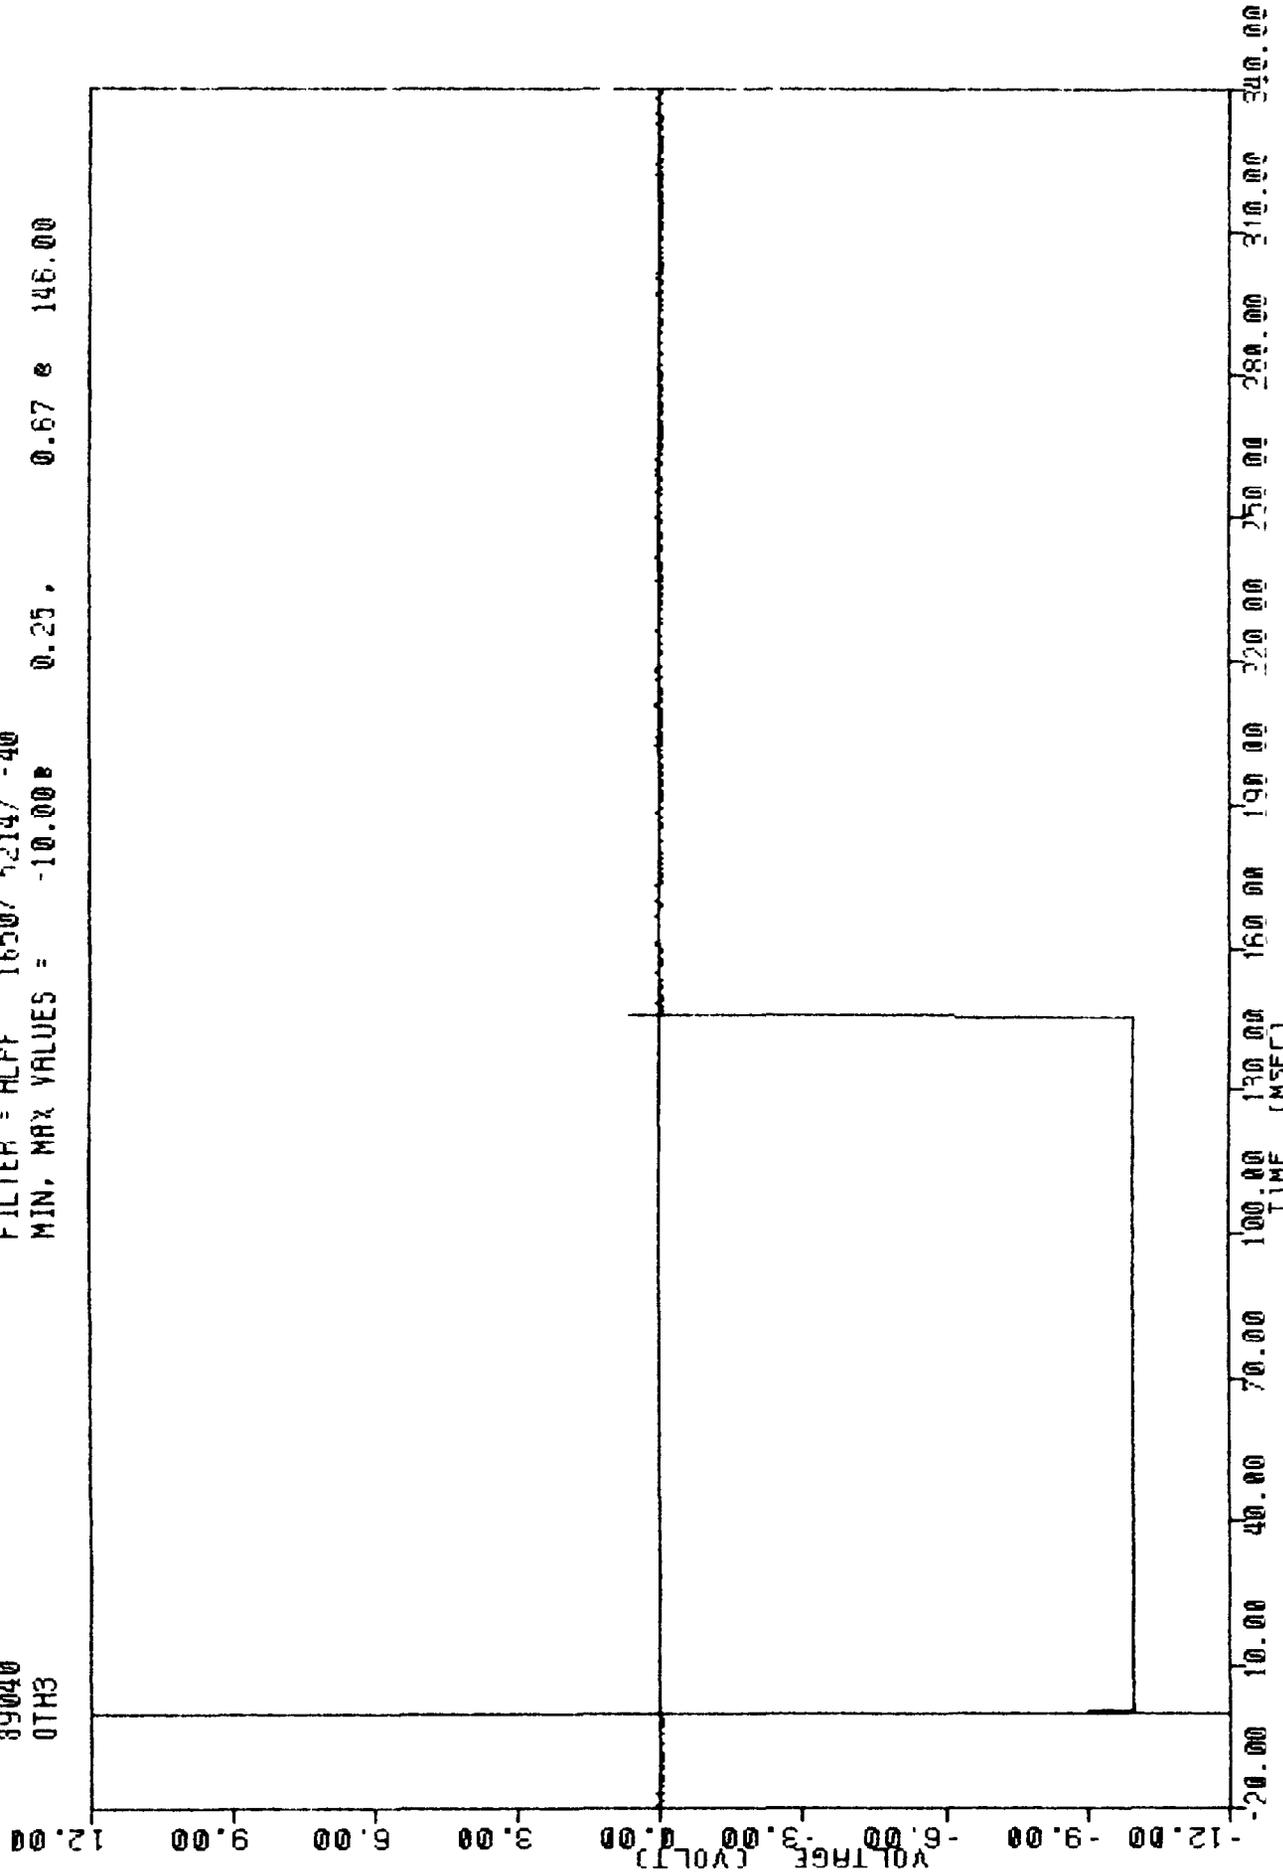
CONToured MOVING BARRIER INTO 90 DEG 1983 HONDA PRELUDE AT 35.9 MPH #4
 VEHICLE CONTACT SWITCH - CENTER - 2

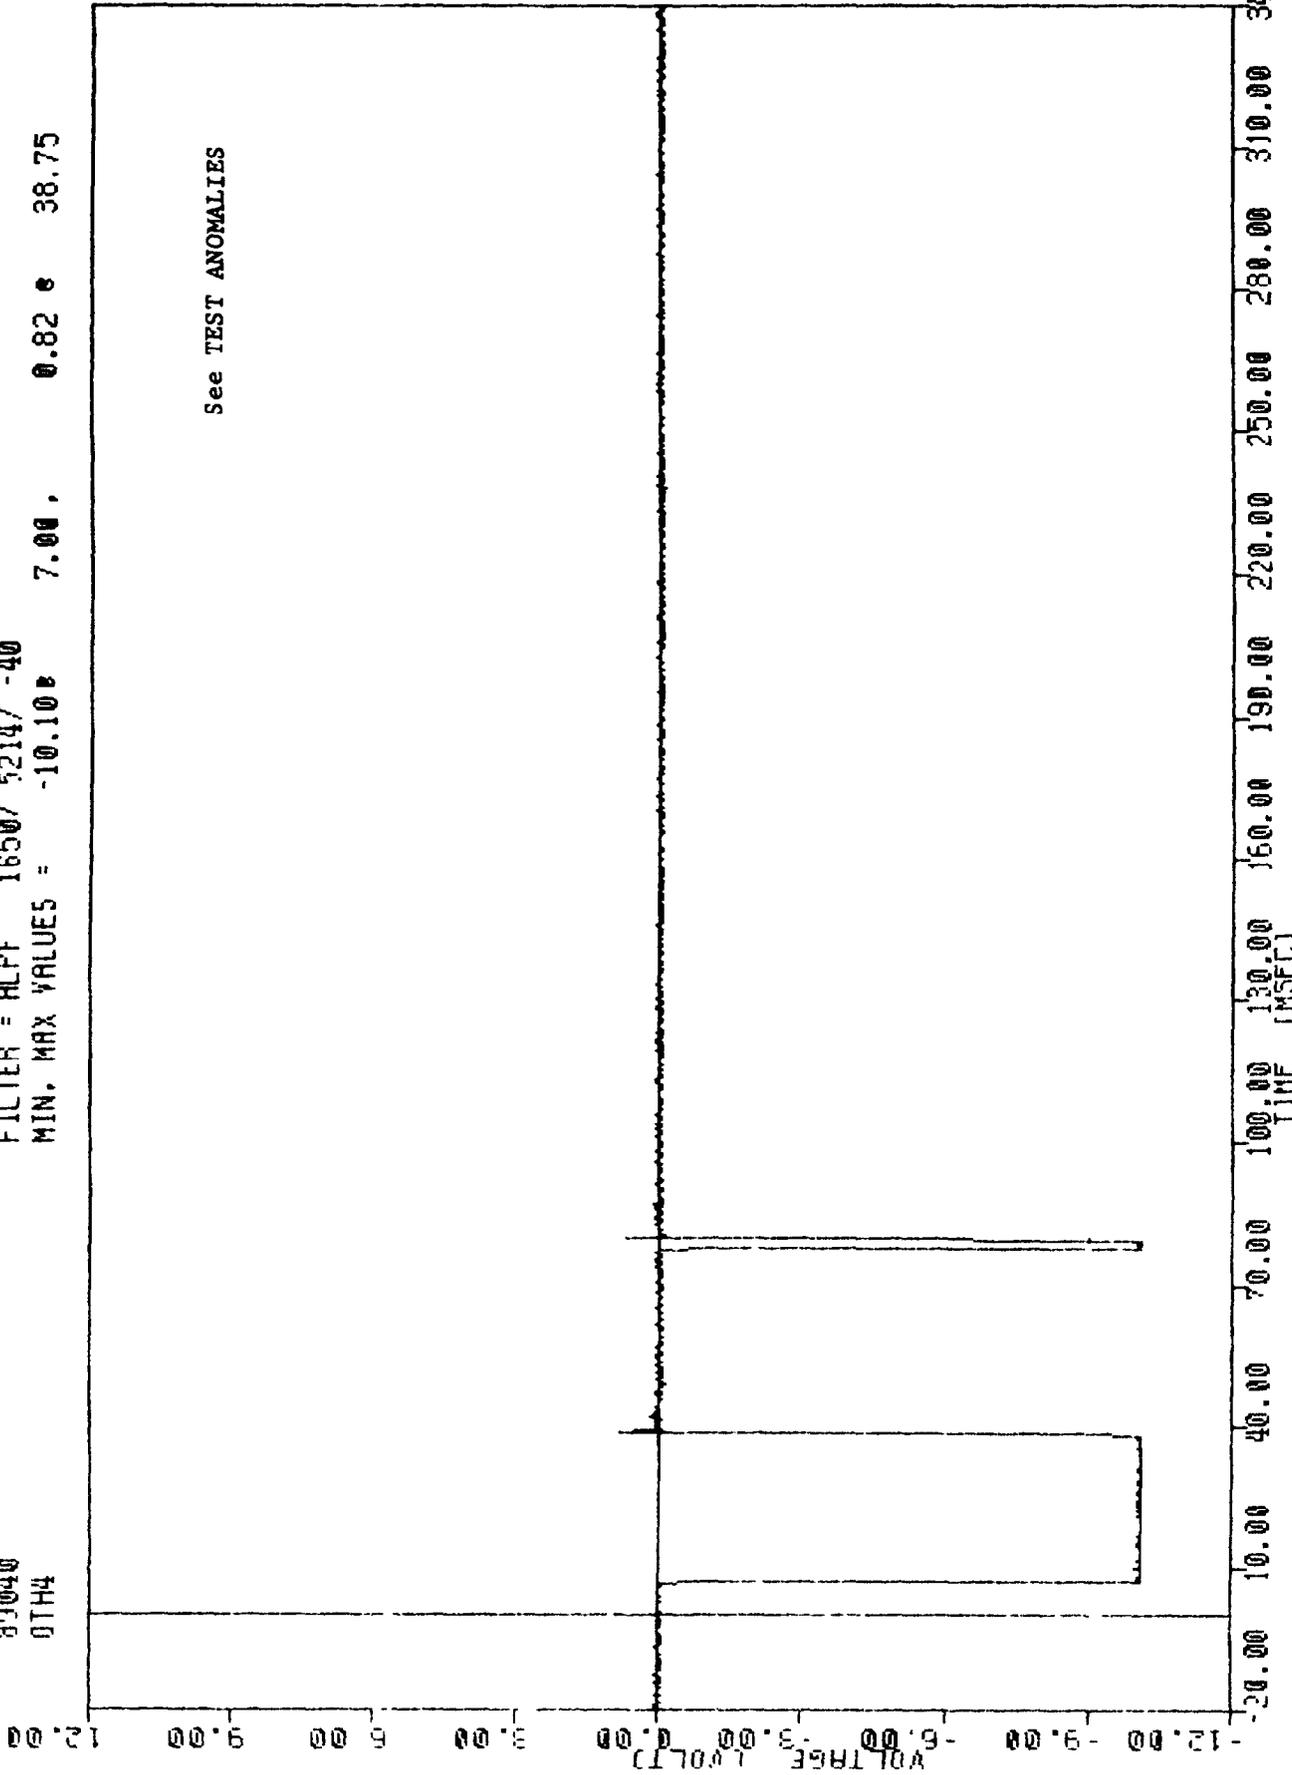
CONToured MOVING BARRIER INTO 90 DEG 1983 HONDA PRELUDE AT 35.9 MPH *4
VEHICLE CONTACT SWITCH - RIGHT
