DOT HS 807 441

Final Report

Final Report of 270° Contoured Moving Barrier Impact into a 1983 Honda Prelude 2-Door Coupe in Support of Crash III Damage Algorithm Reformation

The purpose of the four 270° contoured moving barrier impact tests was for research and development in support of the CRASH III damage algorithm reformulation.

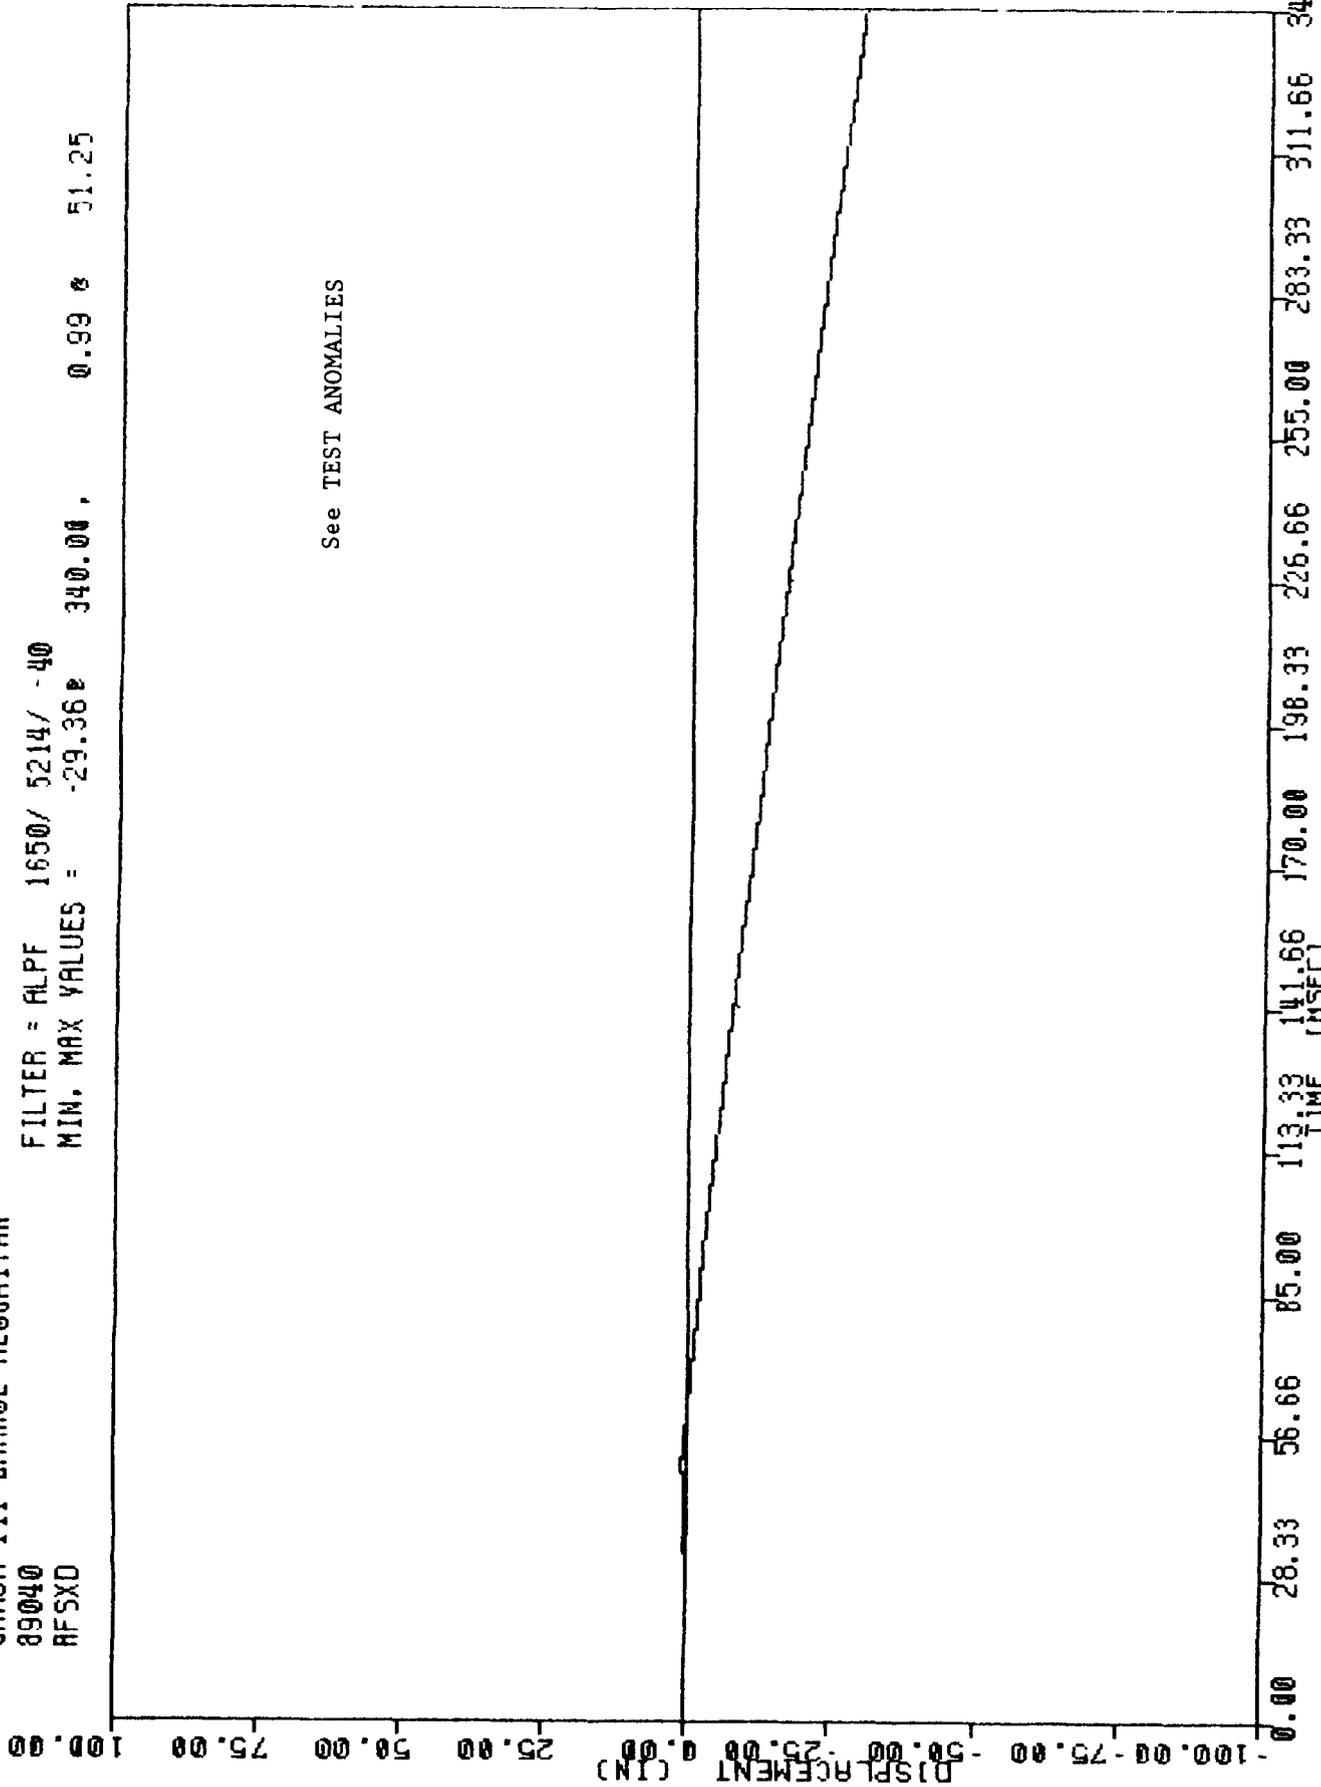
CONTOURED MOVING BARRIER INTO 90 DEG HONDA PRELUDE AT 35.9 MPH #4
 RIGHT FRONT SILL X AXIS DISPLACEMENT

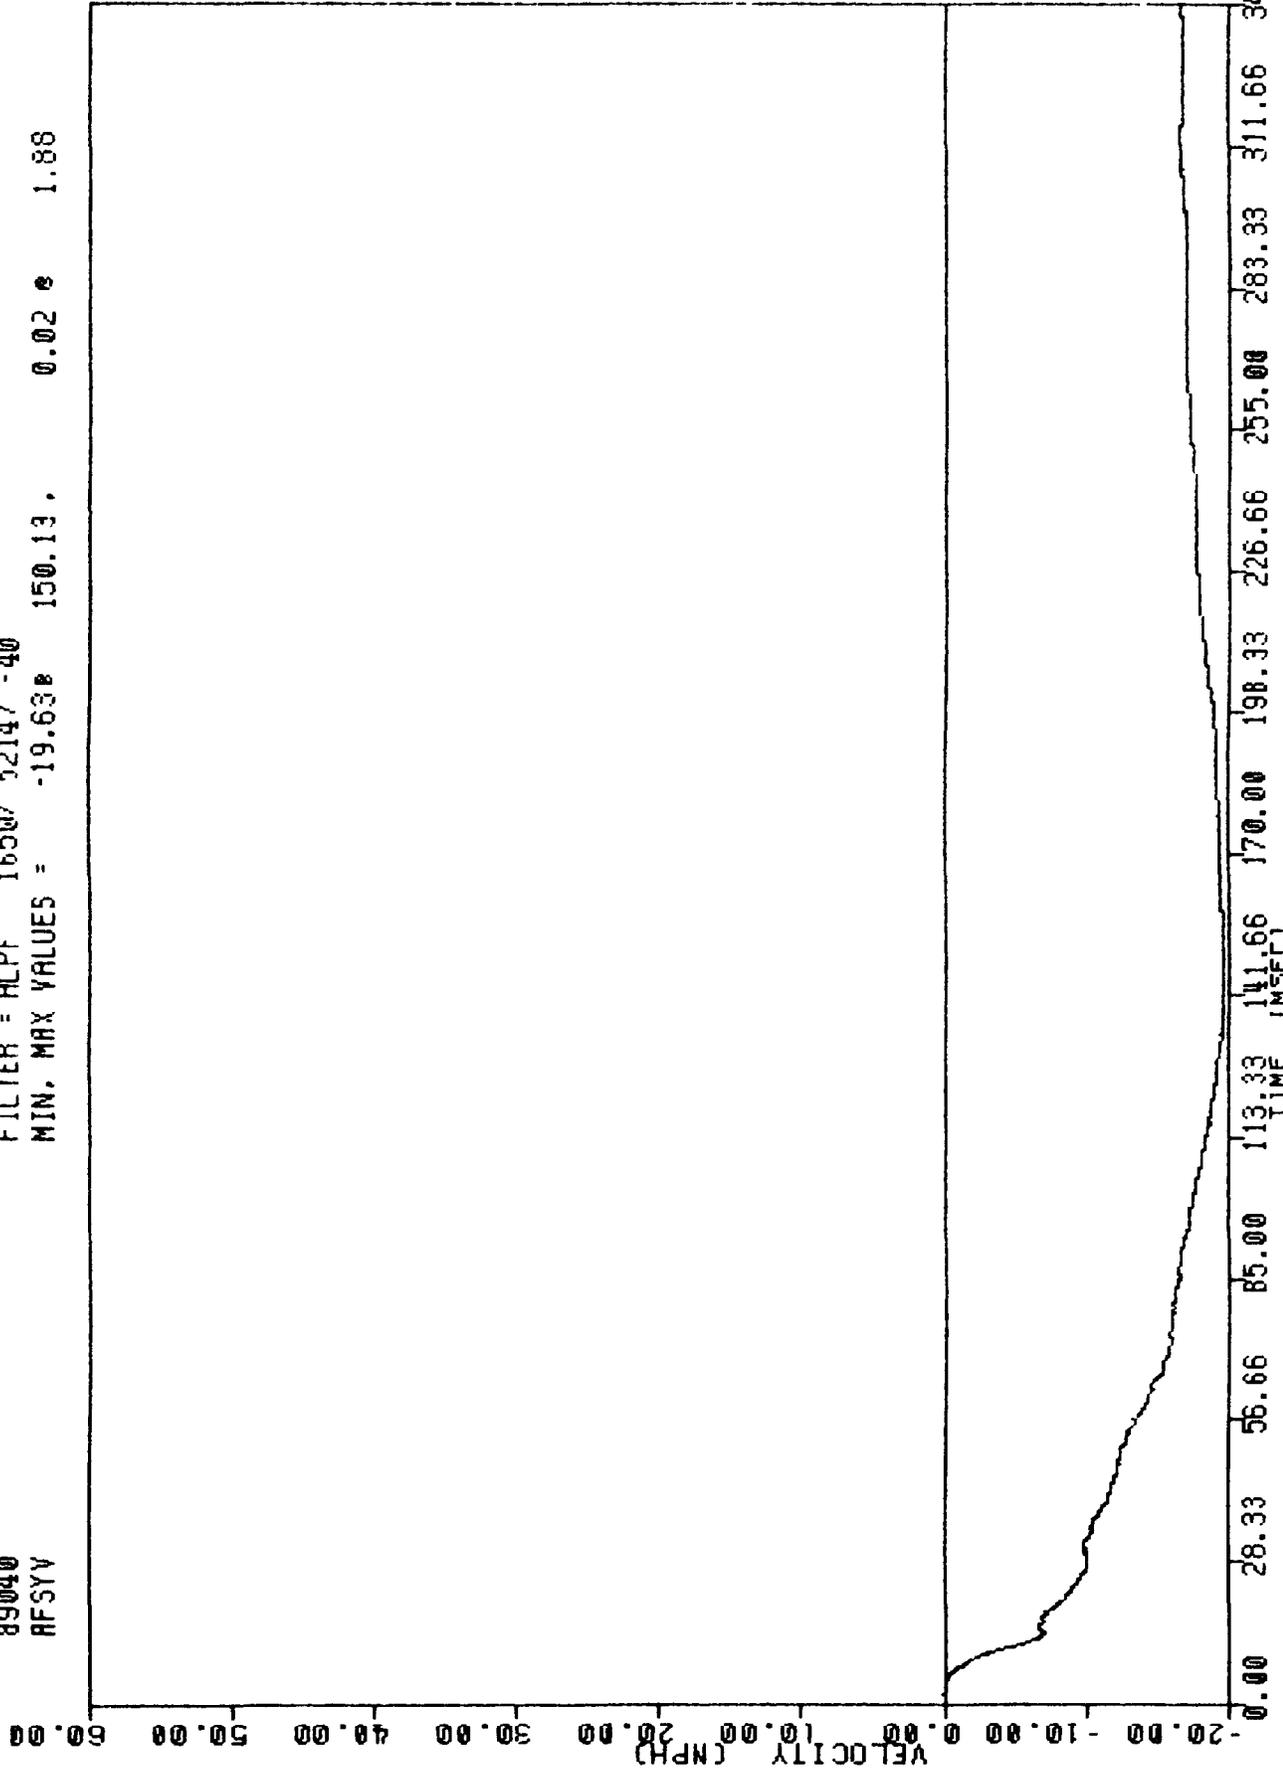
CONTOURED MOVING BARRIER INTO 90 DEG HONDA PRELUDE AT 35.9 MPH #4
RIGHT FRONT SILL Y AXIS VELOCITY

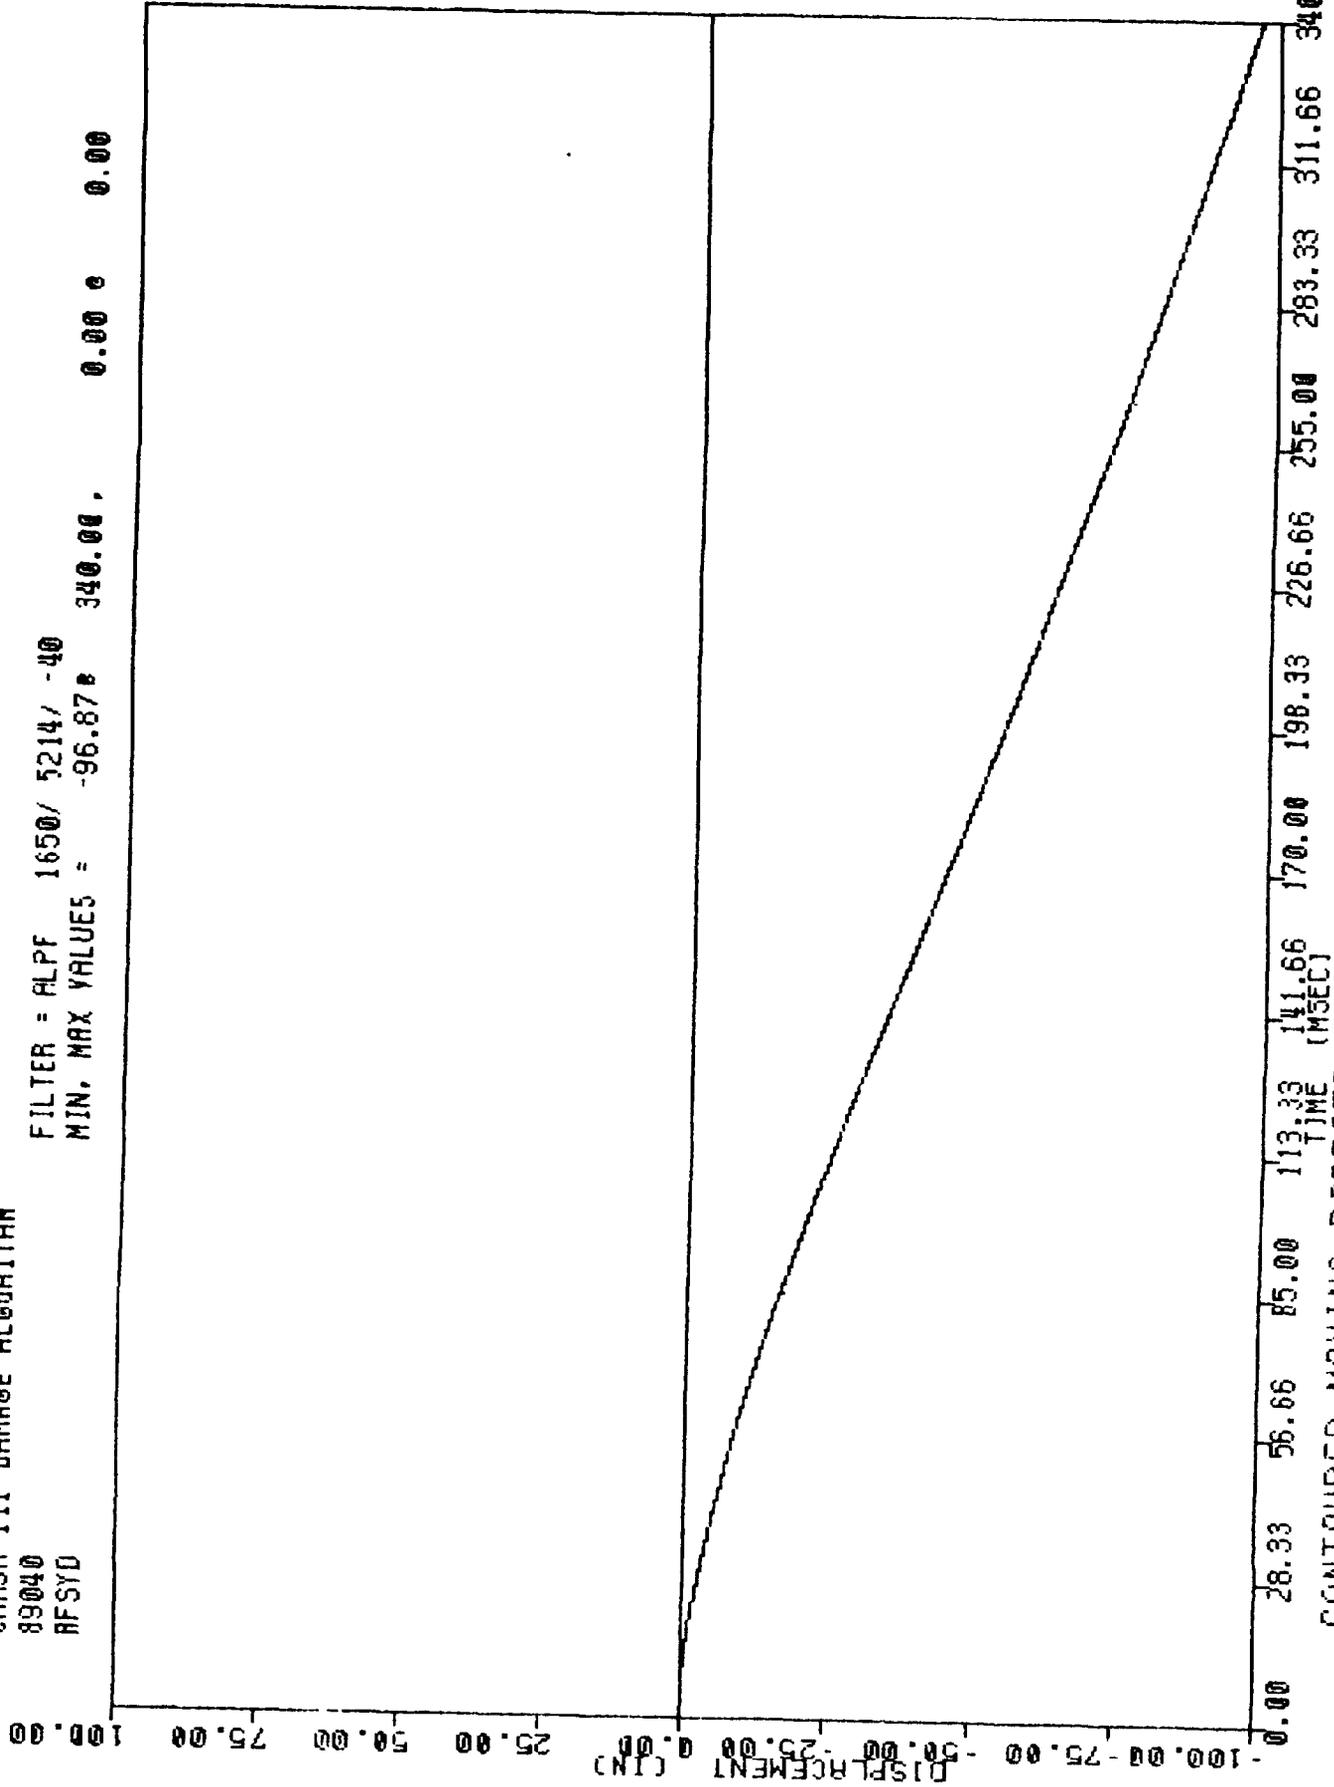
CONTOURED MOVING BARRIER INTO 90 DEG 1983 HONDA PRELUDE AT 35.9 MPH #4
 RIGHT FRONT SILL Y AXIS DISPLACEMENT

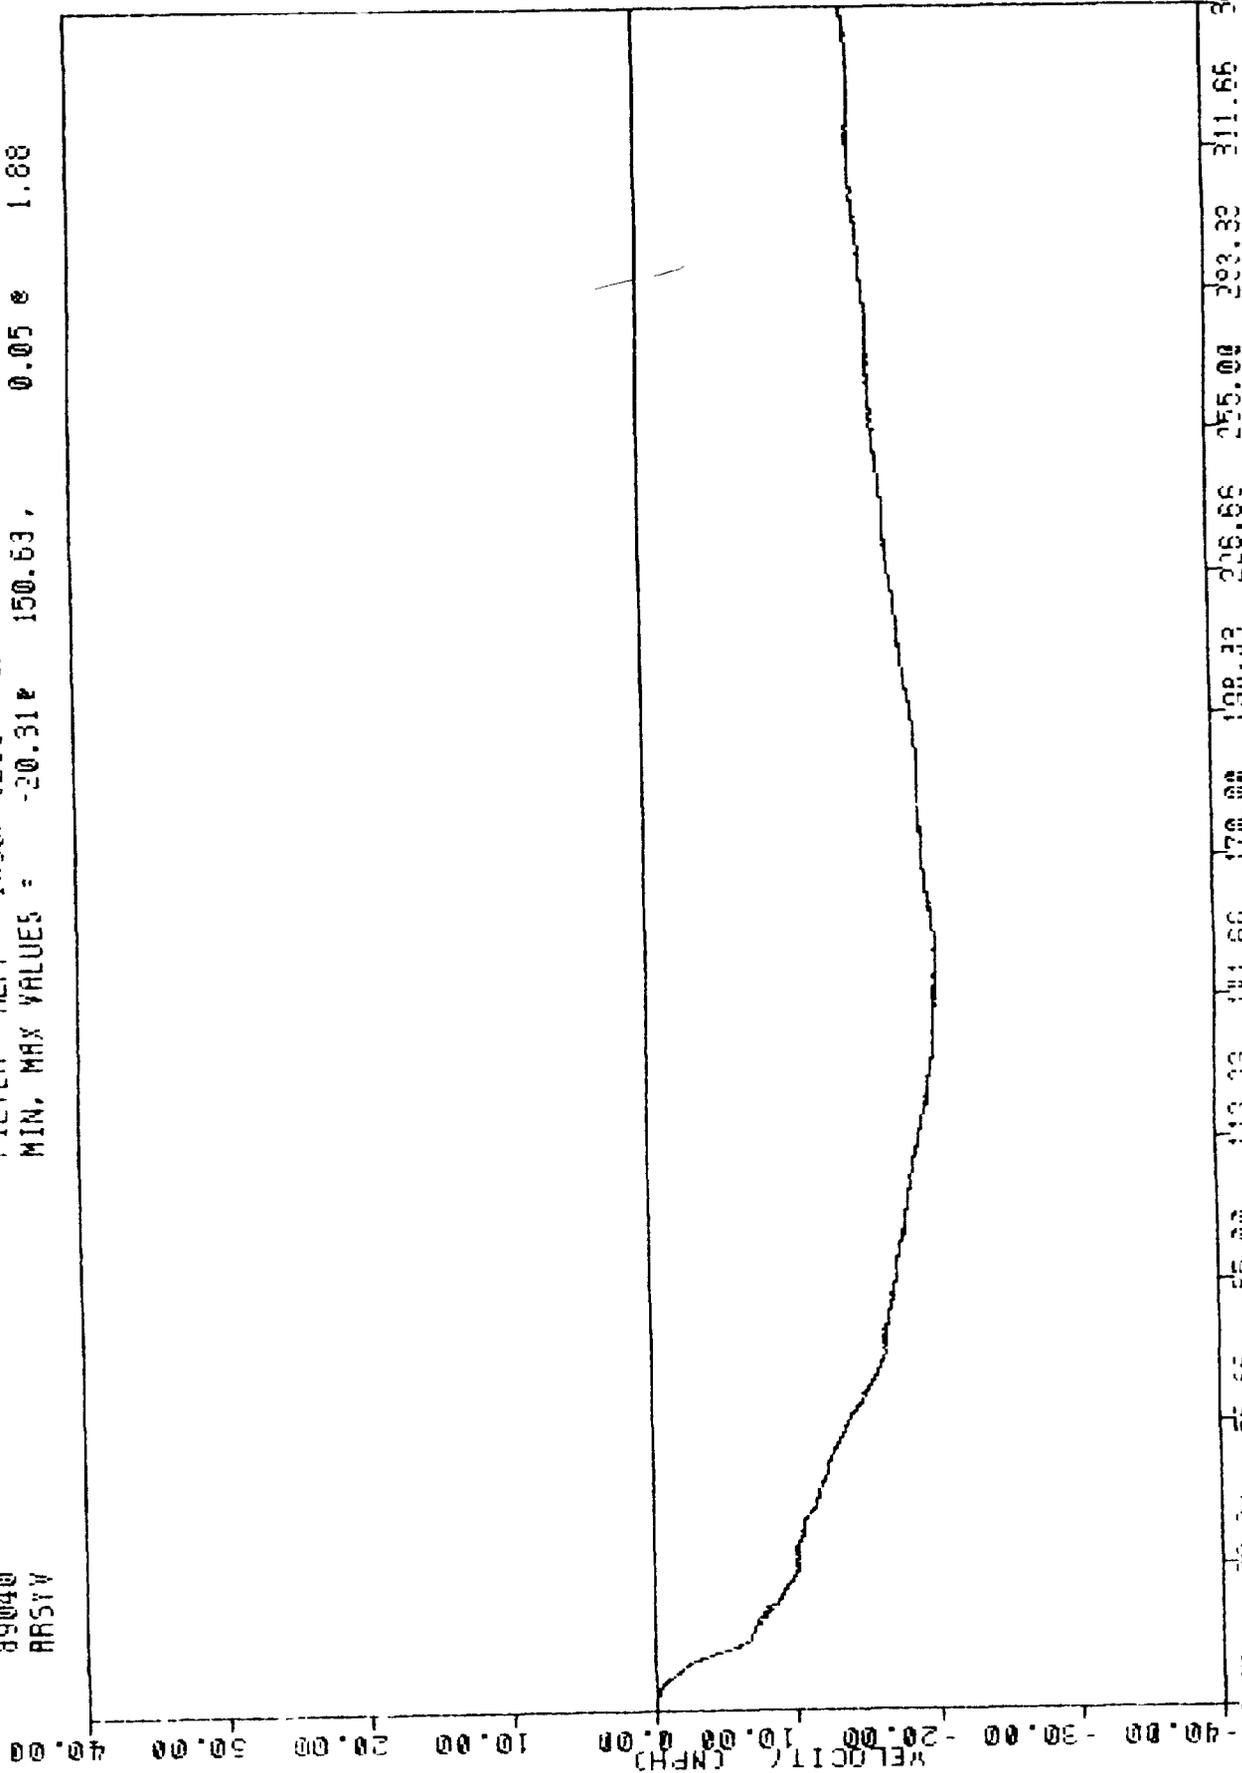
CONTOURED MOVING BARRIER INTO 90 DEG HONDA PRELUDE AT 35.9 MPH #4
 RIGHT REAR SILL Y AXIS VELOCITY

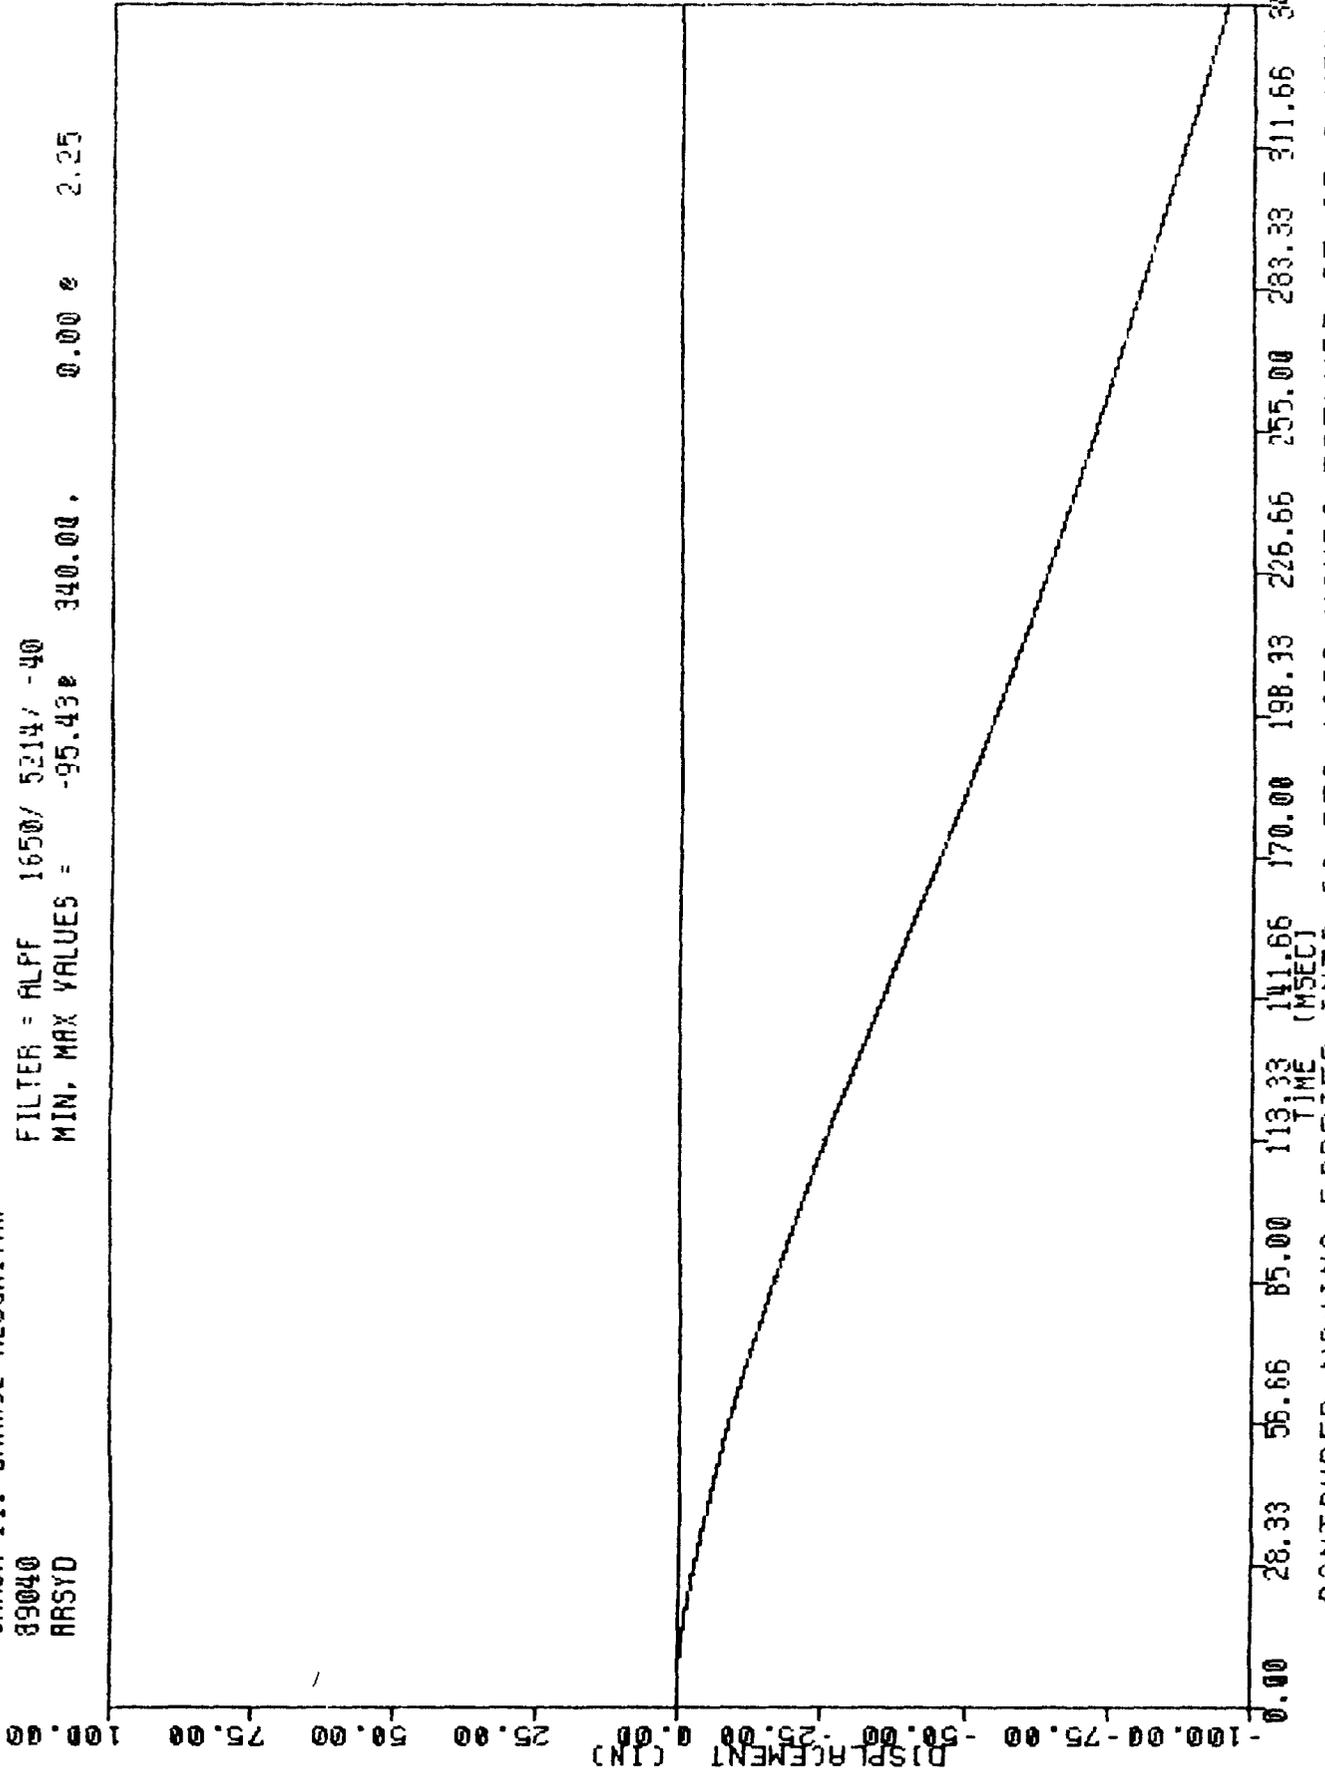
CONToured MOVING BARRIER INTO 90 DEG 1983 HONDA PRELUDE AT 35.9 MPH *4
 RIGHT REAR SILL Y AXIS DISPLACEMENT

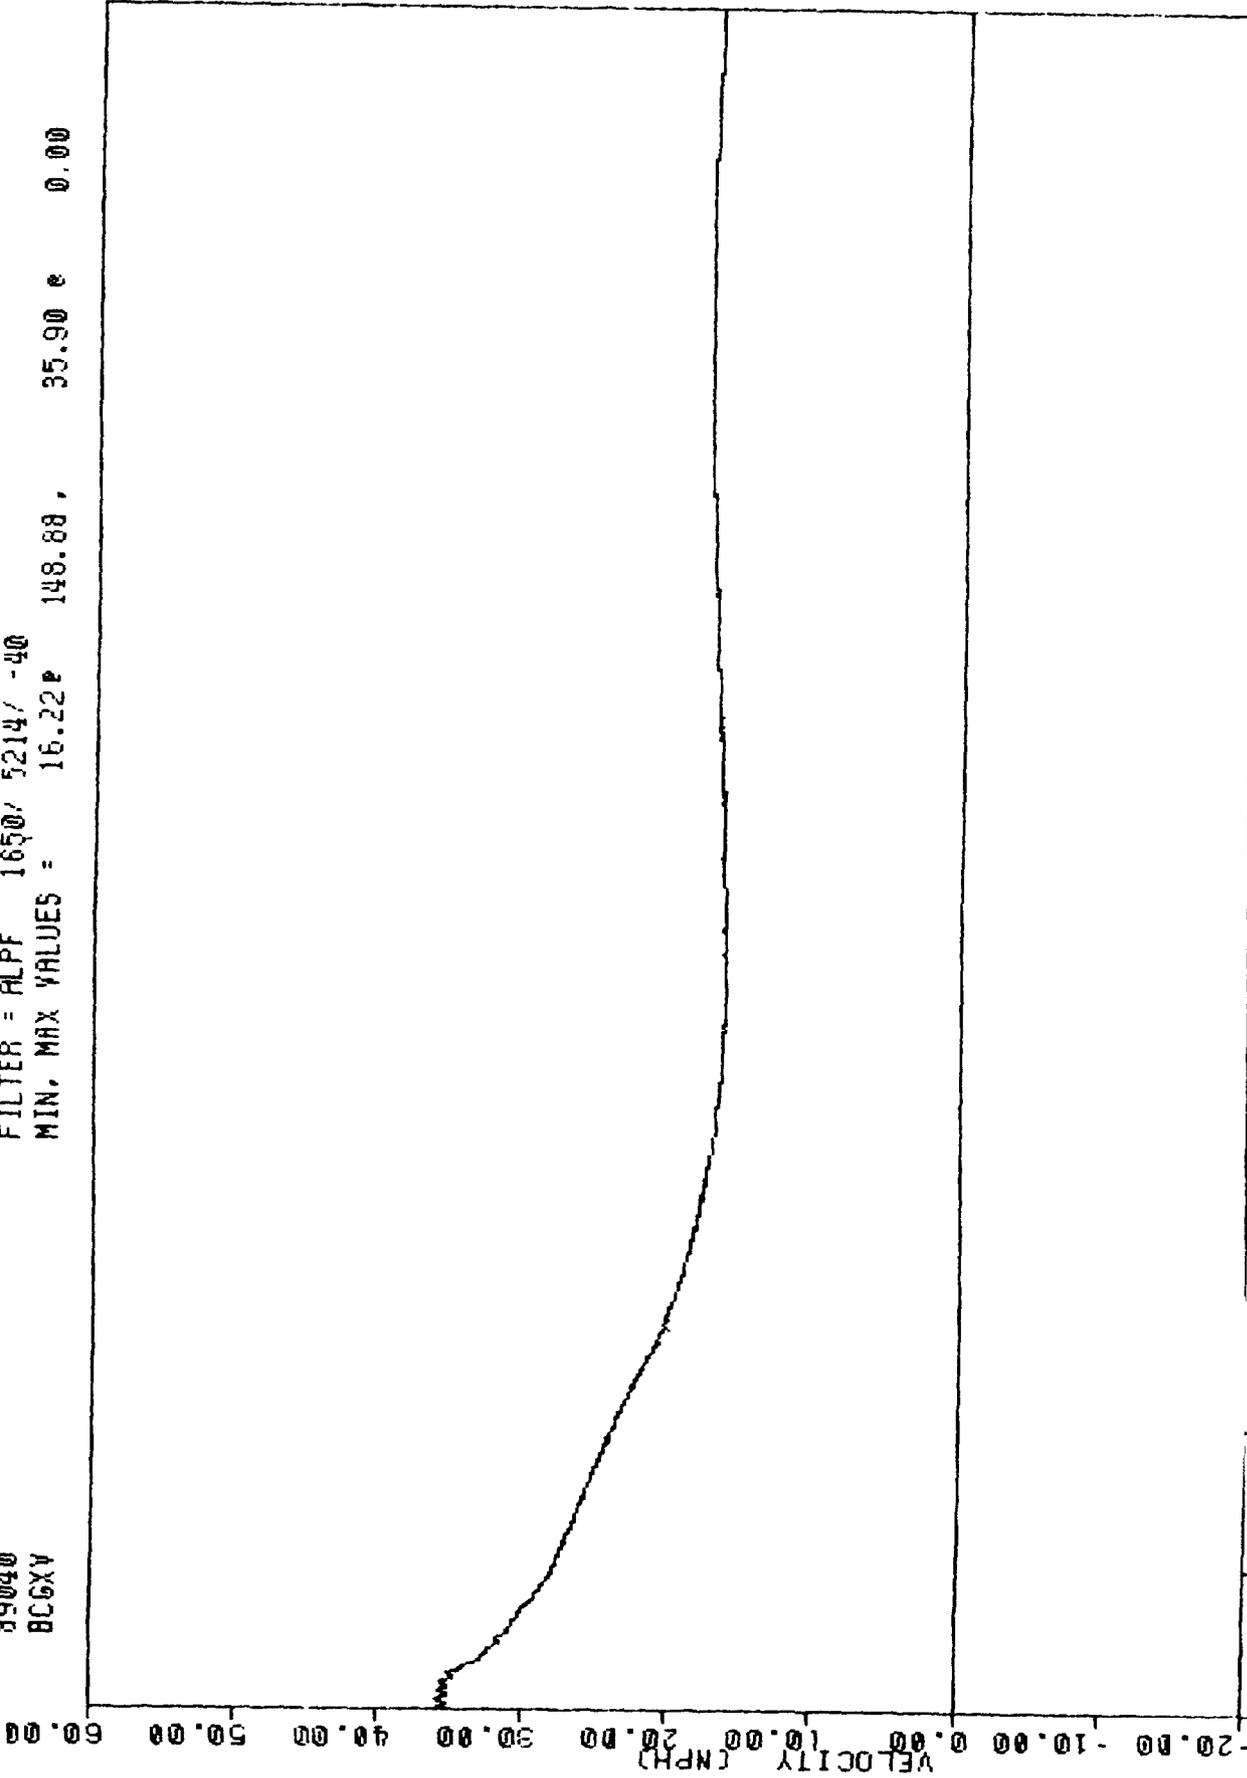
CONToured MOVING BARRIER INTO 90 DEG HONDA PRELUDE AT 35.9 MPH *4
CONToured MOVING BARRIER CENTER OF GRAVITY X AXIS VELOCITY

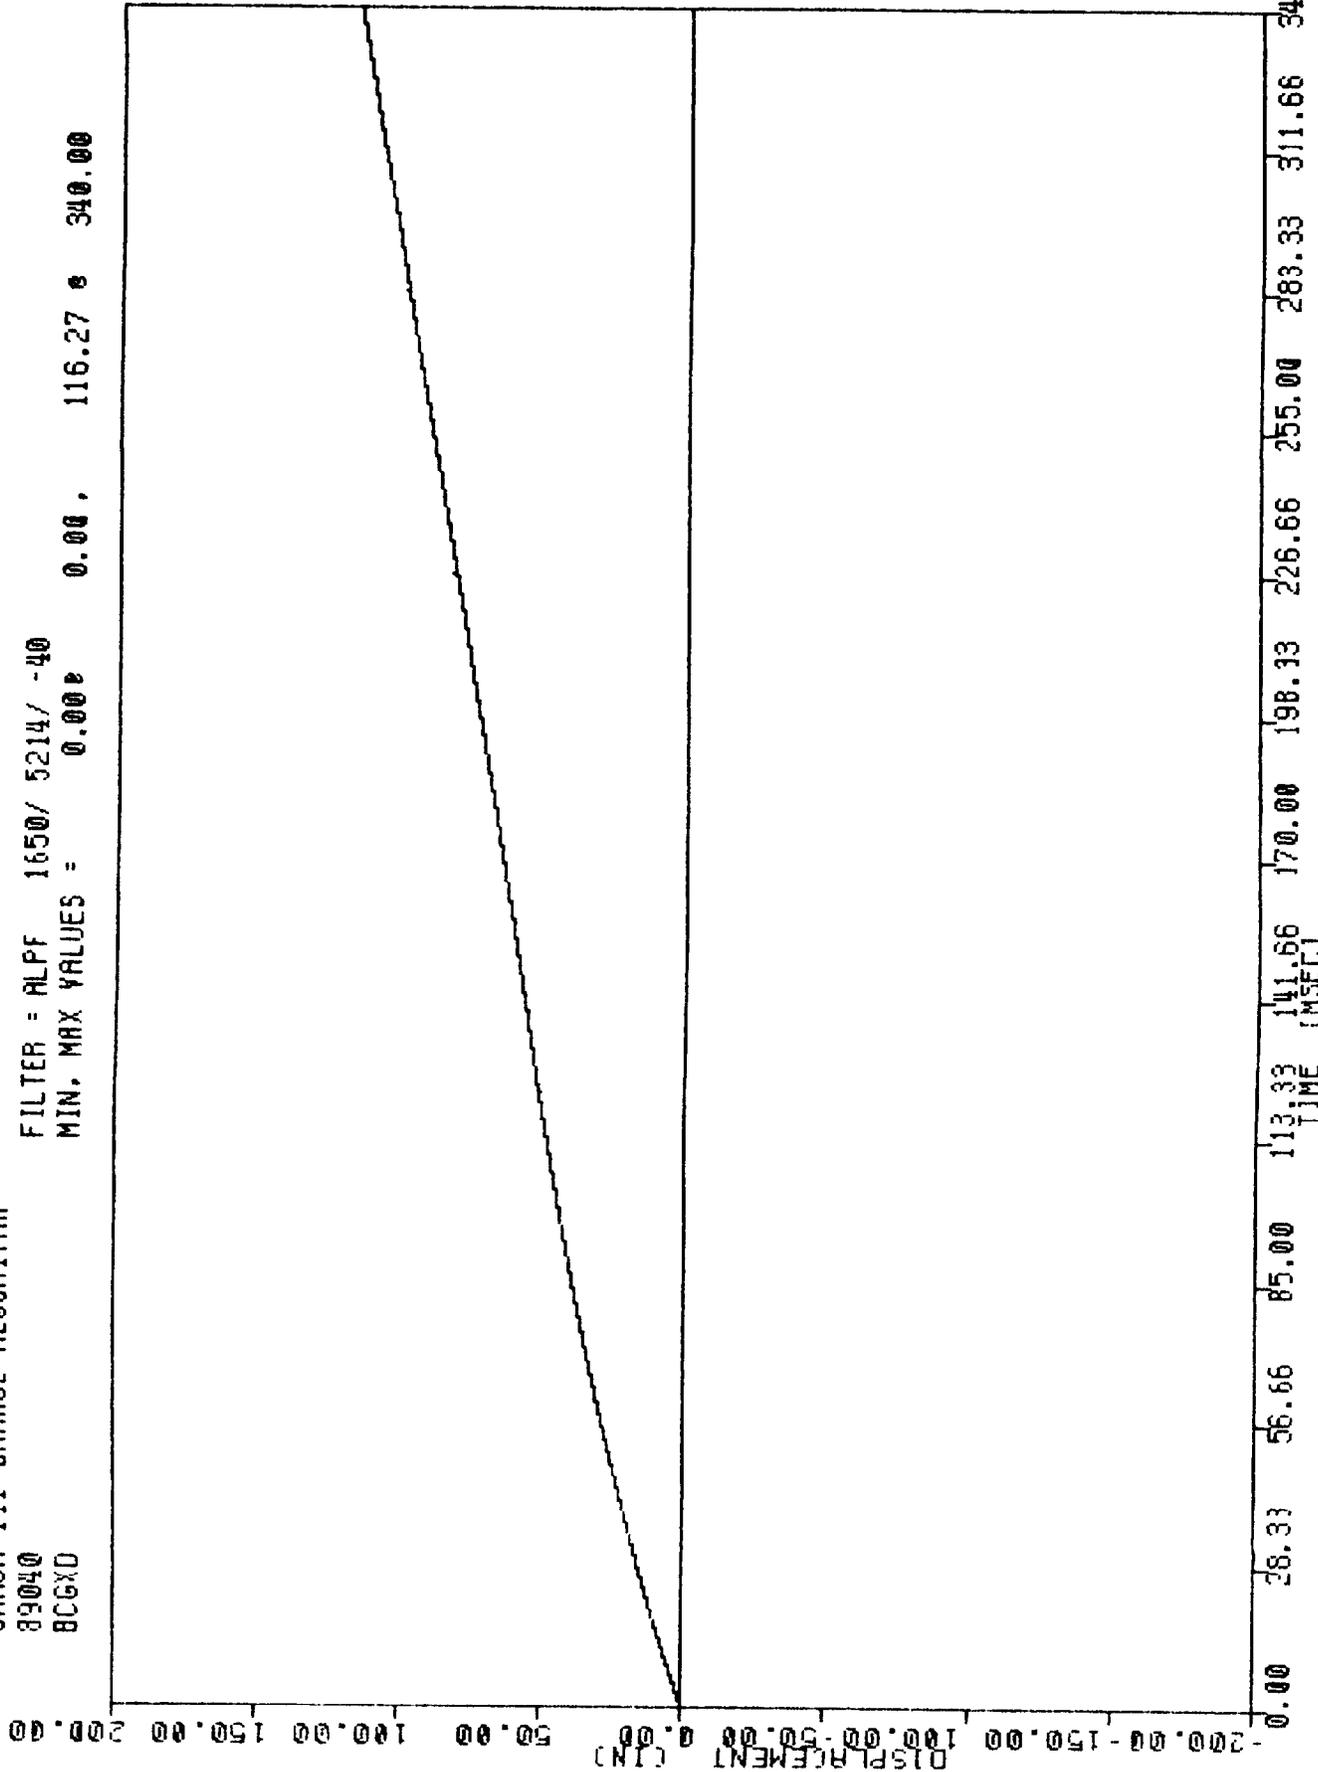
CONTOURED MOVING BARRIER INTO 90 DEG HONDA PRELUDE AT 35.9 MPH #4
 CONTOURED MOVING BARRIER CENTER OF GRAVITY X AXIS DISPLACEMENT

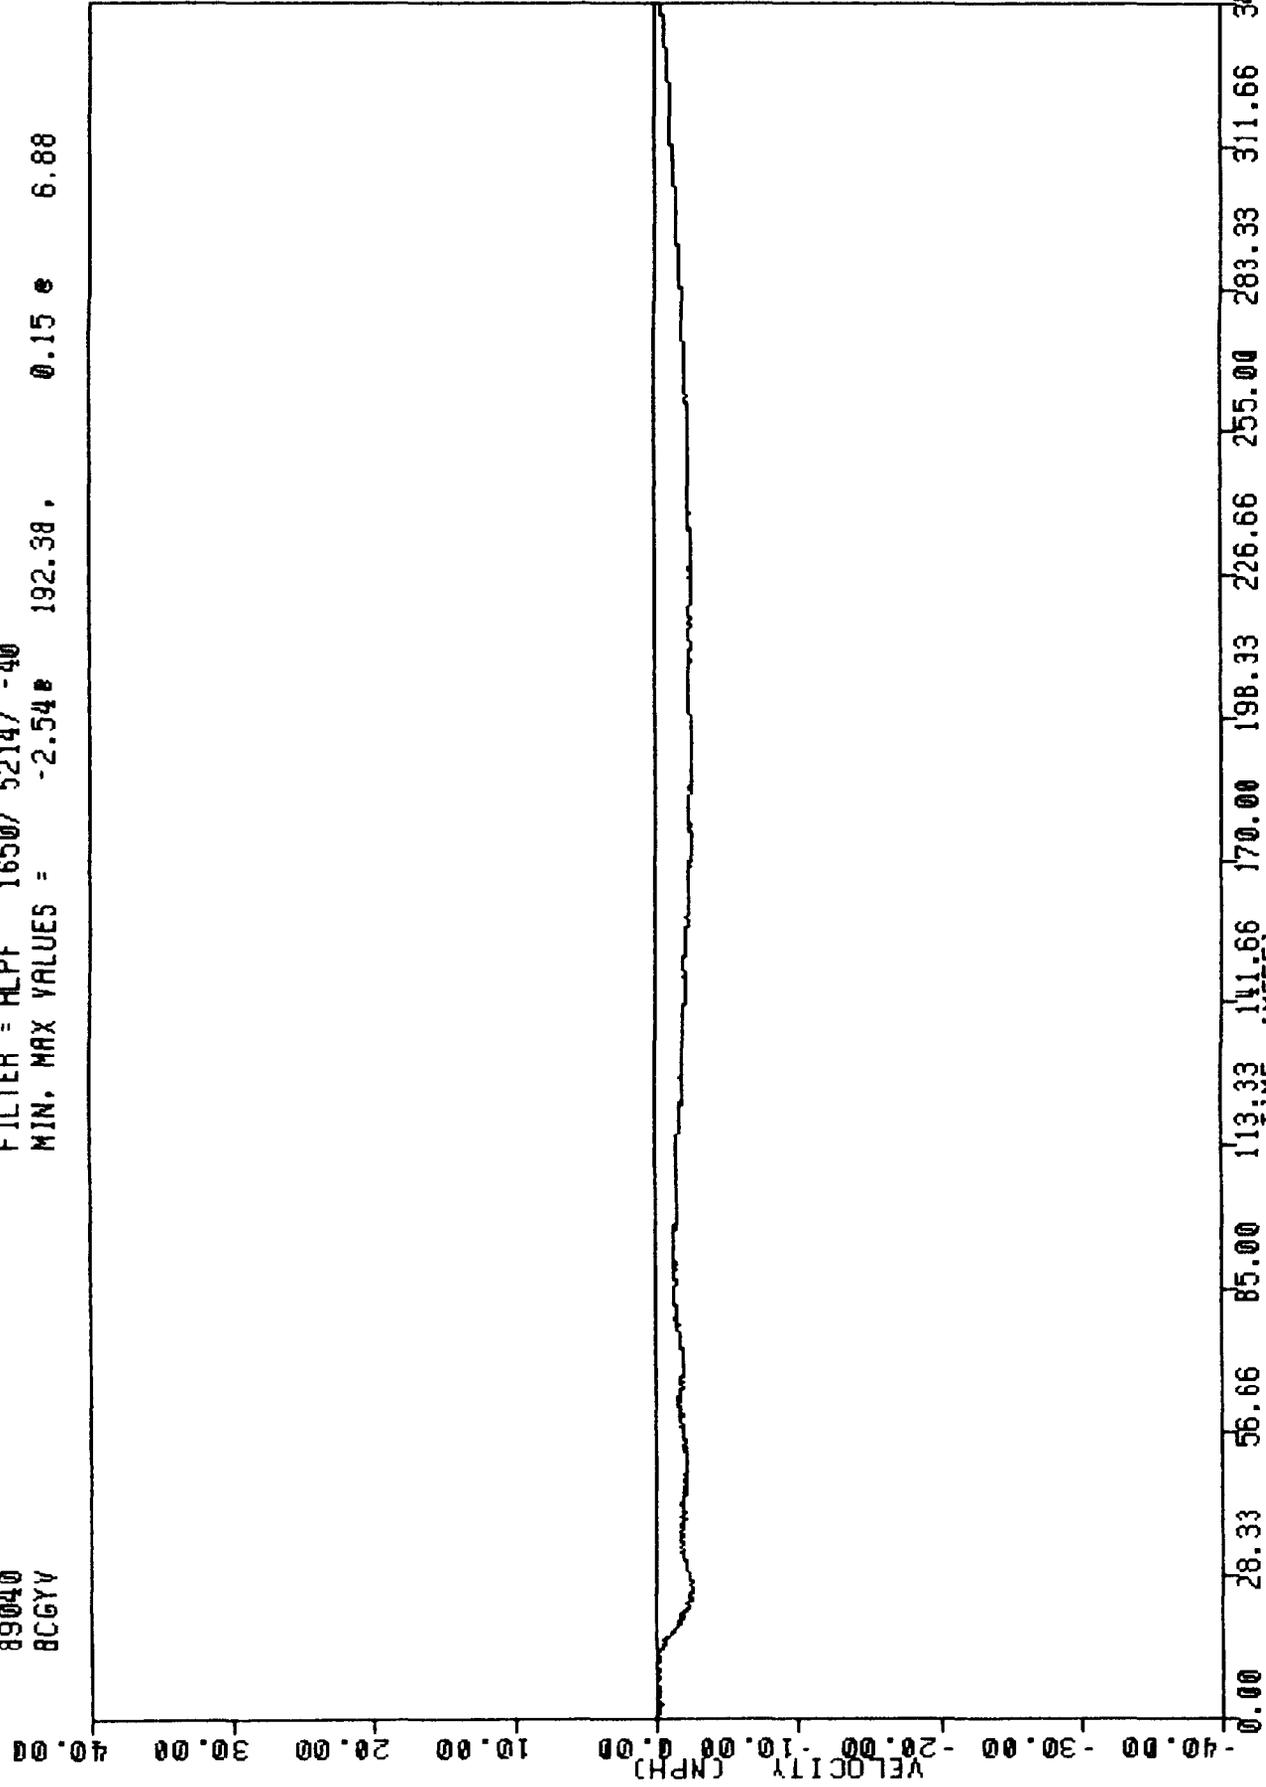
CONToured MOVING BARRIER INTO 90 DEG 1983 HONDA PRELUDE AT 35.9 MPH #4
 CONToured MOVING BARRIER CENTER OF GRAVITY Y AXIS VELOCITY

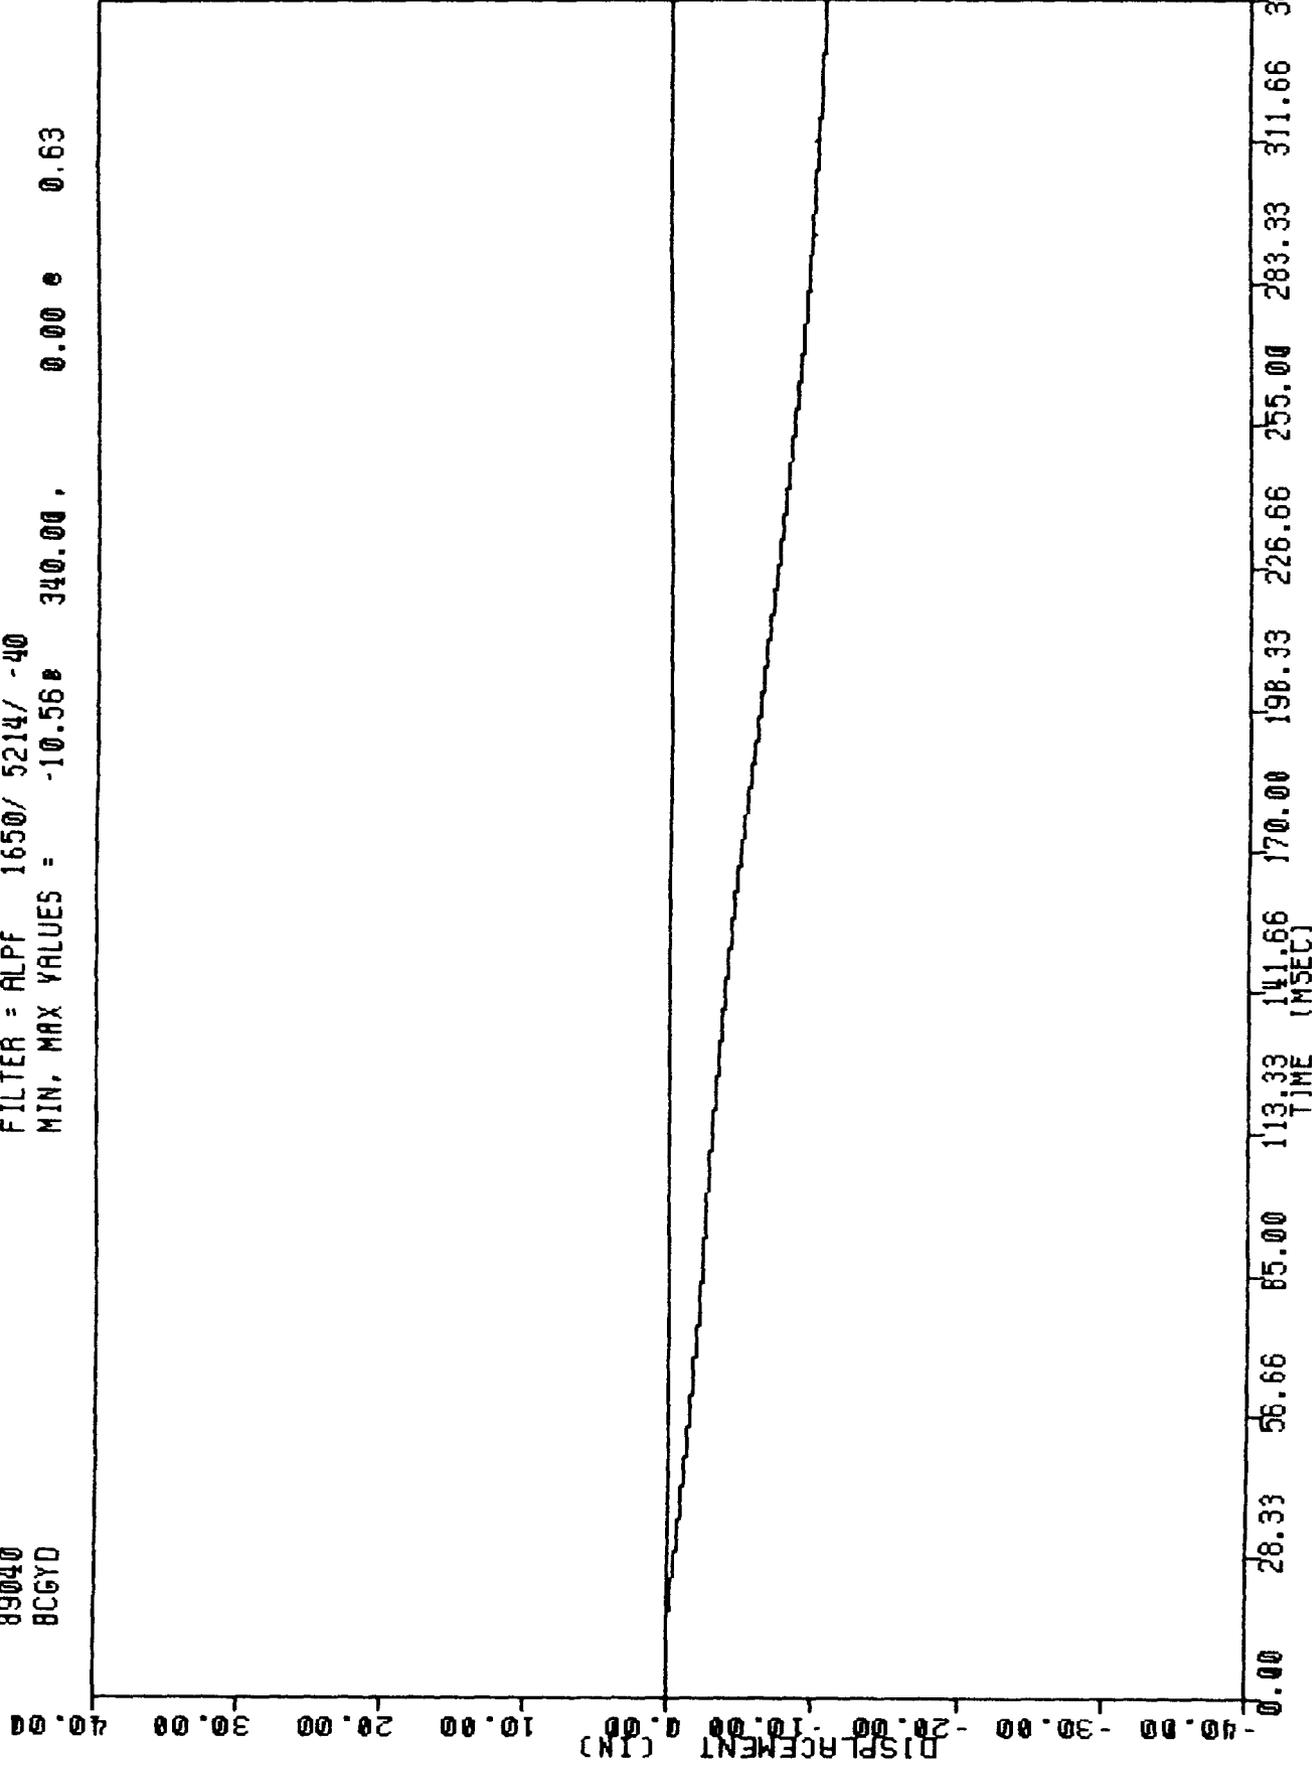
CONTOURED MOVING BARRIER INTO 90 DEG HONDA PRELUDE AT 35.9 MPH #4
 CONTOURED MOVING BARRIER CENTER OF GRAVITY Y AXIS DISPLACEMENT
