REPORT NUMBER: 301-KAR-18-002
SAFETY COMPLIANCE TESTING FOR FMVSS 301R
FUEL SYSTEM INTEGRITY – REAR IMPACT
79.3 KM/H 70% OVERLAP REAR IMPACT

VOLKSWAGEN DE MEXICO
2018 VOLKSWAGEN TIGUAN 5-DOOR MPV

NHTSA NUMBER: C20185802

PREPARED BY:
KARCO ENGINEERING, LLC.
9270 HOLLY ROAD
ADELANTO, CA 92301

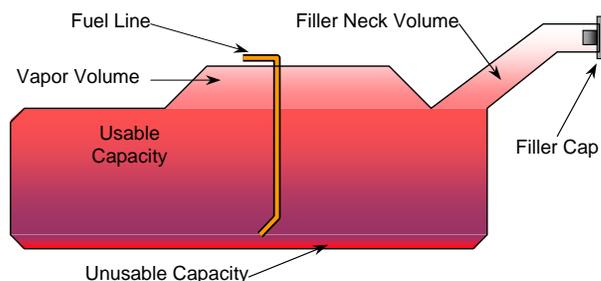
VEHICLE FUEL TANK ASSEMBLY

The vehicle is equipped with an electric fuel pump. The fuel pump is activated when the ignition is turned to the "ON" position. The fuel pump will run when the engine is running.

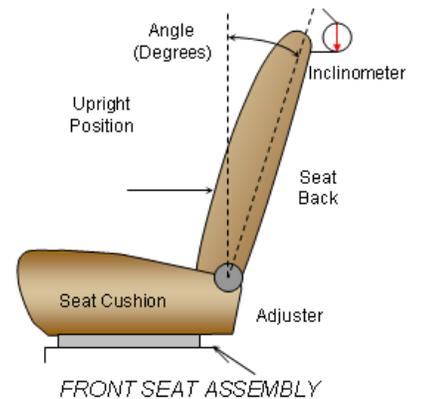
SEAT BACK ANGLE

Seat back angle is measured using a digital inclinometer placed on the headrest post.

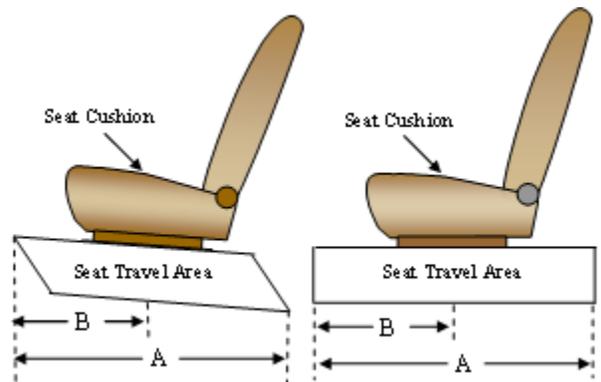
SEAT FORE/AFT POSITIONS

The total seat travel is measured from the forward most possible position to the rear most possible position. The driver's seat is set to the middle of the fore-aft travel. The passenger's seat is set to the middle of the fore-aft travel.

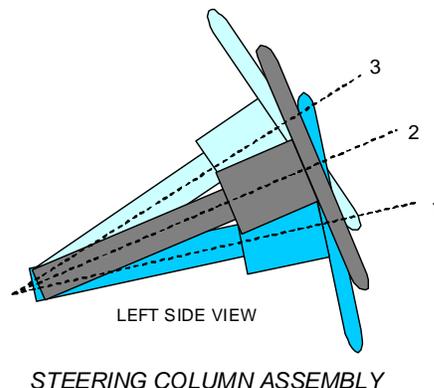
STEERING COLUMN POSITIONING

Steering wheel and column adjustments are made so that the steering wheel hub is at the geometric center of the locus it describes when moved through its full range of motion. A digital inclinometer is used to measure a plate which is placed across the rim of the steering wheel for angular measurements. A tape measure is used to measure telescoping steering wheel travel.

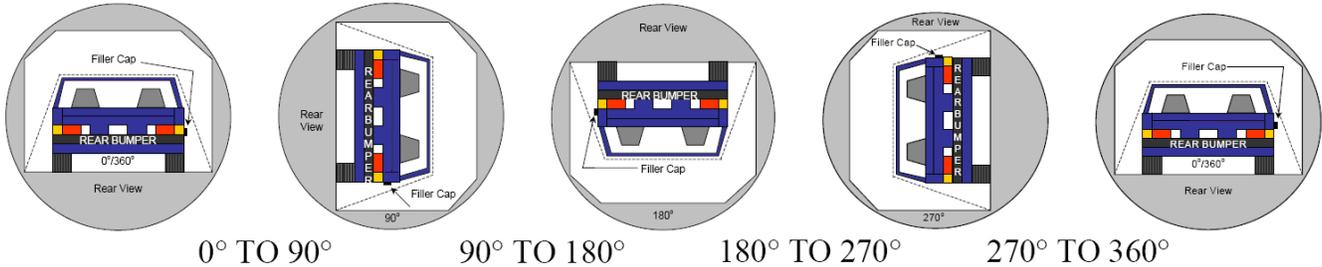
1. The specified fixture rollover rate for each 90° of rotation is 60 to 180 seconds.
2. The position hold time at each position is 300 seconds (minimum).

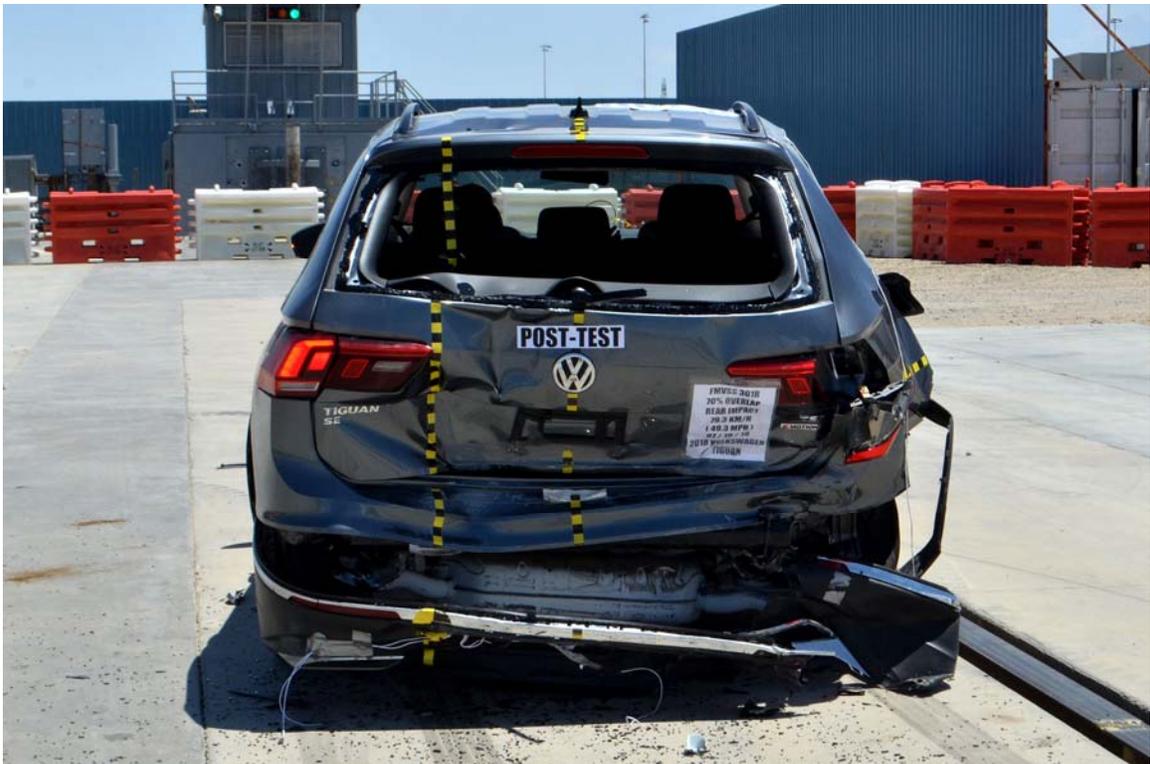
FIGURE 14. Post-Test Rear View of Test Vehicle

No.	Description	Pre-Test	Post-Test	Difference
1	Total Length at Centerline	4685	4495	190
2	Total Length	4685	4610	75
3	Total Width	1835	1897	62
4	Left Side Wheelbase	2780	2785	5
5	Right Side Wheelbase	2780	2740	40

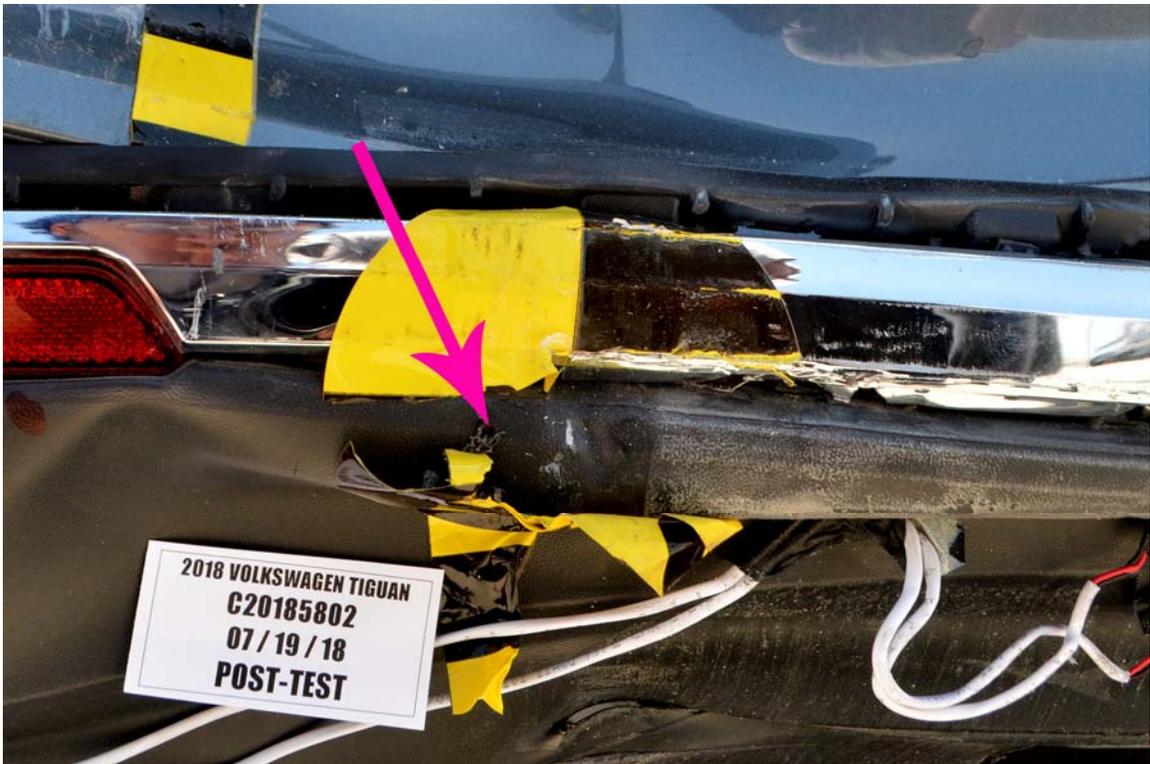
FIGURE 22. Post-Test Close-Up View of Impact Point Target

Measured Parameter	Units	Tolerance	Value
Vehicle Width	mm		1835
Vertical Impact Reference Line (Left of Vehicle Center Line)	mm		367
Actual Impact Point (Left of Vehicle Center Line)	mm		367
Horizontal Offset (+ right / - left)	mm	± 50 of Intended Impact Point	0
Vertical Offset (- down / + up)	mm	± 40 of Intended Impact Point	15

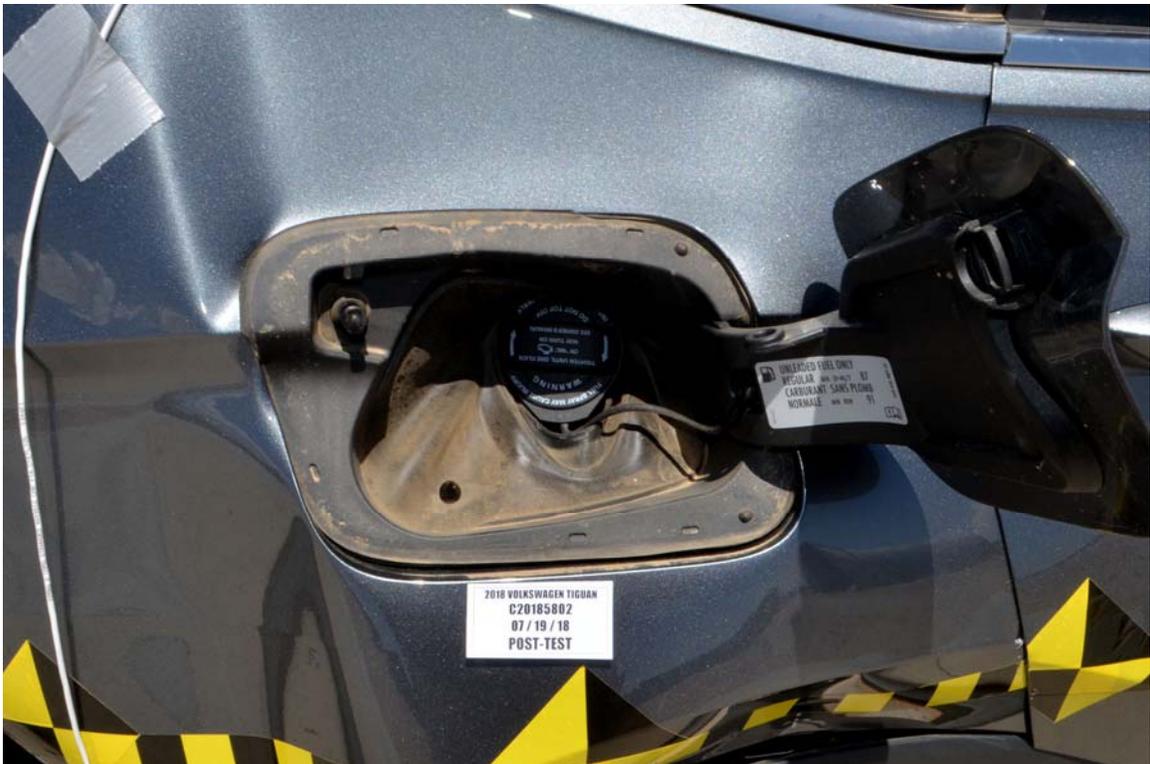
FIGURE 24. Post-Test View of Fuel Filler Cap

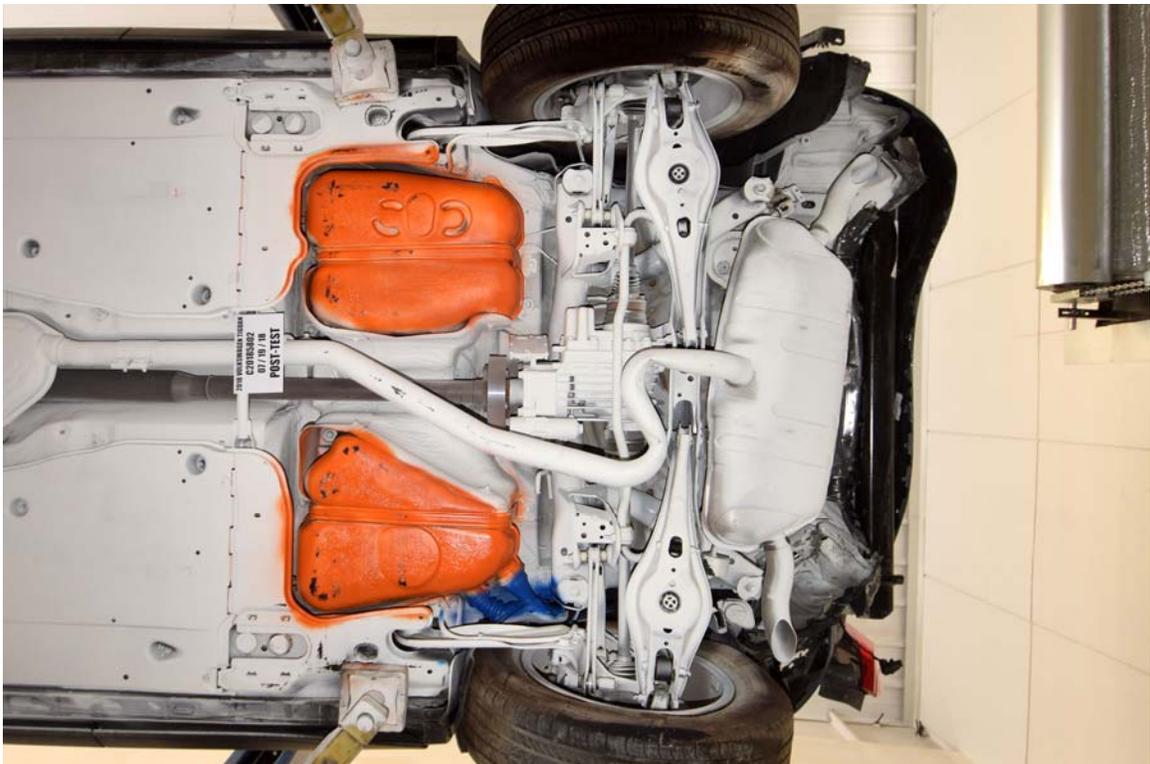
FIGURE 26. Post-Test Rear Underbody View of Test Vehicle

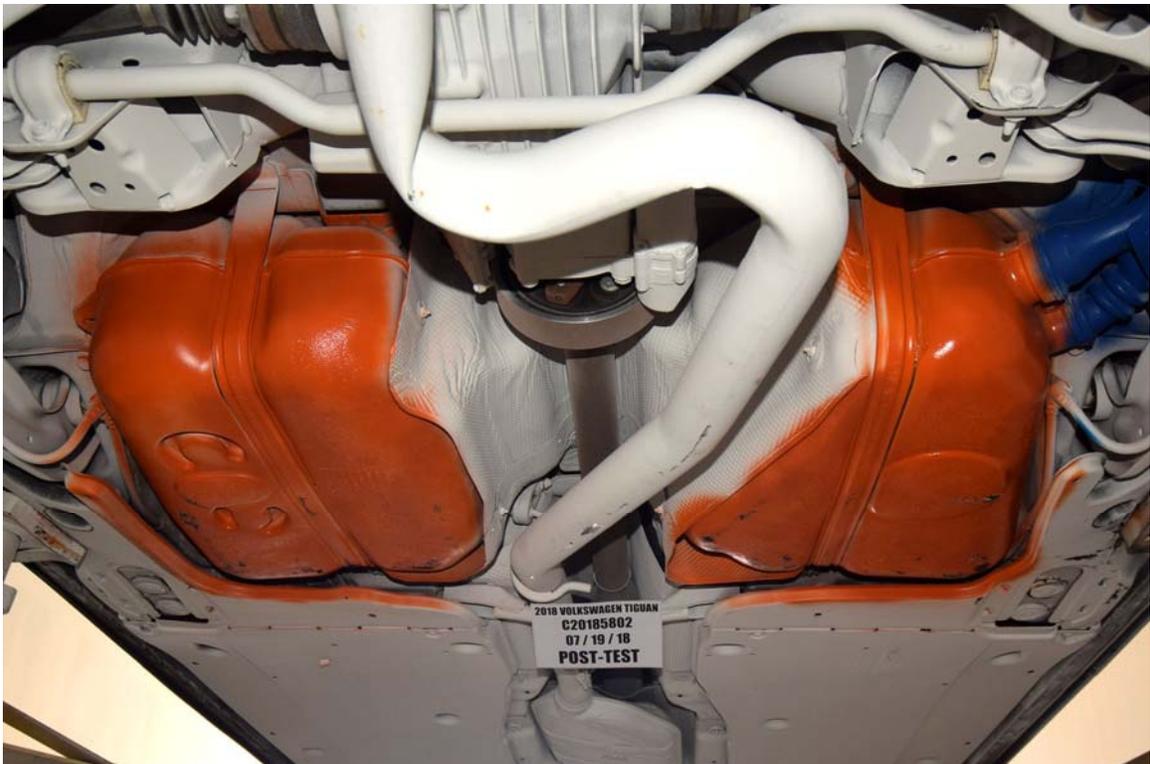
FIGURE 28. Post-Test Underbody View of Fuel Tank

Spillage: None

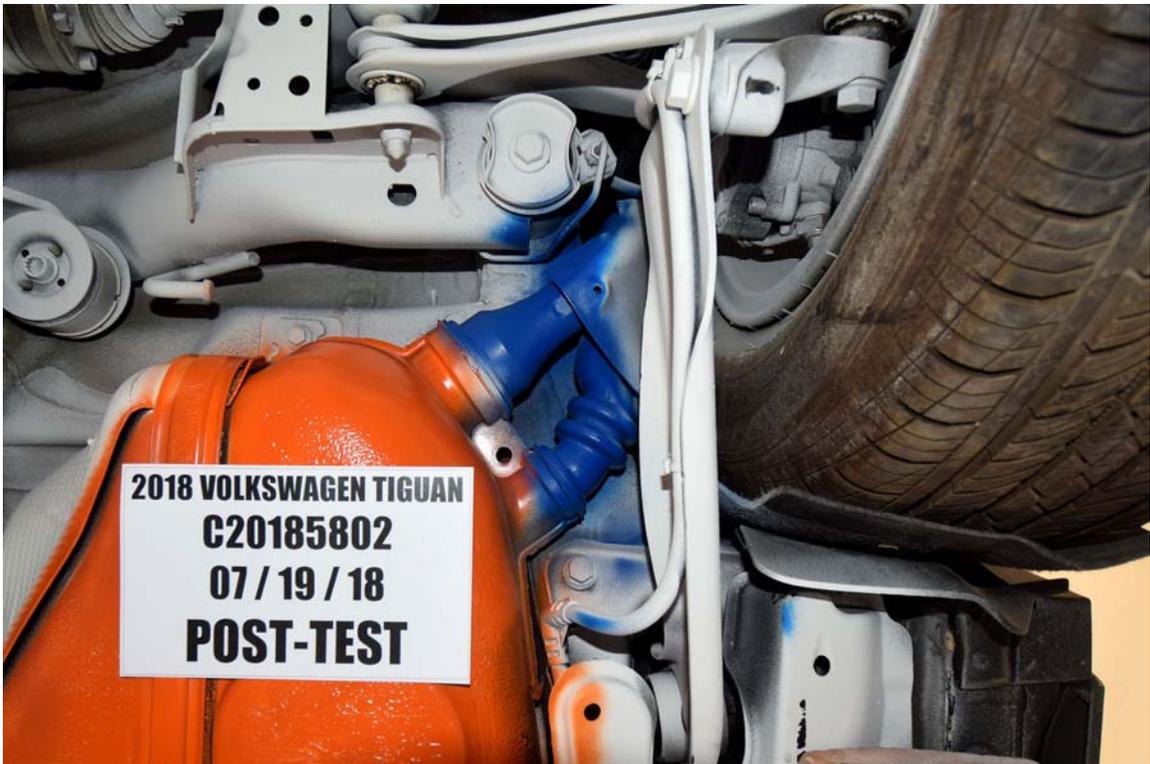
FIGURE 30. Post-Test Underbody View of Fuel Lines

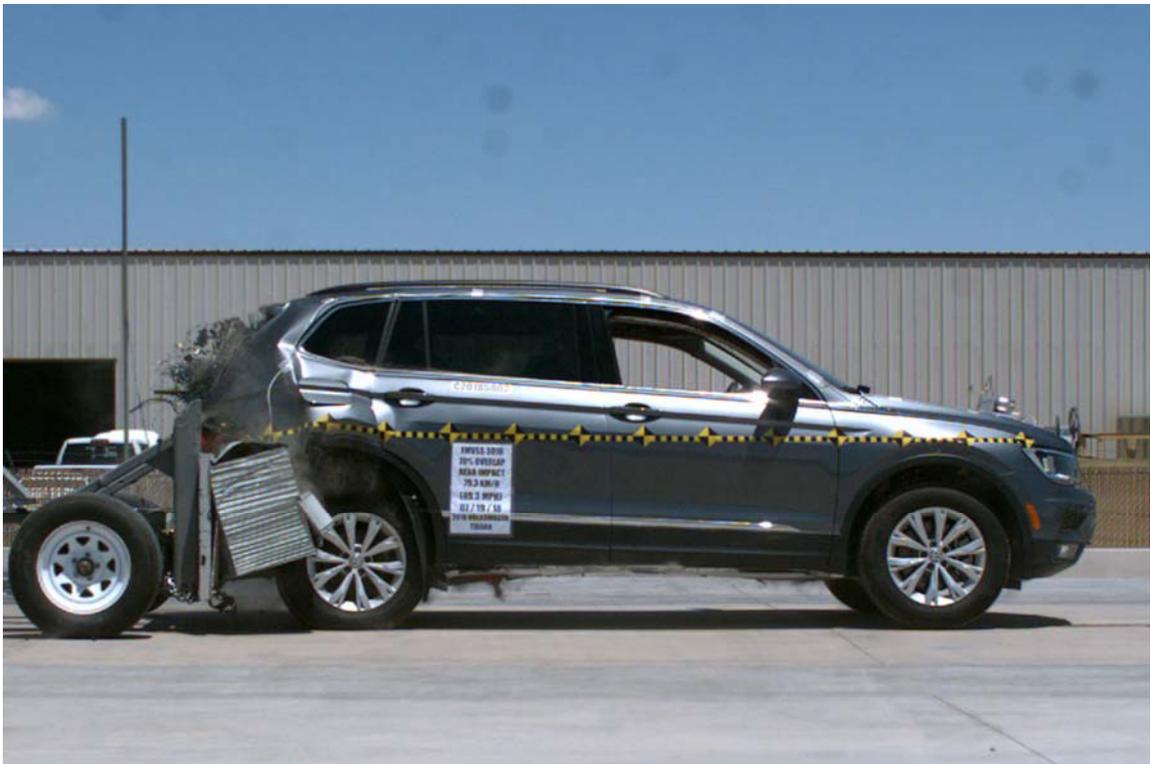
FIGURE 36. Impact Event
