**PROCEEDINGS**

22nd Annual International Workshop on Human Subjects  
for Biomechanical Research  
Fort Lauderdale, Florida

# THE DEVELOPMENT OF A PROTOCOL FOR DOCUMENTING VEHICULAR SITTING POSTURE OF CAR OCCUPANTS INVOLVED IN REAR-END COLLISIONS

Jocelyn Pedder	RONA Kinetics and Associates Ltd. Vancouver, Canada
Dainius Dalmotas	Transport Canada Ottawa, Canada
Tom Gibson	Biokinetics & Associates Ltd. Ottawa, Canada
Don Gilbert	Insurance Corporation of British Columbia Vancouver, Canada

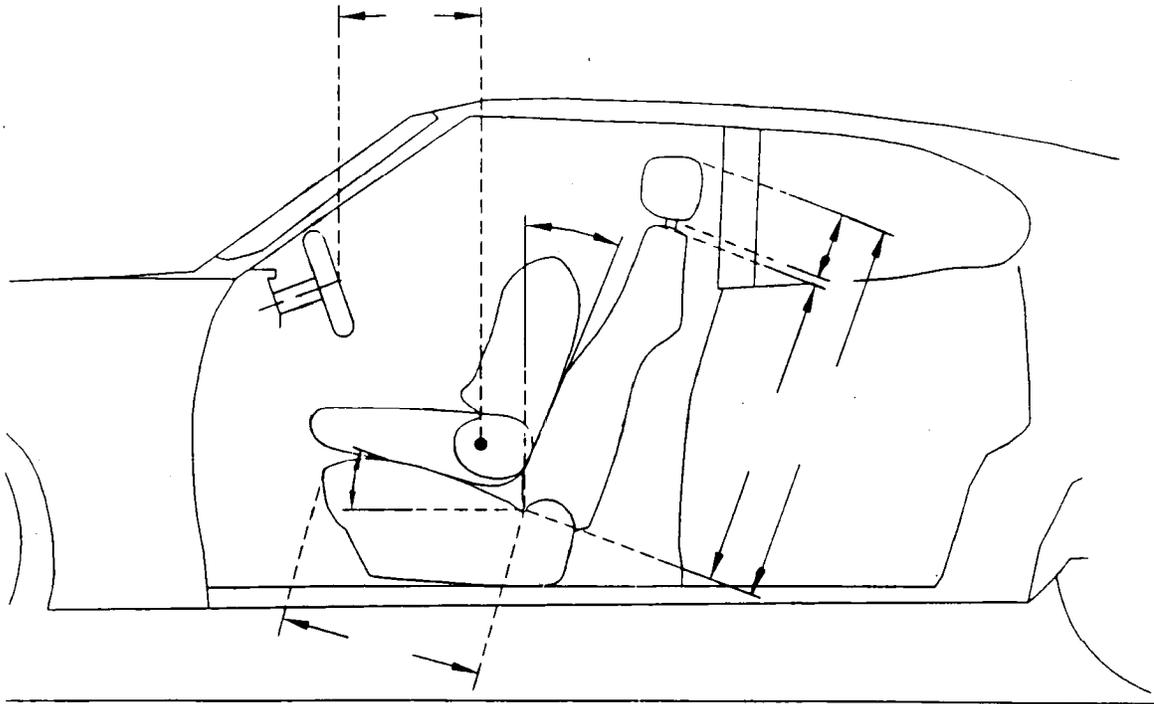
Photographs were then taken of the seated subject from the driver's door opening and around the vehicle at 45° intervals. The photographs were taken "in-line" with the subject's head and at least one lateral photograph (on each side) was taken perpendicular to the vehicle seat back. The position of the subject's head was then measured relative to the top and front surface of the head restraint. The subject's sitting height, thigh length, and the distance from their chest to the steering wheel were also measured. The subject was then asked to get out of their vehicle and the vehicle/seat dimensions as shown in figure 1 were recorded with the help of a 2D H-point template.

Figure 1: Schematic Showing Vehicle/Seat Dimensions Recorded

top of the driver's head and secondly the height from the depressed seat to the top of the head restraint. The H-point template was modified to facilitate seat back angle measurements and measurements to the steering wheel hub. As speed was of the essence, any efforts to reduce the time of documentation were worthwhile.
