Emerging Data Collection Partnerships: FHWA and NHTSA develop the framework for the next generation In-Service Performance Evaluation of Guardrail End Terminals

Paper Number 17-0146

The objective of this paper is to present preliminary results of a novel data collection partnership between FHWA and NHTSA to conduct a pilot In-Service Performance Evaluation (ISPE) of Guardrail End Terminals (GETs). It will discuss source materials developed for the ISPE of GETs; explain the data collection partnership, methodology and status; and introduce sample cases.

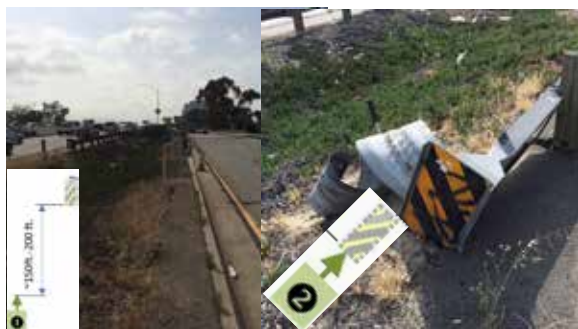
Figure 1 provides the first contrast of traditional (left) and targeted data collection (right). Traditionally, crashworthiness data sets offered images providing environmental context. For this reason, photo location 1 documents the approach to the damaged end terminal, from 150 to 200 feet. Photo location 2, provides a closer view allowing positive identification of the GET. Findings:

- positive identification of butt-weld, indicative of an ET-PLUS with a five-inch channel.
- the kink appears to have been induced by moving the rail off the roadway and not by the impact event.

Figure 1. Traditional Photo Location 1 (left) and Targeted Photo Location 2 (right)

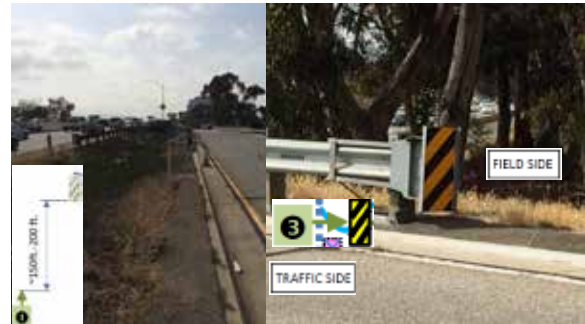
Figure 2 provides a supplemental positive head identification, from photo location 3 on the traffic side. This view also provides the context for guardrail, within the crash environment. Images are only taken if either the lane has been closed or the data collector has been cleared to safely enter the active travel lane. This view can be helpful for highly deformed GETs, as a comparison with Figure 1. Although Figure 2 shows a repaired end terminal, this image is used primarily to

illustrate a photo taken from location 3. In most cases this would show a damaged end.

Figure 2. Traditional Photo Location 1 (left) and Targeted Photo Location 3 (right)

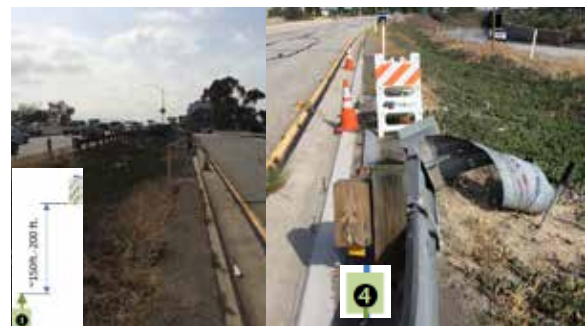
Figure 3 provides the back view of the GET taken from photo location 4. Findings:

- appears post 2 performed as intended.
- probable low speed impact, with extrusion of less than 1 panel length.
- device may have been moved from traffic side to field side by maintenance forces.

Figure 3. Traditional Photo Location 1 (left) and Targeted Photo Location 4 (right)

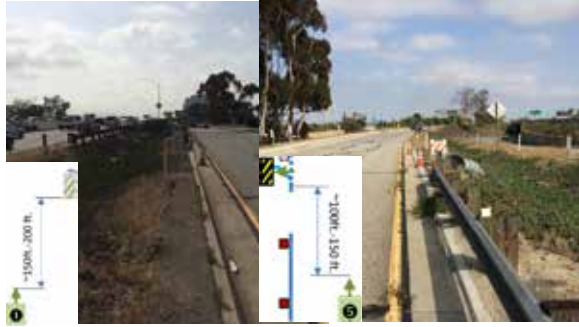
Figure 4 provides a look back toward the guardrail end terminal, from photo location 5 at 100 to 150 feet away. Photo location 5 complements the approach context, initially seen in photo location 1.

Figure 4. Traditional Photo Location 1 (left) and Targeted Photo Location 5 (right)

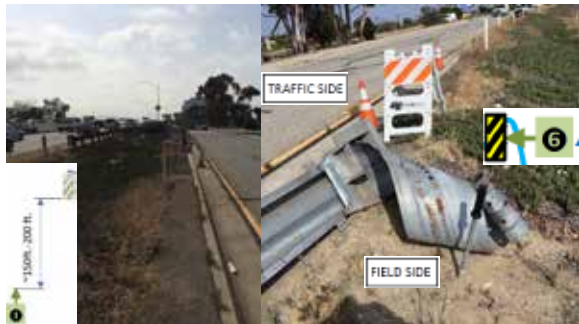
Figure 5 shows adjacent terminal displacement with length of need displacement behind guardrail. This is taken from photo location 6, on the field side looking toward the traffic side. Findings:

- no unusual folds or tears in the ribbon.
- condition suggests no existing damage to w-beam before impact event.

Figure 5. Traditional Photo Location 1 (left) and Targeted Photo Location 6 (right)

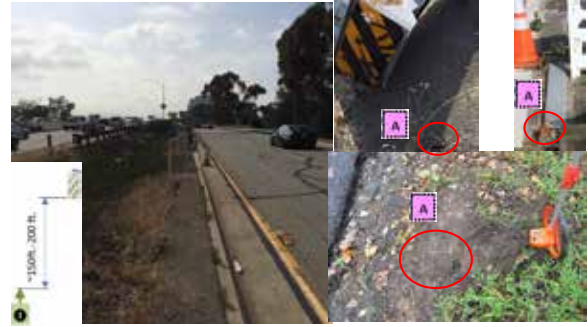
Figure 6 provides multiple examples of post damage captured above the location. Images of posts remaining in place are also instructive. The lower left image uses a measuring wheel to highlight location of post hole.

Figure 6. Traditional Photo Location 1 (left) and Targeted Photo Location A (right)
