COLLISIONS BETWEEN CARS AND UNPROTECTED ROAD USERS - IS THERE MORE TO ADDRESS THAN THE FRONT OF THE CAR?

German Insurers Accident Research

Paper Number 17-0359

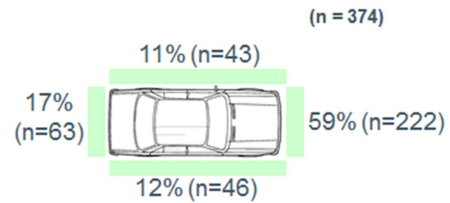
Figure 1 shows the frequencies of different initial contact point locations (impact location) on cars in collisions with pedestrians. It reveals that collisions with the side of a vehicle (side impacts) are the second most frequent type at 23%. Collisions with the left and right side of the vehicle occur with similar frequency, but a significant proportion of collisions (17%) occur at the rear end of the vehicle (rear impacts).

Figure 1: Distribution of impact locations on the car (initial impact at the car) in collisions between cars and pedestrians

As figure 1 shows, collisions between a pedestrian and the left- or right-hand side of a vehicle accounted for 23% of the accidents. There is no significant difference in the number of cases involving the left and right sides of vehicles. Children aged 12 or younger were involved in twice as many collisions with the right-hand side (in 11 cases, accounting for 24% of all accidents) as with the left-hand side (5 cases, amounting to 12% of the total). In 25 of the 89 cases (28%), the pedestrian had contact with one of the vehicle's wing mirrors. In over half of these cases (15 out of 25), the pedestrian was hit only by the wing mirror (17% of all side-impact collisions).

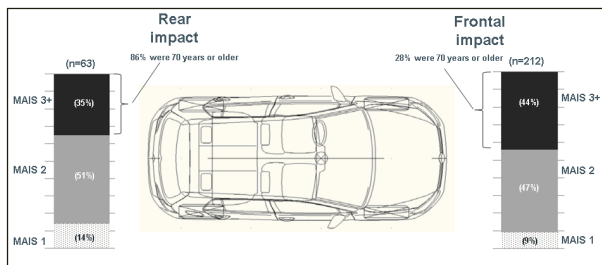
If you compare only the seriously injured pedestrians (MAIS 3+) in frontal and rear impacts with each other (figure 2), the percentage for rear impacts (35%) is not much lower than that for frontal impacts (44%). However, it is noteworthy that 86% of the seriously injured pedestrians in rear impacts were at least 70 years of age, compared with 28% for frontal collisions. Although the collision speeds in rear impacts were significantly lower than in frontal impacts, the advanced age and thus greater vulnerability of the injured pedestrians may offer a plausible explanation for this. Further detailed analyses show that two-thirds of the relevant injuries suffered were caused by a secondary impact with the ground. In frontal impacts only 10% of injuries were caused in this way.

Figure 2: Comparison of the severity of pedestrian injuries in rear and frontal impacts

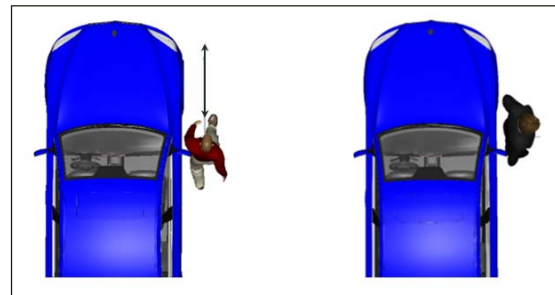
An analysis of the accidents revealed that some of them would not have happened if the cars had been equipped with camera monitor systems instead of wing mirrors (see examples in figure 4). Camera monitor systems will thus help to make the contours of vehicles more pedestrian friendly.

Figure 4: Examples of collisions between a pedestrian and a car's wing mirror (on the left, the pedestrian is walking in the same direction as the car is moving; on the right, the pedestrian is standing with his back to the vehicle as it moves past)

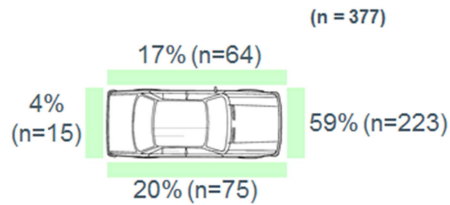
Figure 5 shows the frequencies with which different impact locations on cars are involved in collisions with cyclists. 37% (n=139) of all accidents between cars and cyclists were side-impact collisions (side impacts), whereas rear-end collisions (rear impacts) accounted for only 4% (n=15). It is noteworthy that in 18% of the side impacts (n=25), the cyclist collided with a door that was being opened. These accounted for around 7% of all collisions between cyclists and cars in which the impact location on the car is known (n=377). 24 of these cases occurred on the left-hand side of the car. In 23 of these 24 cases it was the driver's door that was hit. However, as

Figure 5: Distribution of impact locations on the car (initial impact at the car) in collisions between cars and cyclists

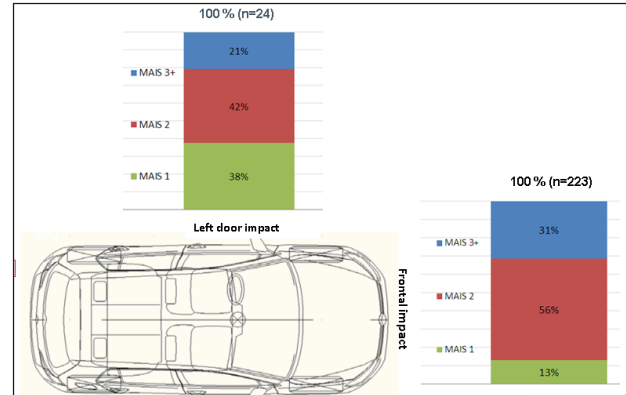
If we compare the severity of the injuries sustained by the cyclists in collisions with the front of a vehicle with that of cyclists who collided with a door, we find a different distribution within the two groups (figure 6). On the one hand it is noticeable that 21% of all injuries sustained in collisions with a car door are MIA 3+ injuries. However, in comparison to that, frontal impacts are more severe as they result in 50% more MAIS 3+ injuries.

Figure 6: Severity of the injuries sustained by cyclists in collisions with the driver's door compared with collisions with the front of a vehicle

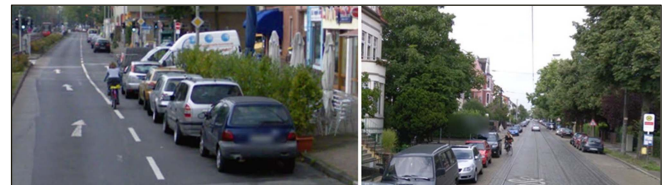
When we look more closely at these 24 cases in which the cyclist collided with the driver's door, it is noteworthy that in 19 cases (79% of the total) the cyclist was riding on the road and attempting to pass the parked vehicle. In most cases in the material studied, there were no separate cycling facilities at the accident location (see examples in figure 7).

Figure 7: Two accident locations in the case material with typical infrastructure

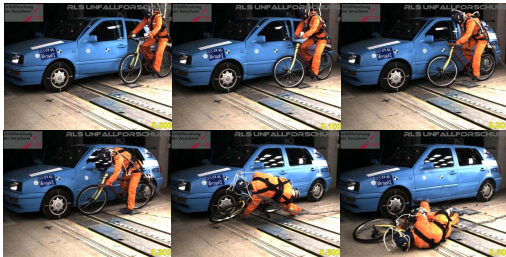
In order to reconstruct the kinematics involved in these collisions, crash tests were carried out in a project of the Department of Motor Vehicles at TU Berlin. A dummy sitting on a bicycle was pulled towards an open car door at a speed of around 14 km/h. The bicycle traveled along a rail until shortly before the collision. The dummy was also released from its guide rail shortly before the collision. The bicycle and dummy were thus able to move freely. The angle at which the car door was opened was varied. The dummy was fitted with measuring equipment. The sequences of images shown in figures 8 to 10 clearly show the effect of the angle at which the car door is open on the kinematics of the cyclist and the final position of the bicycle. The points of impact of the cyclist with the car door essentially explain the injuries to the head

The larger the angle at which the door was open, the shorter the distance the cyclist was thrown, and in this case the final positions of both the cyclist and the bicycle were near the door.

Figure 8: Collision with a driver's door open at an angle of 26.5 degrees and with a small overlap in the handle area of the handlebar

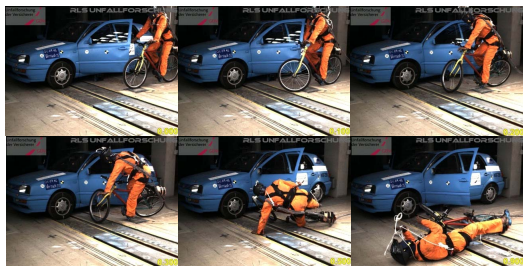
Figure 9: Collision with a driver's door open at an angle of 45 degrees and with a small overlap in the handle area of the handlebar

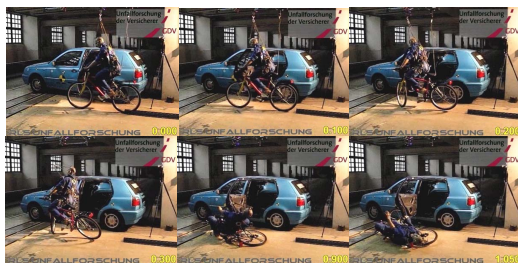
Figure 10: Collision with a driver's door open at an angle of 90 degrees and with an overlap half the length of the handlebar

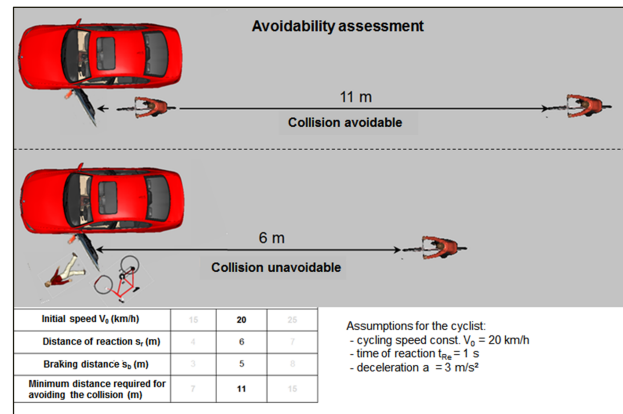
Figure 11 shows an example of the critical times and distances involved as a cyclist approaches a car. Assuming a reaction time of 1 second to recognize the danger (the driver's door opening in this case) and decelerating with 3 m/s², a cyclist traveling at 20 km/h would have to be at least 11 meters from the door in order to avoid an accident. On the other hand, at a distance of 6 meters (i.e. about 3 to 4 meters

from the vehicle's rear end), the cyclist would have no chance of reducing speed and would therefore hit the door virtually without braking.

Figure 11: Simplified avoidability assessment for different distances between a cyclist and a car door, assuming the cyclist sees the open door, immediately initiates an emergency braking and comes to a halt (without crashing)

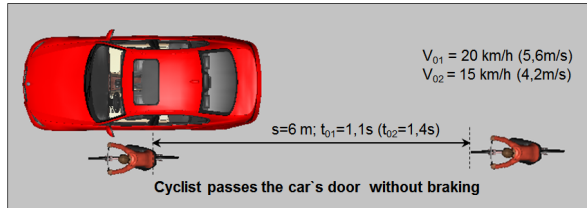
There are already technical solutions available on the market for the door-opening scenario. These warn the driver when vehicles or cyclists are approaching (Audi AG, 2016). Much more promising, however, are systems that prevent the door from being opened in the event of danger. The time period required to allow a cyclist is relatively short, so there is no reason to expect it would be difficult for vehicle occupants to accept this (see figure 12). For example, a cyclist at a

distance of 6 meters from the door traveling at 20 km/h would have passed the car in about 1 second. Even for a slow cyclist (15 km/h), the door would only have to remain blocked for a maximum of 1.4 seconds. It can be assumed that drivers' acceptance of the system would increase once they had experienced its benefits directly.

Figure 12: Theoretical assessment of the time required for a cyclist to pass at the point when the driver intends to open the door

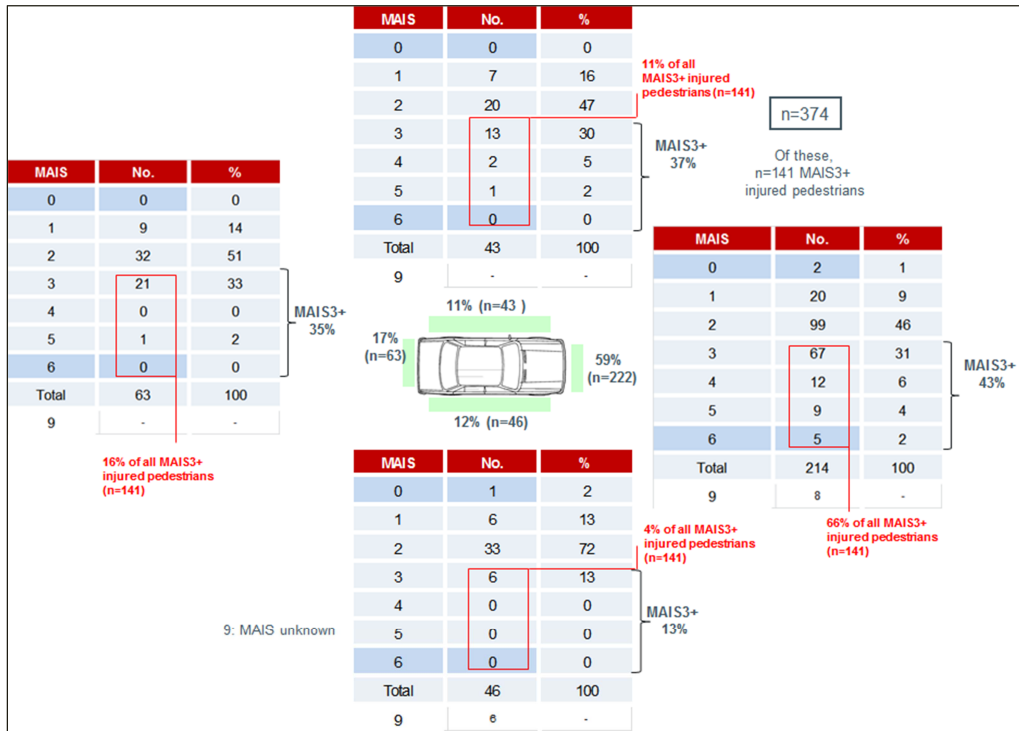
Annex 1 : Injury severity by impact location on the car in collisions with pedestrians

With regard to the severity of the injuries sustained in collisions between pedestrians and vehicles, annex 1 shows that 43% of injured pedestrians suffered a MAIS 3+ injury in frontal collisions. These accounted for 66% of all pedestrians with MAIS 3+ injuries in the accident material. If we look at collisions with the rear end of vehicles, we see that 35% of the injured pedestrians sustained MAIS 3+ injuries. These accounted for 16% of all pedestrians with MAIS 3+ injuries. Collisions with the sides of vehicles came just behind. 15% of all pedestrians with MAIS 3+ injuries sustained them in this type of impact.

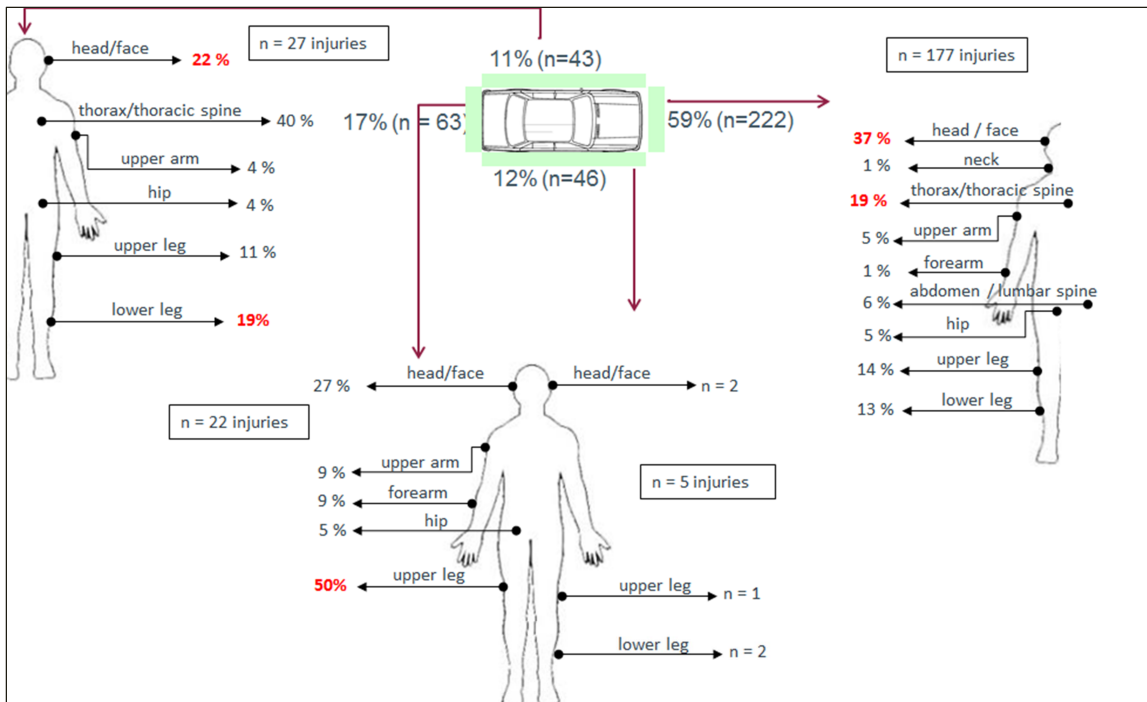
Annex 2 : AIS 3+ pedestrian injuries by regions of the body and impact location on the car

If we look more closely at the injuries of pedestrians in collisions with the rear end of cars annex 2, we see that 50% of AIS3+ injuries were upper leg injuries. Head injuries were also frequent, accounting for 27%.

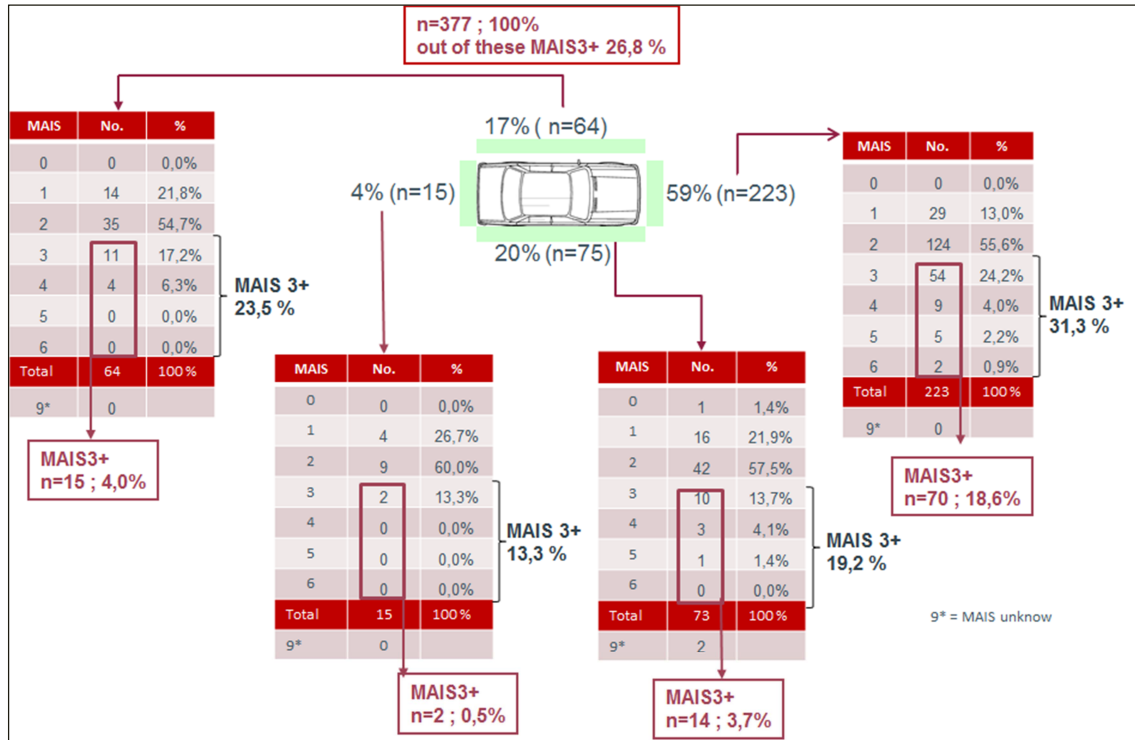
Annex 3 : Severity of cyclists' injuries by impact location on the vehicle by regions of the body and impact location on the car

When we look at injury severity by impact location on the car, we see that, as with pedestrians, the front of the vehicle dominates (annex 3). In frontal impacts 31% of the injured cyclists sustained MAIS 3+ injuries. These accounted for 69% of all cyclists with MAIS 3+ injuries in the accident material. Collisions with the sides of vehicles came next. In collisions with the left-hand side of the car, 24% of cyclists sustained serious injuries (MAIS 3+), and in collisions with the right-hand side, it was 19%. In rear impacts, 13% of the cyclists were seriously injured.

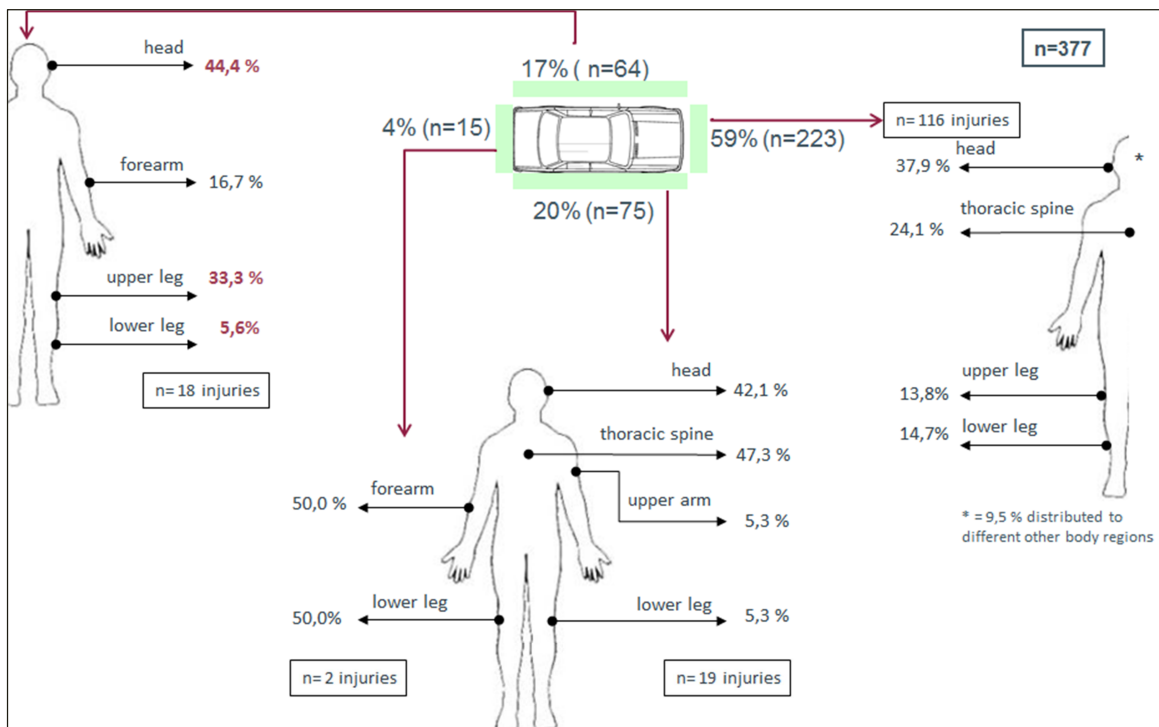
Annex 4 : AIS3+ injuries of the cyclists by impact location on the vehicle

When we look more closely at collisions with the left-hand side of the vehicle, we see that 44% of the serious injuries were head injuries. Around 39% of the serious injuries were to the lower extremities. Annex 4 provides an overview of the injuries sustained by impact location on the vehicle.

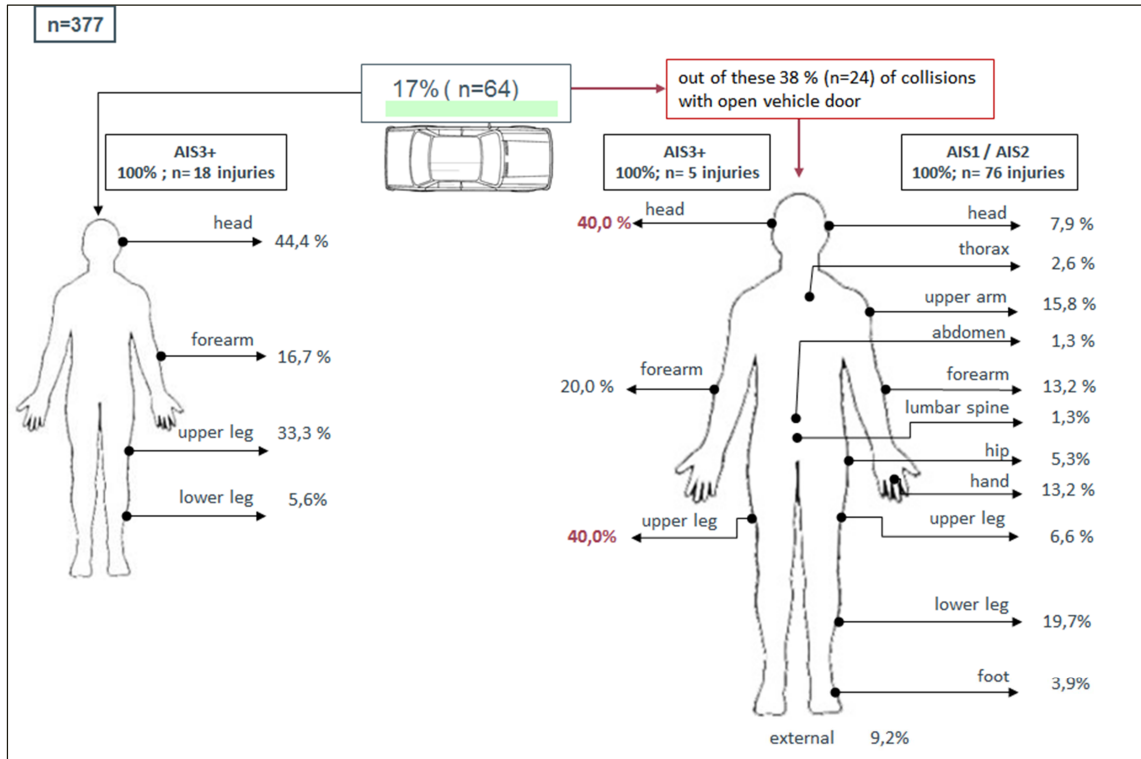
Annex 5 : Severity of the injuries sustained by the cyclists to different regions of the body in collisions with the driver's door

Collisions of a cyclist with a car door that was being opened were found to have happened almost exclusively on the left-hand side of the vehicle, indicating a need for further analysis of this accident constellation. Annex 5 shows the injuries of the cyclists in these situations by region of the body.

and extremities derived from the accident data and shown in annex 5.
