COMPARISON OF EURONCAP ASSESSMENTS WITH INJURY CAUSATION IN ACCIDENTS

Adrian Fails and Roy Minton

TRL Limited

Document Number 319

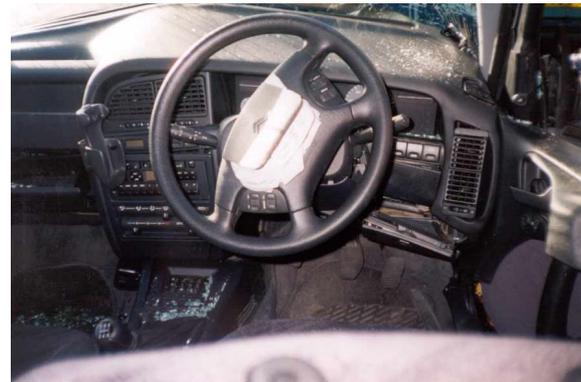
The Volkswagen Polo steering wheel moved only in the more severe of the two cases studied, but upwards by the same amount as that in the EuroNCAP tested car. In the BMW 3 series, EuroNCAP noted steering wheel movement as an important feature and displacement was observed in a case-study impact of considerably lower severity. Similarly, the Citroën Xantia from CCIS demonstrated displacement of the steering wheel at a much lower impact severity. The direction and amount of displacement differed from the test results, but residual displacement highlighted by EuroNCAP is evident in the real crash. Figure 1 shows the movement of the Xantia's steering wheel.

Figure 1. Xantia steering wheel, showing inboard and upward movement.

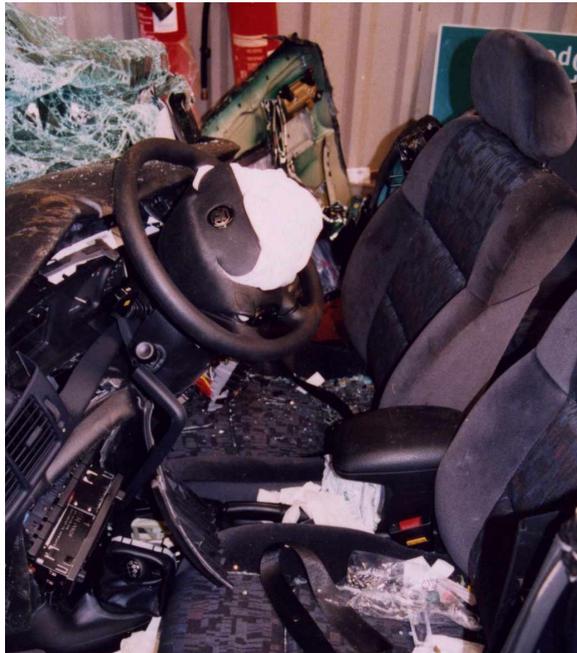
The most severely impacted Vauxhall Vectra led to an injurious contact of the driver’s chest and abdomen with the steering wheel. This driver suffered AIS4 injuries to the chest. These were a tear of the thoracic aorta, bilateral haemothorax and multiple contusions to both lungs. Although seat belt loading will have been significant for this occupant, contact with the steering wheel was clearly severe. EuroNCAP does not rate the abdomen in frontal impacts, and the steering wheel is unlikely to make injurious contact with the abdomen of a restrained driver except in a case such as this rare one.

Figure 2. Damage to Vectra steering wheel rim, due to loading from contact with driver’s chest.

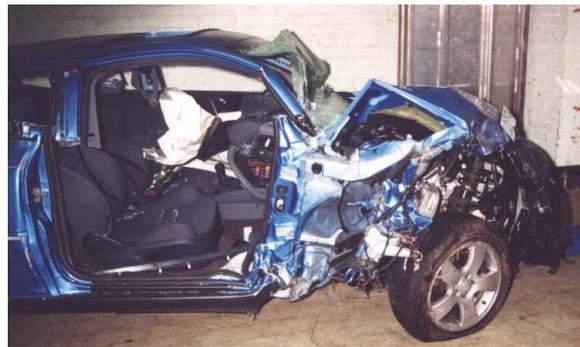
Intrusion of the fascia to some extent was present a large proportion of the EuroNCAP tests for the models studied here. Notable exceptions were the Volkswagen Polo, Vauxhall Vectra, Audi A3 and Renault Megane. Apart from the one catastrophically damaged Vectra, fascia intrusion was not observed as a problem for the drivers of the cars in this list and there was little or no intrusion of the fascia that was considered hazardous to the chest. The Polo and Megane impacts were of lower severity and higher overlap than the EuroNCAP test, and no conclusion can be drawn as to how well the fascia would be controlled in a more severe impact. The Audi A3 did suffer 210 to 260mm of intrusion of the driver’s fascia, however this was a severe impact in which there was only 27 percent overlap with the other car.

Figure 3. Audi A3 showing fascia intrusion in a low overlap impact.

The driver of the Audi was a 35 year old male of 1.80m stature and 89kg mass. Restrained by seat belt and airbag, he suffered only AIS1 injuries in this impact. Along with strain injury to the cervical and lower thoracic spinal regions, he had a right shoulder abrasion from the seat belt, and a laceration to the tongue from biting it at some stage in the impact. There were no injuries to the driver's chest, and the evidence for loading of the upper body is limited to the shoulder abrasion which was undoubtedly caused by the restraint system.

EuroNCAP has concerns over the driver's legs in the Audi A3, however in the single A3 in this sample, 260mm intrusion of the fascia at knee level resulted in no knee injury (Figure 3).

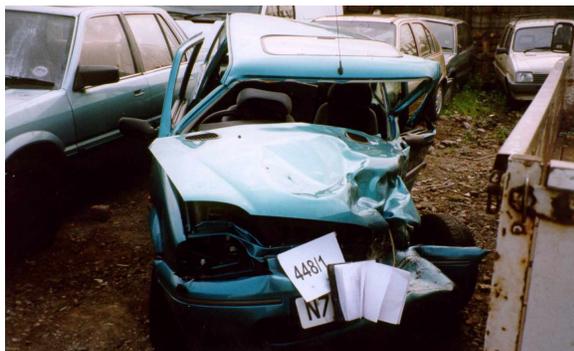
This failure of the passenger compartment structure is most clearly demonstrated in the two Rover 100 cases. Although both of these impacts were biased to the passenger's side rather than the driver's side, each had an overlap of approximately 65 percent and a severity comparable to the EuroNCAP test. These cases were remarkable in that the injury severity in each Rover was low. The driver of the car in Figure 4 escaped with small lacerations, while her male front seat passenger was uninjured. The Rover's nearside longitudinal was crushed and bent. There was no energy-absorbing crush of the offside longitudinal, which bent inwards. This bending to the nearside was evident in the roof, as the nearside A-pillar translated backwards and pulled the roof down and across towards the nearside. The passenger door buckled, and split apart in a similar pattern of damage as that seen in the EuroNCAP test car's driver's door.

Figure 4. Rover 100 compartment failure.

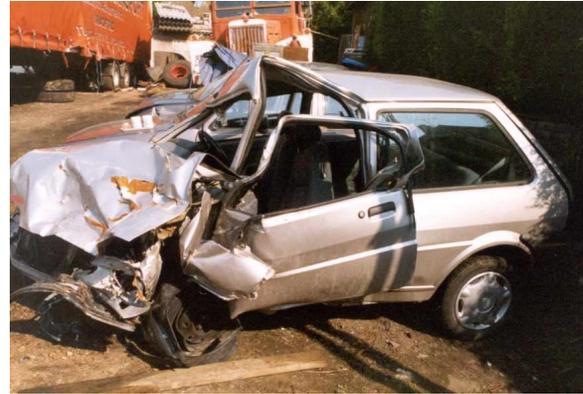
Figure 5. Rover 100, showing passenger compartment failure.

The driver of the Rover in Figure 5 also survived with very minor injuries. There was no front seat passenger. This vehicle shows damage very similar to the previous Rover 100 case. Almost all of the Rover's impact energy was absorbed on the passenger side of the car and the offside longitudinal was bent inboard without any crushing.

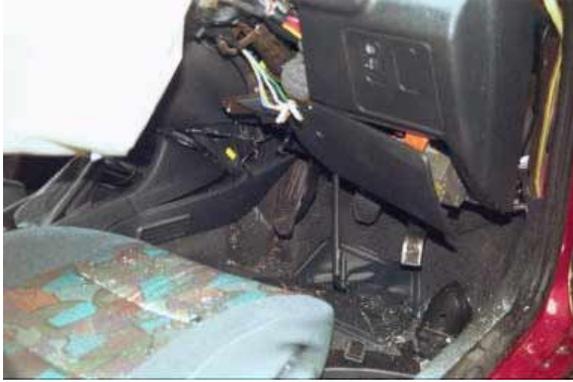
Of the seven Peugeot 306s, one in particular showed several serious injuries. This was a severe impact, and the restraint loading fractured the driver's clavicle. Of note in this context is that the restrained driver suffered a fracture of the right femur from contact with the steering column and its shroud.

Figure 6. Peugeot 306 steering column & shroud, showing right knee contact area.

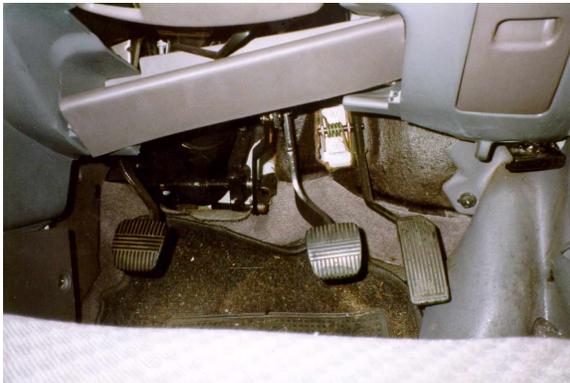
Both of the Nissan Micras in the sample caused AIS1 injuries to their drivers' knees. The first case saw right knee injury from the fascia, and laceration of the left knee from contacting a bracket behind the fascia. (Figure 7) In the second Micra, the right knee suffered a penetrative AIS1 injury from contact with the fascia and the broken steering column cover.

Figure 7. Nissan Micra, showing disruption of lower fascia.

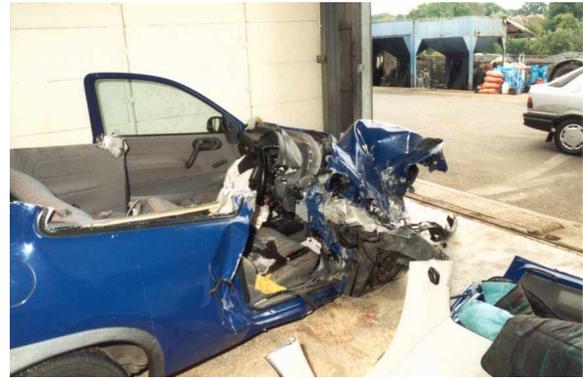
Three of the six Corsas showed some knee interaction with the fascia. There was an AIS1 right knee injury to the driver in the first case from contact with the fuse box cover, and bilateral AIS1 knee injuries were suffered by the driver of the second case (the fuse box was again implicated). The fatally injured driver in the third case had an AIS2 fracture in the left knee region from the intruding fascia, with a more serious right knee contact related to fractures of the femur, tibia and fibula. This Corsa (Figure 8 and 9) had severe fascia intrusion in the driver's knee area and, although the impact was with a heavy goods vehicle, both longitudinals were involved so this should not be discounted by regarding it as an under-run case.

Figure 8. Vauxhall Corsa showing overall damage.

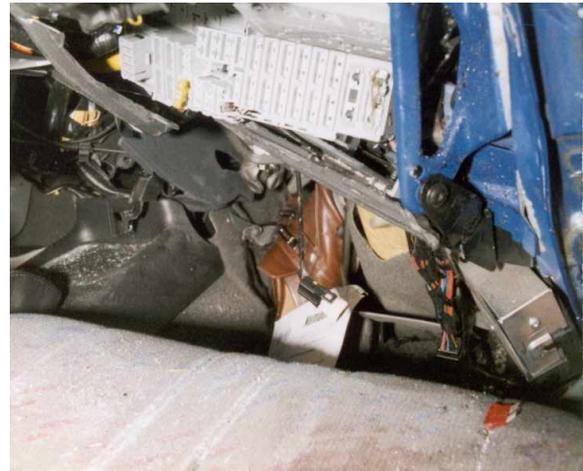
Figure 9. Vauxhall Corsa showing disruption of lower fascia and fuse box.

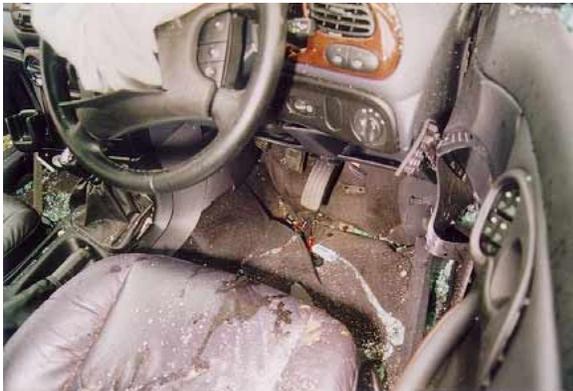
In one of the eight Mondeos, there was a recorded upward pedal movement of 160mm. This is twice the amount of movement set as EuroNCAP's limit. In this case the driver suffered a fracture of the right ankle, which may have been due to loading of the foot by the pedal (had the foot been on that pedal at impact) or possibly by the associated footwell intrusion. Whichever mechanism caused the ankle injury, the vertical movement of the brake pedal in this case did not result in any injury to the proximal portion of the lower leg. Another of the Mondeos highlighted a comminuted fracture of the 44 year old female passenger's heel. Clearly no pedal movement was associated with this, but there was no footwell intrusion here either.

Figure 10. Ford Mondeo – upward movement of pedals.

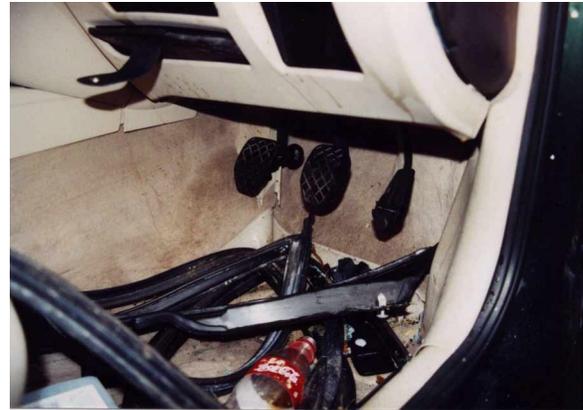
The case study Audi A4 suffered 80mm of footwell intrusion on the passenger side (to which the overlap was biased) but no injury was caused to the passenger as a result of this. Similarly there were no injuries below the knees of the driver of the case study Passat. There was no intrusion of the footwell, and the 34 year old male driver's only serious injury was a fractured sternum from belt loading. He was close to median stature and mass, at 1.78m and 79kg.

Figure 11. Volkswagen Passat footwell, showing no intrusion.

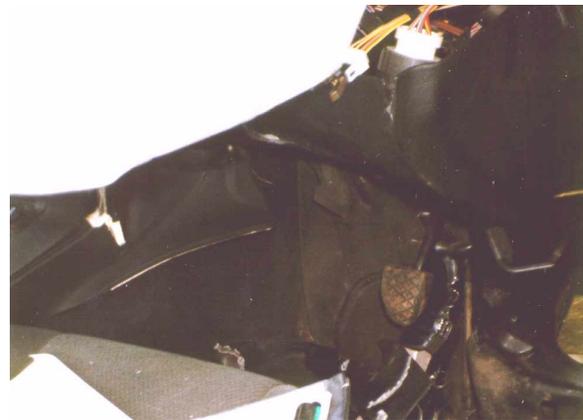
In the BMW 3-series case study a fracture of the driver's left medial malleolus (AIS2) was caused by entrapment of the ankle between disrupted pedals, however upward motion of these was not evident. There was also an AIS3 comminuted intra-articular spiral fracture of the lower left tibia.

Figure 12. BMW 318i footwell with disrupted pedals.

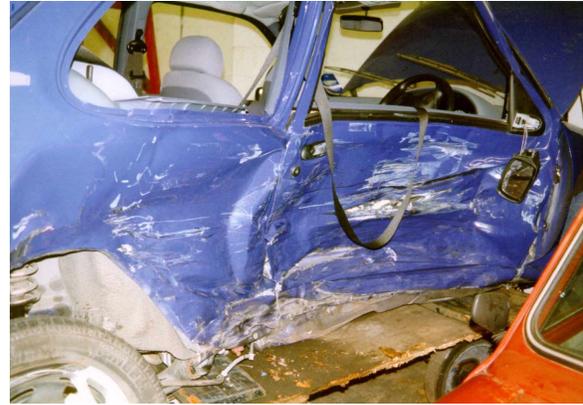
One of the three Fiesta case studies illustrates a pattern of injuries that is a clear example of serious injury having occurred to both the head and the thorax. In this case, which was of similar severity to the test, the driver suffered a head impact directly with the impacting vehicle. There was no evidence that her head hit the B-pillar, but her head did make violent contact with the headlamp area of the intruding car, causing a fracture of the base of her skull and partial transection of the brain stem. Figure 13 shows the Fiesta.

Figure 13. Side impacted Fiesta, in which the driver suffered an AIS6 head injury.

This mechanism of head injury is patently not confined to this one model, nor does its occurrence in this case indicate that any particular model’s safety rating relative to its peers is flawed. It would clearly be unsupportable to suggest that this evidence relates to any one model in particular. Rather, it applies to all cases in which the head exits the perimeter of the vehicle.

Based on the conclusions of wider analysis, this is a valuable case to illustrate that prevention of contact with the B-pillar is not sufficient to afford protection to the head in this type of impact.

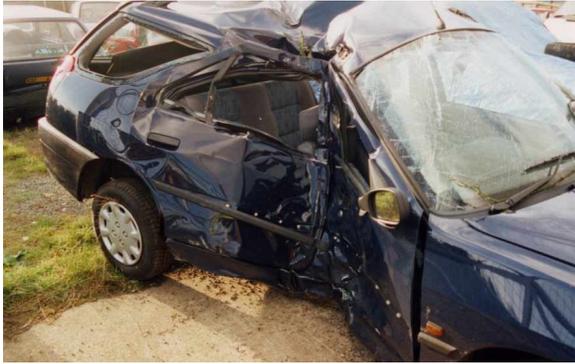
In this impact, the Peugeot struck a tree, but this was directly on the B-Pillar area, and was a severe impact. Although leaving a maximum crush of 730mm, the impact was not aligned such that the driver’s head was brought into direct contact with an intruding object. This separates this case from the issues described in the previous section and allows comparison of the overall distribution of injury to the struck side occupant. The driver of this car was killed, but the pelvis and head were uninjured in the impact. The injury to the aorta is indicative of a very high thoracic acceleration. However, even without this injury to the main artery of the body, the thorax showed severe injury to the lungs and serious rib cage injury.

Contact with the B-pillar was the cause of the fracture of the right clavicle. This indicates that the shoulder was impacted by the intruding B-pillar (supported by the tree) but that the head was not impacted in this way. Had it been contacted here, there would have been a very great likelihood of serious head injury.

Figure 14 Pole-impacted Peugeot 306, in which the injury pattern matched EuroNCAP's side impact assessment.
