OLD CAR CRASH TEST PROGRAM

Paper Number 147

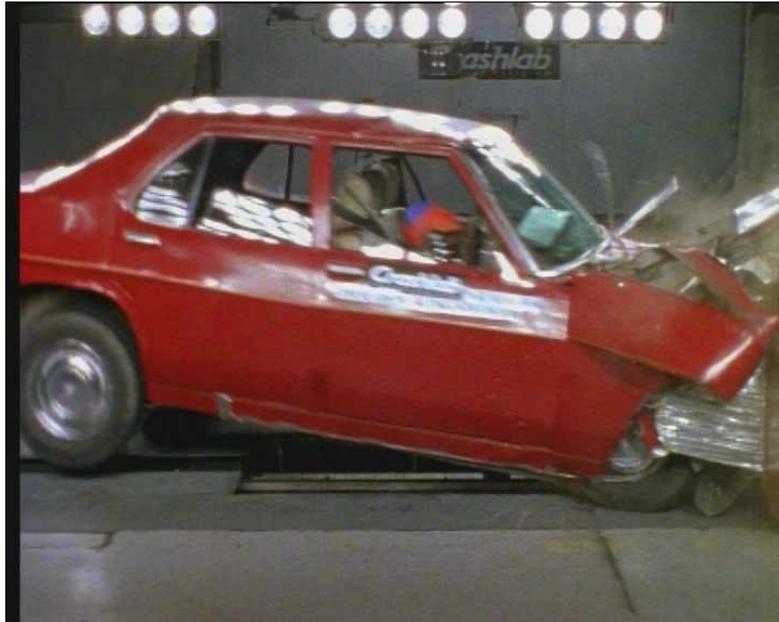
1977 Holden Kingswood offset crash test at 64 kmh⁻¹

The seat belt broke during the Kingswood crash test, contributing to the poor protection from serious head injury for the driver. This could be expected on a number of vehicles of this age in normal use. The passenger compartment held its shape well, but with substantial intrusion into the driver's footwell.

The front part of the driver's floor was pushed substantially rearward and the firewall ruptured. The brake pedal moved up and the accelerator pedal broke off. The dash buckled and moved towards the driver, while the instrument panel was forced downwards. The steering wheel broke away from the steering column. The steering column brackets fractured allowing the steering column to come away from the dash. The roof buckled slightly, though the front pillar on the driver's side appeared to be intact. The width of the driver's doorway did not shorten and the driver door did not buckle. All doors remained closed during the crash.

Seat belt failure meant poor restraint system performance. The seat belt broke across the lap section. The chin, nose, left cheek and the top of the dummy's head hit the steering wheel. The back of the head hit the head restraint of the seat on rebound. The driver's knees and shins were severely impacted on the broken dash and steering column, suggesting serious lower leg injury. The left foot appeared to be caught between the fallen dash and the buckled floor. The driver was wedged between the seat and the steering wheel and dash.

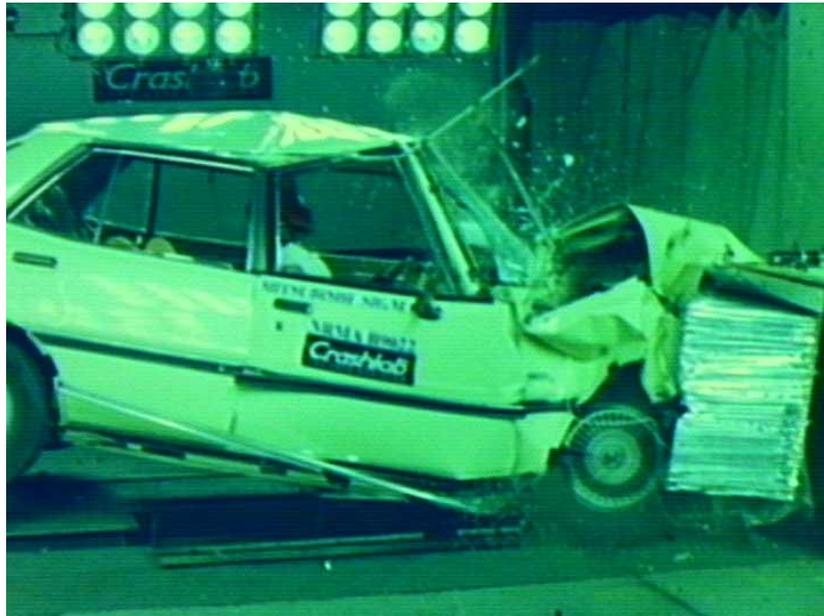
1977 Mitsubishi Sigma offset crash test at 64 kmh⁻¹

The Sigma's passenger compartment held its shape very well and there was only moderate deformation of the driver's footwell. There was marginal protection for the driver's head and the Mitsubishi Sigma received a poor overall evaluation.

The front part of the driver's floor moved slightly rearward. The brake pedal moved up towards the driver. The dash remained reasonably intact, but the instrument panel broke due to the steering column collapsing and caused the plastic casing to come into contact with the driver during the crash. The steering wheel was bent and the steering column dropped onto the dummy's legs. The front pillar on the driver's side remained straight even though the roof buckled considerably. The width of the driver's doorway shortened by around 40cm and this door buckled slightly, causing a strip of metal to protrude into the driver's compartment which could have caused further injury. All doors remained closed during the crash.

The driver's face (chin and forehead) made severe impact with the steering wheel and the back of the driver's head hit the head restraint. The driver's left leg hit the steering column and the gear stick. The back of the driver's seat collapsed, moved forward and then remained in the reclined position after the crash. The large movement of the driver's seat could have caused serious neck injury.

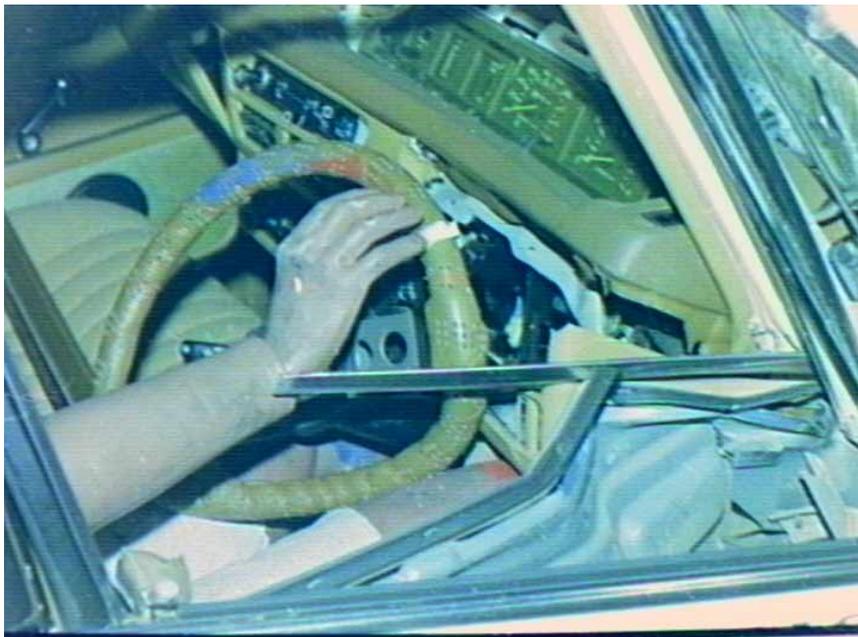
Interior of 1977 Mitsubishi Sigma after offset crash test at 64 km⁻¹ showing separation of the steering column from its brackets
