# PERFORMANCE OF THE PROTOTYPE WORLDSID DUMMY IN SIDE IMPACT CRASH TESTS

**Martin Page**

Paper number 482

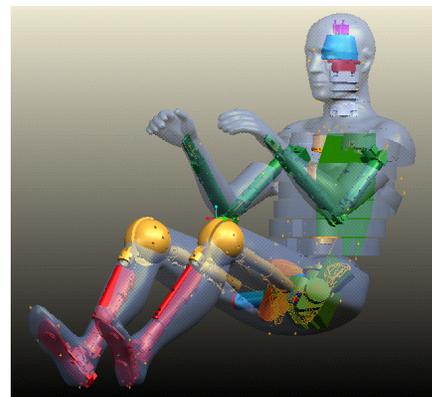
**FIGURE 1** CAD image of the WorldSID prototype dummy

The WorldSID prototype dummy (see FIGURE 1 and FIGURE 2) is representative of a mid-size male with an overall mass of 77.3 kg and a stature of 1753 mm. Its anthropometry is based on a study carried out expressly for the automobile occupant[3], having first checked this data against all known pertinent data sources for the world population [4].

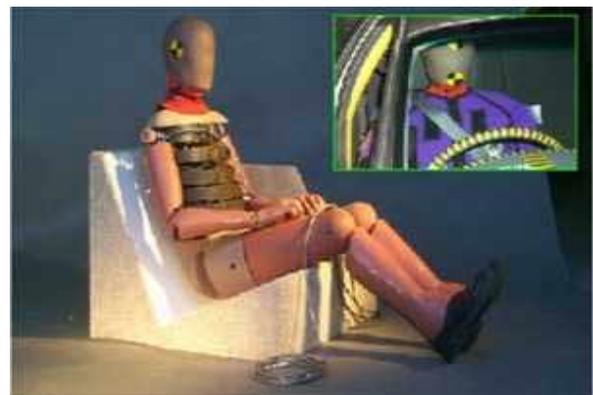
FIGURE 2 The WorldSID prototype dummy.

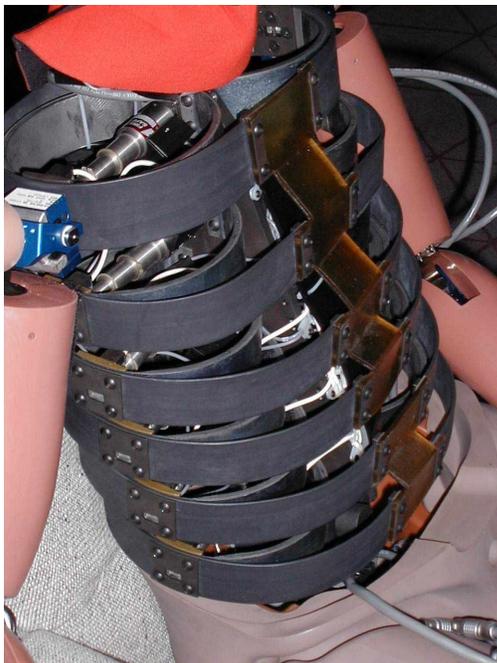
**FIGURE 3 View of the WorldSID prototype shoulder, thorax and abdomen ribs**

The head is made up of a one-piece polyurethane skull, with bonded skin, which fits over a central instrumentation core. The neck is of similar design to that of the ES-2 dummy and is adjusted to give a biofidelic response in flexion and extension in addition to its lateral biofidelity. The thorax is composed of three Nitinol® super elastic alloy ribs (see FIGURE 3). Each rib consists of an outer band and a secondary inner band which contributes to giving the thorax a biofidelic response. Two abdominal ribs and a shoulder rib, all of a similar design to that of the thorax, bring the total number of ribs to six. The pelvis (see FIGURE 4) is a totally new concept which includes a polymer pelvic bone incorporating the form of the pelvic girdle and giving humanlike flexibility of the pelvis structure. The lumbar spine (see FIGURE 5) is a radically new design allowing de-coupling of the thorax and pelvis segments to be achieved. The lower extremities have been developed expressly for the WorldSID dummy and include purpose-designed, instrumented side impact knees (see FIGURE 6) and integrated shoes.

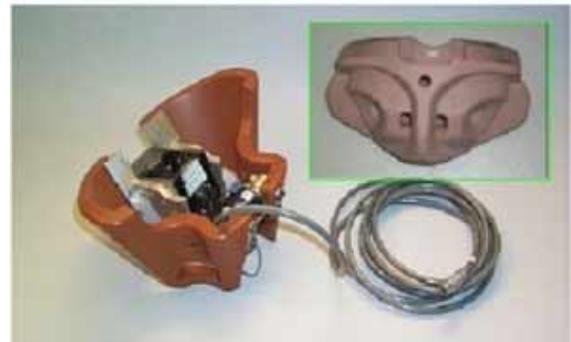
**FIGURE 4 Pelvic structure and pelvis flesh (insert).**

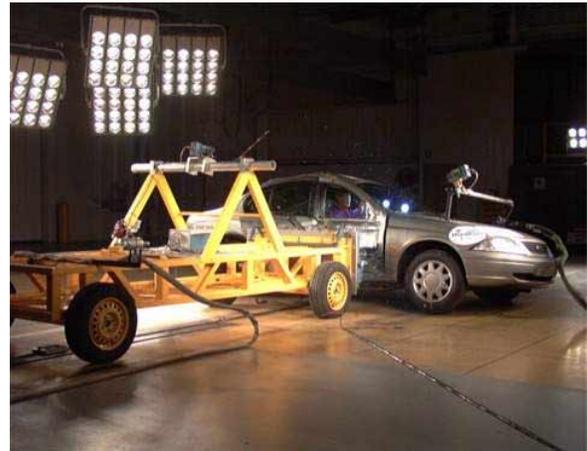
**FIGURE 7 WorldSID barrier test.**

The Falcon is 96/27/EC compliant but no side airbag was fitted. For this test, as for the other tests described below, the dummy was fitted with its optional full arm, fully instrumented on the struck side. The decision to fit this arm, rather than the stub arm option, was made in order to verify that the upper extremity instrumentation was functioning correctly. FIGURE 7 shows the impact.

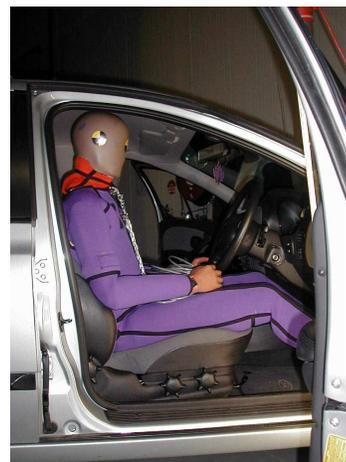
**FIGURE 8 WorldSID dummy seated in Falcon prior to final positioning.**

The dummy, dressed in its standard suit (see FIGURE 8), was positioned using the draft procedure developed by the Design Team specifically for this dummy. The seat was positioned at the mid-point of the rail and the back rest was set to 20°. The test was run without glazing in the driver's door window. FIGURE 9 shows the car after the barrier test.

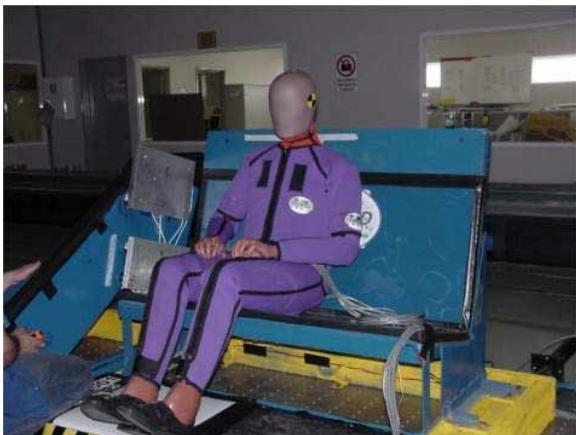
**FIGURE 10 WorldSID on sled.**

The two identical sled tests were based on thorax test 5 and pelvis test 7 of the ISO TR 9790. The rig for this type of test consists of a rigid, bench-type seat at one end of which is a rigid, vertical wall (see FIGURE 10). Two rectangular load plates are mounted on this wall via load cells, one at each corner of each plate. When the sled is subjected to a deceleration, the dummy slides along the bench, into the load plates as shown in FIGURE 11.

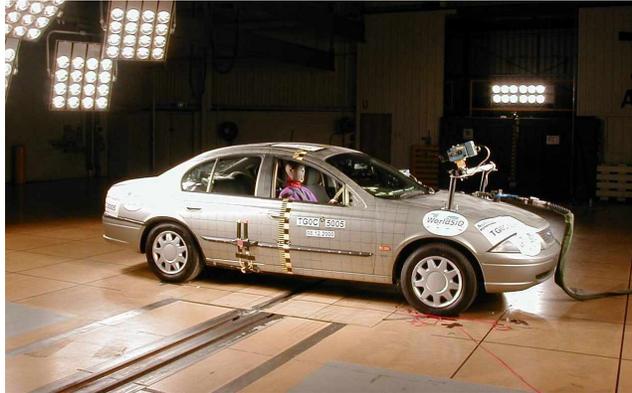
**FIGURE 12 Dummy in Falcon prior to impact**

For this test, the stationary struck car was a Falcon identical to the one used in the previous MDB test (see FIGURE 12). The test configuration was also

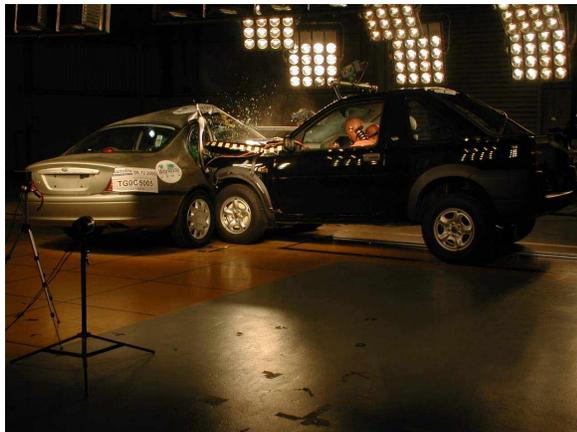
**FIGURE 13 Falcon with WorldSID impacted by the Freelander.**

The dummy was positioned again in the same manner and in the driver position. Once again, the instrumented full arm was used. The centre axis of the striking car was aimed at the R-point position of the struck car. The test was run without glazing in the struck car driver's door window. The test is shown in FIGURE 13 and a view of the vehicles after impact is shown in FIGURE 14.

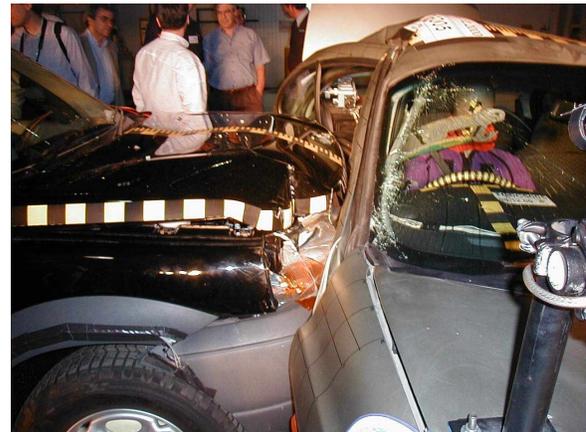
**FIGURE 14 Falcon and Freelander post test.**
