## A STUDY OF NASS ROLLOVER CASES AND THE IMPLICATION FOR FEDERAL REGULATION

Paper Number 05-0415

### ABSTRACT

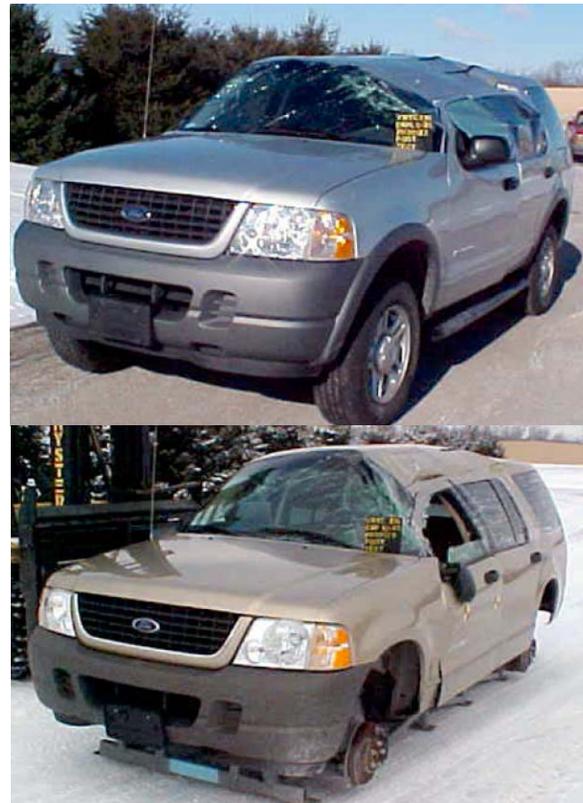
**Figure 1. The NHTSA test vehicles: at 5° pitch and 25° roll at top and at 10° pitch and 45° roll at bottom. The damage is similar only in that the damaged roof's contour follows the shape and angle of the platen used in the test.**

We disagree substantially with these conclusions based on the test results themselves. These tests produced residual crush that was different from that observed in real-world rollovers in NASS (see Figure 1), for example, and that were somewhat different from each other reflecting the angle at which the platen was forced into the roof (note particularly the differences in A and B pillar damage). The force on each hydraulic ram used to press the platen into the roof was separately recorded, and the force displacement curves in these two cases are substantially different in all three pair of tests.

In each of these NHTSA tests, the roof flattened against the platen rather than collapsing and buckling as is typical of vehicles in dynamic rollovers (See Figure 1). For comparison, we looked at 10 NASS cases involving 2001 and 2002 Explorers with significant rollover roof damage but no complicating factors (four of which are shown in Figure 2). The damage to these roofs was more complex, involving buckling, greater rearward or lateral displacement of the roof panel, and other features. There were three other 2002 Explorer rollovers in NASS, two of which resulted in little or no roof damage, and one of which was catastrophic.

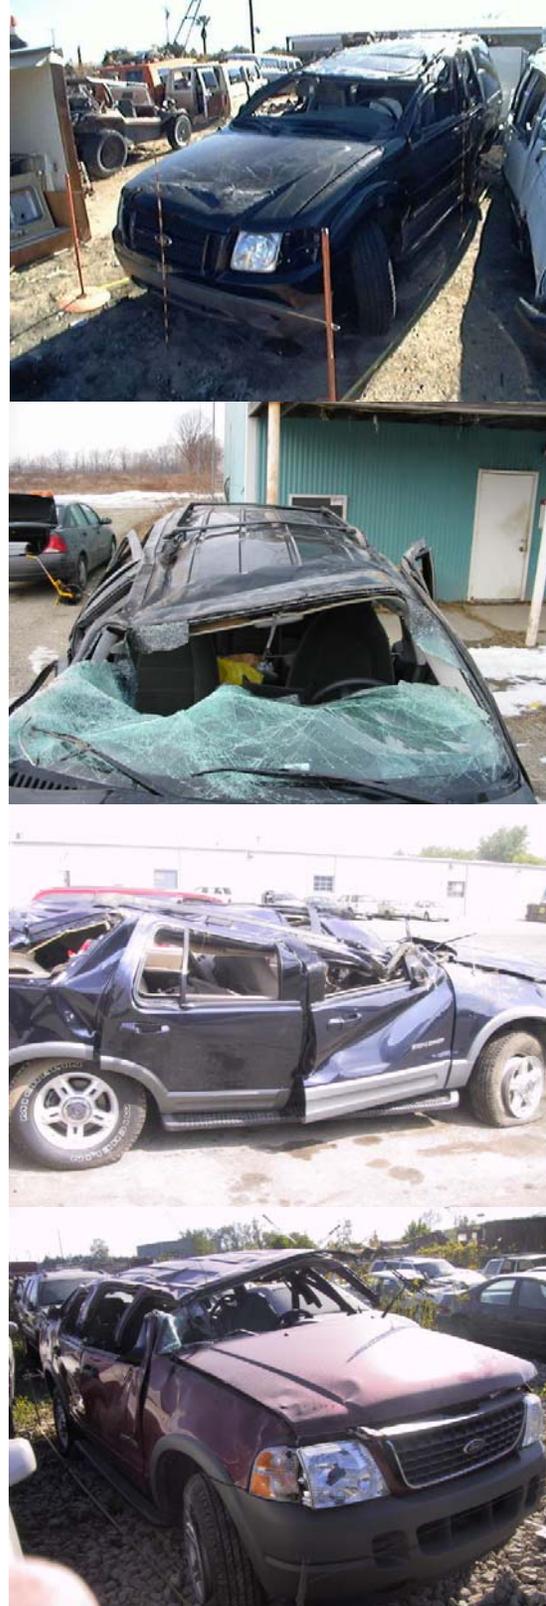
**Figure 2. Four NASS 2002 Explorer case vehicles (2002-078-143, 2002-12-168, 2002-011-129, and 2001-11-048).**

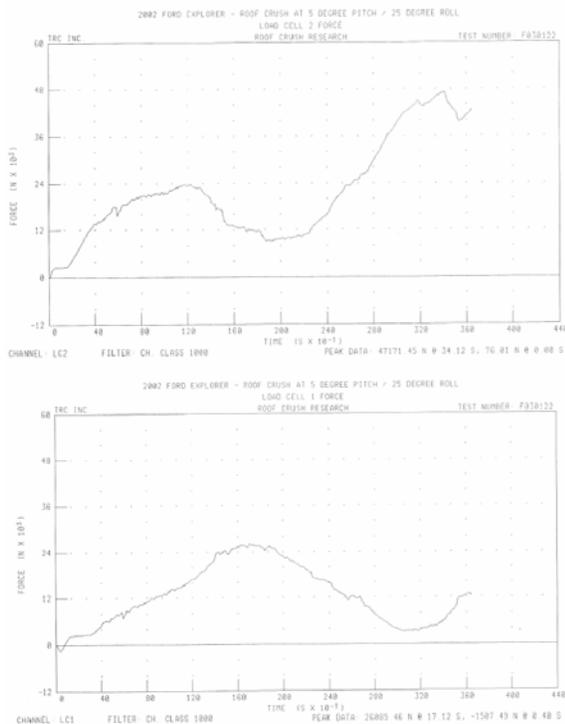
**Figure 3. Curves of Force versus time (which is proportional to displacement) for the 2002 Ford Explorer in NHTSA’s test at 5° pitch and 25° roll under FMVSS 216 test conditions carried out to 254 mm of displacement. The upper curve is the force at the front of the platen while the lower curve is the force at the rear of the platen.**

In the tests of the 2002 Ford Explorer conducted at 5° pitch and 25° roll, failure of the windshield resulted in a substantial reduction in the vehicle's roof crush resistance, as measured by the forward ram (see curve at left side of Figure 3), from a peak at about 85 mm (3.3 inches) displacement of 24,000 N (5,400 pounds) to about 10,000 N (2,250 pounds) at 130 mm (5 inches) displacement. At that point the rear ram was supporting 24,000 N (because the platen was fully engaged with the B pillar and rear roof structure). However, the force on the rear ram went down to less than 4,000 N (900 pounds) after the B and C pillars had failed at about 210 mm (8 inches).

We completely disagree with the conclusion of the NHTSA test engineer that they produced similar results. The tests conducted at 5° pitch, 25° roll show a substantial loss of roof crush resistance after the failure of the windshield, particularly as measured by the forward ram. This behavior is not observed in the 10° pitch and 45° roll test of the Explorer, for example. In the latter tests, virtually all of the resistance to the platen comes from the forward ram. It appears that much of that resistance comes from the lower body, not the roof. The final damage in the two cases reflects the angle of the platen in the test, and is not representative of damage observed in actual rollover accidents.

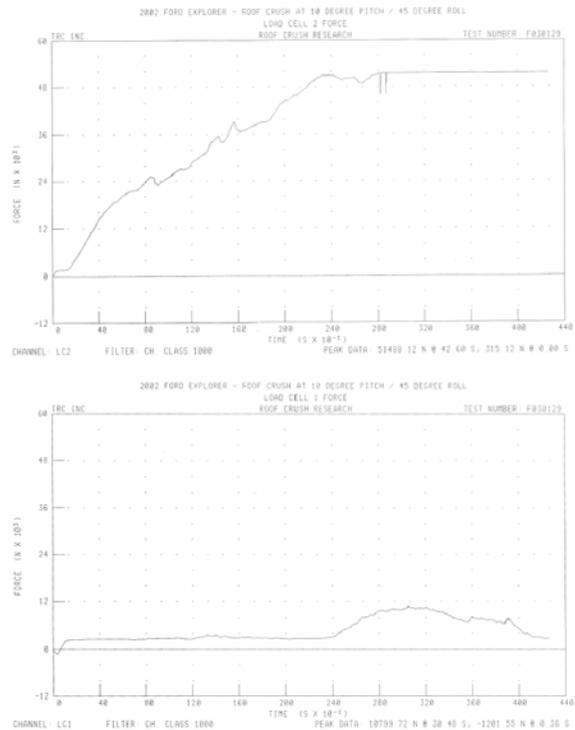
**Figure 4. Curves of Force versus time (which is proportional to displacement) for the 2002 Ford Explorer in NHTSA’s test at 10° pitch and 45° roll under FMVSS 216 test conditions carried out to 254 mm of displacement. The upper curve is the force at the front of the platen while the lower curve is the force at the rear of the platen.**

Because of the roof's tumblehome, the platen in the Explorer 10° pitch and 45° roll test almost immediately engaged the base of the A pillar which conveyed substantial force resistance. Although it is difficult to tell from the photograph (page 30, VRTC report), it also appears that the platen was not properly positioned on the Explorer's roof. The longitudinal centerline of the lower face of the platen is supposed to be located "on the initial point of contact" with the roof, while the photograph makes it appear that it is at least 5 cm below that point. This

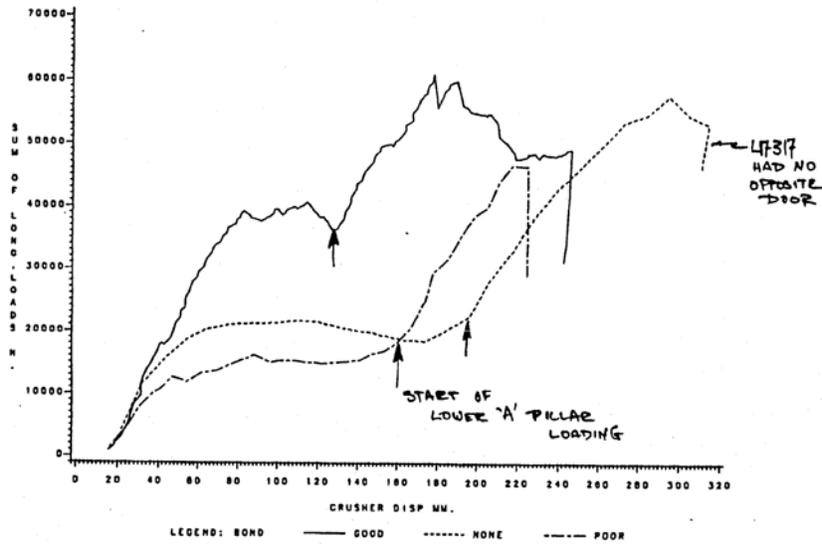
CAB ROOF CRUSH GM C10 CABS  
WINDSHIELD AND BACKLITE BOND VARIATIONS

1. Door side glass does not fracture because of door frame deformation in this test mode. (Test #L18019 applied 200 mm. of crush at top of door frame without side glass fracture.) The tempered glass fractures if contacted by the load cell edge or bolts on load cell.
2. Bonded backlites, as well as bonded windshields, are structurally significant. They interact with the roof so that localized buckling instead of translation occurs.
3. Bonded backlite together with bonded windshield eliminated most of the deformation in the "A" and "B" pillars on the side opposite the load. BONDING of BOTH REDUCED by a FACTOR OF TWO the "MATCHBOXING" of the cab; the translation of the roof as an unbent panel (see Figure 7). BONDING of BOTH INCREASED by a FACTOR OF TWO the LOAD carrying ability of cab (see Figure 10).

PRODUCTION WINDSHIELD AND ACRYLIC BACKLITE
