TECHNICAL BASES FOR THE DEVELOPMENT OF A TEST STANDARD FOR IMPACTS OF POWERED TWO-WHEELERS ON ROADSIDE BARRIERS

Paper Number 07-0332

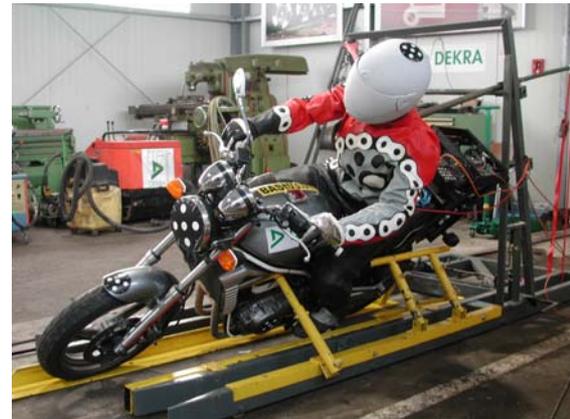
Figure 7. Test sled inclined impact with dummy and motorcycle.

Figure 7 shows the sled that was used for this impact configuration. It is in principle the same as used in the second configuration but with an additional device which is mounted. This device enables an inclination of 45° which initiates the tumble of the dummy and the motorcycle.

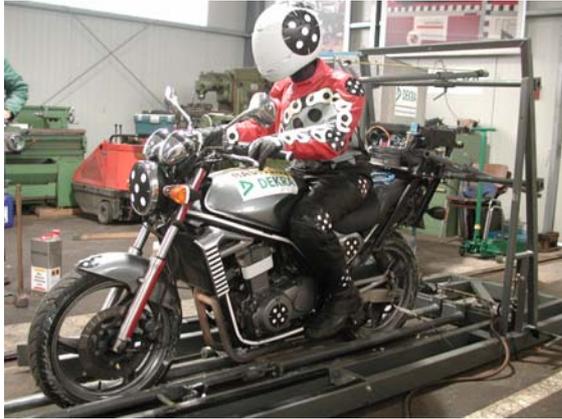
Figure 9. Test sled upright impact with dummy and motorcycle.

Figure 9 shows the sled with the mounted motorcycle and the dummy. A motion sequence of both impact configurations is depicted in figure 10.

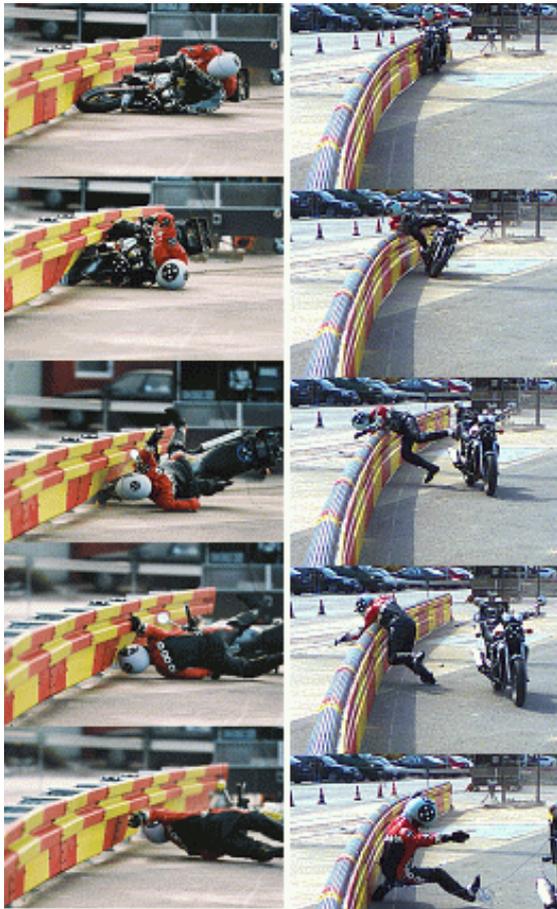
Figure 10. Motion sequence of inclined and upright crash test.

Some loads of the upright test are displayed in Table 3. The separation into primary and secondary data can roughly be seen in Figure 10 right column. Secondary data begins at the last picture sequence just when the dummy has left the guard rail. The data collected until this point is primary data. Data after this point – including head impact on the ground – is secondary data.

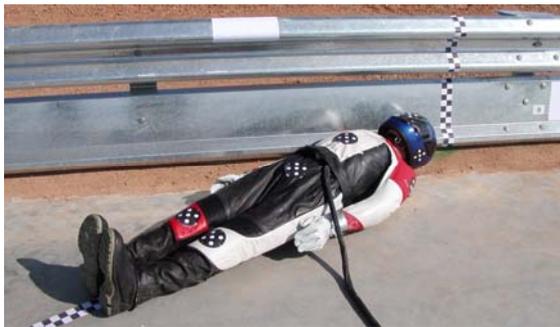
Figure 15. Trajectory and dummy position.

The Spanish standard defines the impact speed of 60 km/h as the impact speed for the all three possible trajectories detailed in the standard for punctual (PS) and continuous (CS) motorcycle protective systems (MPS). Taking into account the three trajectories, the launching position is defined as depicted in figure 15, where the dummy spine axis coincides with the approximation trajectory.

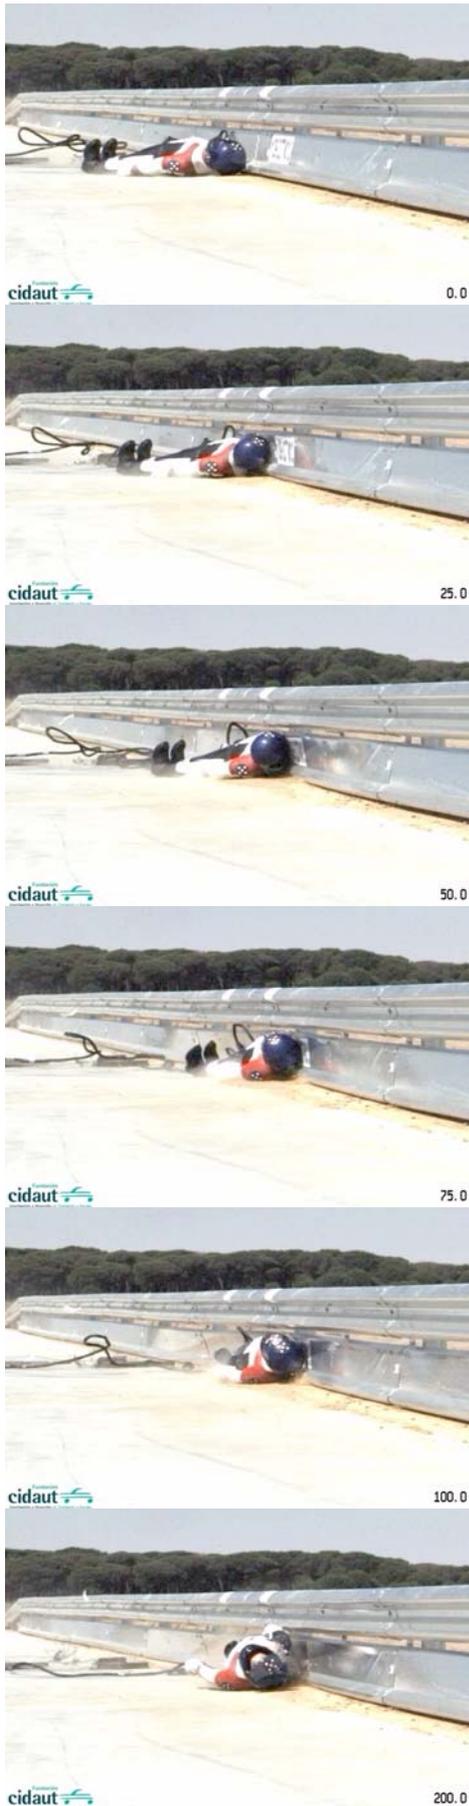
Figure 16. Test side view.

By courtesy of HIASA, an example of an impact test passed with level I result (best level) according to the Spanish standard is shown in figures 16 and 17.

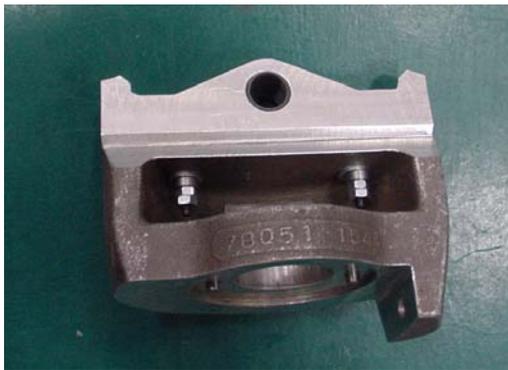
Figure 19. Frangible shoulder/clavicle.

Implications for Dummy Modification – The Hybrid III dummy was designed for frontal impact testing. The only measurement, that can be taken to assess lateral loading with a reasonable effort, is equipping the dummy with a sensor to measure lateral acceleration at Th4. However, as the dummy is not biofidelic in lateral loading, the measurement results may be misleading. As a first step to improve the biofidelity for a sliding impact of a motorcyclist into a barrier it is proposed to use a frangible shoulder as depicted in figure 19. Apart from the possible improvement of the biofidelity, some of the components of a Hybrid III dummy may not fully comply with the strong load requirements in lateral tests. An irreparable and costly fracture of the dummy shoulder has not only been reported for the LIER tests as stated above. Also Buerkle and Berg [Buerkle and Berg 2001] reported such a shoulder fracture. The Spanish impact standard described above considers such a modified shoulder for the Hybrid III. Inertial moments and weight are not changed significantly from the original dummy and its failure is aiming at reproducing that of a clavicle in the human body.

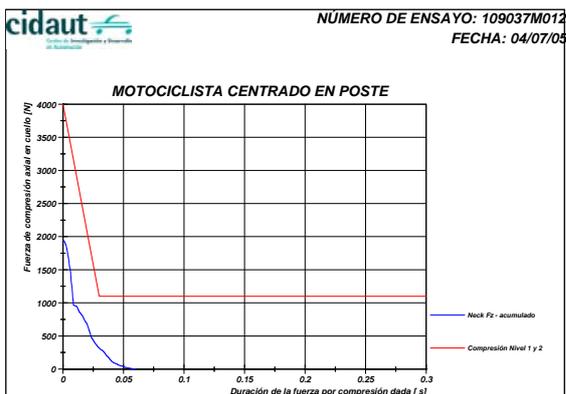
Appendix C Fz compression measured on neck

Test results	Limit Level I
HIC 36	107.16	650
Fx	Appendix A	Appendix A
Fz traction	Appendix B	Appendix B
Fz compression	Appendix C	Appendix C
Mxc	75.63	134 Nm
Myc flexion	42.75	190 Nm
Myc extension	37.26	42 Nm
Working width	0.41	EN1317 m
