HUMAN/DUMMY ROLLOVER FALLING (EXCURSION) SPEEDS

Donald Friedman

Paper Number 07-0503

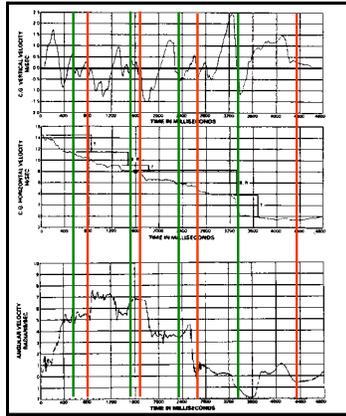
**GM Malibu I
Test 5**

Near Side Contacts:
(Green Lines)

- 550 ms = 0.6 mph
- 1500 ms = 0.3 mph
- 2350 ms = 1.2 mph
- 3350 ms = 1.2 mph

Far Side Contacts:
(Red Lines)

- 790 ms = 0.6 mph
- 1677 ms = 0.4 mph
- 2662 ms = 1.2 mph
- 4330 ms = 0.7 mph

Figure 1. Malibu production vehicle roof contact speed with the ground.

The Malibu experiments, were 16 rollovers with 8 production vehicles and 8 with roll cages, each with restrained and unrestrained occupants[2,3]. The production roofs typically struck the ground at 1 mph and rollcaged vehicles struck at 3 mph as shown in Figures 1 and 2. Roll caged roofs are not rigid: they typically intruded two inches at speeds of up to 5 mph. The roll caged vehicle and occupant falling speed in combination with the intrusion speed are insufficient to produce serious to fatal injury[4].

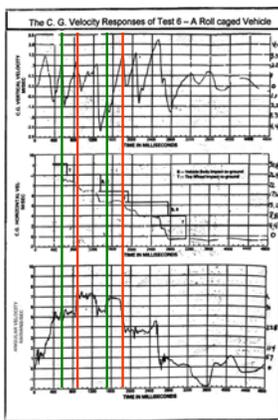
**GM Malibu I
Test 6**

Near Side Contacts:
(Green Lines)

- 575 ms = 2.2 mph
- 1500 ms = 2.5 mph

Far Side Contacts:
(Red Lines)

- 836 ms = 2.7 mph
- 1802 ms = 3.1 mph

Note: Similar data between vehicle types. The main difference is the rollcaged vehicle does not crush.

Figure 2. Malibu rollcaged vehicle roof contact speed with the ground.

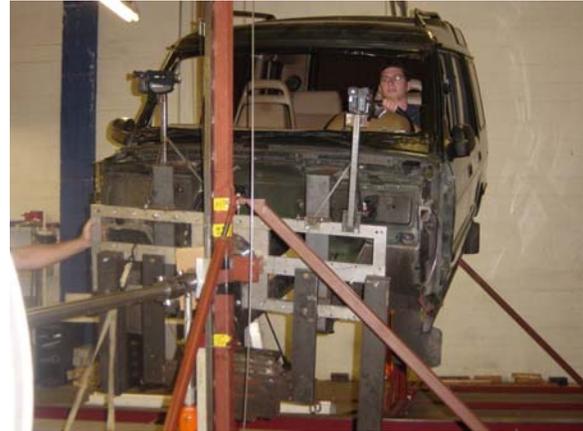
Figure 4. Spit Test Setup.

We used the Jordan Rollover System (JRS) fixture for this study. The vehicle was suspended between the two drop towers which allowed the vehicle to be freely rotated about its longitudinal roll axis as shown in Figure 4.

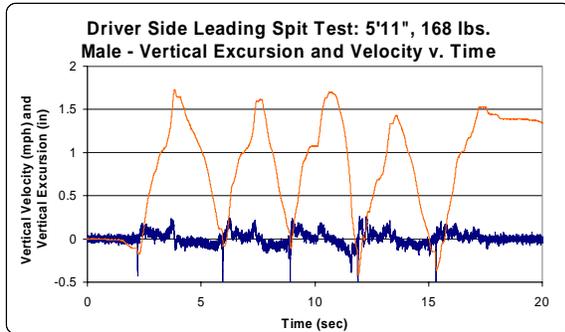
Figure 5. Spit Test Results – Near Side Occupant. Excursion (inches) in orange and velocity (mph) in blue.

Data from two of the tests with the same occupant on both the near and far side of the vehicle are shown in Figures 5 and 6. The near side excursion was lower than the far side excursion. In addition, the near side excursion is fairly consistent from roll to roll, while

the far side excursion increases modestly with increasing numbers of rolls.

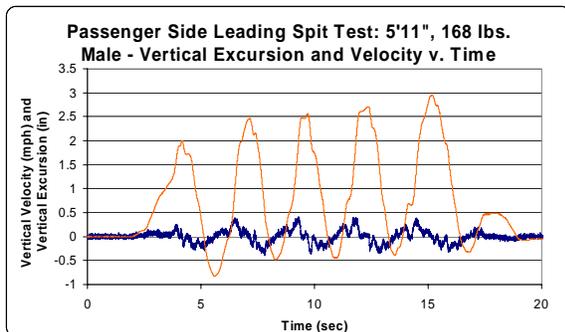
Figure 6. Spit Test Results – Far Side Occupant. Excursion (inches) in orange and velocity (mph) in blue.

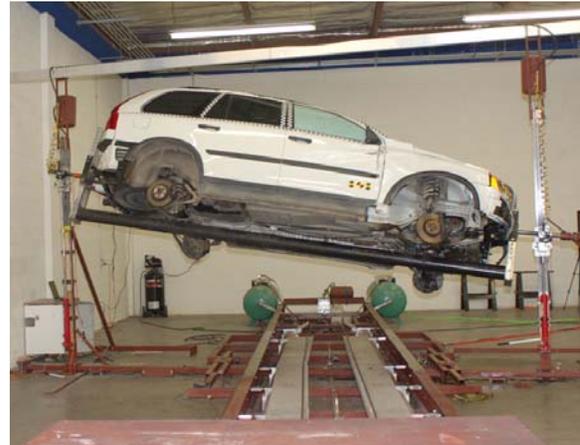
Figure 7. JRS Test Setup.

This test is similar to the spit testing portion of the study where an instrumented HIII dummy was placed in the near side of a midsize SUV, which underwent a dynamic impact, see Figure 7. The test vehicle, which had a strong roof, had previously undergone two dynamic rollover tests with only slight damage to the near side. The impact was from a drop height of 4 inches, at 214 degrees per second of roll and a roadway velocity of 15.7 mph. The vehicle struck the ground at a roll angle of 153 degrees, a yaw angle of 10 degrees and a pitch angle of 10 degrees.

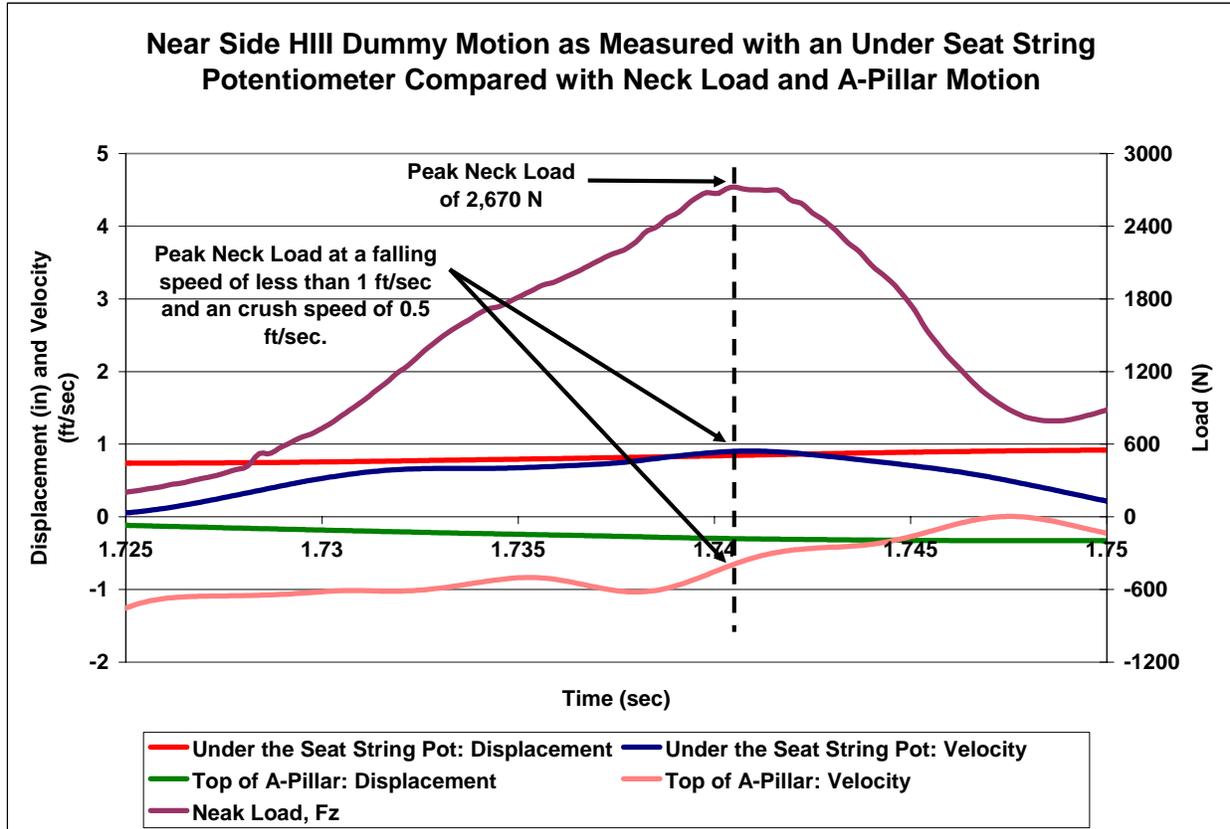
Figure 8. JRS test results focusing on the near side impact.

The data traces of interest in this study are presented as a function of time in Figure 8. The vehicle roll angle is 158 degrees at the 1.725 seconds and 163.4 degrees at 1.75 seconds.

Figure 8 illustrates the motion of the roof at the A-pillar, the hybrid III dummy and the resulting neck load during the near side impact. In this case with a near side occupant, a peak neck load of 2,670 N was recorded at which time the A-pillar was intruding into the occupant compartment at ~ 0.5 ft/sec while the dummy was moving towards the roof at less than 1 ft/sec due to the impact and excursion. At the time of this impact, the dummy had moved outward and upward and was positioned under the roof rail near the intersection with the door window frame. At this point, the excursion of the dummy was limited by the roof. The neck load was due to a combination of the motion of the dummy and the roof.

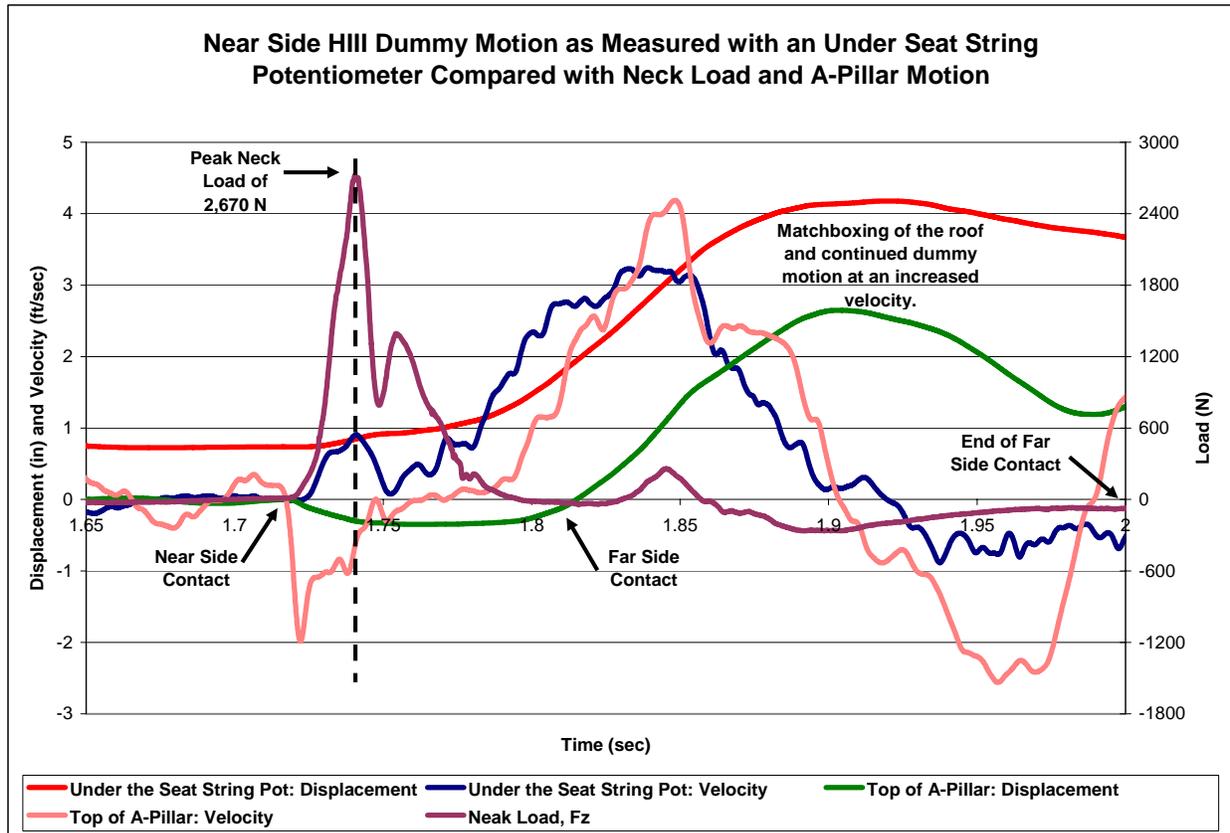
Figure 9. JRS test results focusing on the near side impact.

Figure 9 illustrates the same test sequence over a longer time period illustrating the effects of the far side impact. Figure 9 represents the vehicle traveling from 142 degrees of roll to 230 degrees. In the far side impact, the roof was moved upward and outward away from the near side occupant. This allowed the dummy to move further upward at higher velocities with the deforming roof. This resulted in the highest recorded excursion velocity of ~3 feet per second. However, due to the motion of the roof/vehicle and the dummy there is only a small increase in neck load at this time.

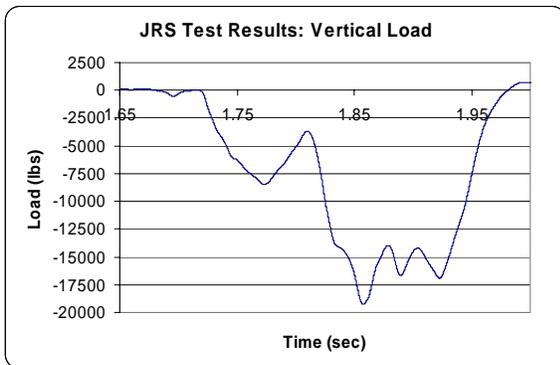
Figure 10. Vertical load during impact.

The near side impact during this test was significant with a vertical load of 8,500 lbs measured by the instrumented roadbed. This device allows for direct measurement of the load applied to the structure. This load was approximately 1.8 times the weight of

the vehicle and is illustrated in Figure 10. After the near side impact, the vehicle continued to roll striking the far side of the roof prior to the end of the test. In this case, the load was much higher on the far side of the roof with a peak load of ~19,300 lbs (or 4 times the weight of the vehicle). It should be noted that the near and far side loads do not always follow this pattern. Larger near side than far side loads have been seen in several tests.

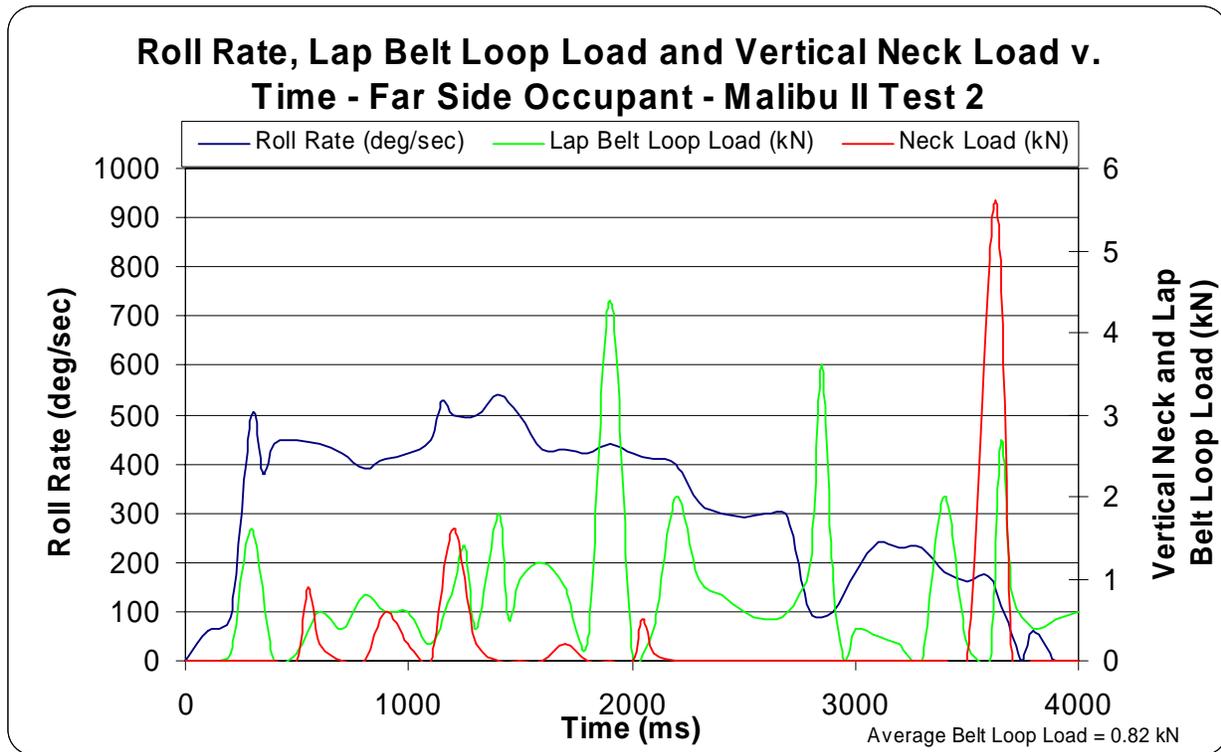
Figure 11. Malibu II Test 2 – Rollcaged Vehicle Data.

These figures from Malibu II were created by digitizing the graphical data provided with the study. The electronic data has never been released to the public for independent analysis. They provide another method for examining the cause of the high neck loads seen during several of the tests in this series. Figure 11 is a graph of Malibu II Test 2, a

reinforced vehicle. A peak neck load is at the end of the sequence where the roll rate has decreased to less than 200 degrees per second from an earlier peak of more than 500 degrees per second. In effect this relieves the lap belt loop load as the dummy reacts to lower centrifugal force.

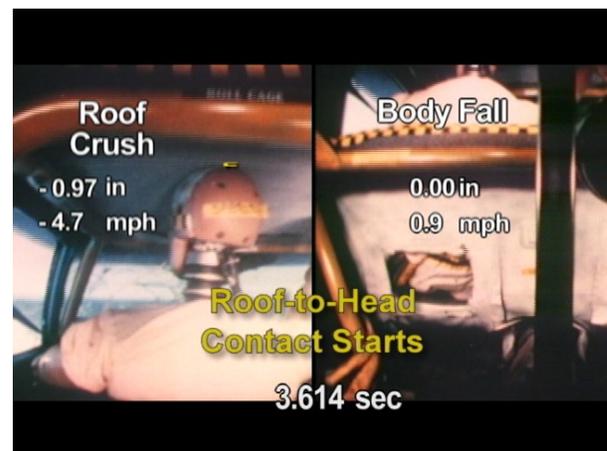
Figure 12. Split screen of Malibu II 2L1 roof and dummy motion.

The occupant excursion and excursion velocity during this impact can be analyzed by examining the high speed video of the test and utilizing the timing data determined during the original analysis of the tests. In this impact, dubbed Potentially Injurious Impact (Pii) 2L1 (Test 2, left dummy, first impact over 2000 N) the interior photoanalysis of 2L1 roof and occupant motion is shown in Figure 12 just as roof/head contact starts. The intrusion velocity of the rollcaged roof after 0.97 inches of intrusion is 4.7 mph while the occupant is moving towards the roof at 0.9 mph as identified by the by the dummy buttocks motion.

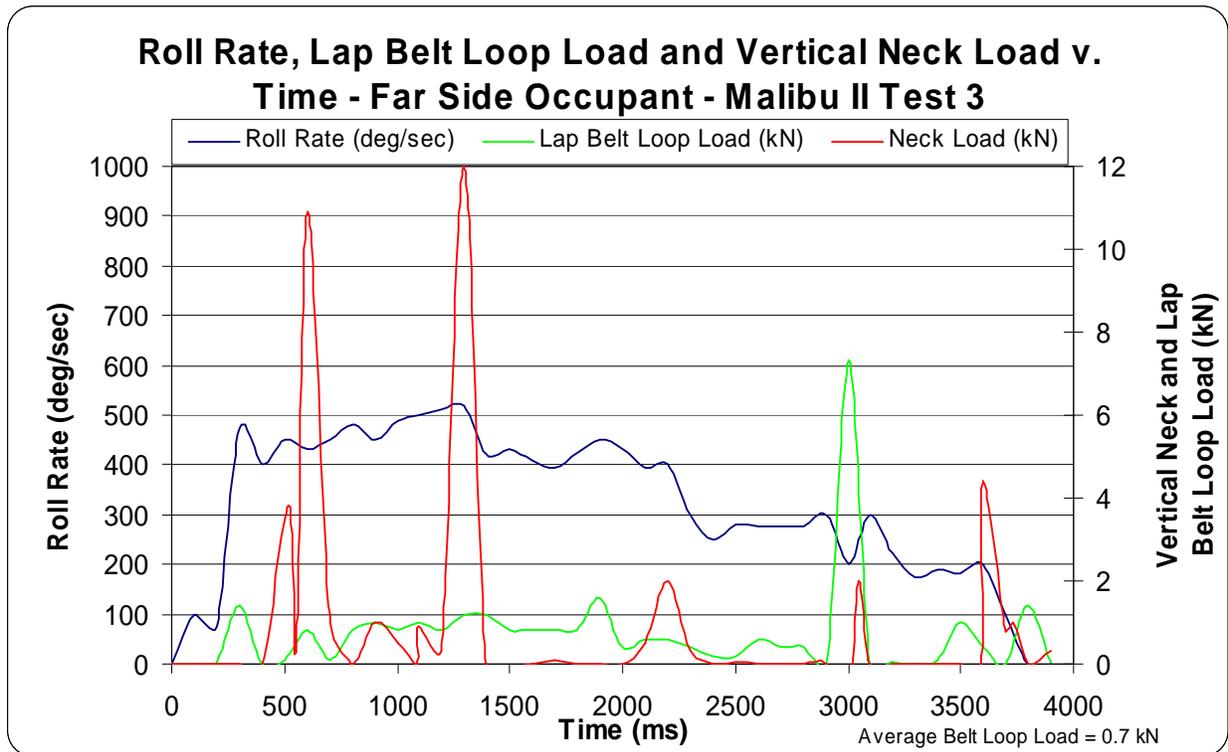
Figure 13. Malibu II Test 3 – Production Vehicle Data.

Figure 13 examines Malibu II Test 3 of a production vehicle. In this test, there are two spikes in the neck load early in the test at approximately 700 and 1300 ms. An examination of these neck load spikes illustrates a corresponding decrease in the lap belt load. The decrease in belt load is caused by the roof deformation pushing the dummy towards the seat and

unloading the belt. Any lessening of belt load due to moving of belt anchor points, typically the D-ring on the B-pillar, would occur with the roof crush after the diving theory would predict an injury – prior to roof crush.

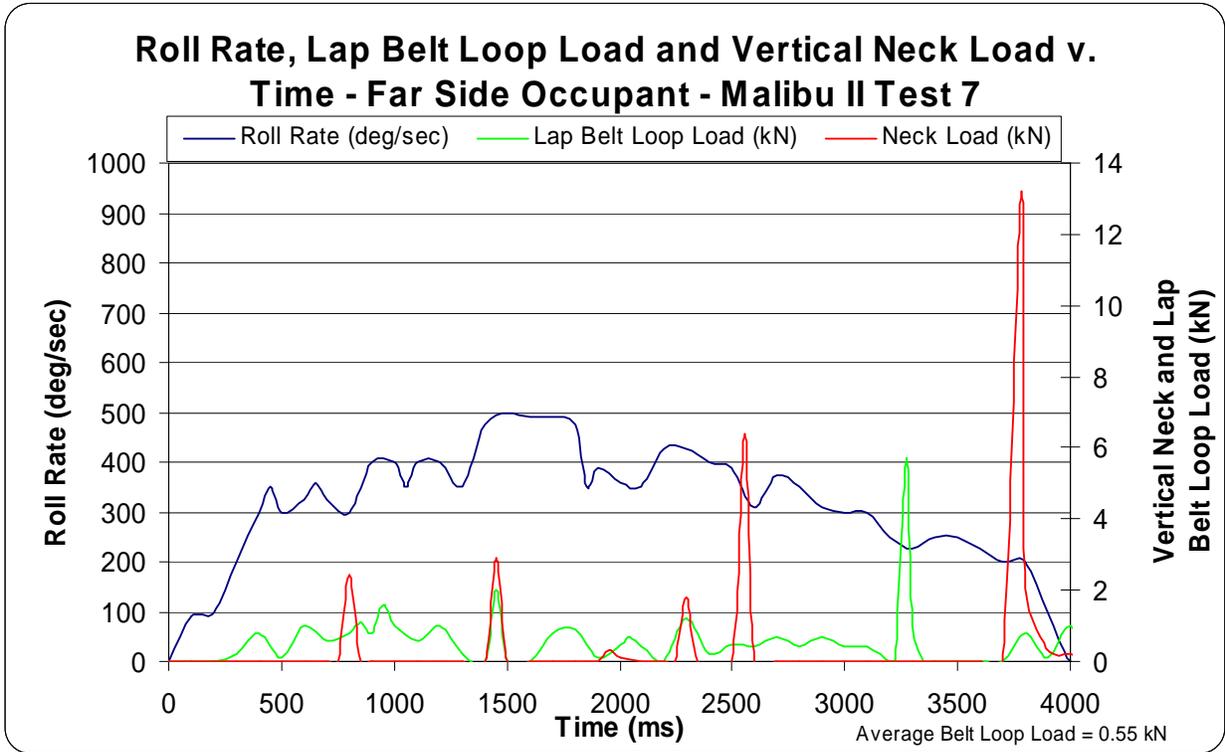
Figure 14. Malibu II – Production Vehicle Test 7 Data.

Figure 14 examines Malibu II Test 7 of a production vehicle. This is similar to the graphs from Test 3. In this case, the peak neck load is near the end of the sequence where the roll rate has decreased to approximately 200 degrees per second. The belt load is relatively low as compared to the peak belt load in the test at which point there was no neck load of note. If a diving type mechanism was the prime force in this event, then you would need to see an increase in belt load, but this is not present. The data clearly indicates something else is driving the neck load. Examination of the test video illustrates a moving buckle, as described in Malibu I [2], striking the dummy’s head and reported in a 2005 ESV paper [11].

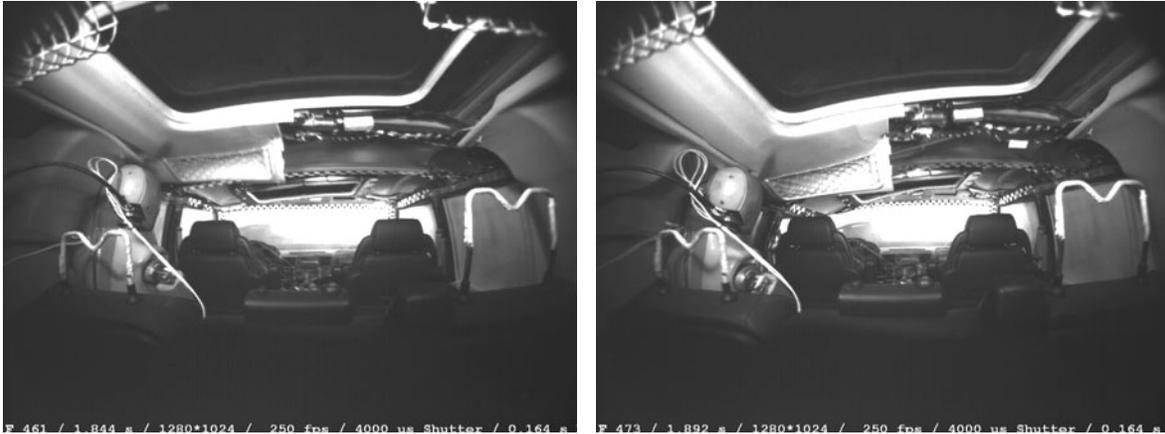
Figure 15 A and B. Video excerpts from test. In the first picture, the dummy has moved upwards toward the roof and the roof is beginning to crush. In the second picture, the roof is loading the dummy.

A comparison of neck load, belt load and roof crush was also made experimentally in a dynamic rollover test utilizing the JRS. In this test, a mid-sized SUV was tested with a restrained, instrumented Hybrid III 5th percentile occupant in the far side rear seat. The vehicle was instrumented with string potentiometers on the near and far side with an interior high speed camera. The test was an examination of small occupant motion in rollover accidents as no roof contact was expected during the test. However, a large buckle was formed due to the design of the roof and the occupant was contacted. This impact can clearly be seen on the high speed interior camera, see Figure 15.

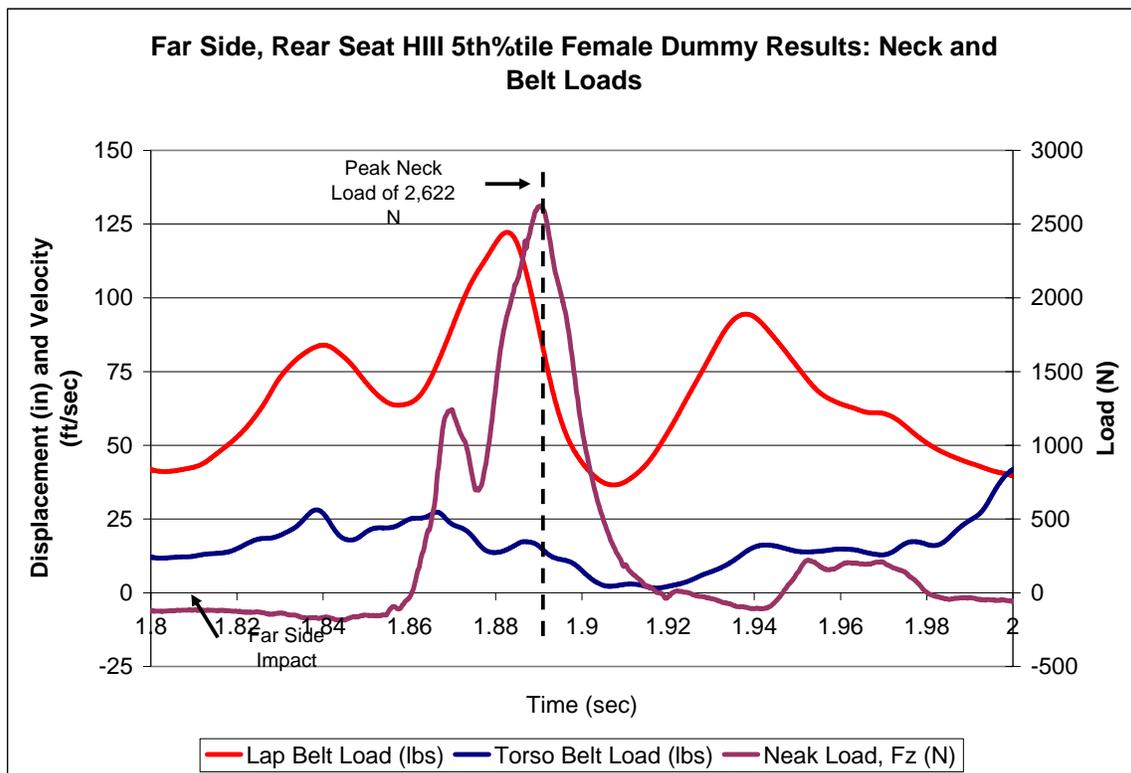
Figure 16. JRS test results focusing on belt and neck loads during a far side impact.

The data from this test clearly demonstrates the peak neck load occurring as the belt load is decreasing with little or no motion of the restraint system anchor points, see Figure 16.

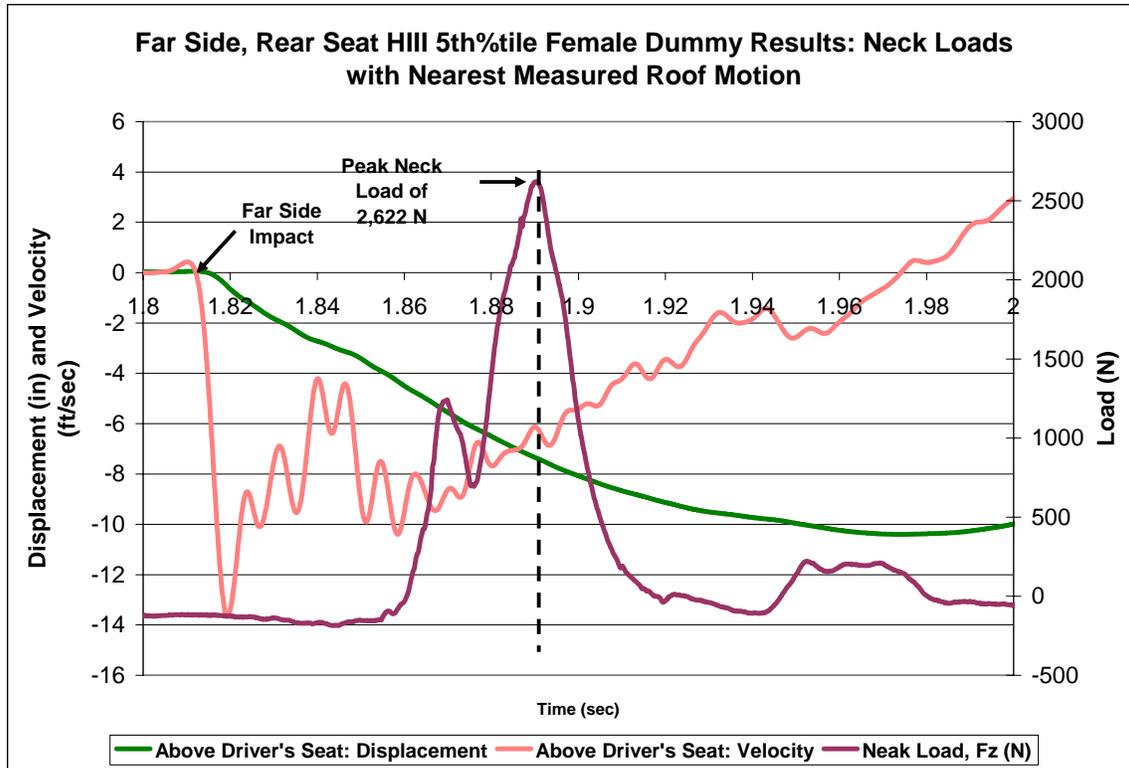
Figure 17. JRS test results focusing on roof motion and neck loads during a far side impact.

While there were no string potentiometers immediately above the rear seat dummy, a string potentiometer was located above the driver’s seat and recorded the motion of the buckle that struck the occupant. The timing and motion of this buckling structure is very similar to the effects above the dummy. Figure 17 illustrates the motion of the roof and comparison to the neck load in the dummy.
