ANTI LOCK BRAKING AND VEHICLE STABILITY CONTROL FOR MOTORCYCLES – WHY OR WHY NOT?

Institute for Transport Economics at the University of Cologne
Germany
Paper Number 09-0072

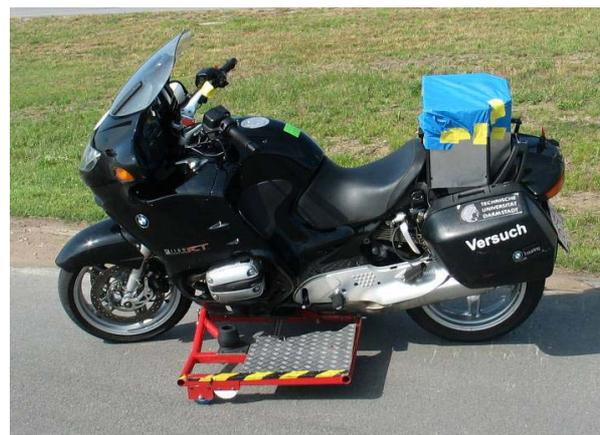
Figure 1. Test motorcycle BMW R1150RT; during braking tests with integrated and hidden measurement instrumentation and outriggers to limit damage in case of a fall

Beyond motorcycle test data such as wheel speeds, front and rear suspension strokes, brake and clutch lever travel, steering angle, and yaw and roll rate, human data such as the tonicities of musculus flexor digitorum (left hand) and musculus trapezius pars descendens (right side) have been recorded as well as the heart frequency. Between the tests,

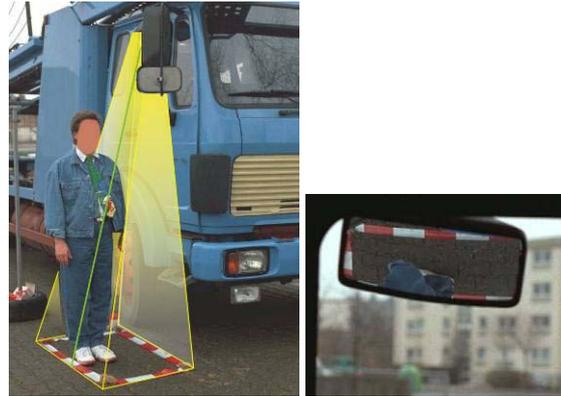
Figure 5. Visibility of a pedestrian by an old class V mirror (71/127/EC)

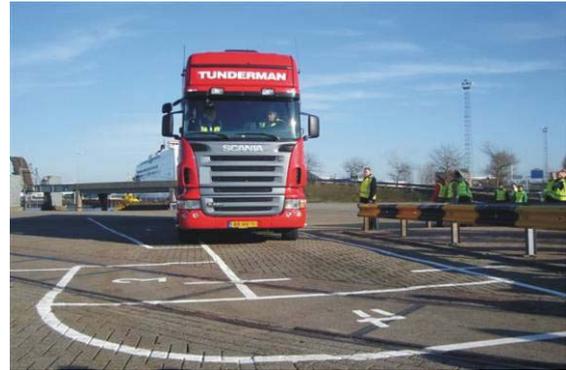
Figure 11. System to adjust truck mirrors following the regulation 2003/97/EC developed in the Netherlands

The main cause of the described accident were the not correctly adjusted mirrors. But how could these mirrors be adjusted in a better way? There is an idea coming from the Netherlands to paint special markings on the road (see Figure 11). These markings may give the truck driver an orientation to adjust the mirrors. The Dutch system has a small disadvantage. It requires much space beside the truck. Daimler, DEKRA and MAN found an improvement (see Figure 12). On one hand the new system requires less space to the side (4,5m instead of 15m). It includes on the other hand also markings for trucks with an old mirror system (yellow markings). There is also a separation between the mirrors at the co-driver's side and the front mirror. This is caused by the different points of orientation. The adjustment of the front mirror is orientated to the front of the truck whereby all other mirrors are orientated to the eye-point of the driver. There could be an extreme combination of truck and driver which may result in an adjustment of the mirrors with a small mistake. This mistake may end in a blind spot and cause an accident. Therefore Daimler, DEKRA and MAN decided to separate the system in two adjustment areas.

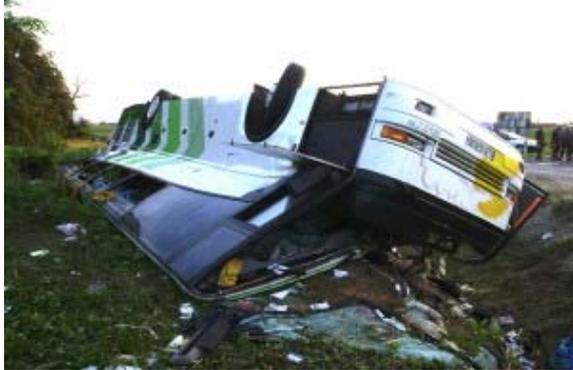
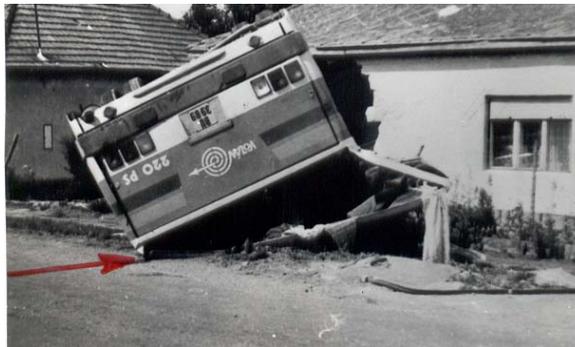
Figure 1. General collapse of the superstructure in rollover

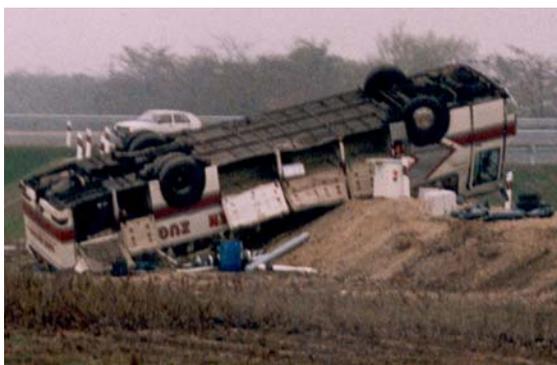
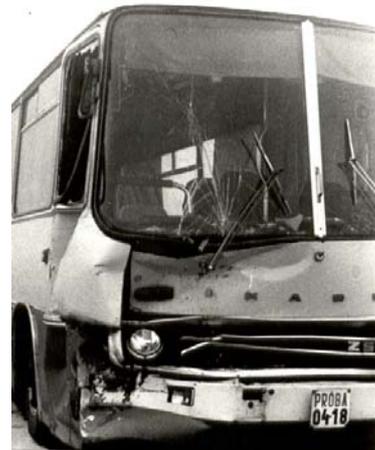
Figure 2. Local large-scale deformation of the bodywork

At the beginning it was not considered, but later it became evident that the EE-s can be used only if the bodywork of the bus – at least in the surroundings of the EE – is not strongly damaged. The large scale structural deformations generally prevent to access, to operate and use the EE. Figure 1. gives examples about the total collapse of the superstructure in rollover accidents. These pictures prove that in these cases it is meaningless to talk about EE-s. Figure 2. shows examples when only one, or just a few EE-s can not be used because of strong, local structural deformations.

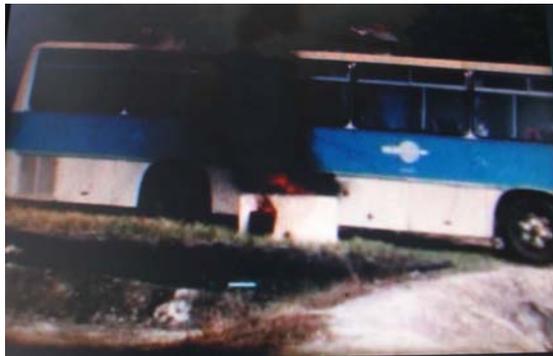
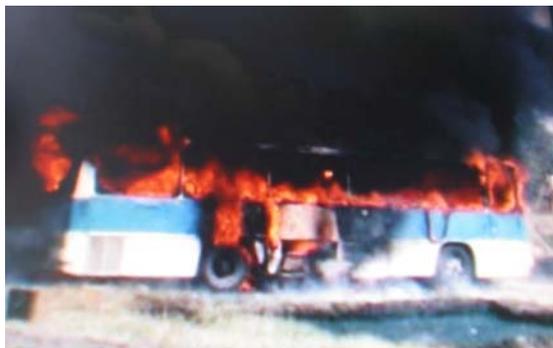
Figure 3. Fire tests with complete bus type IK255

Fire tests were carried out in Hungary with three complete buses (type IK 255 and IK 415) simulating five fire sources. Figure 3. shows one test when the whole fire propagation process was observed and studied with the measurement of temperature and some poisoning gas concentration increasing. [1] The source of fire was in the closed box of the heating device, under the floor. The measured values (CO, HCl, HCN gas concentrations; temperatures T_{far} far from the fire source and T_c close to that) are presented on Figure 4. Without detailed discussion of the test results it may be said that from the first possible observation of the fire, the available time for evacuation was in the range of 200-300 sec. The smoke density was not measured, but visually detected by filming it was developed very rapidly. The critical values of gas concentrations are marked by a horizontal line on the left side of the diagram. The life danger is mainly due to the gas and smoke concentration and less to the high temperature.

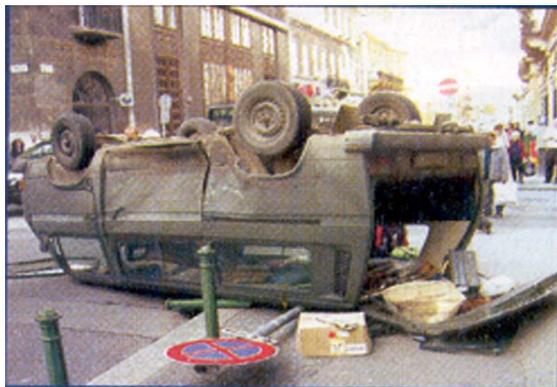
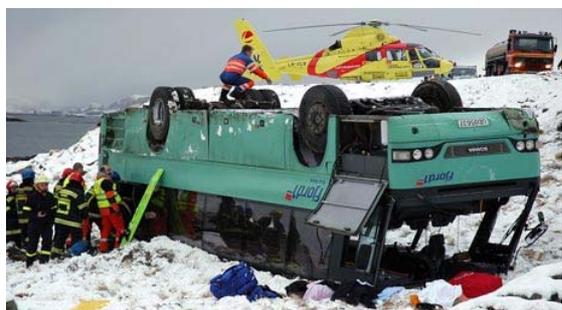
Figure 6. Usability of escape hatches (?)

The assumption that the usability of a certain type of EE is the same in different accident situation is also not true. Figure 6. shows some examples. The escape hatches are absolutely not usable when the bus is laying on its roof. The side emergency windows are well usable (on both side) in this situation in large buses, but they are almost useless in small buses. For small buses the rear wall door is very useful in this case.

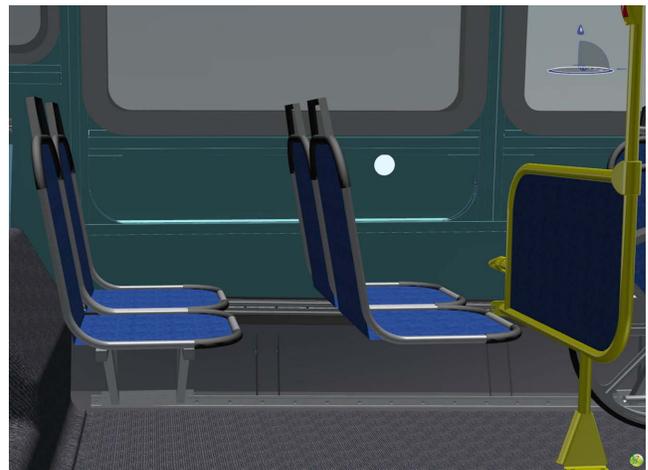
Figure 6. Seat-to-Seat Configuration (left), and Seat-to-Divider Configuration (right).

The objectives of these tests were to study the passenger kinematics and injury mechanisms for typical seat-to-seat and seat-to-divider layout configurations (see figure 6). Due to the number of tests conducted it was also possible to study the test-to-test variability of the occupant kinematics and injury mechanisms for the 50th and 95th percentile ATDs. The crash pulse for these tests was obtained from a previous structural analysis of typical frontal crashes [6]. Figure 5 shows the frontal crash configuration; a 30 mph head on collision between a low floor transit bus and a Dodge Caravan; and the pulse at the bus passenger compartment used for the testing.

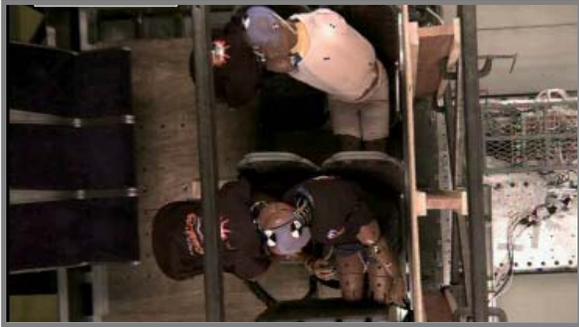
Figure 16. 5th percentile Neck Compression Injury Mechanism, due to Head-to-Head Contact.

Figure 18. 50th percentile Neck Extension Injury Mechanism, due to Head-to-Head Contact.

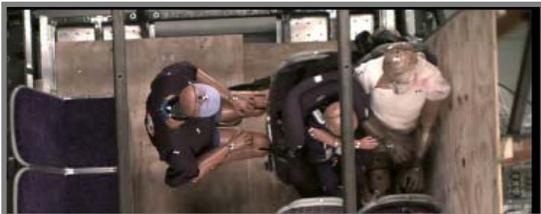
Figure 17. 95th percentile Femur Compression Injury Mechanism, due to Head-to-Head Contact.

The most common injury mechanisms for passengers seated on side facing seats during sided impact conditions are; head and neck injuries due to head-to-head or head-to-body contacts (see figures 16, and 18) and femur compression due to femur-seat contacts (see figures 18 and 19).

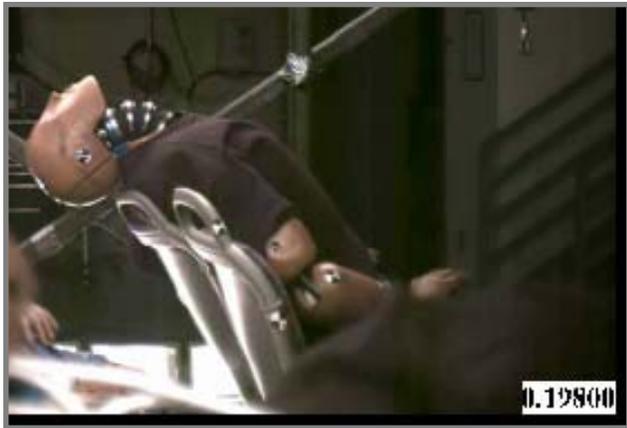
Figure 23. Crash Condition 20 mph Bus – 0 mph Bus Rear Impact (5th, 50th and 95th percentile Passenger Kinematics).

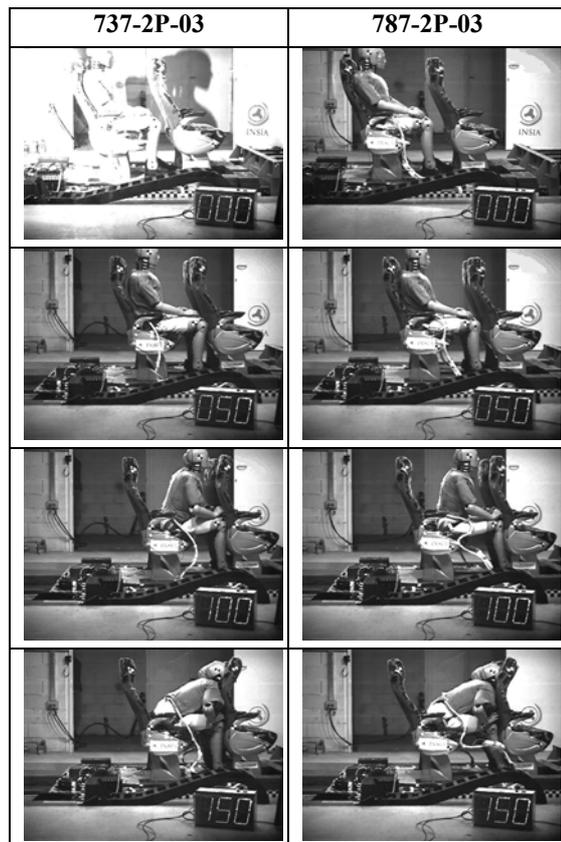
Figure 29. Sequence of images for setup 3 (2P seat belt).

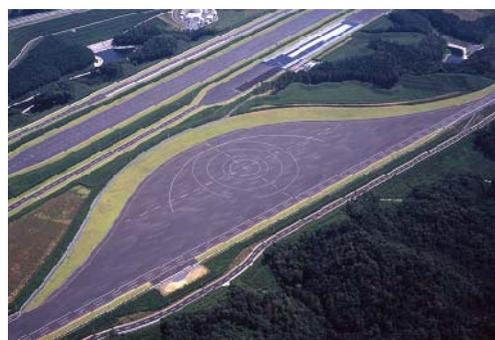
Figure 4. Test course (circular test track)

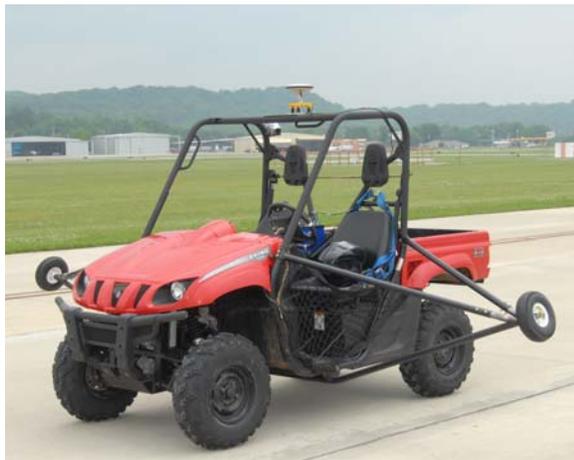
Figure 2. Test vehicle as prepared for testing (Yamaha Rhino 450).
