AN ANALYSIS OF HOSPITALIZED MOTORCYCLISTS IN THE STATE OF MARYLAND BASED ON HELMET USE AND OUTCOME

Paper No: 09-0061

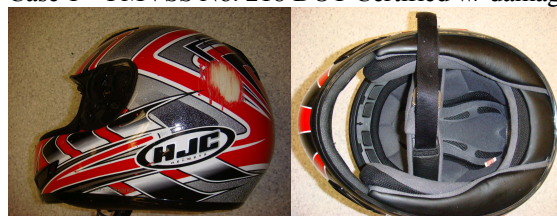
Case 1 – FMVSS No. 218 DOT Certified w/ damage

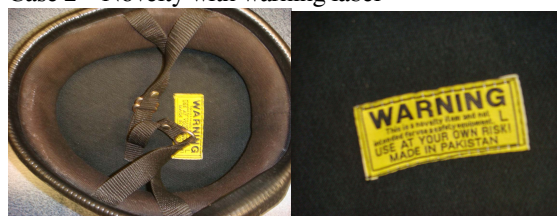
Case 2 – Novelty with warning label

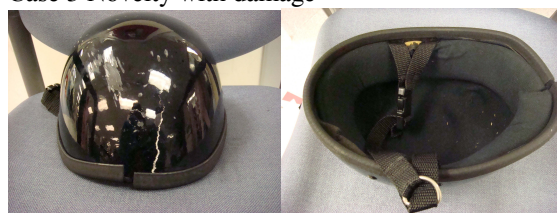
Case 3 Novelty with damage

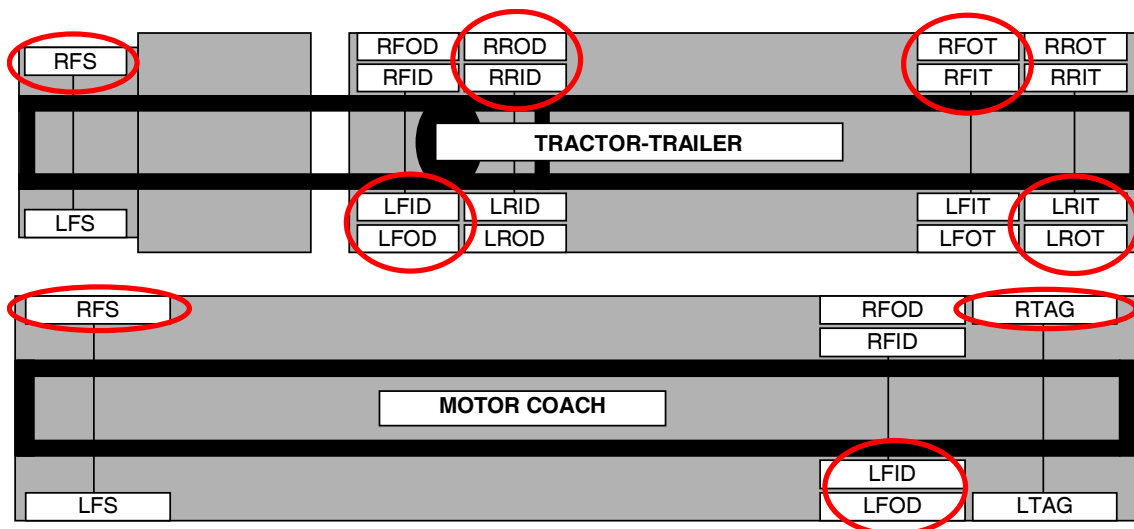
Figure 5. Tractor-Trailer and Motorcoach Instrumentation Package Location.

The test vehicles were a 2001 Freightliner FLD tractor, coupled to a 2001 Utility Trailer Manufacturing Co. 2000S tandem axle flatbed semi-trailer, and a 2003 MCI motorcoach. To acquire highly accurate pressure and temperature measurements (i.e., to establish "ground truth" against which readings from the various test articles could be compared), laboratory grade sensors were installed at each test wheel position. This required removing the wheels, machining replacement wheels for mounting thermocouples and pressure taps, and routing wire bundles to the data acquisition system (DAS) mounted in the cab of the truck and motorcoach. Figure 5 shows the installation location of each of the instrumentation packages on the tractor-trailer and motorcoach.

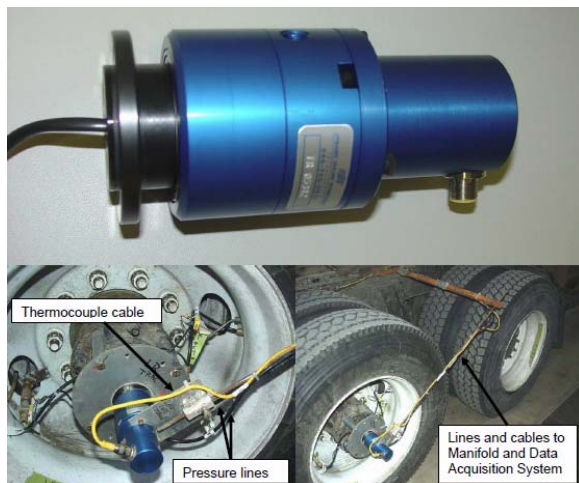
Figure 6. Rotary Union and Wheel Installation Detail.

Additional test equipment consisted of: internal tire temperature thermocouples (nine, analog); tire pressure transducers (two, analog); custom-fabricated dual-flow combination rotary union and slip ring assemblies (five); a custom-fabricated pressure control manifold; primary and secondary brake reservoir and treadle valve pressure transducer (three, analog); a digital marker switch for the test driver's use to indicate when a warning was observed; and a digital non-contact fifth wheel. Figure 6 displays the details of the wheel end rotary union instrumentation package.

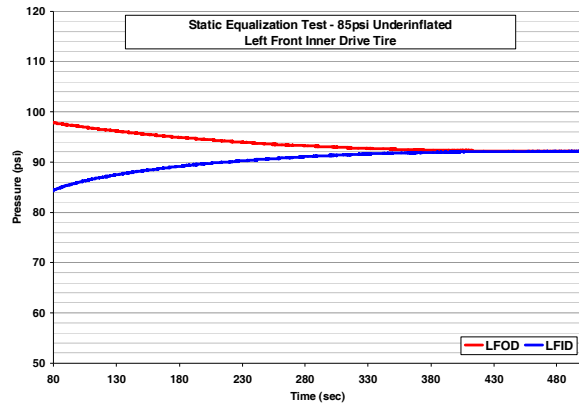
Figure 7. Static Equalization Test.

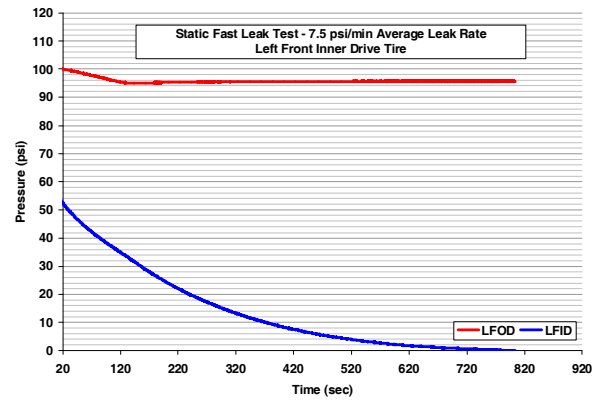
Figure 10. Equalizer Static Fast Leak Test.

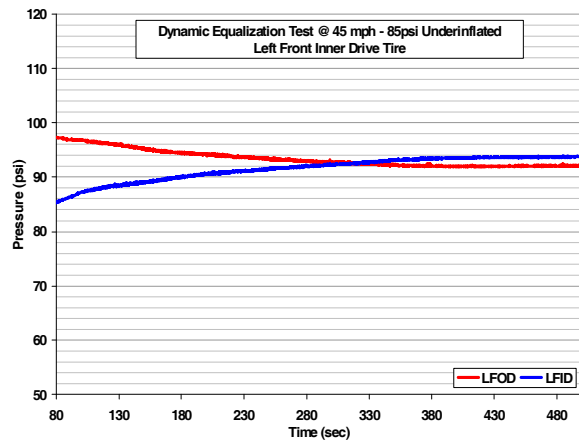
Figure 8. Dynamic Equalization Test.

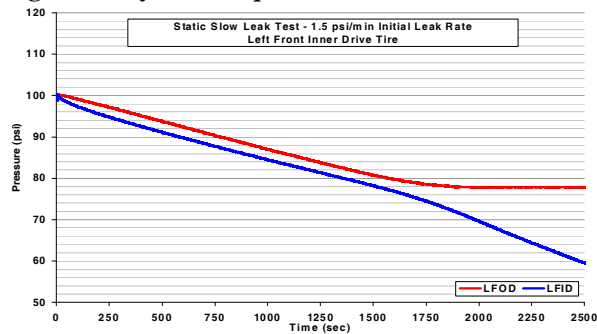
Figure 9. Equalizer Static Slow Leak Test.

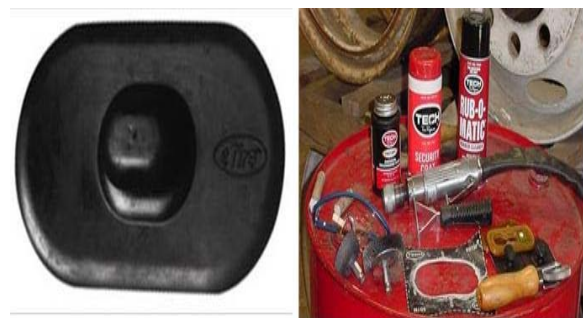
Figure 15. eTire Mounting Patch and Installation Tools.

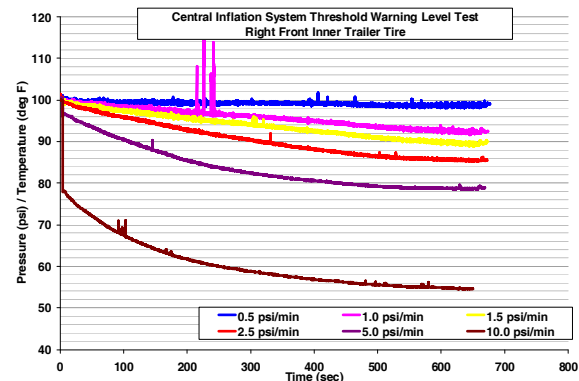
Figure 17. Trailer-Mounted ATIS With Various Leak Rates.

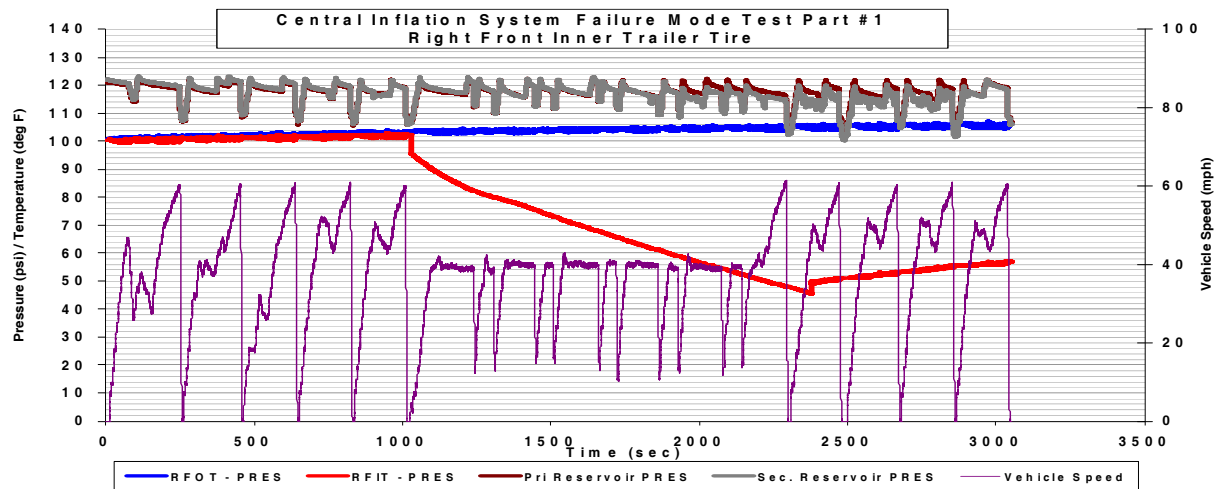
Figure 18. Trailer-Mounted ATIS Brake Snubs With Tire Leak.

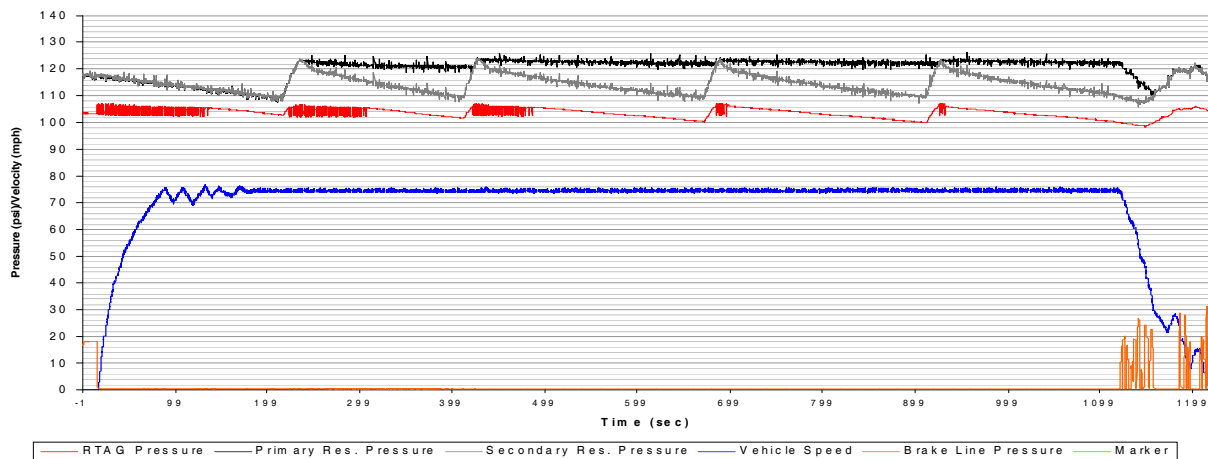
Figure 19. Motorcoach-Mounted ATIS Tire Leak at Highway Speed.

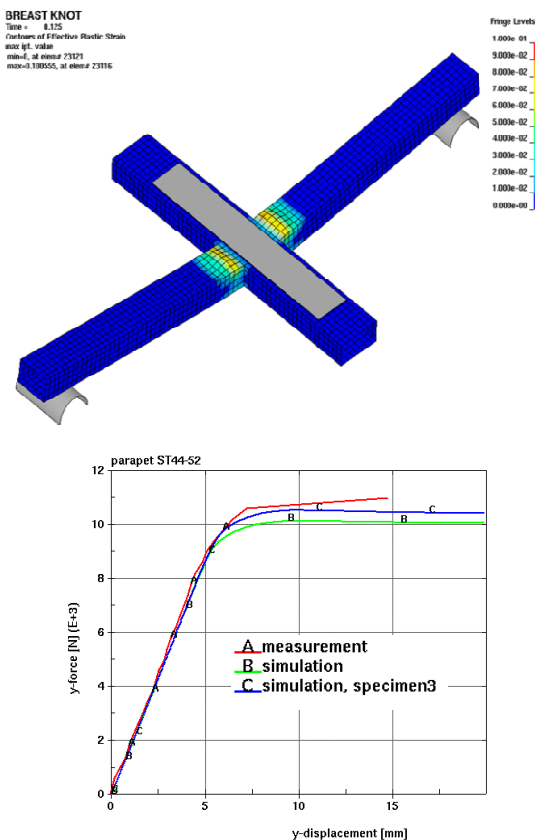
Figure 3. LS-DYNA simulation results for breast knot subassemblies

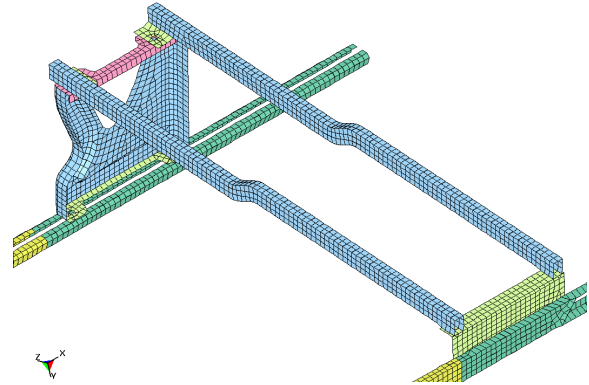
Figure 6. FEA Model of the seat structure

All deformable parts were modeled with the 4-node Belytschko-Tsay shell elements with three integration points through the shell thickness [18]. The shell element formulation is based on Belytschko-Lin-Tsay formulation with reduced integration available in LS-DYNA [19]. This element is generally considered as computationally efficient and accurate. The shell element that has been, and still remains to be, the basis of all crashworthiness simulations is the 4-noded Belytschko and Tsay shell. Upon completion of mesh generation of bare structure, masses were imposed according to a certain methodology. First, a list of masses of the vehicle was prepared. The engine, gearbox, air conditioner and fuel tank were roughly 3D modeled as rigid parts, the inertias were calculated analytically and mass and the inertia was imposed on a representative node (on the approximate center of gravity points for the relevant part) of these parts. The axles were modeled with rigid truss elements and the mass and the inertias were imposed using the same method. The masses particularly located were imposed by using mass elements. The distributed masses were imposed by changing the density of the related region. Further details on bus FEM can be obtained from the study by Guler et al. [15].

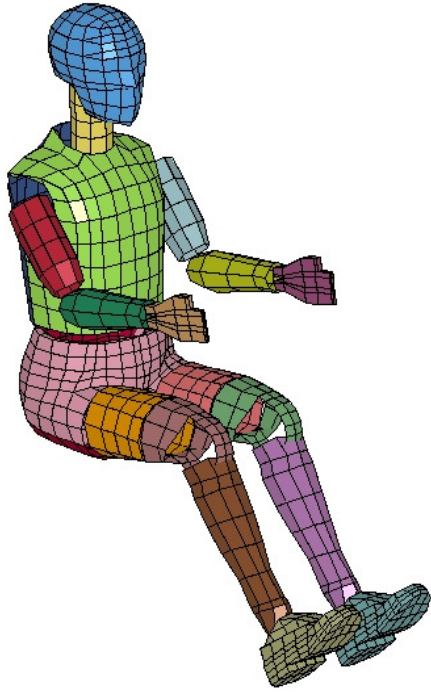
Figure 7. Hybrid III Dummy

Hybrid III 50th percentile dummy was used to represent passengers riding in the bus during a rollover accident. Dummy is a completely deformable finite element model (see Figure 7) and detailed information about the dummy can be found

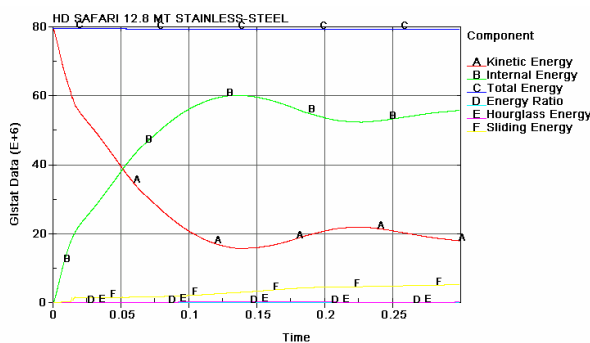
Figure 11. Energy distribution versus time

In order to check the accuracy of the simulation results, the first thing to check is whether the total energy remains constant during the simulation time period. The graph showing various energy distributions obtained from the rollover simulation of the bus structure is given in Figure 11. As shown in this figure, the total energy remains constant which is one of the indications for correct analysis results. It can be observed that the kinetic energy drops and transforms into internal energy (strain energy + sliding energy) over the time and the hourglass energy remains negligible.

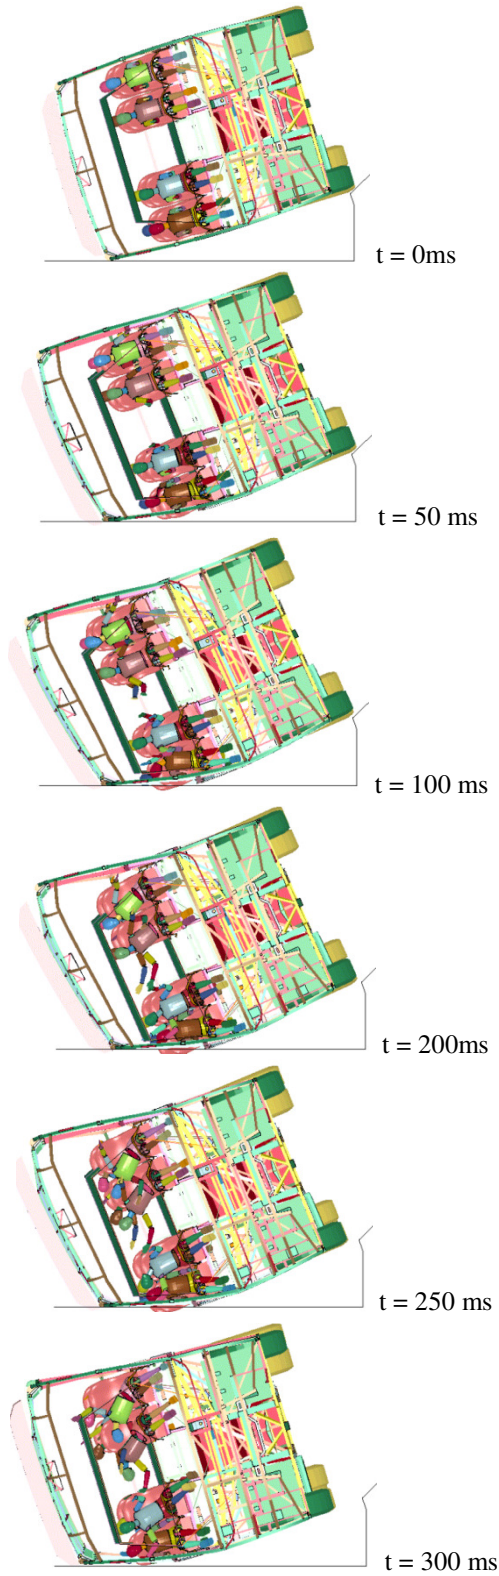
Figure 14 Sequential pictures showing behavior of lap-belted dummies during ECE R66 test simulation.

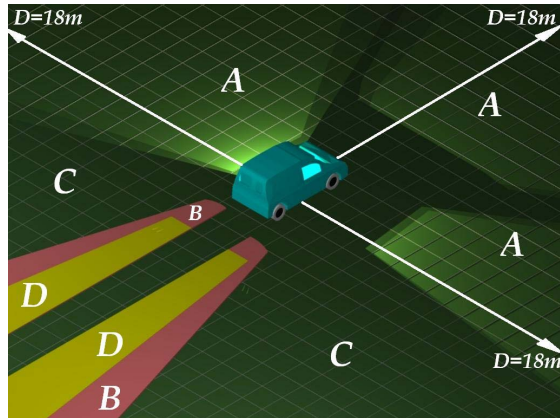
Figure 2. The areas around the vehicle category N_1 which are visible

demanded by regulations. Areas C – areas the observation of which is impossible till now.

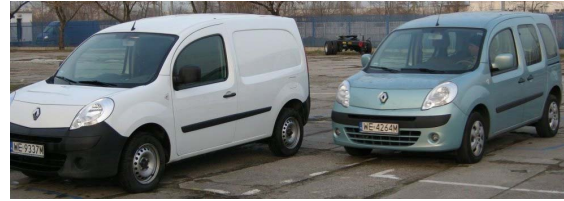
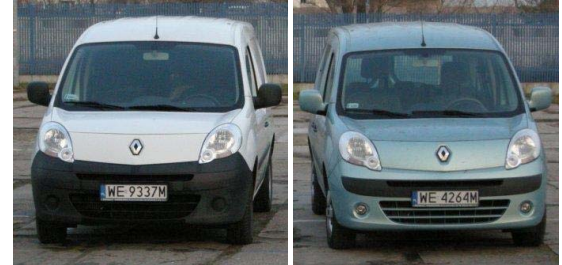
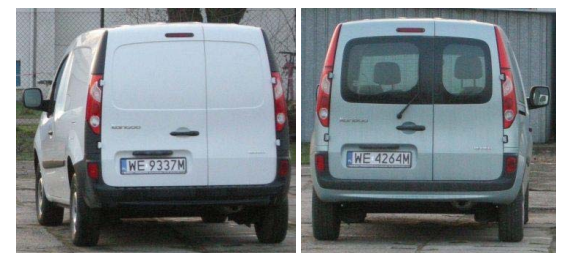
Figure 4. Vehicle Renault Kangoo – truck and car – body versions

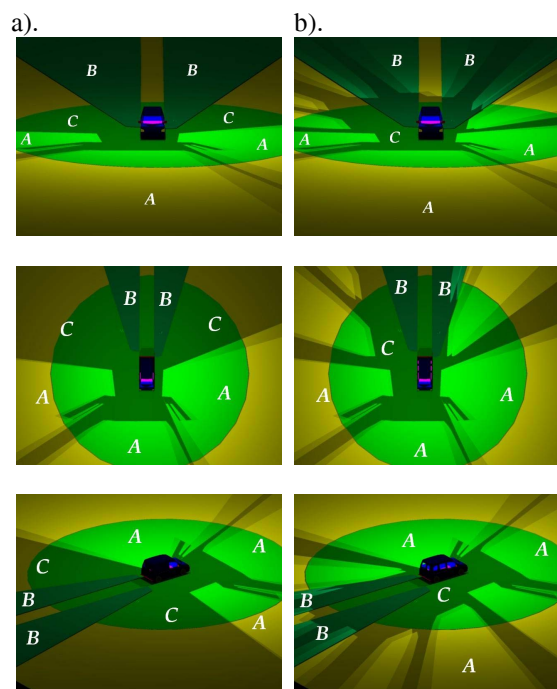
Figure 5. The direct and indirect visibility field for Renault Kangoo: a). truck category N_1 and b). car category M_1

Moreover the drivers of the above do not have identical possibilities to observe the surroundings. In the truck of category N_1 the area which can be observed by the driver is radically reduced. Is it needed, is it necessary, and is it possible to eliminate the difference in the “surroundings visibility” of trucks in comparison with the passenger cars, especially these which are based on the identical body. The lack and also insufficient information from the cars surroundings during driving are one of the causes of the rise of collisions and accidents. Unobscured observation of all the area surrounding the vehicle is radically limited, in the small trucks of category N_1 in comparison with passenger cars of M_1 category. It is particularly easy noticeable and perceptible in the vehicles of categories M_1 and N_1 of the same brand whose bodies are similar. In the vehicle of the passenger car version the side walls and the rear wall have the glazed windows, through which the driver can observe surroundings. Additionally it is equipped with the indirect visibility devices which are identical as in the version of the truck except the interior mirror. In general the interior mirror is not mounted in the truck. In the truck, in the area behind the driver, in general the windows in the side walls and in the rear wall are not fitted or used. As a result the driver can observe considerably smaller area of his surroundings.

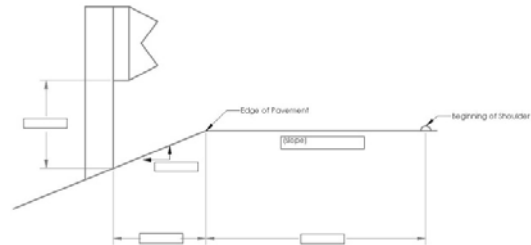
Figure 2. Guardrail and Road Environment Measurements. This figure was included in the site survey sheets to gather data about the distance of the object from the road and the slope of the road.

Measurements of the shoulder width, slope, and distance between the object and end of the pavement were also taken at each site. A diagram was included in the survey sheet to clarify the required measurements (Figure 2). The distance of the object from the road may have an effect on the severity of a collision; if the object is further away from the flow of traffic, the motorcyclist will have more time to slow down before colliding with it.

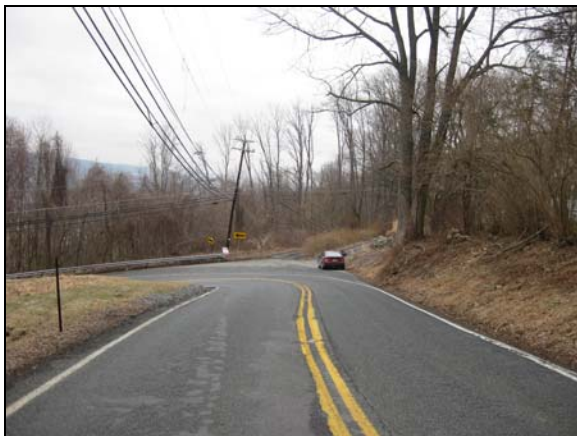
Figure 3. Route 579, Bethlehem Township, Hunterdon County. Four motorcycle-guardrail collisions took place at this site in 2007.

On Route 579 in Bethlehem Township in Hunterdon County, a crash location was investigated where there were 4 motorcycle-guardrail collisions in 2007. The posted speed limit on the road is 35 mph, with a reduction to 10 mph around the curve. The road took a sharp turn left, and disappeared from vision due to the downgrade of the road (Figure 3). There were two driveways ending at the curve.

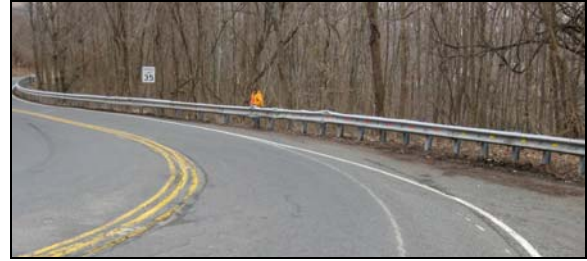
Figure 4. Damage to guardrail. There is notable damage to the rail and the posts in multiple areas.

There were at least 5 areas of damage along the W-beam guardrail, suggesting other vehicle crashes had occurred on the same curve (Figure 4). Some of the steel strong posts were also bent and damaged.

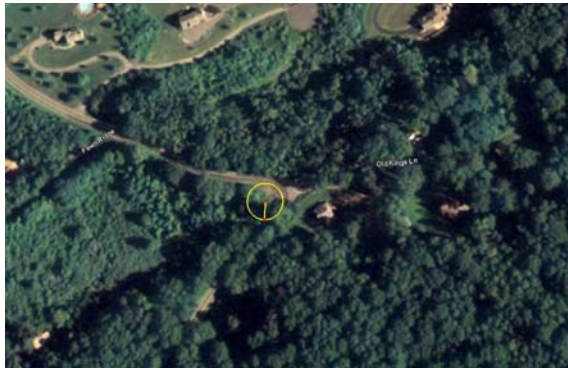
Figure 6. Radius measurement of example site.
The radius of the curve was measure to be 49 feet.

The geometry of the site was analyzed using Google Earth Pro. The radius of curvature of the site was measured to be 49 feet (Figure 6). This is a very narrow curve as none of the other sites investigated using the satellite imagery were found to have a radius under 100 feet.

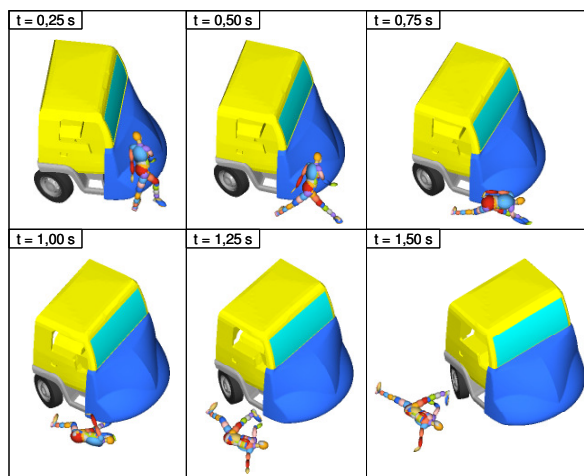
Figure 3. Deflection of the pedestrian in a right-cornering scenario (Version 84).

The kinematics of the pedestrian model can be seen in Figure 3. Shortly after the primary impact the pedestrian model loses contact to the ground and turns away from the truck. When touching the ground the right leg is already beside the plateau. The rest of the body is deflected to the side. During the secondary contact the pedestrian model rolls to the side and rests at a sufficient clearance to the truck wheels.

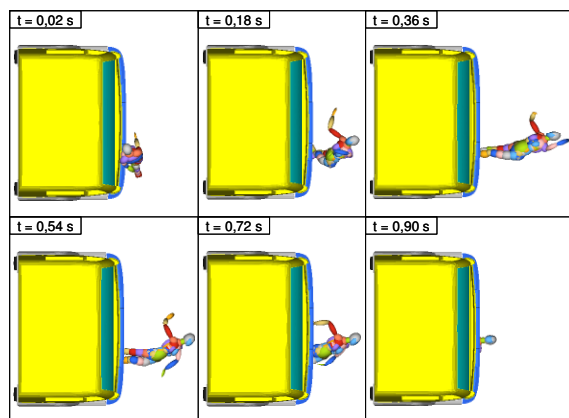
Figure 10. Kinematics of the 5 % female in the straightforward driving scenario.

Figure 10 shows an example of a run over situation in the straightforward driving scenario. The sequence shows the 5 % female at a collision angle of 75° positioned 50 cm right from the front centre. Arms and legs are in position 1. As a result of the steep front it cannot be avoided that the pedestrian reaches under the truck. In the sequence the model is only run over but in 11 of the 16 cases within this scenario the pedestrian model is actually rolled over. Five of these cases are highly crucial as essential body regions are rolled over.

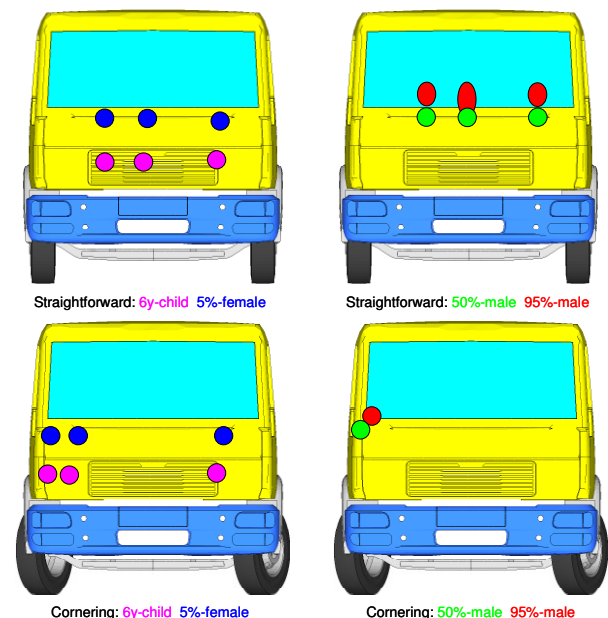
Figure 12. Head impact areas.

The head impact areas can be seen in Figure 12 divided into straightforward driving and cornering scenario. On the left side impact areas of the six year old child and the 5 % female are illustrated. The right side shows the impact areas of the male pedestrian models. Each mark represents one of the defined scenarios and comprises all impact points of the corresponding model within this scenario. A missing mark indicates, that a head impact has not been detected in all of the four belonging cases.

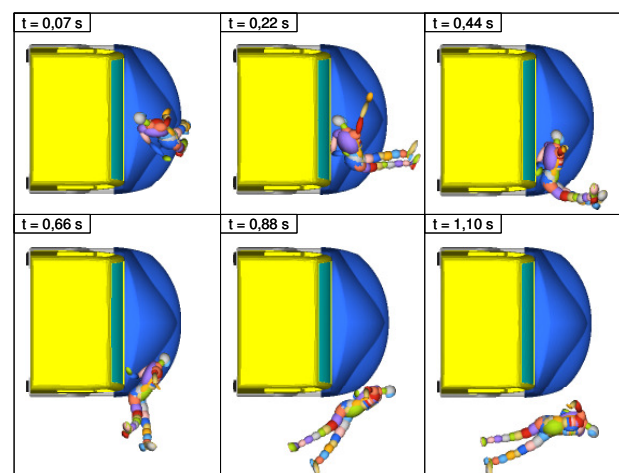
Figure 13. Kinematics of the 95 % male in the straightforward driving scenario.

Figure 13 shows an example of a prevented run over situation in the straightforward driving scenario. The sequence shows the 95 % male model in posture 1 with an impact angle of 90°.

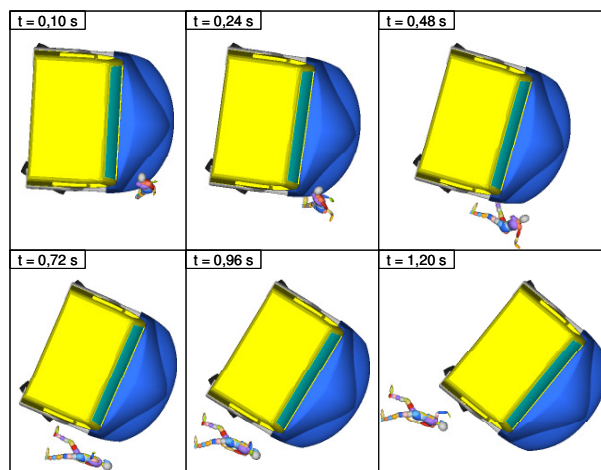
Figure 14. Kinematics of the 6 year old child in the cornering scenario.

In Figure 14 an example of the right cornering scenario is displayed. It shows the kinematics of the six year old child model with arms and legs in position 2 and a collision angle of 90°. In the illustrated position at 100 cm right to the centre of the truck front only one case is critical. The torso of the 95 % male dummy is rolled over due to a disadvantageous drop behaviour caused by a broken shinbone. In all other cases the kinematics are good.

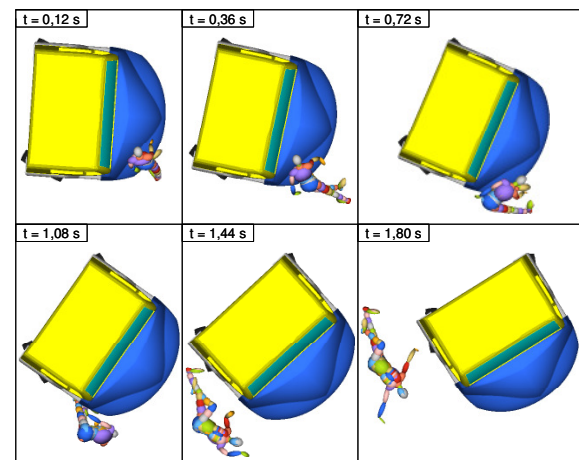
Figure 15. Kinematics of the 50 % male in the cornering scenario.

no critical cases in this scenario as well. Nevertheless, the pedestrian safety is improved. In the basis model the lower extremities are rolled over. This can be avoided with the improved front structure

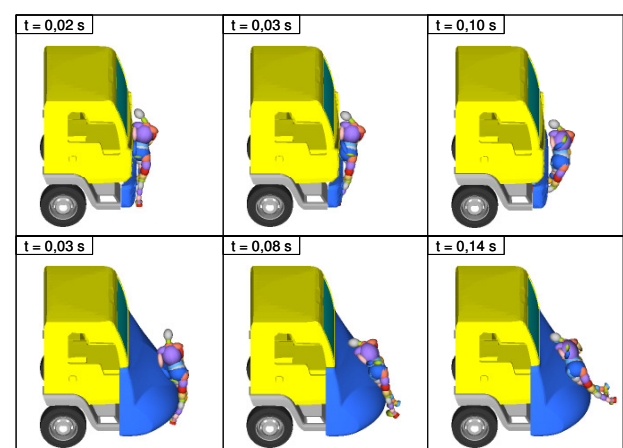
Figure 16. Comparison of primary contact with basis and optimised front (50 % male).

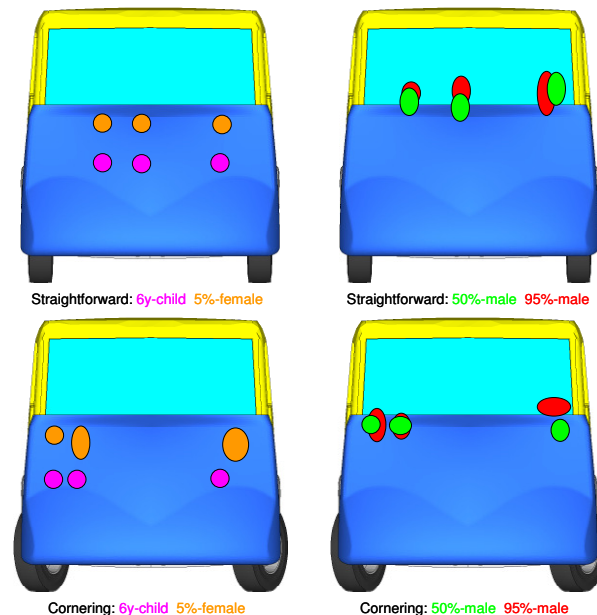
Figure 17. Head impact areas.

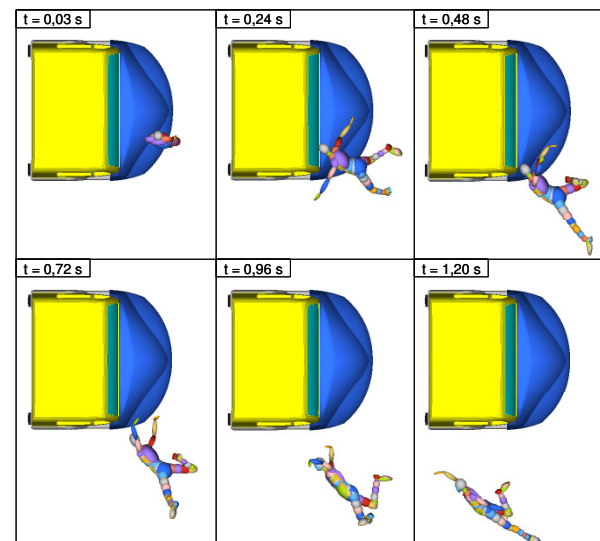
Figure 18. Kinematics of the standing 50 % male model.

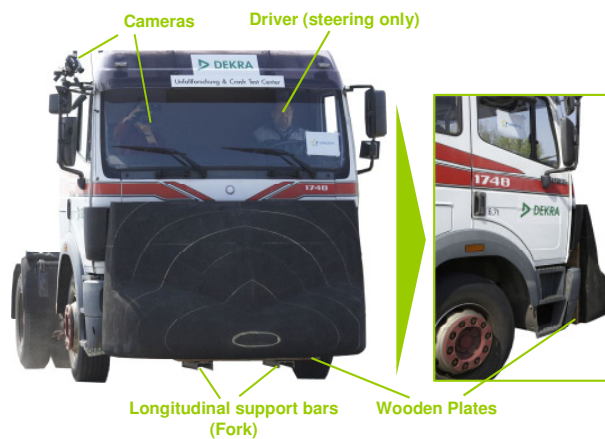
Figure 19. Connection of prototype to the truck. [5]

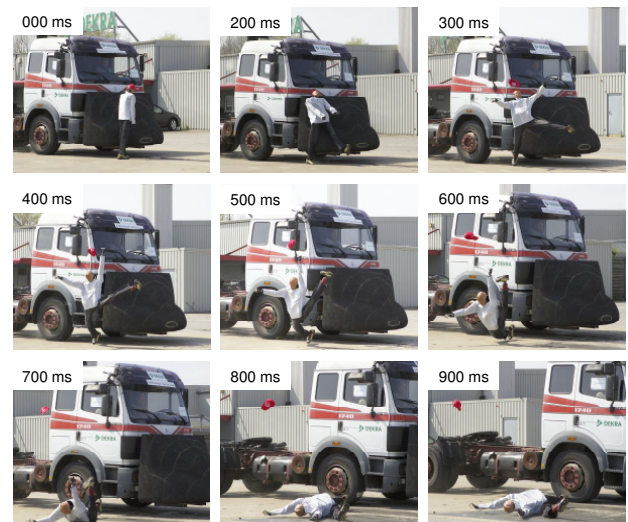
Figure 20. Experimental test. [5]

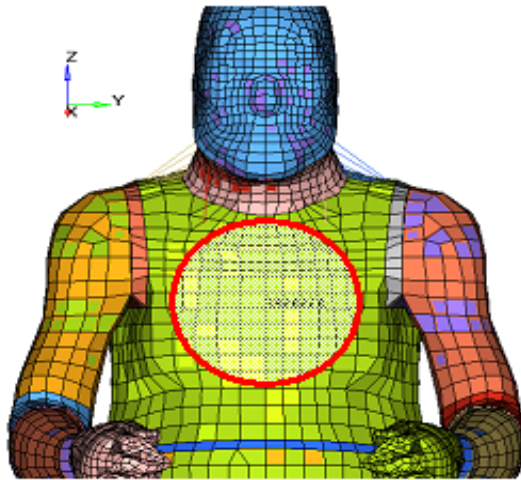
Figure 1. Frontal impact location.

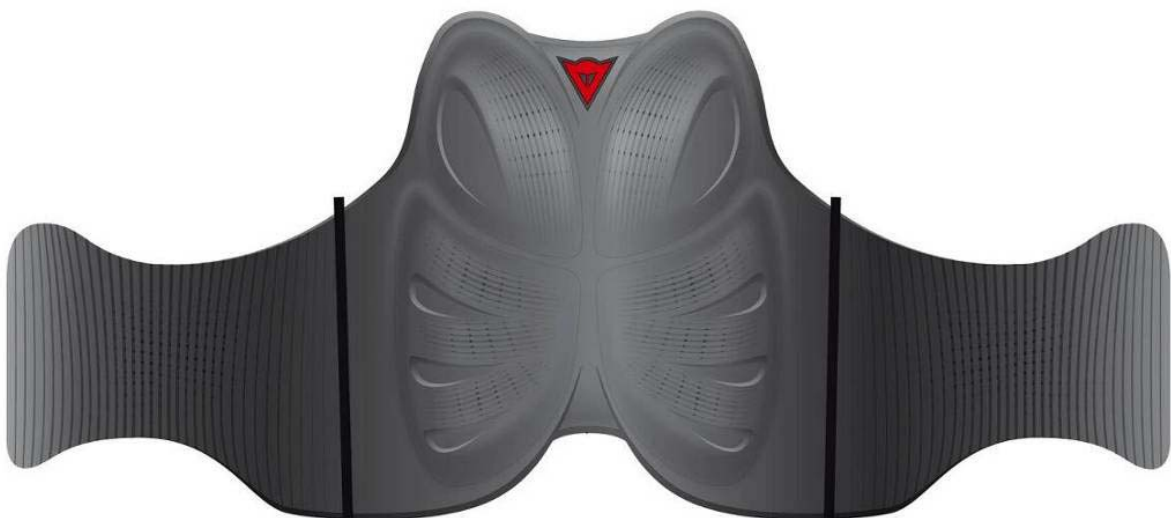
Figure 3 Thorax protector draft design

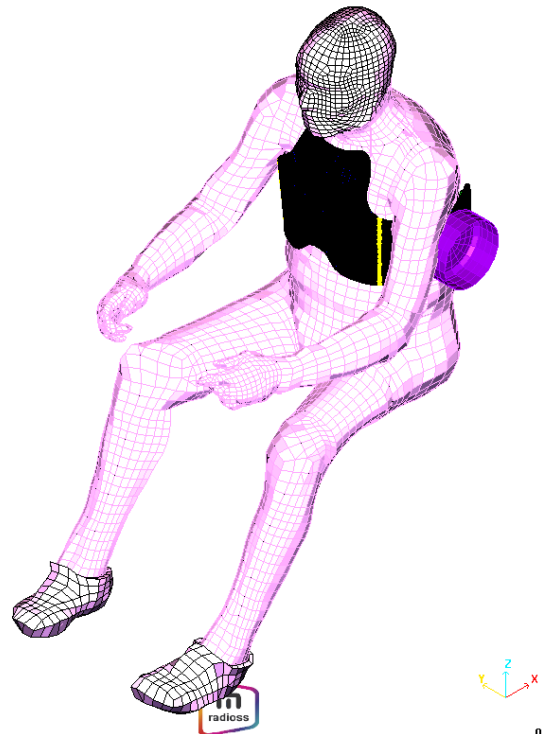
Figure 6. Set-up for simulation of lateral impact including the thorax protector.

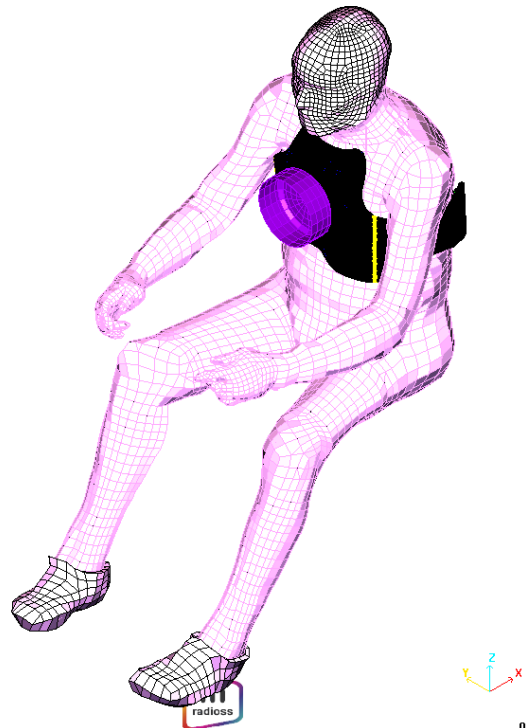
Figure 7. Set-up for simulation of frontal impact including the thorax protector.

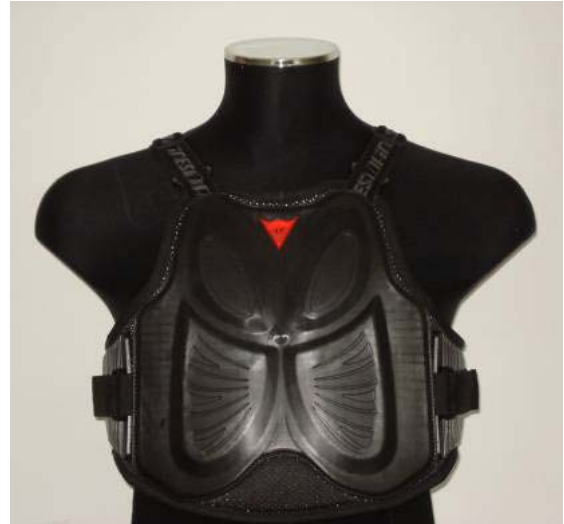
Figure 9. Protector without honeycomb

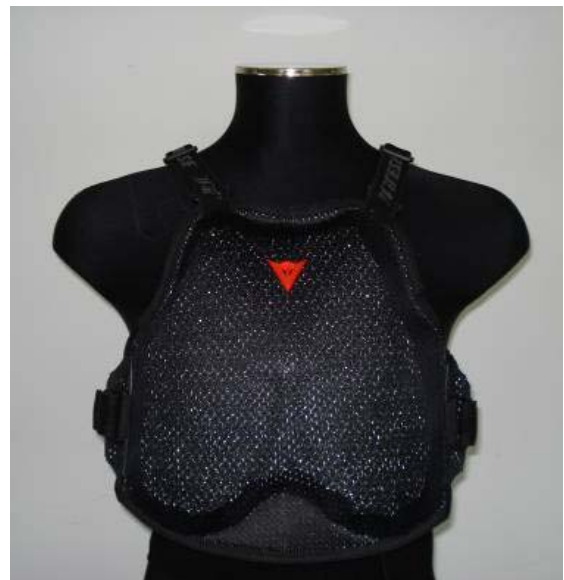
Figure 10. Protector with honeycomb outside.

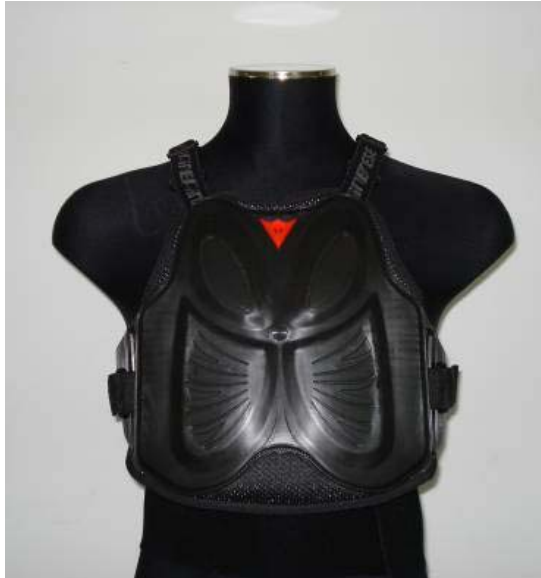
Figure 11. Protector with honeycomb inside.

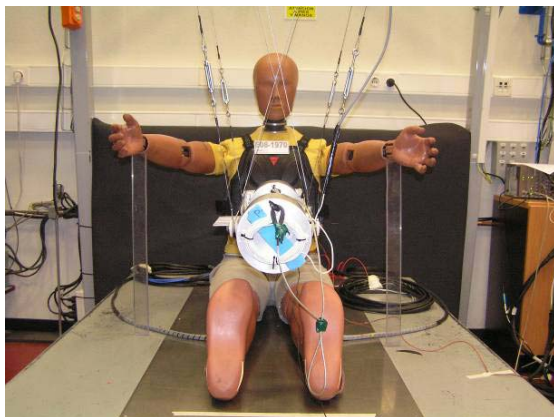
Figure 12. Impact test with Hybrid III – frontal view.

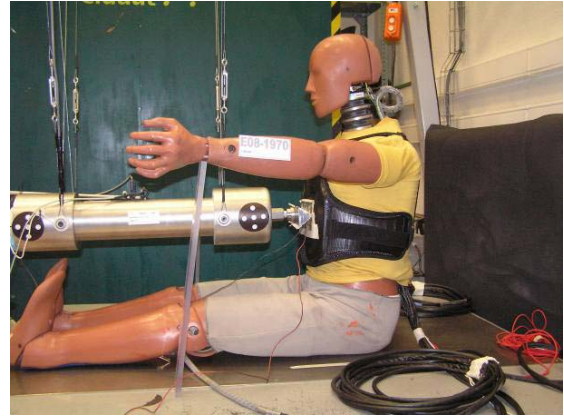
Figure 13. Impact test with Hybrid III – lateral view.

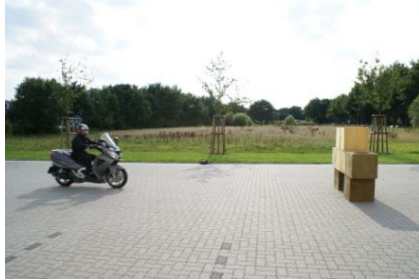
Figure 5. PTW travelling towards a fixed obstacle.

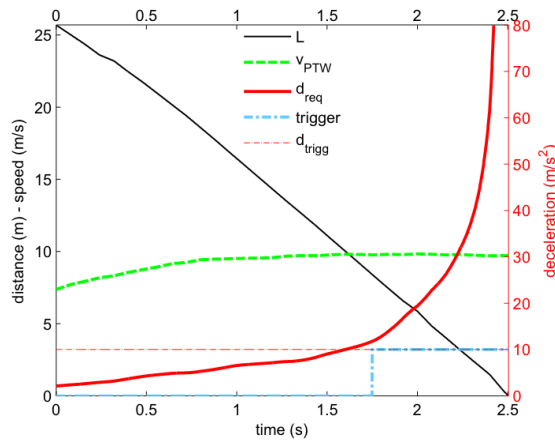
Figure 7. Risk evaluation for a specific PTW travelling towards fixed obstacle with no awareness.

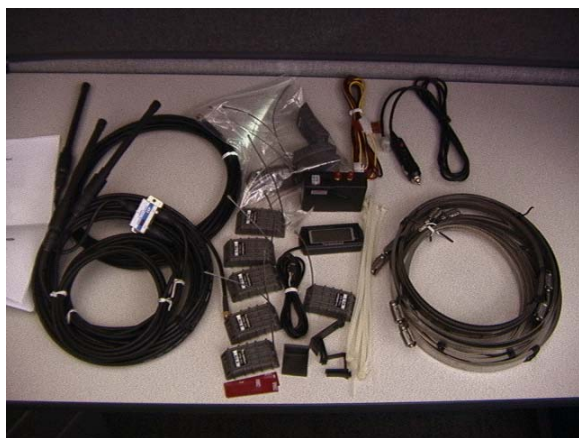
Figure 3. Tire-SafeGuard (rim mount) components kit.

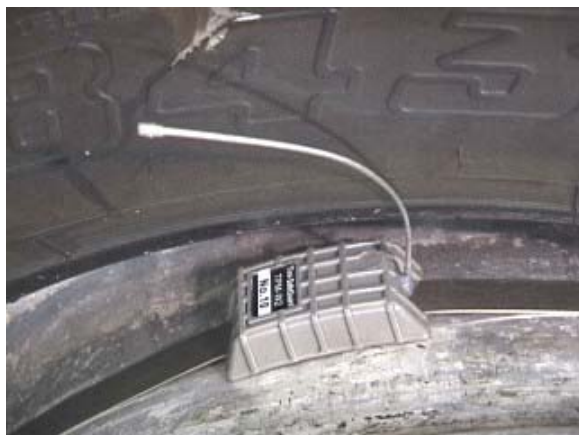
Figure 4. Tire-SafeGuard sensor and rim-mounting band – showing antenna.

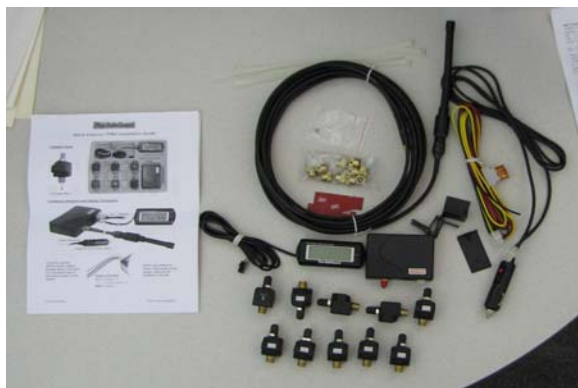
Figure 6. Tire-Safeguard (flow-through) components kit.

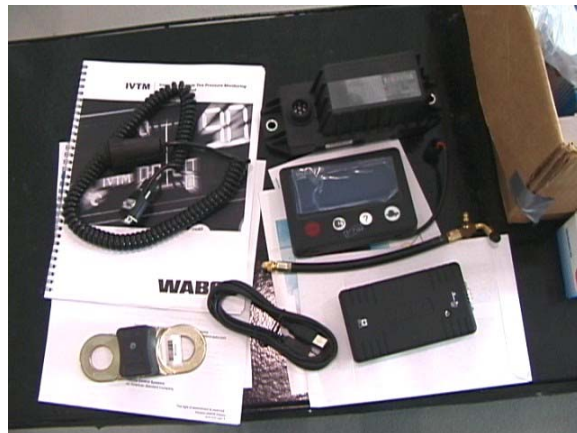
Figure 8. IVTM components kit.
