Update on Investigation of New Side Impact Test Procedures in Japan

National Traffic Safety and Environment Laboratory

Paper Number 11-0200

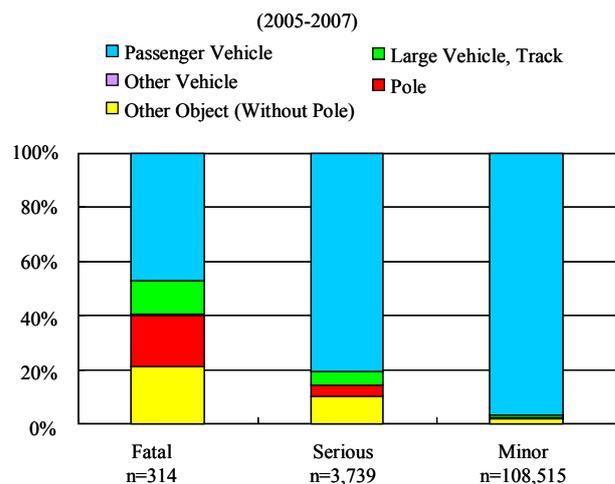
Figure 1 - Type of striking vehicle and object involved in side impact accidents (fatal, serious and minor injuries).

As for the minor injury accidents of a vehicle being struck by “passenger vehicles,” 70% of the injured body regions were the “neck.” As shown in Figure 1, 97% of the striking objects were “passenger vehicle” in minor injury accidents. That is, almost all of the injured body regions in minor accidents were the “neck.”

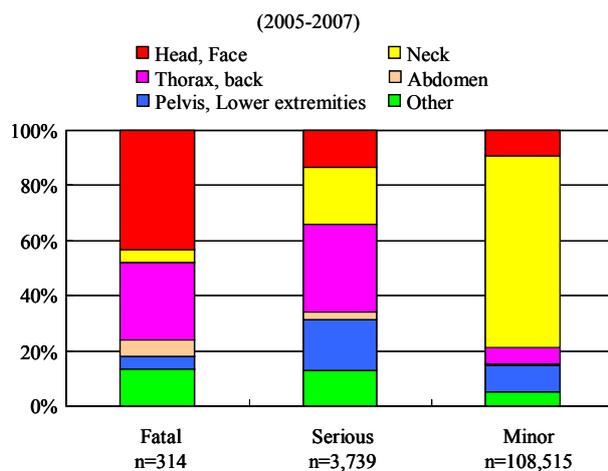
Figure 2 shows the injured body regions of the occupants by injured level. In the fatal accidents, 43%

of the injured body regions were the “head, face” and 28 % were the “thorax, back.” In the serious injury accidents, 32% of the injured body regions were the “thorax, back,” 21% were the “neck,” 19% were the “pelvis, lower extremities,” and 13% were the “head, face.” In minor injury accidents, 69% of the injured body regions were the “neck.” The “head, face” was the largest source in fatal accidents and not a small source in the serious injury accidents. The “thorax, back” was the next largest source in the fatal accidents and the largest source in the serious injury accidents. Thus, it has been determined that protecting the head and thorax of the occupant is important for reducing the fatal and serious side impact accidents.

Figure 2 - Injured body regions in side impact accidents by injury level.

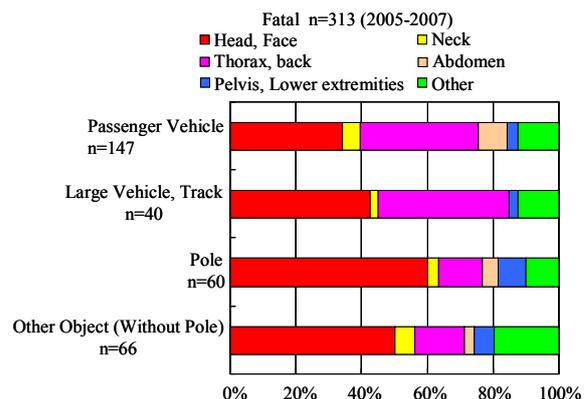
Figure 3 shows the injured body regions of the Figure 3, 4, and 5 show the injured body regions of the occupants by striking objects in the fatal, serious injury, and minor injury accidents. As for the fatal accidents, when struck by “passenger vehicles,” 36% of the injured body regions were the “thorax, back” and 34% were the “head, face.” When struck by “large vehicles, trucks,” 43% of the injured body regions were the “head, face” and 40% were the “thorax, back.” When struck by a “pole,” 60% of the injured body regions were the “head, face” and 13% were the “thorax, back.” When struck by “other object (without pole),” 50% of the injured body regions were the “head, face” and 15% were the “thorax, back.” In the side impact fatal accidents where the vehicle was struck by another vehicle, the number of occupants injured at the “head, face” and “thorax, back” was similar and larger than that for the other body regions. In the side impact fatal accidents where the vehicle was struck by “other object,” the number of the occupants injured at the “head, face” was larger than that for all of the other body regions.

Figure 3 - Injured body regions for fatal side impact accidents by striking object.

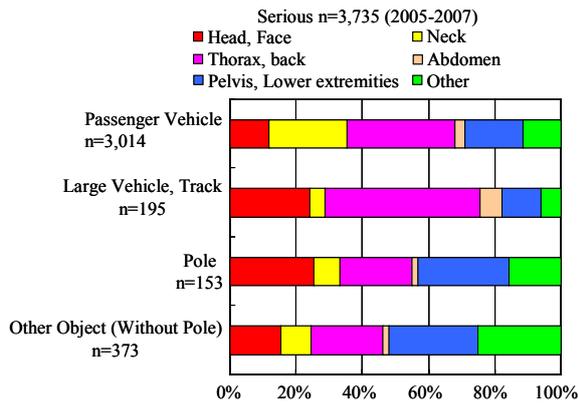
As for the serious injury accidents, when struck by “passenger vehicles,” 33% of the injured body regions were the “thorax, back” and 24% were the “neck.” When struck by “large vehicle, truck,” 47% of the

injured body regions were the “thorax, back” and 24% were the “head, face.” When struck by “pole,” 27% of the injured body regions were “pelvis, lower extremities,” 25% were the “head, face,” and 22% were the “thorax, back.” When struck by “other object (without pole),” 27% of the injured body regions were the “pelvis, lower extremities” and 22% were the “thorax, back.” In the side impact serious accident of the vehicle struck by a “passenger vehicle,” the number of occupants that injured the “neck” was larger probably because the serious injury had been judged during the days that the victim visited the hospital. And in Japan, generally, the neck-injured occupants in a traffic accident visit the hospital for a longer time even though the injury may have had an AIS value of 1. In all cases, the percentage of occupants that injured the “thorax, back” was larger than 20%, especially for the case involving being struck by a “large vehicle, truck,” which was 47% and was larger than any other case. In the side impact fatal accidents involving a vehicle being struck by a “large vehicle, truck” and a “pole,” the percentage of occupants that injured the “head, face” was larger than 20% and was larger than that for the other cases. In the side impact fatal accidents involving vehicles being struck by objects, the percentage of occupant that injured the “pelvis, lower extremities” was 27% and was the largest body injured region for this case.

Figure 4 - Injured body regions for serious injuries in side impact accidents by striking object.

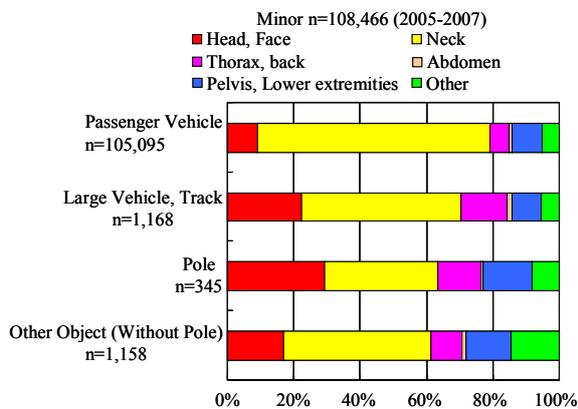
Figure 5 - Injured body regions for minor injuries in side impact accidents by striking object.

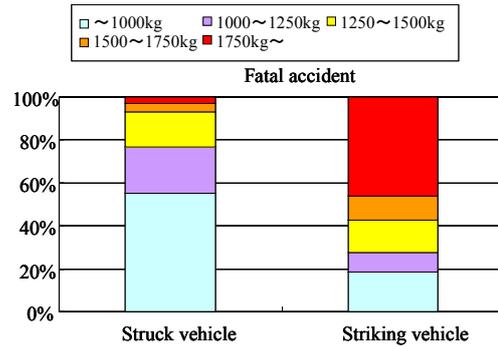
Figures 6, 7, and 8 show the curb mass of the striking vehicles and struck vehicles in the fatal accidents, serious accidents, and minor accidents, respectively. As for the fatal accidents, the percentage for which the curb mass of the striking vehicles was larger than 1500 kg was about 57%; while, in contrast, the percentage for which the curb mass of the struck vehicles was smaller than 1250 kg was about 76%. The percentage rate of the heavier vehicles was large for the striking vehicle, and the percentage rate of the lighter vehicles was large for the struck vehicle.

Figure 6 - Curb mass of the struck vehicles and striking vehicles for fatal in side impact accidents.

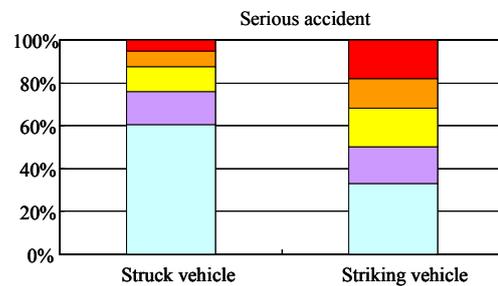
As for the serious accidents, the percentage of the striking vehicles that the curb mass was larger than 1500 kg was about 31%; while, the percentage of the struck vehicles that the curb mass was smaller than 1250 kg was about 76%. The percentage rate of lighter vehicles was relatively large for the struck vehicle. The percentage rate of heavier vehicles was relatively large for the striking vehicle in the serious accidents but smaller than that in the fatal accidents.

Figure 7 - Curb mass of the struck vehicles and striking vehicles for serious in side impact accidents.

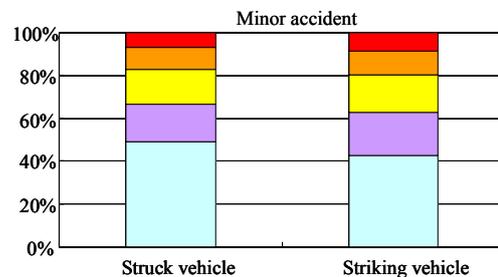
As for the minor accidents, the percentage rates of the curb mass of the striking vehicles and that of the struck vehicles were similar. In the serious injury and

Figure 8 - Curb mass of the struck vehicles and striking vehicles for minor in side impact accidents.

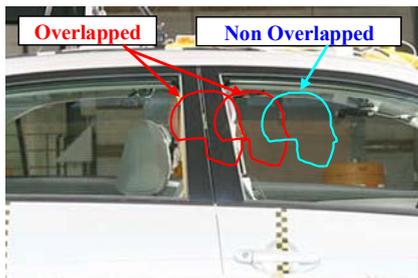
Side views of vehicles traveling in both directions on a road near an intersection were filmed with a video recorder. Using the side view of the filmed occupants, the percentage of the occupants whose head overlapped with the B-pillar was examined. The head positions of the drivers (right side) and the front passengers (left side) were surveyed. The surveyed vehicles were limited to the passenger cars (sedans, wagons, K-cars and IBOXs). That is, large vehicles (such as trucks and buses) and 2-door cars were excluded from the survey. In total, 565 cars were surveyed from the driver side, and 1,290 cars were surveyed from the front passenger side. However, note that only 165 front passengers were examined since the front passenger seating frequency was observed to be only 13%. Figure 9 shows the criterion used to evaluate whether the head overlapped the B-pillar. Note that, even if only a portion of the head overlapped with the B-pillar, it was defined as head/B-pillar overlap.

Figure 9 - The criterion of judgment for the head overlapping the B-pillar.

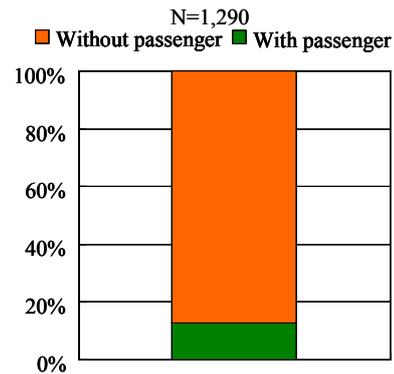
Figure 10 shows the percentage of vehicles that have passengers in the cars in this research. As already mentioned above, the number of vehicles that contained an occupant seated in the passenger seat was 165 during this research.

Figure 10 - The percentage of vehicles containing a front seat passenger occupant.

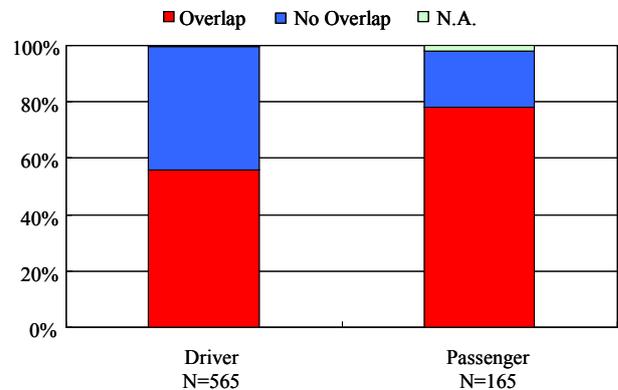
Figure 11 shows the percentages of head/B-pillar overlap for the driver and front passenger. Fifty-six percent of drivers and 78% of front passengers were determined to have head/B-pillar overlap. The percentage of front passengers was large probably because front passengers have the freedom to change their seat positions, whereas the driver must adjust the seat to accommodate reaching the steering wheel and floor pedals in order to drive the vehicle.

Figure 11 - Percentages with head and B-pillar overlap by front seat seating position.

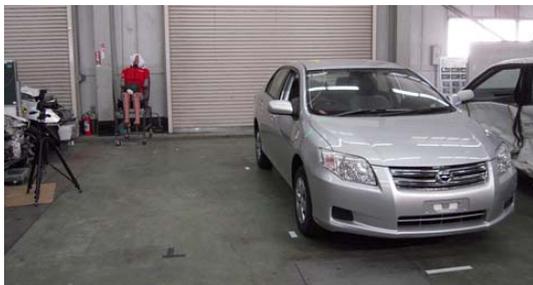
females being 8. Figure 12 shows the vehicle and the camera position used in this study. Figure 13 shows an example case of this study. Figure 14 shows the measurements of the distance from the B-pillar to the head. The distance was measured from the center of the ear to the front edge of the B-pillar.

Figure 12 - The vehicle and the camera position in this study.

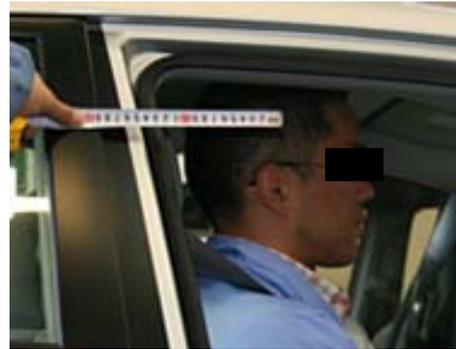
Figure 14 - The measurement of the distance from B-pillar to the head.

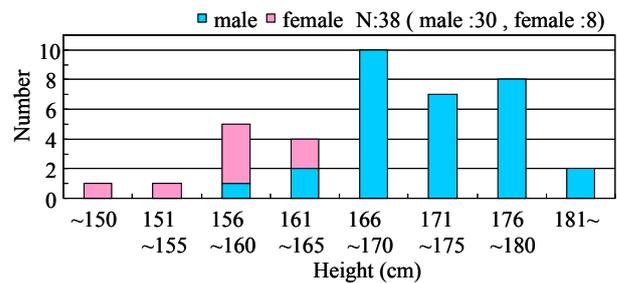
Figure 15 shows the heights of the examinees. The average height of the examinees was 169 cm, with that of the males being 172 cm and that of the female being 157 cm. In this study, the height of the 50th percentile Japanese male was 170 cm and that of the 50th percentile Japanese female was 158cm.

Figure 15 - The height of the examinees by the sex.

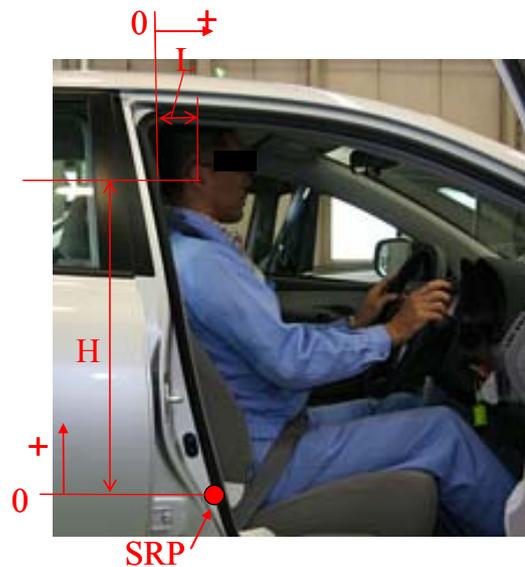
Figure 16 shows the different measurements made for locating the head position in this research. L is defined at the horizontal distance from the center of the ear hole to the front edge of the B-pillar. H is defined as the vertical distance from the Seat Reference Point (SRP) to the center of the ear hole. The zero point of L is defined to be the front edge of the B-pillar, and the positive direction is defined as the direction heading from the rear of the vehicle to the front of the vehicle. So when the parameter L measurement was large, the distance from the B-pillar to the head was large. And when the parameter L measurement was negative, the B-pillar and the ear hole were overlapped. The zero point of H is the SRP location, and the positive direction is in the direction from the seat bottom up to the roof of the vehicle.

Figure 16 - The definition of the measurements.

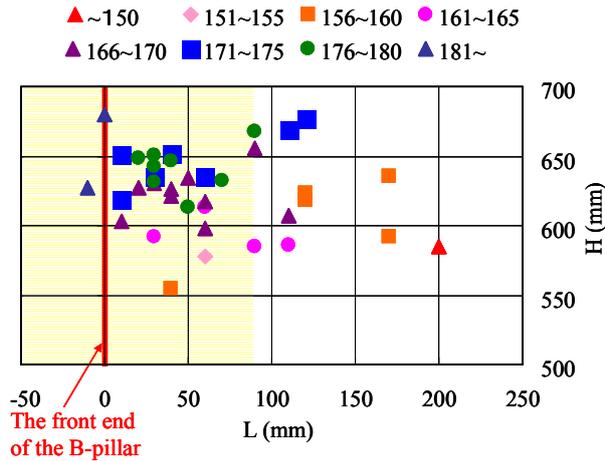
Figure 17 shows the head positions of the examinees by the height in this research. The 50th percentile of the Japanese head length from the forehead to the rear of the head is about 180 mm. If the center of the ear hole is assumed to be the center of the head, an L measurement smaller than 90 mm indicates that the head and B-pillar were overlapped. The yellow area of Figure 17 depicts the measurements in which the L measurements were smaller than 90 mm. The number of measurements in the yellow area was 26 and

represented 68% of the examinees. From the pictures, the number that overlapped the head and B-pillar was 30 and near to the number from the judgment from Figure 17. It seemed to be a tendency that, when the height was large, the L was small and the distance from B-pillar to the center of the head was small. But, there were some cases that, even though the height was large, the L was large. For example, the maximum L of the height in the range “151~155” was larger than the minimum L of the height in the range of “171~175”. This was most likely due to that individual variability was larger than the influence of the height.

Figure 17 - The head positions of the research by the height.

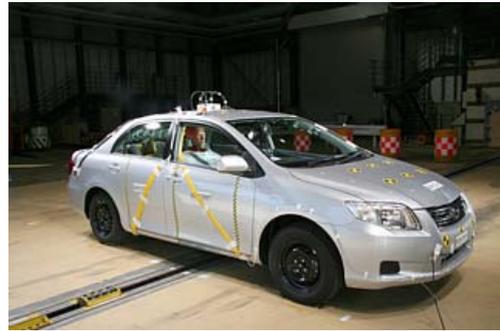
In order to understand the effectiveness of the CSA, a series of crash tests were carried out using two types of vehicles as a struck vehicle. Vehicle 1 was a sedan type small passenger vehicle that is popular in Japan. Vehicle 2 was a K-car that is categorized in Japan as a very small size vehicle. Vehicle 2 also is a popular K-car in Japan. Figure 18 shows Vehicle 1 and Figure 19 shows Vehicle 2. Table 1 presents the test vehicles’ specifications. The Vehicle 1 was 220 mm larger in width and 310 kg heavier in curb weight than Vehicle 2. Tests 1, 2, 4, and 5 were conducted based on the specifications of Regulation ECE/R95 other than the aspect for the positioning of the dummy as previously stated. The dummy position was defined such that the dummy head overlapped the B-pillar. Figure 20 shows the ECE/R95 mobile deformable barrier (MDB) used in this test series.

Figure 18 - The photo of the Vehicle 1 that was the small passenger vehicle tested in this study.

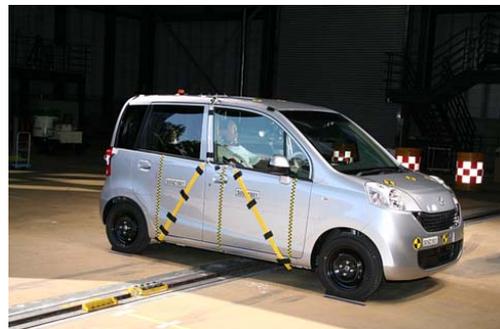
Figure 19 - Photo of Vehicle 2 that was the K-car tested in this study.

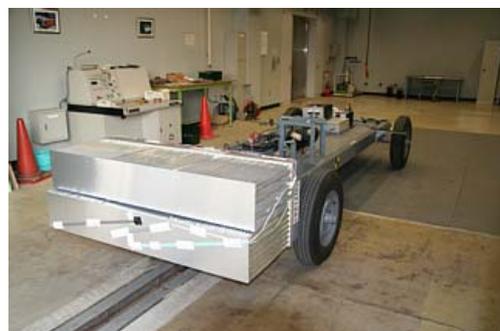
Figure 20 - Photo of the ECE/R95 MDB used in this study.

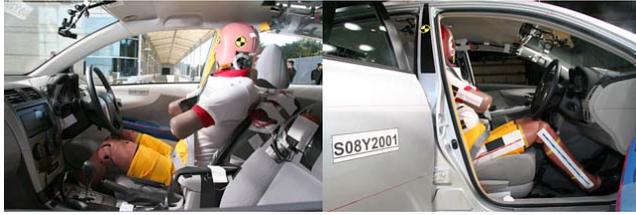
Figures 21 and 23 show the dummy seating postures in the Vehicle 1 and 2 before the tests 1, 2, 4 and 5. As shown, it is seen that the dummy head and B-pillar overlapped. Tests 3 and 6 were the JNCAP tests conducted of Vehicle 1 and Vehicle 2, from which data was used for reference, though the impact

Figure 21 - The photos of dummy seating position in Vehicle 1 before tests 1 and 2.

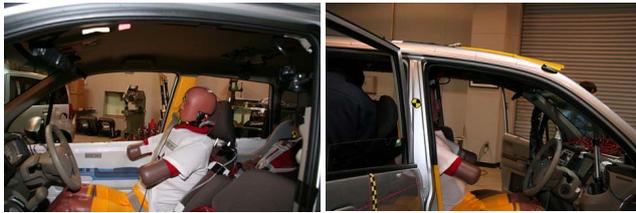
Figure 23 - Photos of dummy seating position in Vehicle 2 before tests 4 and 5.

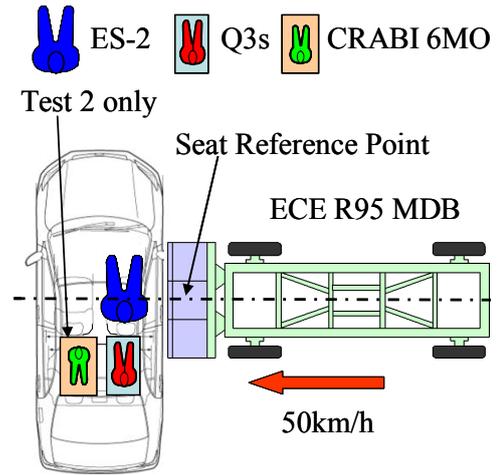
Figure 25 and Table 2 show the test configuration and specifications of Vehicle 1. Figure 26 and Table 3 show the test configuration and specifications of Vehicle 2. For these tests, ES-2 dummies were seated in the front driver seats of the struck vehicle. In addition, a front facing child restraint system (CRS) was installed in the rear right seat (near side) and a Q3s dummy was placed in the CRS in Tests 1, 2, 4, and 5. Additionally, in Test 2, a rear facing CRS was installed in the rear left seat and a CRABI 6-month dummy was placed in the CRS. In this study, the injury measures and kinematic behavior of the ES-2 dummies in the front seats of the struck vehicles are compared.

Figure 25 - Test configuration of Vehicle 1.

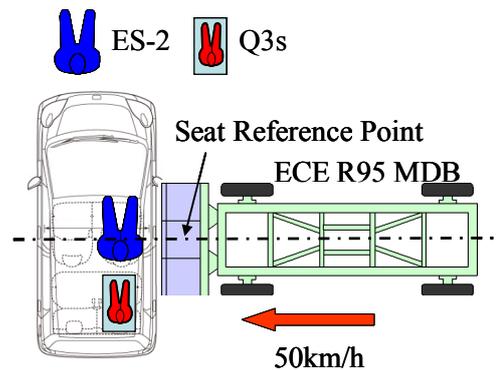
Figure 26 - Test configuration of Vehicle 2.

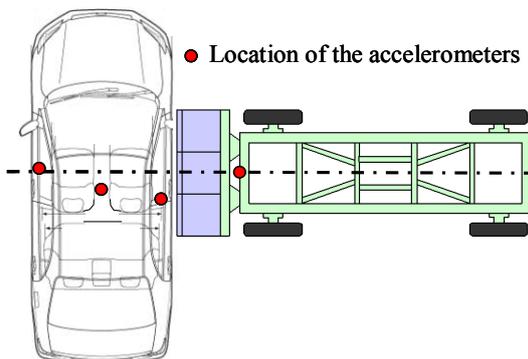
Uni-axial accelerometers were attached to the B-pillar inner panel and to the opposite side sill at the center of the front door of the struck vehicles; and tri-axial accelerometers were attached to the center of gravity (C.G.) of both the striking MDB and struck vehicles. The locations where the accelerometers were attached are shown in Figures 27 and 28.

Figure 27 - Locations of accelerometers in Vehicle 1.

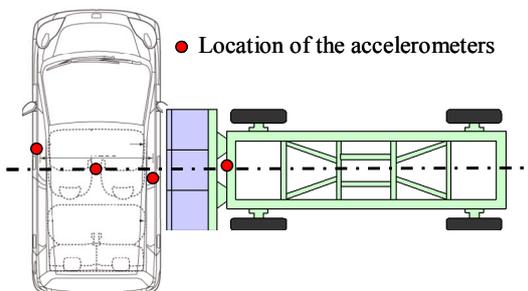
Figure 28 - Locations of accelerometers in Vehicle 2.

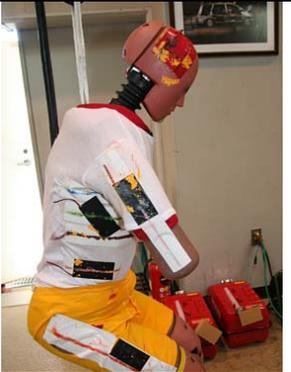
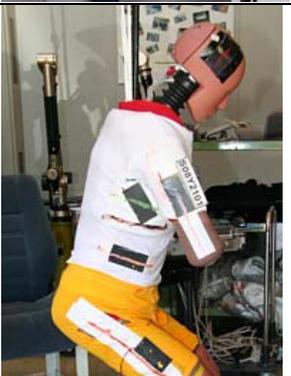
Table 5 – The interior and dummy in Vehicle 1 after the crash test

Photographs of the vehicles interior conditions and dummy taken after Tests 1 and 2 were conducted are shown in Table 5, and those after Tests 4 and 5 were conducted are shown in Table 6. The contact points of the dummy head with the vehicle interior are marked with the red circles. As for the vehicle without a CSA (Tests 1 and 4), the contact points of the vehicle interior to the dummy head were the B-pillar. In Test 2, the paint mark of the dummy head was at the CSA inflated area. In Test 5, the paint mark from the head contact was at a section of the CSA where it did not inflate, but as can be seen in the photograph was very near to the inflated area.

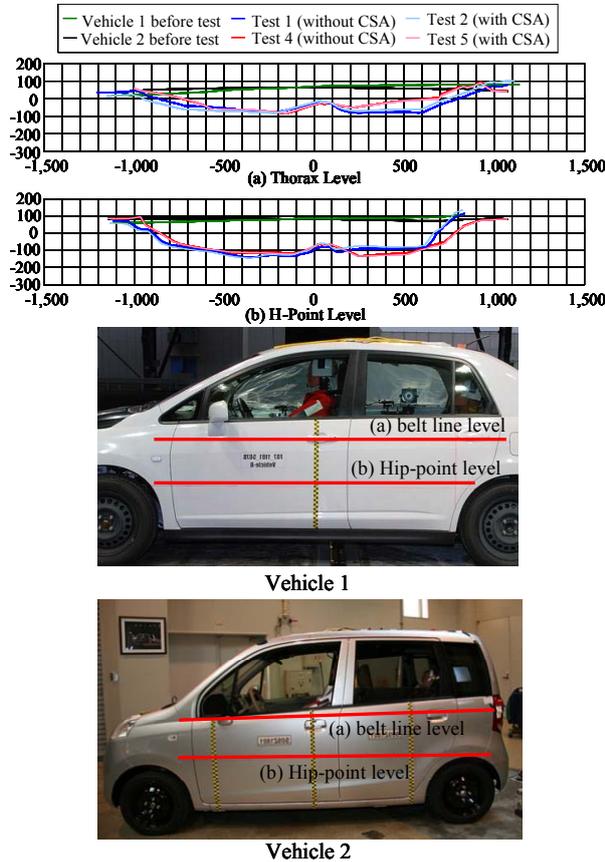
The exterior deformations of the struck vehicles at the belt line level and the Hip-point level after tests 1, 2, 4 and 5 are shown in Figure 29. At the belt line level of the SRP (i.e., at about -126 mm), the deformations of the struck vehicles measured in all tests were almost the same (about 140 mm). At the Hip-point level of the SRP, the deformations of the struck vehicles in all tests were almost the same (about 210 mm).

Figure 29 - Exterior deformation of struck vehicles.

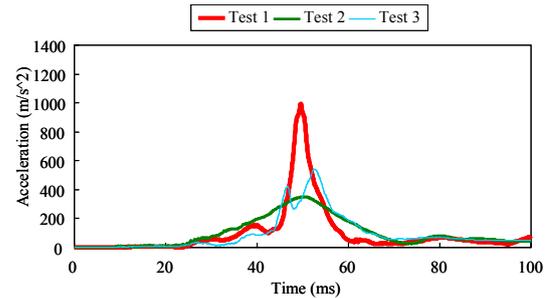
of the dummies during these tests are shown in Figures 30 and 31. In all tests, the initial rise time of the head resultant acceleration occurred at about 20 ms. Sharp rises occurred at about 45 ms in Tests 1 and 3 and at about 50 ms in Tests 4 and 5. In Tests 2 and 6, a sharp rise did not occur. The reason why the sharp rise did not occur in Test 6 was that the head did not make contact to the vehicle interior during the test. As for the maximum resultant acceleration, Test 4 had the largest magnitude at 1207 m/s². The magnitude of the acceleration in Test 1 was the next largest at 996 m/s². The magnitude in Test 5 was next to Test 1 at 808 m/s². The magnitude in Test 6 was next to Test 5 at 556 m/s². The magnitude in Test 3 was next to Test 6 at 543 m/s². The magnitude in Test 2 was the smallest at 351 m/s².

Regarding a comparison between the same vehicle type, the dummy maximum head resultant acceleration in a vehicle with a CSA was smaller than that in a vehicle without a CSA. Also, the dummy maximum head resultant acceleration in a vehicle without a CSA when the dummy head was not overlapped with the B-

pillar was smaller than that when the dummy head was overlapped with the B-pillar (though the MDB impact speed was 5 km/h higher when the dummy head was not overlapped). As for the difference between the maximum head resultant accelerations of the dummies in a vehicle with and without a CSA, Vehicle 1 had a larger difference than Vehicle 2. The reason of the difference was probably due to the difference of the design of the inflated area of CSA, specifically the CSA equipped in Vehicle 1 restrained the dummy head before the dummy head made contact to B-pillar; whereas the CSA equipped in Vehicle 2 did not restrain the head before the contact occurred.

Figure 30 - Head resultant accelerations time histories in Vehicle 1.

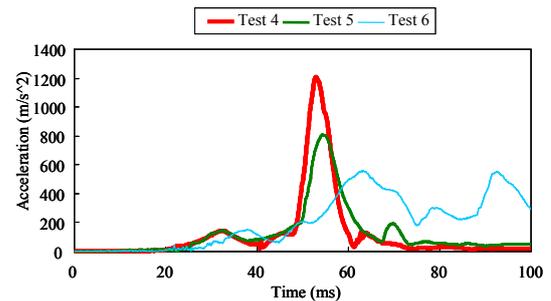
Figure 31 - Head resultant accelerations time histories in Vehicle 2.

As for the head performance criterion (HPC), more specifically the Head Injury Criterion (HIC), Test 4 was calculated to be 588 and was the largest of all the tests. Test 6 was calculated to be 411 and was the next largest, but the dummy head did not make contact to an object as seen from the video. (This is the reason why the shape of the head resultant acceleration time history of Test 6 was different from those of the other

tests as shown Figure 31). HPC is used for the case when the head makes contact to an object. So the HPC of Test 6 was the reference. Test 5 was calculated to be 274 and was the next to Test 6. Test 1 was calculated to be 255 and was next to Test 4; however, it was similar to that in Test 4. Test 3 was calculated to be 113 and was the next to Test 1. Test 2 was calculated to be 86 and was the smallest of all the tests.

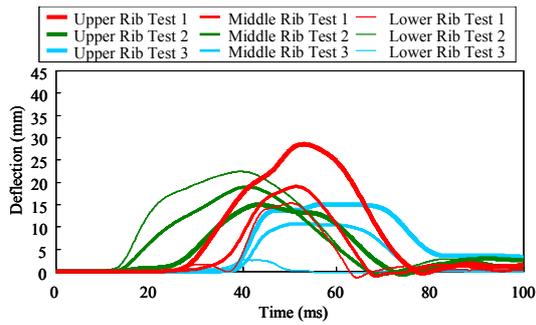
The time histories of the thoracic rib deflections of the dummies are shown in Figures 32 and 33. As for the initial rise time of the thoracic rib deflection, the rise time in Test 2 occurred at about 15 ms and that in Test 5 occurred at about 16 ms. Both initial rise times occurred earlier in these tests than in the other tests. The initial rise time in Test 6 occurred at about 20 ms and was next in time after that for Tests 2 and 5. The initial rise time in Test 4 occurred at about 24 ms and was next in time after that for Test 6. The rise time in Test 1 occurred at about 29 ms and was next in time after that for Test 1. The rise time in Test 3 occurred at about 38 ms and was the latest in time of all of the tests. As seen in these figures, the initial rise times of the thoracic rib deflection in the vehicles with a CSA and SAB were earlier than those in the vehicles without a CSA and SAB.

Figure 32- Thoracic rib deflections time histories in Vehicle 1.

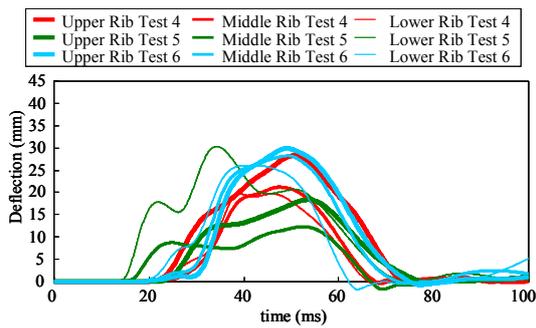
Figure 33- Thoracic rib deflections time histories in Vehicle 2.

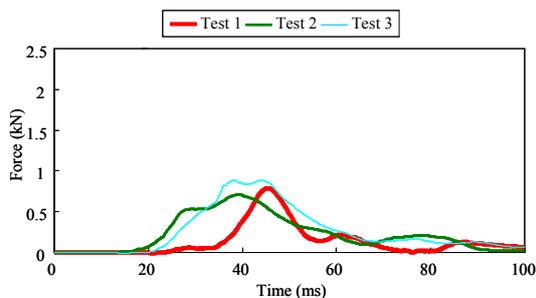
The time histories of the abdominal forces of the dummies are shown in Figures 34 and 35. As for the initial rise time of the abdominal forces, the rise time in Test 5 occurred at about 16 ms and was the earliest occurring in all of the tests. The rise time in Test 2 occurred at about 20 ms and was the next earliest occurring. The rise time in Tests 3 and 6 occurred at about 22 ms and were next in time after Test 2. The rise time in Test 4 occurred at about 25 ms and was next in time after Tests 3 and 6. The rise time in Test 1 occurred at about 35 ms and was the latest occurring in all of the tests. Regarding the comparison between the same vehicle type, the initial rise times of the abdominal force in the vehicles with a CSA were the earliest and those in the vehicle of J-NCAP test conditions were the next earliest. Those in the vehicles without the SAB were the latest. This may be due to the fact that the SAB covered the abdominal area.

Figure 34- Abdominal force time histories in Vehicle 1.

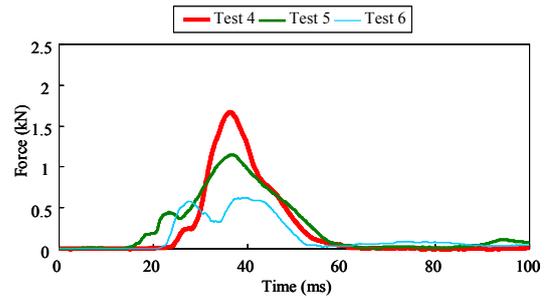
Figure 35- Abdominal force time histories in Vehicle 2.

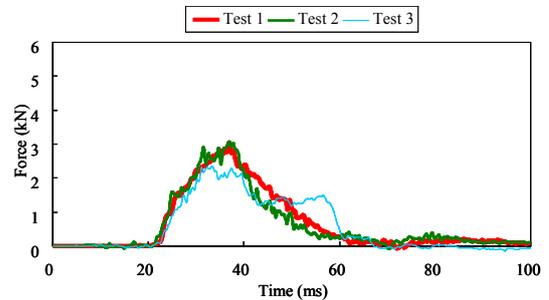
The time histories of the pubic forces of the dummies are shown in Figures 36 and 37. The initial rise times of the pubic forces occurred at about 21 ms and were very similar in all tests. This may be due to the fact that the SAB did not cover the pelvic area.

Figure 36 - Pubic force time histories in Vehicle 1.

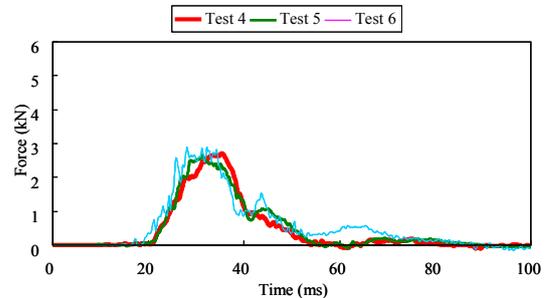
Figure 37 - Pubic force time histories in Vehicle 2.

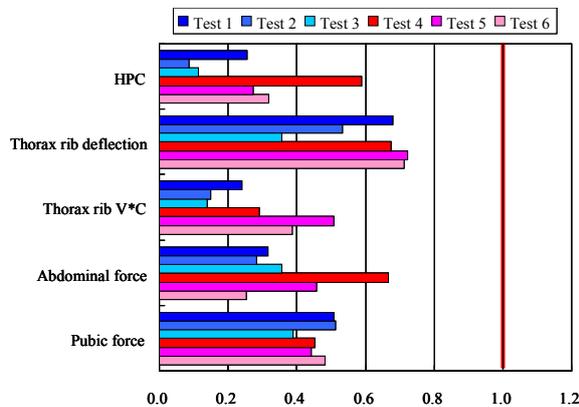
The maximum injury measures of the ES-2 dummy and the corresponding IARVs for the dummy as specified by ECE R95 are shown in Tables 11 and 12. The ratios of the injury measures to the IARVs are shown in Figure 38. As can be observed, all of the injury measures were less than the corresponding IARVs.

Figure 38 - Ratios of injury measures to IARVs.

In comparing the head injury measures within the same vehicle type, it was observed that those of the vehicle with a CSA were smaller than those for the vehicle without a CSA. As a result, it was determined that the CSA is effective in decreasing head injuries. However, the head injury measure ratio of Vehicle 1 with a CSA to that without a CSA was 0.33, and that of Vehicle 2 was 0.47; so the head injury measure
