# NHTSA RESEARCH ON IMPROVED RESTRAINTS IN ROLLOVERS

Paper Number 11-0213

# CRASH-TEST RESULTS TO ANALYSE THE IMPACT OF NON-PROFESSIONAL REPAIR ON THE PERFORMANCE OF SIDE STRUCTURE OF A CAR

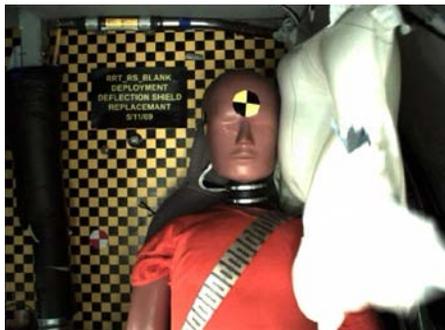
Figure 1: Deployed Airbag

The original RRT was modified to include a roof and door structure along with an inflatable curtain and was renamed the rollover reaction surface tester (RRST). The cab structure (the roof and door structure) was taken from a 2006 Honda Ridgeline truck cab, and the inflatable curtain was from a 2007 Chevrolet Silverado 1500. This structure was enhanced by various support beams to ensure multiple testing could be conducted. Although a headliner was not used, a deflection pan was fabricated to ensure a repeatable inflation into the cab structure. Figure 1 shows the curtain inflated in the cab structure. The original characteristics and framework<sup>1,2</sup> of the device remained the same.

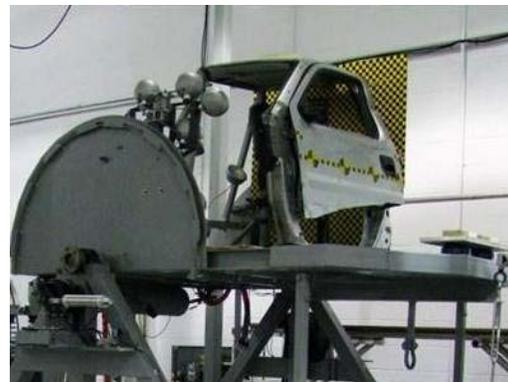
Figure 3: Rollover Reaction Surface Tester (RRST)

Figure 2 is a schematic of the device, and Figure 3 shows the actual test device. The coordinate system is set to the dummy for excursion analysis. The device has four (4) main features consisting of the following:

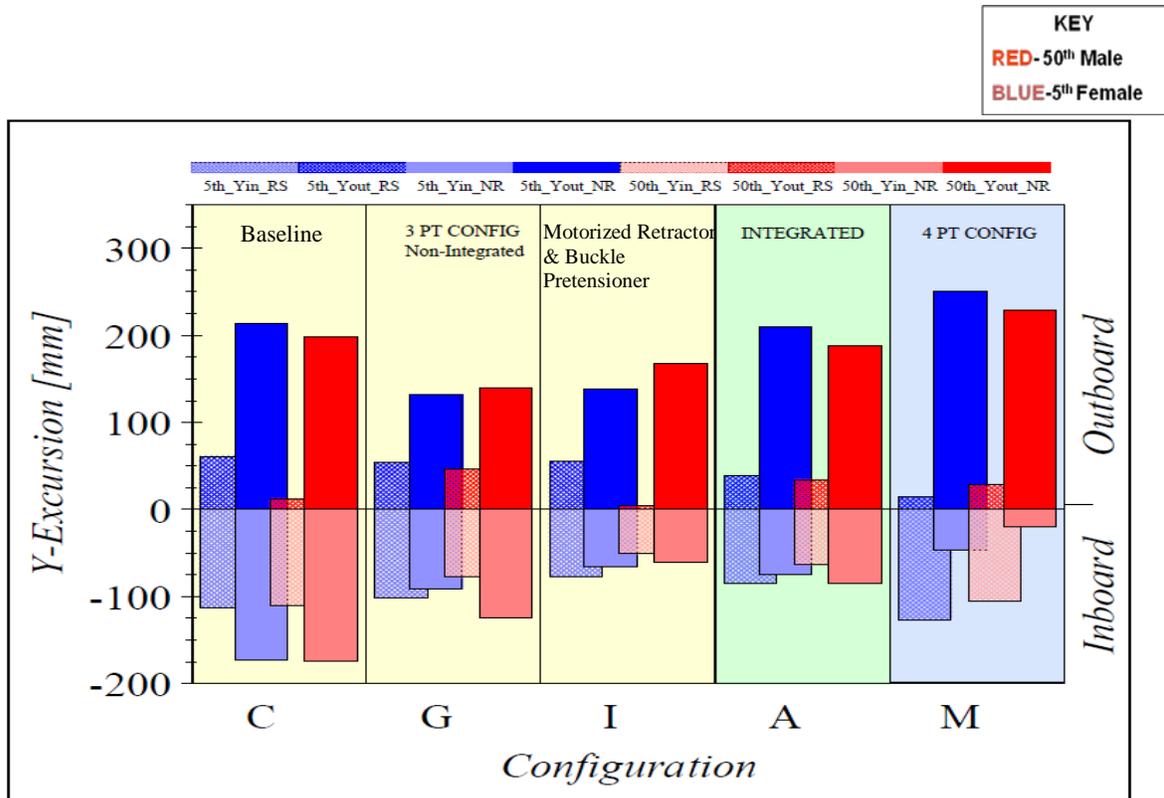
Testing with the reaction surfaces (roof, door, and air curtain) produced less lateral outboard and vertical excursion than the non-reaction surface testing, for both dummies and all of the belt configurations. This was not necessarily the case for inboard lateral motion. Configuration I generally had the lowest, or nearly the lowest, excursions for both dummies.

Figure 4: Reaction vs Non-Reaction Lateral Excursions

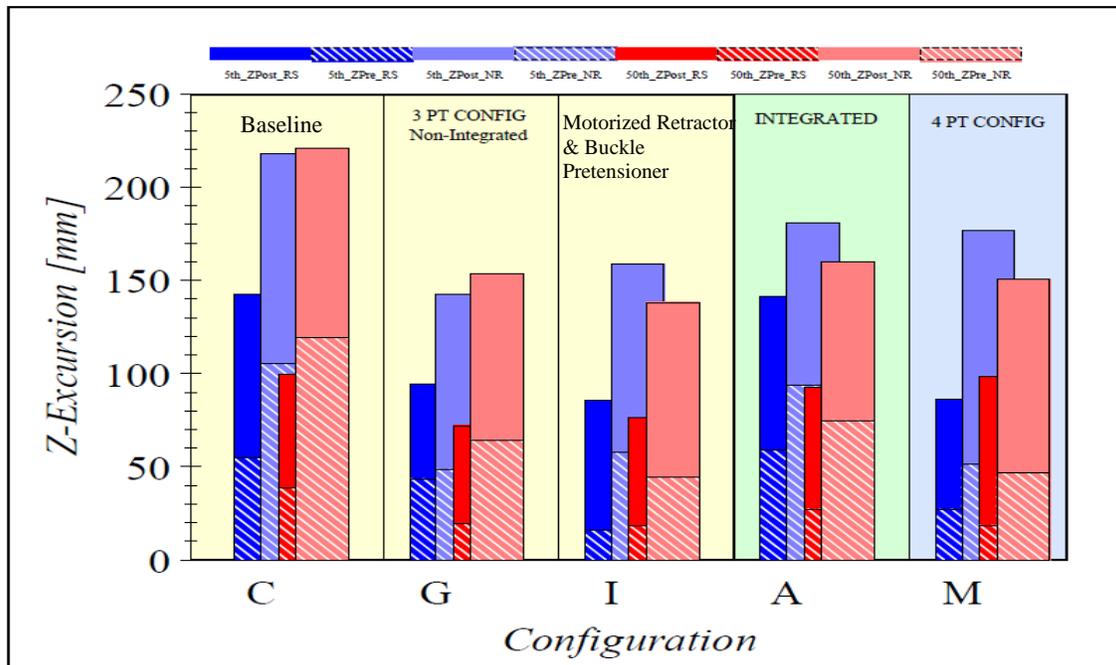
Figure 5: Reaction vs Non-Reaction Vertical Excursions

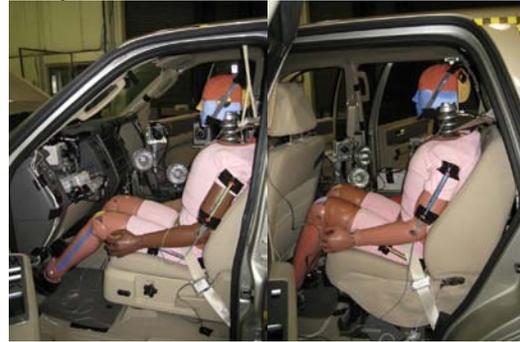
Figure 6: Trailing Front and Rear Occupants

Except for the FMVSS No. 208 dolly tests, two tests were conducted in each of the test modes. For the first test of each mode, the trailing side front and rear occupants and the leading side front occupant were restrained using the baseline configuration (C). For the second test of each mode, the trailing side front and rear occupants were restrained using Configuration I, and the leading side front passenger was restrained using Configuration G. These same configurations, and others, were also tested in the four FMVSS No. 208 dolly tests, but not necessarily in the

same order. See Table 2 for details. This paper focuses on the results from the trailing side occupants.

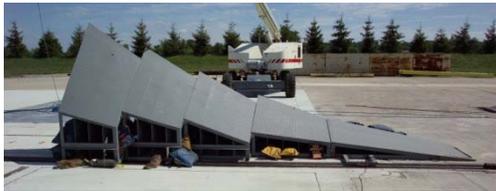
**Figure 8: Corkscrew Ramp**

Corkscrew Ramp Trip: The vehicle was propelled at 30 mph and released prior to the ramp, allowing it to freely roll up a corkscrew ramp (height of 6' and maximum twist angle of about 50°). The right side of the vehicle was the trailing side (Figure 8).

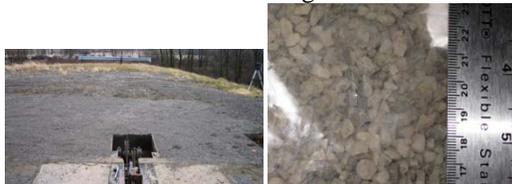
**Figure 9: Soil Pit and Aggregate.**

Soil Trip: The vehicle was pulled laterally at 30 mph and then released prior to the soil so that it could rotate freely into the soil. The soil consisted of #9 crushed limestone aggregate in a 300 square foot area (see Figure 9). The left side of the vehicle was the trailing side.

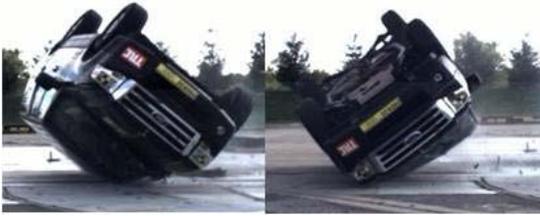
**Figure 11: FMVSS No. 208 Dolly Test**

In a typical dolly test, the vehicle comes off the platform with some rotational velocity. Then the leading side tires (right side for these tests) interact with the ground, tripping the vehicle and

causing it to rotate one or more quarter turns (Figure 11).

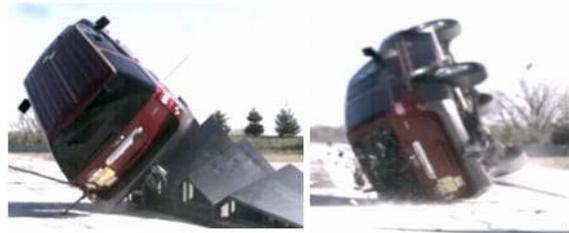
**Figure 15: Corkscrew Ramp**

These tests were conducted such that the trailing side was the right side of the vehicle. The vehicles were released at the base of the ramp at 30 mph. As the vehicles rolled up the ramp, the right front corner rose rapidly, and the vehicles rolled counter clockwise (Figure 15).

The kinematics of the vehicles in the two corkscrew ramp tests were similar through the first 90°. In test 1, the vehicle rolled 180° and landed on its roof. In test 2, the vehicle rotated about 114°, but came back to about 90°, ending up on its left side.

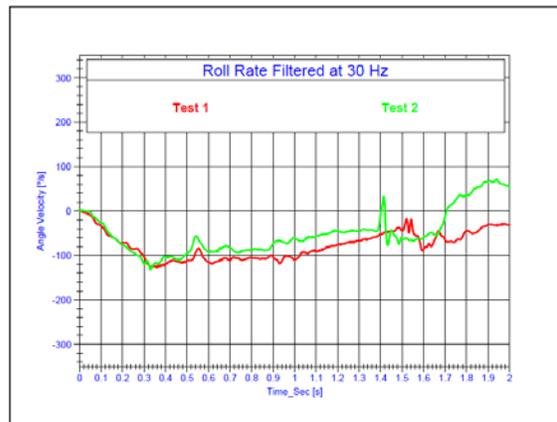
The roll velocities of the two tests are shown in Figure 16, and they are somewhat similar, peaking at about 120 degs/sec. This was a slower roll rate than in the other test modes. Table 4 provides the corkscrew ramp summaries for both tests. The curtains and other pyrotechnics were fired manually 300 ms into the event.

**Figure 16: Corkscrew Ramp Roll Velocities**

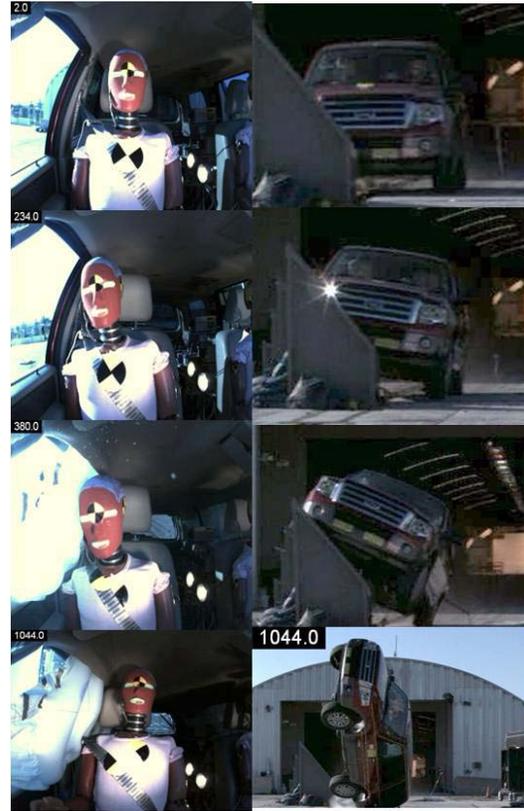
**Figure 17: Trailing Side Front Occupant and Vehicle Positions**

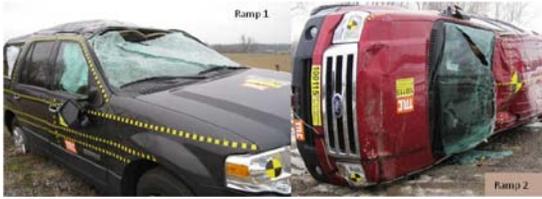
The two vehicles obtained similar damage to the roof and the A through D-pillars. In test 1, the front occupant slipped out of the belt and contacted the roof, and this was not seen in test 2 or with the rear occupant. Figure 21 shows the roof crush damage from the two tests.

**Figure 21: Soil Trip Vehicles**

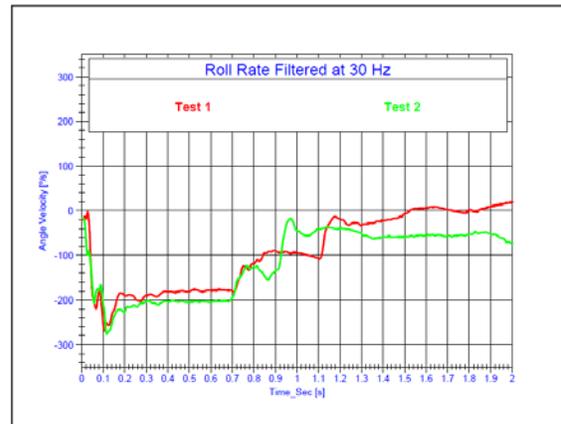
The roll velocities in the two tests were very similar, about 269-276 deg/sec (Figure 23). The vehicle in test 1 rolled about 180°, and the vehicle in test 2 rolled about 270°.

**Figure 23: Curb Trip Roll Velocities**

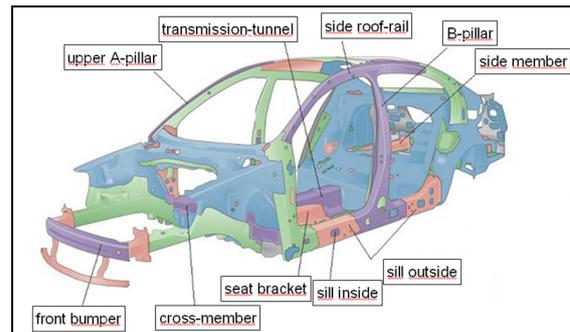
**Figure 1. Distribution of steel in a VW Passat B6 (Source - VW)**

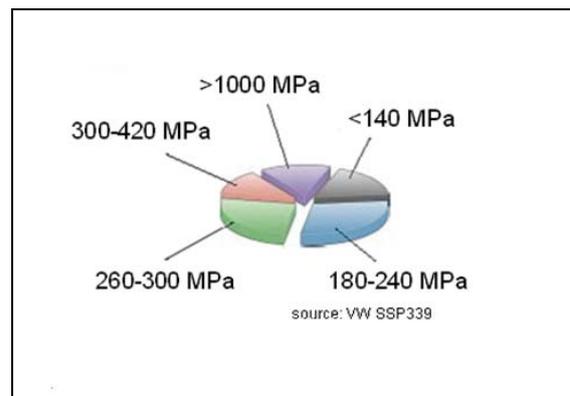
**Figure 2. steel grades in a VW Passat B6 (Source - VW)**

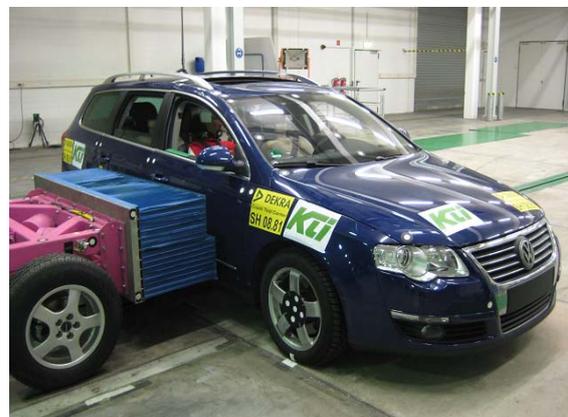
As depicted in Figures 2 and 3 (the first crash test setup), the car was positioned relative to the carriage with its deformable barrier. The test was carried out at a speed of 50 km/h (+/- 1 km/h). A Dummy, ES-1, 50% male, 72 kg (+/- 1.2 kg) was positioned on the front passenger side seat and weight dummies of 76 kg on the back seat. The restraint systems were active. After the crash, the damaged car was repaired with recognized methods of car repair, but without specific information for this model i.e. non-professional repair. Subsequently the Passat underwent a second crash test in the same configuration. Finally, differences in deformation behaviour between the two crashes were analysed to determine the implications for passenger safety.

Figure 3. Positioning the mobile barrier

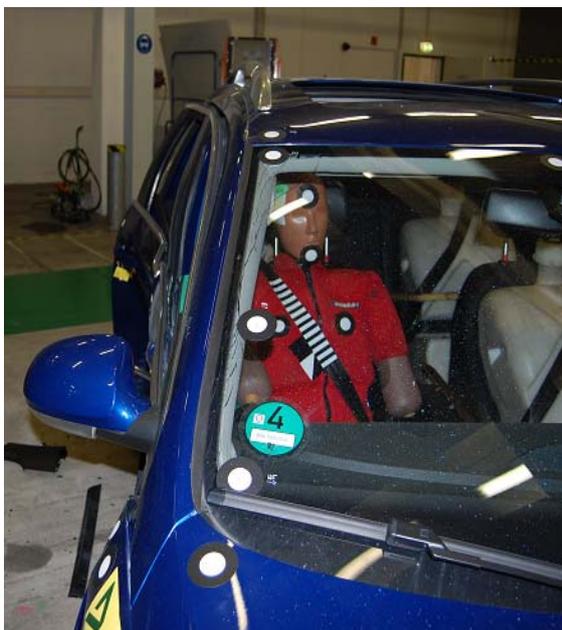
After the side impact the car was severely damaged on the passenger side, as intended. The sill and the floor/undercarriage behind it were particularly distorted. Additionally, the doors and the B-pillar were considerably damaged (Figure 5). There was no damage to the screen pillar or windscreen glass. The pyrotechnic protection/restraint systems (Front and rear passenger side airbags, front passenger belt pre-tensioner and passenger side curtain airbag) were correctly deployed. Overall the car body structure deformed and behaved as expected. As well as the visual analysis, electronic measurement of the car body was carried out. This showed the maximum intrusion to be 161 mm.

Figure 4. Head-on view

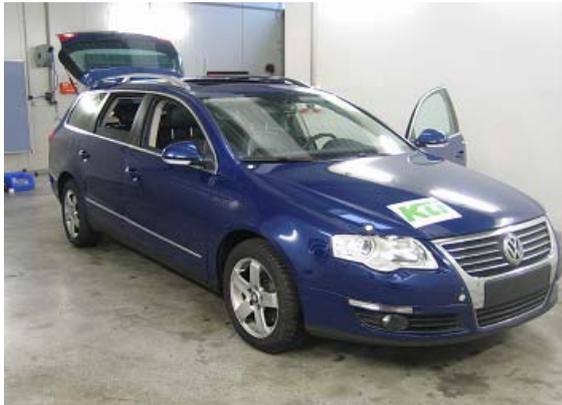
It is recommended that an Inverter type welding machine is used with 10 kA maximum current and a variable pressure (maximum 10 bar) to join the high strength steel safely. The deformed inner sill, made from ultra high strength steel, was re-shaped and partially replaced on a bench then re-fitted using a MAG welding process. Figures 6 to 9 show the non professional repair being carried out.

**Figure 9. The completed repair**

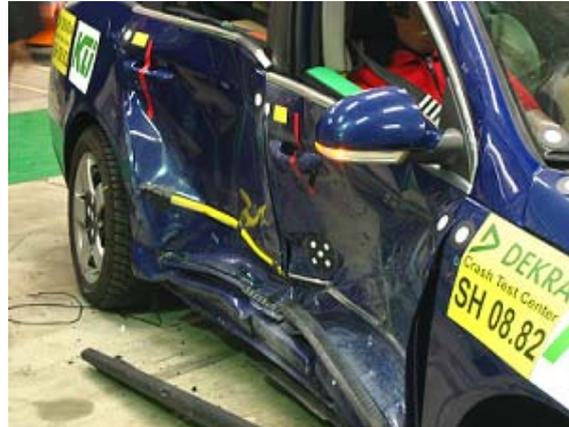
After completing the repair the car was crashed again under the same conditions as the first test in order to make a fair assessment on equal terms. It was immediately evident that there was a substantial difference, with far more comprehensive deformation of the car body after the second impact. The B-pillar had noticeably higher intrusion into the passenger compartment in comparison with the first crash, especially at the lower part at the connection with the sill (Figures 10 and 11). Note: Later measurement of the car body confirmed there was 60 mm more intrusion after the second test, compared to the first crash.

**Figure 10. Damage after second crash**

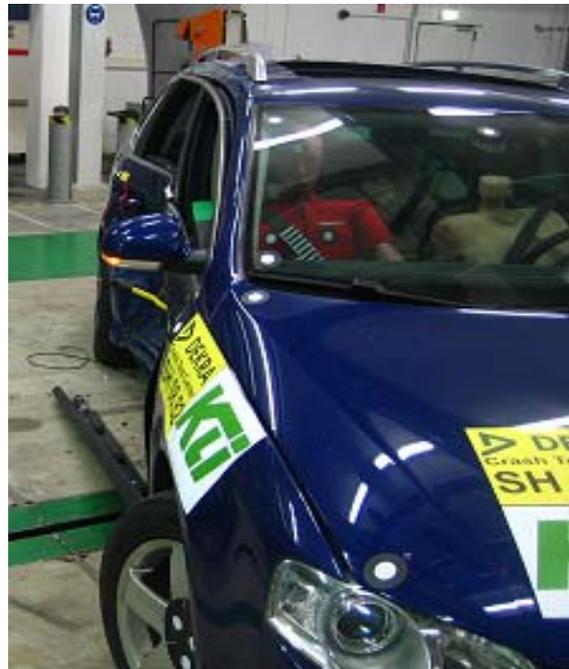
**Figure 11. Higher intrusion to passenger compartment**

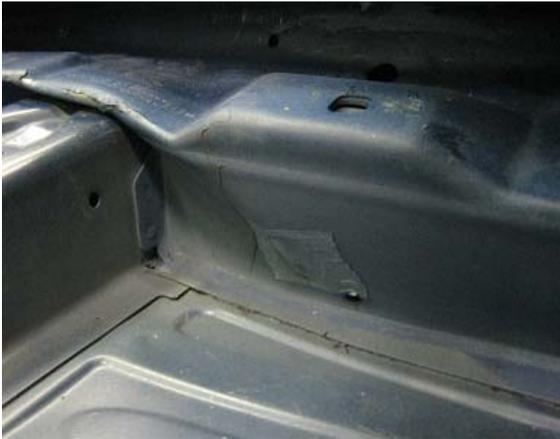
After removing all the seats and necessary trim the deformation of the transmission tunnel after the second test was clear to see. The cross-member which supported the front seat had pushed into the transmission tunnel, distorting it severely. In comparison, there were no measurable changes at the transmission tunnel during the first attempt. (Figures 20 and 21).

**Figure 20. Front seat anchor cross member/transmission tunnel after first crash**

**Figure 21. Front seat anchor cross member/transmission tunnel after second crash**

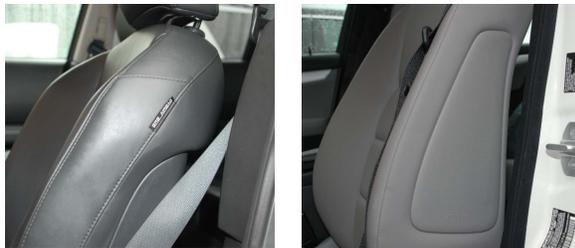
Seat mounted side airbags are packaged relatively close to the occupant. They are concealed within the outer bolster of the seat back. The modules are built into the seat and deploy through a seam in the seat trim or through a separate cover often referred to as an exposed deployment door (Figure 1). To achieve desired performance from the side airbag, the deployment timing to break out of the seat and continue to move into position between the occupant and intruding surface requires optimization. The side airbag module generally consists of an inflator, air bag or “cushion,” and cover. The module inflates when it receives a signal from the sensor, commanding deployment in certain types of side impact accidents. There are three basic types of side airbags, those that provide thoracic coverage, combination head/thoracic coverage, and combination pelvic/thoracic coverage.

(a) Built in seat – deploys through seat seam

(b) Separate module – deploys through a deployment door

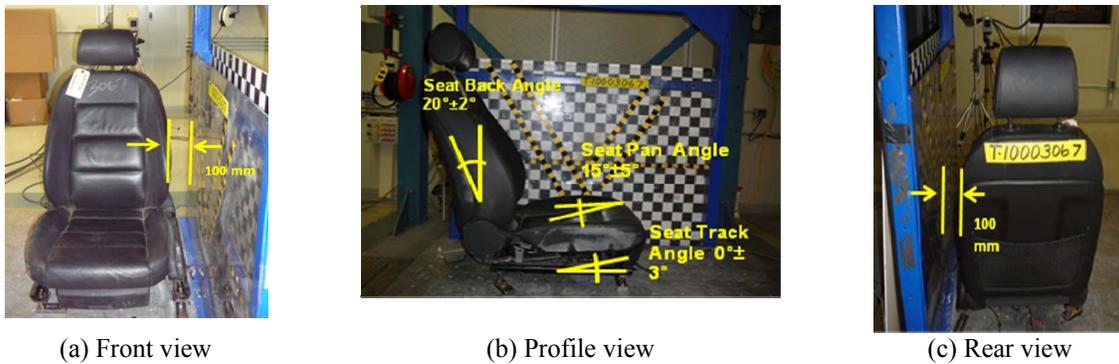
Three camera views were used to capture the deployment (Figure 2). The film speed was 2000 fps, which allowed capture of 0.5 ms intervals during deployment. Photographs were taken before and after deployment.

Figure 2. Test set up.

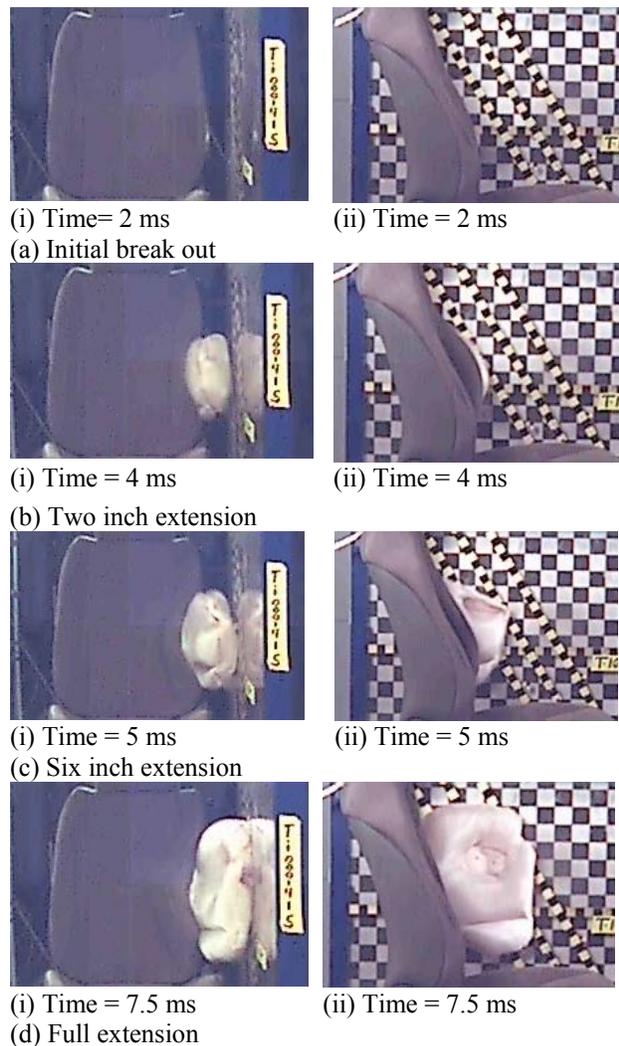
guideline, the point at which the seat bolster first expanded forward was used (Figure 3).

Figure 3. Example of deployment analysis.

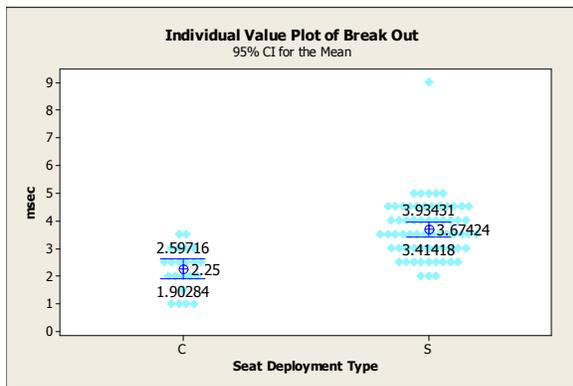
This section analyzes the deployment timing of the side airbags broken down into deployment mechanism types: deployment doors (C), and seam deploy (S). The average breakout times were calculated to be 2.25 ms and 3.67 ms for deployment doors and seam deploy, respectively. The 95% confidence interval suggests average breakout times are significantly different (Figure 5).

**Figure 5. Breakout times by deployment type: door (C) and seam deploy (S).**

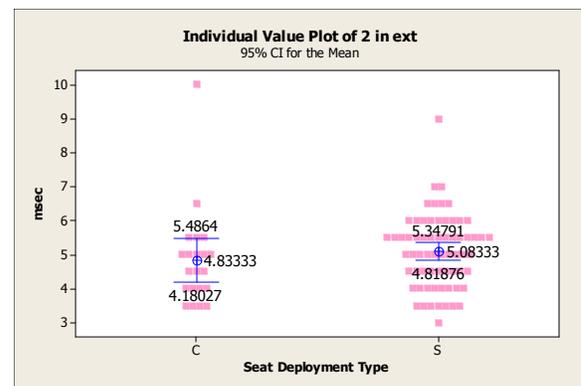
**Figure 6. Two inch extension times by deployment type: door (C) and seam (S).**

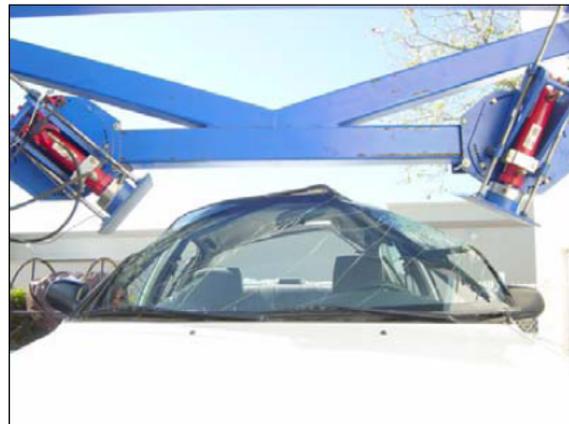
The M216 two-sided fixture applies forces to the roof on one side and then the other at force angles of 10° pitch and 25° and 40° roll, respectively. The M216 results indicate that most vehicles are about half as strong compared to the FMVSS 216 test results at 5° of pitch, as shown in Figures 3 and 4.

Figure 3. M216 two-sided static test machine.

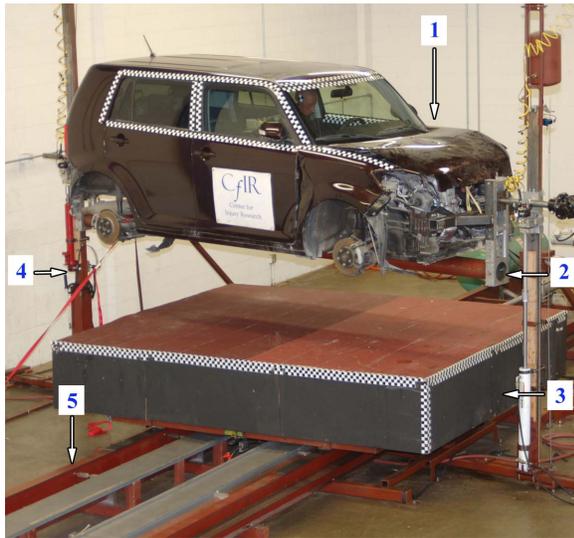
The JRS rollover fixture, shown in Figure 5, is a laboratory device capable of rolling full-size vehicles to 6,000 lbs at 300°/sec, dropping them 4 to 9 inches onto a 20 mph moving roadbed and measuring the roadbed forces and roof intrusion [8].

Figure 5. The JRS fixture key components: 1) vehicle, 2) cradle/spit mount, 3) moving roadbed, 4) support towers, 5) coupled pneumatic roadbed propulsion and roll drive.

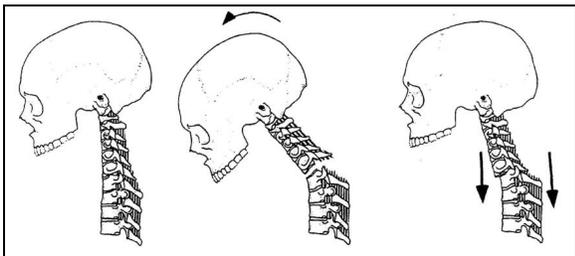
Figure 9 shows the mechanism of a common neck bending Injury, a bilateral facet dislocation. It is initiated by significant flexion of the neck which dislocates the spine. It concludes with the neck contracting, pulling the spine forward and down locking the facets [11].

Figure 9. Hyperflexion neck injury mechanism from Pintar, et al.

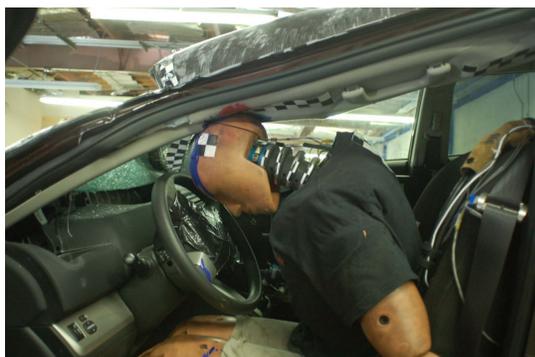
The “soft” low musculature modified Hybrid III dummy neck shown in Figure 12 was literally broken at the lower neck load cell mount as a result of 11 inches of roof crush in this SWR 6.8 vehicle.

**Figure 12. Soft neck of hybrid III dummy.**

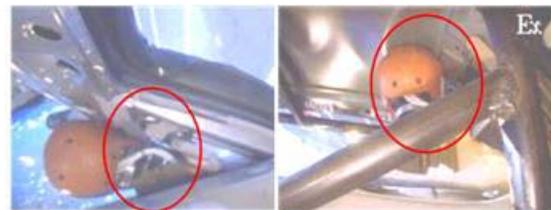
**Controlled Rollover Impact System (CRIS) tests** Published 15 ms video clips and neck injury measure data of production and reinforced 1998 Crown Victorias tested on the CRIS show identical results in roll-caged and production vehicles [16]. In the video dummy movement up to the point of initial roof contact is nearly identical. However, the videos and data to 140 ms tell a very different story. Figure 13 show the interior views. The production vehicle with the grossly bent neck is shown on the left. The deformation of the roof in the production vehicle applied a force to the head of the dummy and caused the neck to bend significantly. No neck bending was observed in the reinforced vehicle (right). Estimated roof crush is 2 inches for reinforced and more than 10 inches for the production vehicle.

**Figure 13. Production vehicle’s neck severely bent after 40 ms (left) and the roll-caged vehicle’s non-injurious neck bending (right).**

The peak lower neck bending moments measured in the production vehicles was 30 to 56% greater than in the reinforced vehicle. The duration of neck bending in the production vehicle was 150% greater for the reinforced vehicles. Dummies in the production vehicles were trapped 2 out of the 5 times in injurious positions that could limit breathing and inhibit safe evacuation [16].

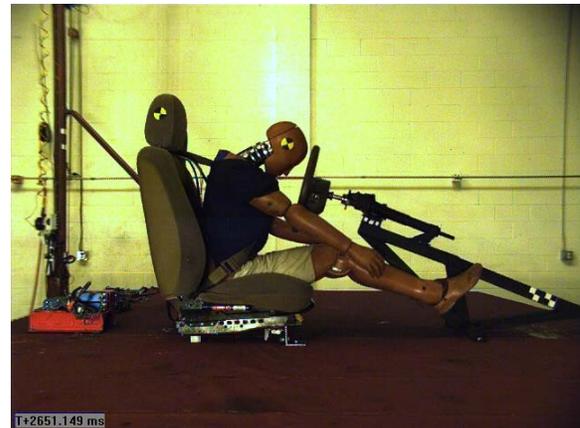
Figure 25. Hybrid III dummy with original musculature neck.

**Frontal impact protection** The reduction in musculature and orientation of the Hybrid III neck as developed for rollover testing appears to explain anomalies in frontal and side impact protection. For instance the IIHS reported an increase in fatalities with advanced airbags compared to the immediately previous designs [22]. An identical set-up for frontal impacts at typical airbag deployment ignition speeds of 15 mph is shown with the Hybrid III dummy with its original and reduced musculature neck in Figures 25 and 26, respectively. The flexibility of the reduced musculature puts the dummy's head in close proximity to the deploying airbag with serious injury consequences if the airbag fires and from striking the wheel hub if it doesn't.

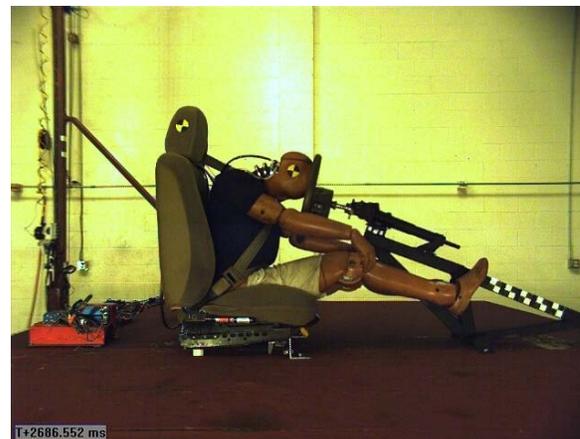
Figure 26. Hybrid III dummy with reduced musculature neck.

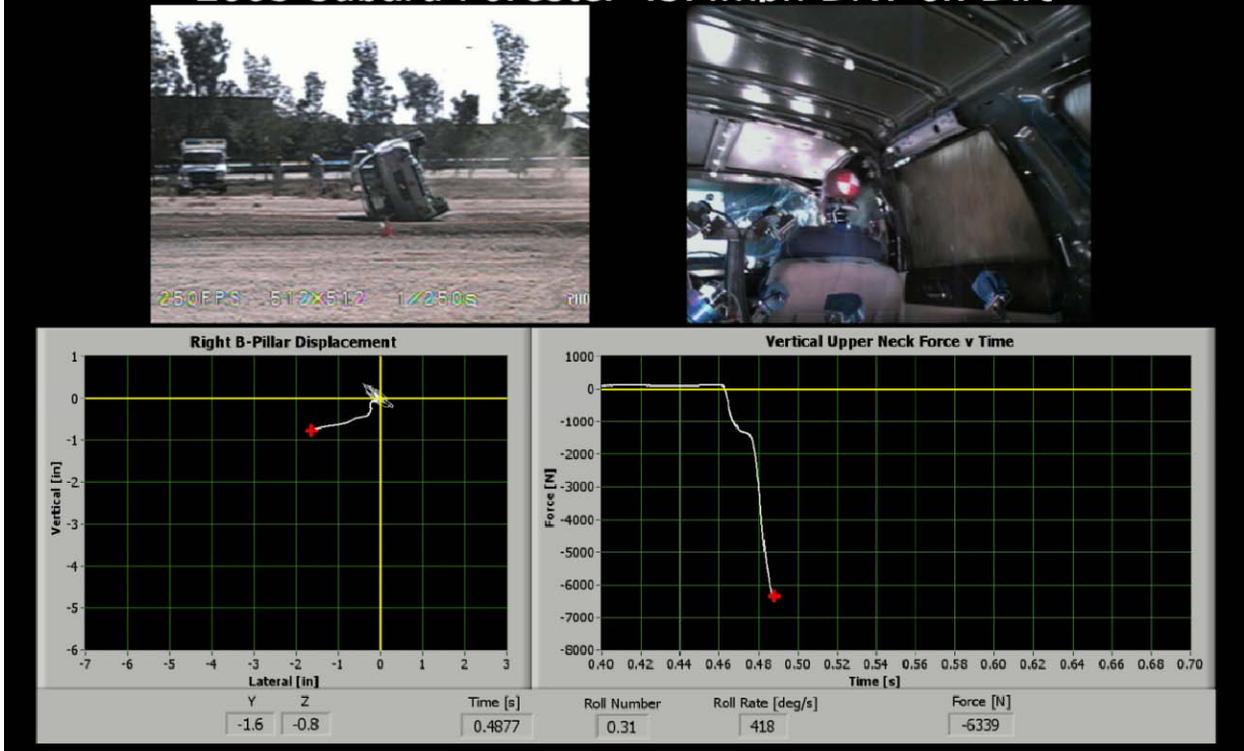
Figure 4. Captured frame from the synchronized data with composite video of the passenger-side B-pillar displacement at the time of passenger ATD peak compressive upper neck load during the first passenger side (near-side) roof rail impact (above).

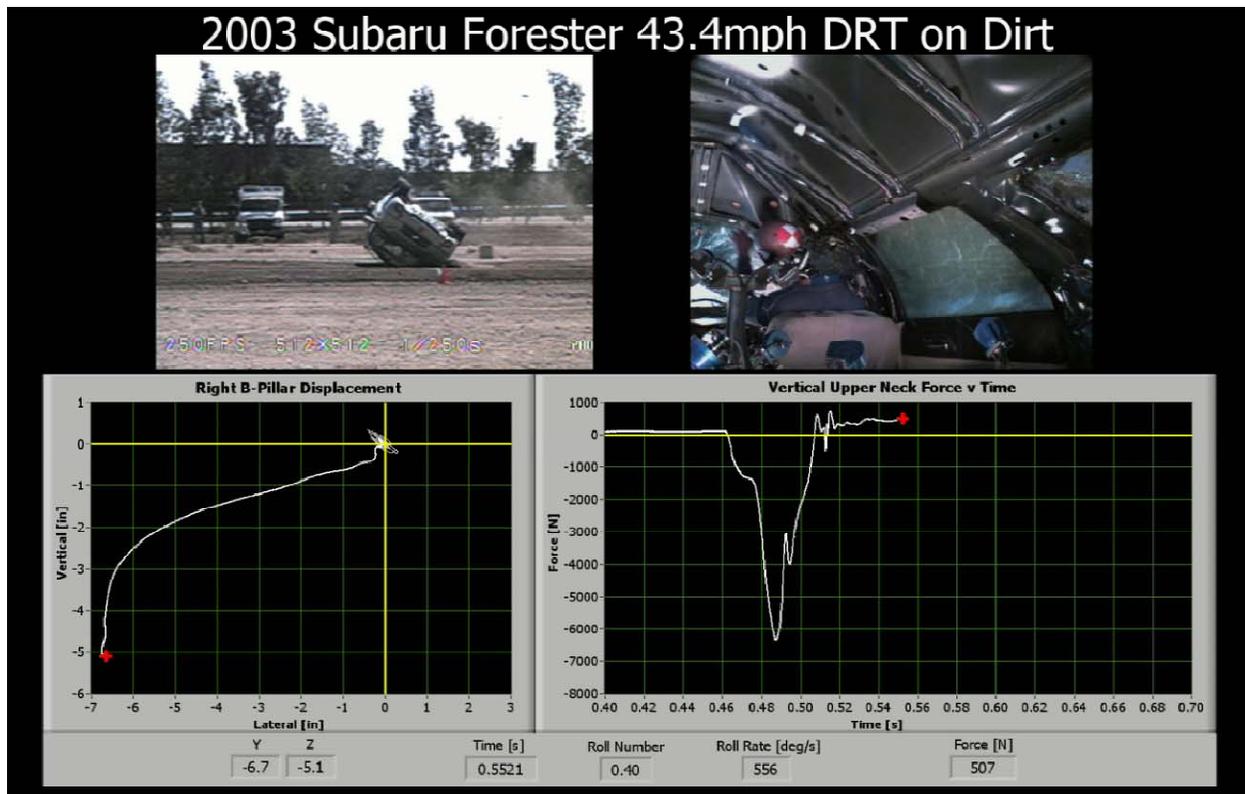
**Figure 5. Captured frame from the synchronized data with composite video of passenger ATD axial upper neck load at the time of peak passenger-side B-pillar displacement during the first passenger-side (near-side) roof rail impact.**

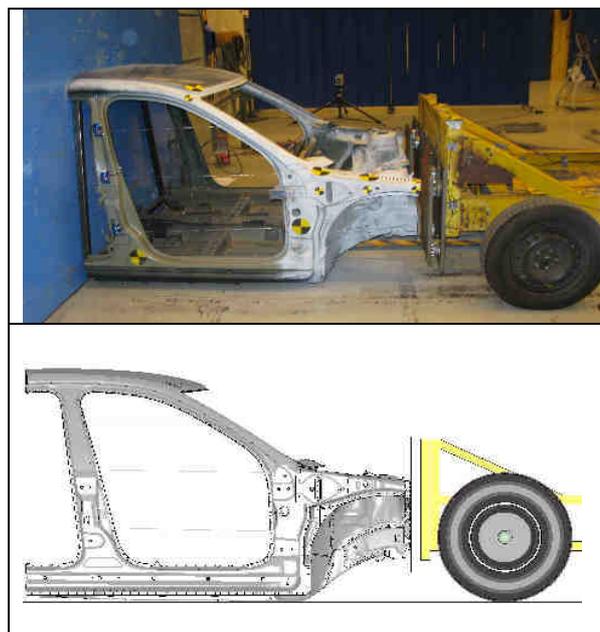
Figure 4. Sub Structure Test Method

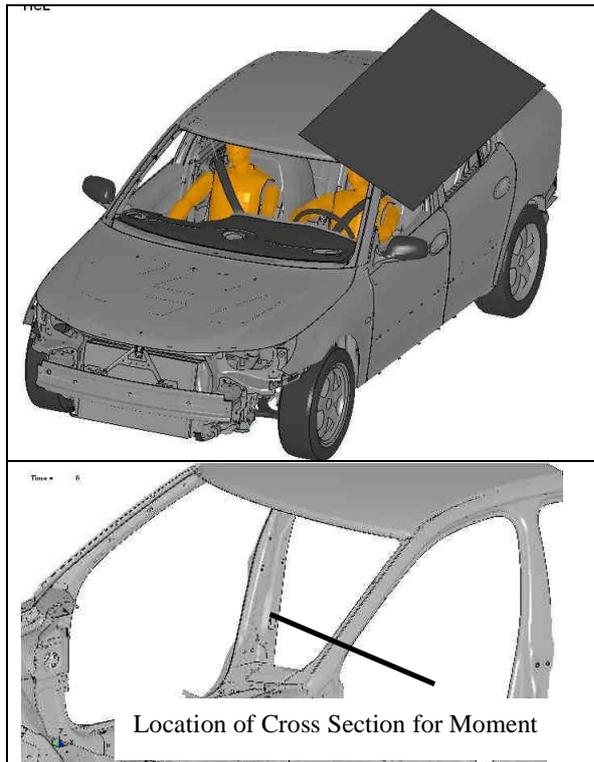
Figure 5. Roof Crush Set Up

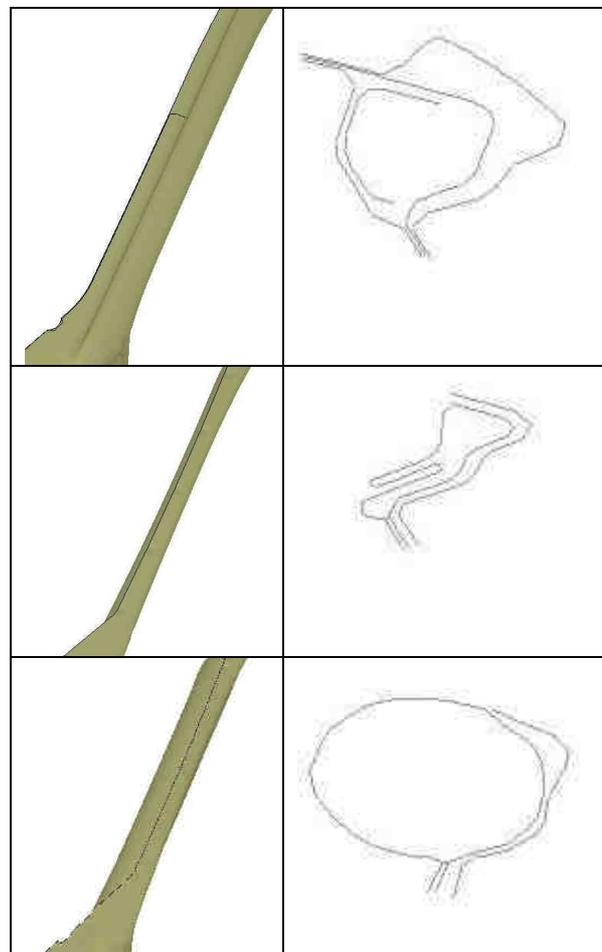
Figure 6. Reference, Unexpanded and expanded A-Pillar

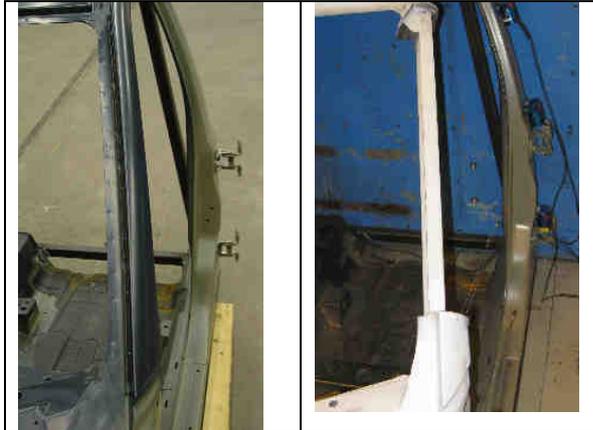
The reduced obscuration angle for the folded expandable A-Pillar relative to the reference state of the art A-Pillar can be observed in Figure 7.

Figure 7. State of the art A-Pillar and UnExpanded Expandable A-Pillar

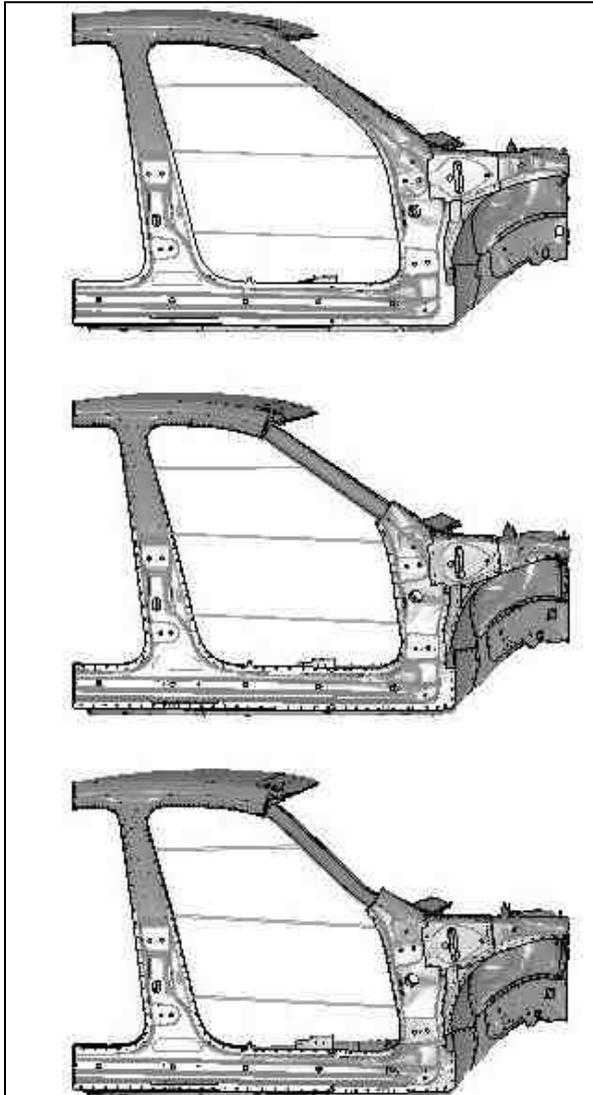
Figure 11. Reference, Expanded and UnExpanded expandable A-Pillar at 60 ms (max deflection)

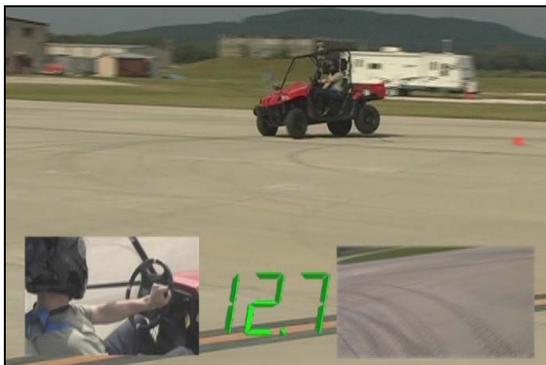
easily lead to a loss of control. The oversteer is promoted by the vehicle's suspension design, in particular the rear-only anti-sway bar. In a corner, this rear anti-sway bar is acting to lift the inside rear wheel as shown in Figure 3. This causes a loss of traction on the rear, causing the rear of the vehicle to want to spin-out and the driver to lose control. The rear only anti-sway bar is necessitated by the rear drive design. The rear of the vehicle does not have a differential. Rather, both half-shafts are driven by the same splines, meaning both rear wheels must rotate at the same speed. In a cornering maneuver on a normal-friction surface, this would cause tire scrub and severe understeer. Therefore, the anti-sway bar is installed to lift the inside rear wheel in a turn to avoid this.

**Figure 4. Screen capture from dynamic testing inside rear tire lift.**

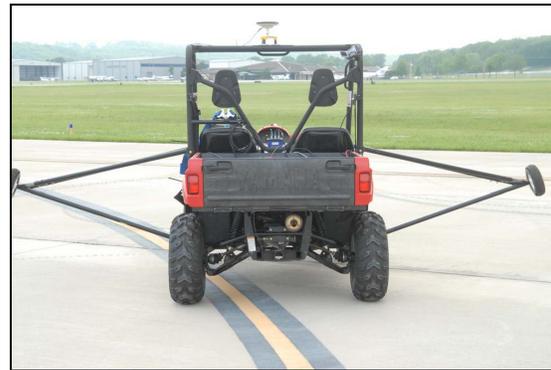
The Engineering Institute tested an alternative design. The Rhino was modified by adding 4 inch spacers at each wheel, removing the spool

rear drive and replacing it with a front differential from another Rhino, and removing the rear anti-sway bar completely. The vehicle performed significantly better with these design changes. The sustained lateral accelerations needed to cause rollover were well into the 0.8 g range. Also, certain tests that consistently caused the Rhino to tip in the stock configuration, e.g. a U-turn while accelerating, did not make the alternative design tip. The open differential was necessary to demonstrate the increased understeer as a result of removing the rear anti-sway bar. Had the spool drive been retained without associated front to rear spring rate and roll rate balancing, it was opined that the vehicle would exhibit too much understeer, especially at low-speed, tight steer maneuvers.

**Figure 5. Photograph of modified Rhino**

As seen from the view of the Rhino in Figure 5 and 7, the Rhino’s roll-cage is positioned very close to the occupant’s seating position, is one of the widest parts of the vehicle, and creates a flat-plane in the plane perpendicular to the direction the photograph is taken.

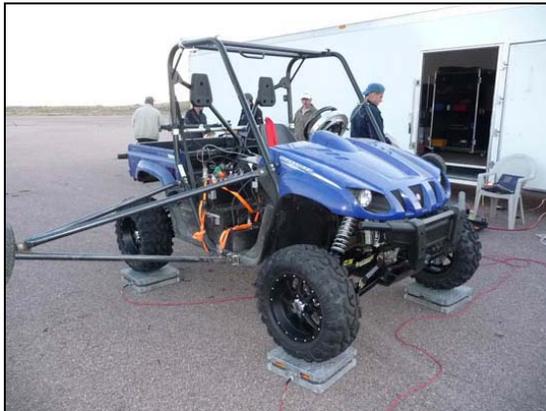
suspension kit from Direct Concept Engineering (DCE). The modifications included longer control arms front and rear, remote reservoir shocks, coil-over springs, suspension droop-limiting straps, and longer drive axles. ITP Baja Cross X/D tires mounted on ITP wheels were also used.

Using the static numbers for the Rhino 450 measured by The Engineering Institute and the increased track width due to the suspension kit, the DCE Rhino has a theoretical SSF of 1.20. The DCE Rhino did not rollover in any pavement test runs at speeds as high as almost 37 mph and lateral forces as high as 0.96g. The only tip-up occurred on the dirt surface with a maximum lateral acceleration of 0.93 g's. The driver's notes indicated a "big dig" into the surface during this maneuver.

**Figure 6. Photograph of DCE modified Rhino**

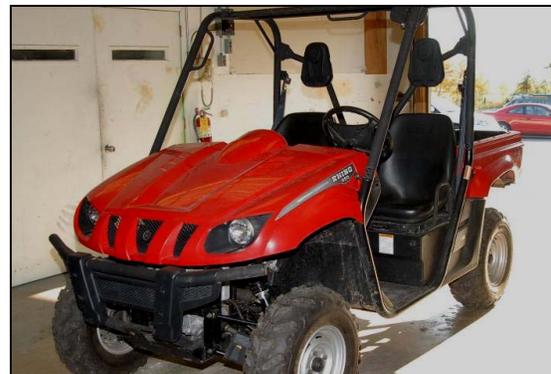
All of these design attributes can increase the likeliness of extremity injury during a tip-over as arms, legs, hands, feet, and even heads can be crushed by the roll-cage. The fact that the cage creates a flat plane and has no extrusions to reduce the contact points means that there are basically infinite crush points as the cage strikes the ground in a tip-over event. In other words, if an appendage is extruded anywhere along the periphery of the roll-cage, it is going to be crushed between the roll-cage and ground.

**Figure 7. View of Yamaha Rhino.**

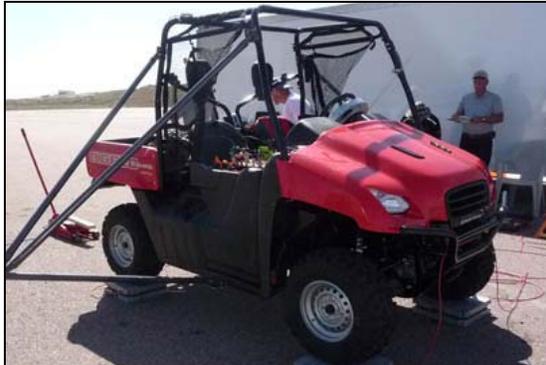
**Figure 8. Photograph of Big Red prepared for testing**

A 2009 Honda Big Red MUV 2009 was tested. The average measured track width of the Big Red was slightly more than 8 inches greater than that of the 660 tested. Measurements of the Big Red confirm that it is statically more stable than the Yamaha Rhino. The increase in static stability also predicts an increase in dynamic stability.

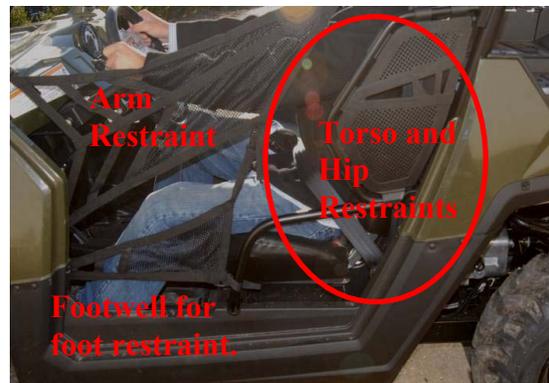
A similar vehicle to the Rhino that incorporates improved occupant retention and protection is the Polaris RZR. A Polaris RZR was loaned to The Engineering Institute for static analysis. The below photograph shows some of the safety features of the RZR. The photograph shows a deep footwell, arm and hand restraint through use of netting, and shoulder/torso and hip restraints integrated into the roll-cage of the vehicle.

In addition to what is demonstrated in the photograph, the RZR also has a vehicle-sensitive retractor that locks at angles greater than 15 degrees off of the installation angle, and the roll-cage is not a flat plane resulting in fewer possible crush points.

**Figure 9. Photograph of occupant restraints of Polaris RZR.**
