CRASH DAMAGE PATTERNS ASSOCIATED WITH CHEST INJURIES IN FAR-SIDE ROLLOVERS

University of New South Wales, Transport and Road Safety Research
Australia
Paper Number 13-0066

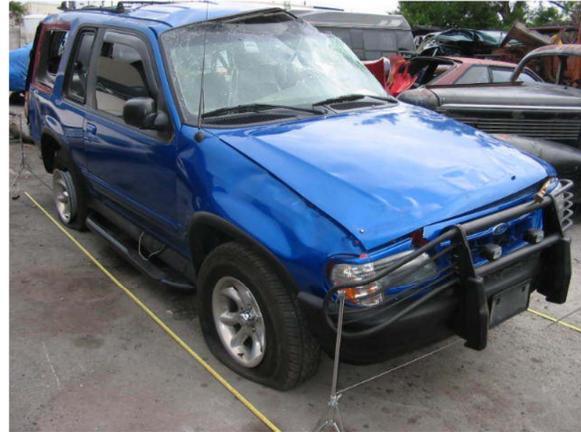
Case 2006 41 176 was a 1996 Ford Explorer that rolled 4 quarter-turns, passenger side leading. The vehicle is shown in Figure 5. There were three occupants, two of which suffered no injuries. The driver was a belted 38 year old male. There was no air bag deployment.

The 38 year old male driver sustained an AIS 4 bilateral lung contusion and AIS 3 bilateral rib fractures, all attributed to the safety belt. He also had 4 AIS 1 skin abrasions to the chest and abdomen and an AIS 1 heart contusion attributed to the belt. There was an AIS 1 right back skin abrasion attributed to the seat. There were 2 AIS 1 lower extremity skin

Figure 5. Case 1 – Ford Explorer – 4 quarter-turns.

The damage patterns for the 4 quarter-turn cases analyzed (cases 1 and 2) and the 8 quarter-turn case (case 6) all display lateral damage to the left front fender. This damage and the tenting of the roof suggest that lateral forces were applied to the vehicle during the third quarter-turn. Computer simulation of 4 quarter-turn cases confirmed this hypothesis [Tahan et al 2013]. The computer simulations further indicated that the dummy impacts the center console during the fourth (final) quarter-turn. This impact was induced by the rebound of the suspension system. Damage to the left front fender in cases 1, 2 and 5 suggest that there was an off-axis roll component or a wobble in the rollover. Simulation indicated that increases in the wobble increase the severity of the occupant impacts to the door and to the center console.

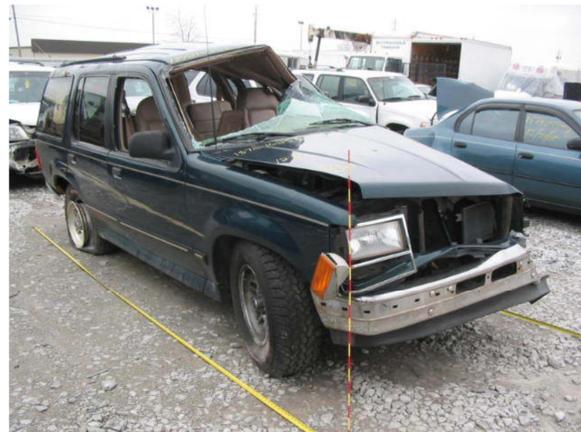
Case 2005 48 248 was another Explorer with more extensive roof damage. This 1994 model, shown in Figure 6, was subjected to a 4 quarter-turn trip-over, passenger side leading. There was no air bag deployment.

Figure 6. Case 2 – Ford Explorer – 4 quarter-turns.

The 54 year old male driver sustained an AIS 4 bilateral lung contusion attributed to the left interior. Also coded were 2 AIS 3 left arm fractures attributed to the roof, an AIS 2 head injury attributed to the roof

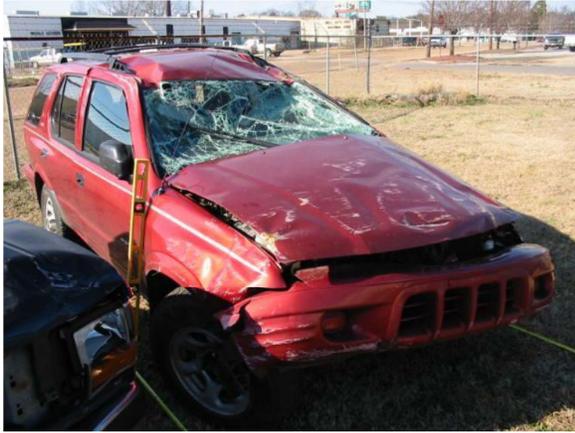
Figure 7. Case 5 — Isuzu Rodeo - 8 quarter-turns.

Case 2004-48-5 involved the 2001 Isuzu Rodeo shown in Figure 7. This vehicle was subjected to an 8 quarter-turn trip-over, passenger side leading. The sole driver was a 26 year old female. She was belted and the air bag did not deploy.

The driver sustained an AIS 3 unilateral left lung contusion and an AIS 1 chest skin contusion attributed to the left interior. There were 2 other AIS 1 leg injuries attributed to the knee bolster. The roof was the contact for AIS 1 injuries to the head, cervical spine and upper extremity.

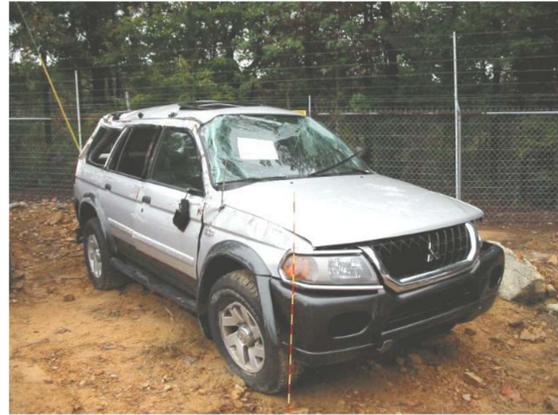
Figure 8 shows a 2002 Mitsubishi Montero that was subjected to a trip over with 8 quarter-turns, passenger side leading. The driver was a 23 year old male. He was belted and the air bag did not deploy.

Figure 8. Case 6 –Mitsubishi Montero - 8 quarter-turns.

The driver sustained a right lung contusion, AIS 3, attributed to the seat, back. He also had an AIS 2 cervical vertebral fracture caused by the roof. There were four AIS 1 facial and scalp lacerations attributed to the roof.

The vehicle in case 6 sustained lateral damage to the left front fender and the left rear upper quadrant. This damage pattern suggests a more extreme wobble than existed in the other cases. The driver in case 6 sustained a right lung contusion attributed to the seat back. Based on the motion shown in Figures 11 and 12, it is probable that this injury occurred during the eighth quarter-turn. It is also possible that in case 6, a rearward component from the upper quadrant impact may have increased the severity of occupant interaction with the vehicle.

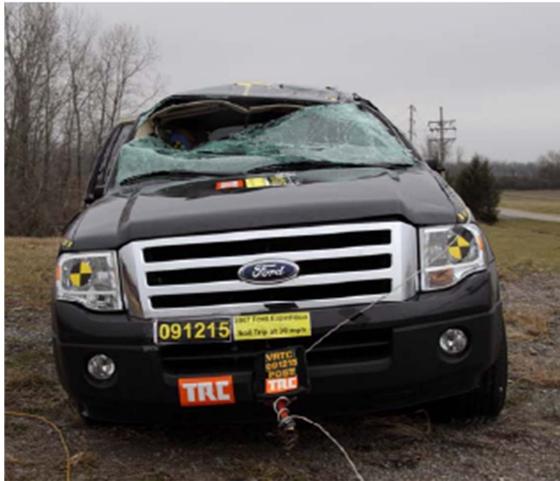
A rollover test of a Ford Expedition conducted by Transportation Research Center for Vehicle Research and Test Center (VRTC) (NHTSA test number 6960), was analyzed to determine occupant motion during an 8 quarter-turn rollover. The damaged vehicle is shown in Figure 9. This test was a soil tripped rollover crash that was conducted to investigate the dynamics of belted occupants during rollover crashes. The Expedition was translated laterally on a test cart at 48.8 km/h (30.3 mph). It was released with its roll axis perpendicular to the direction of the soil trip area. The vehicle contained a belted Hybrid III dummy on the far-side of the rollover. Videos were available showing the dummy motion and the external vehicle position during the rollover.

Figure 9. Damaged Ford Expedition after a rollover test with 8 quarter-turns.

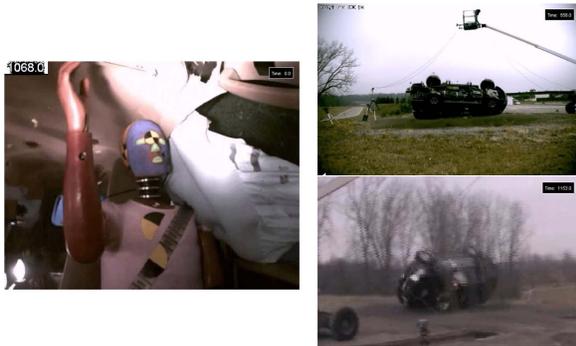
the driver dummy motion at various times of the rollover. Critical conditions showing dummy motion that could contribute to chest injury are shown in Figures 10, 11 and 12. The dummy motion is shown in the left side of the figures. The top right graphic is from the downstream high speed video and the lower right graphic shows the real time video.

Figure 10. Dummy and vehicle position during the third quarter-turn.

The 8 quarter-turn rollover test of the Expedition showed similar opportunities for chest injuries to those discussed above. Figure 10 shows the dummy impacting vehicle side during the third quarter-turn. In this test, an air curtain protects against head injury. A less severe impact with the door was noted at the seventh quarter-turn. The driver in case 5 sustained a left lung contusion attributed to the left interior, suggesting that the injury occurred during the third quarter turn.

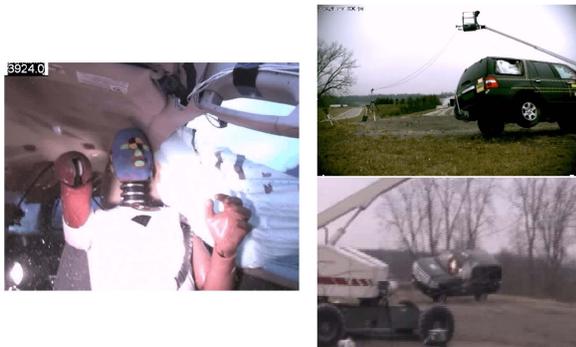
Figure 11. Dummy and vehicle position prior to completion of the eighth quarter-turn.

Figures 11 and 12 show how the dummy moves rapidly from the exterior of the vehicle (Figure 11) to the interior (Figure 12) in less than 200 milliseconds. This motion occurs rapidly during the rebound of the suspension system. In the Expedition test vehicle,

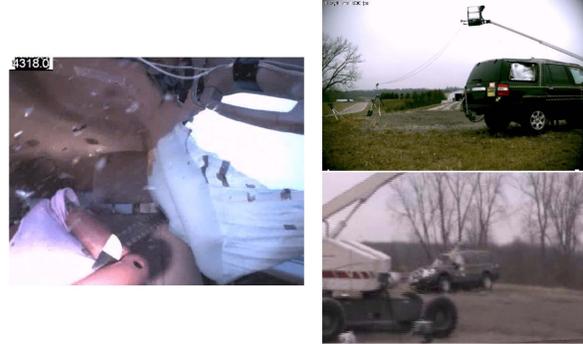
Figure 12. Dummy and vehicle position during the completion of the eighth quarter-turn.

the center console was removed and consequently the dummy head excursion shown in Figure 12 may be greater than in the unmodified vehicle. The chest injury induced by this upper body motion could originate from the seat belt that crosses the lower chest. In real world rollovers the driver's right side chest injury could also be caused by impact with the center console, the seat back or other objects or passengers located to the right of the driver.
