INJURIES TO CHILDREN ONE TO THREE YEARS OLD IN SIDE IMPACT CRASHES

Volpe National Transportation Systems Center
United States
Paper Number 07-0186

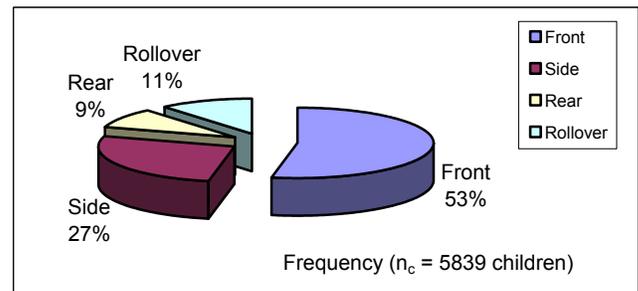
Figure 1: Distribution of crash configurations for all children 0 to 12 years old. Weighted N = 2,732,141 children. NASS CDS: 1995, 1996, 1998-2005

Children comprise more than 50% of the rear seat occupants in motor vehicle crashes. The National Automotive Sampling System, in particular the Crashworthiness Data System [NASS-CDS: 1995, 1996, 1998-2005], estimates that more than 2.7 million children ages 0 to 12 years old were involved in motor vehicle crashes in a period covering ten years of data. Figure 1 shows that 53% of 0 to 12 year-olds were involved in frontal crashes followed by 27% in side impact crashes. Rollover and rear end crashes represented the remaining 11% and 9% of crashes, respectively.

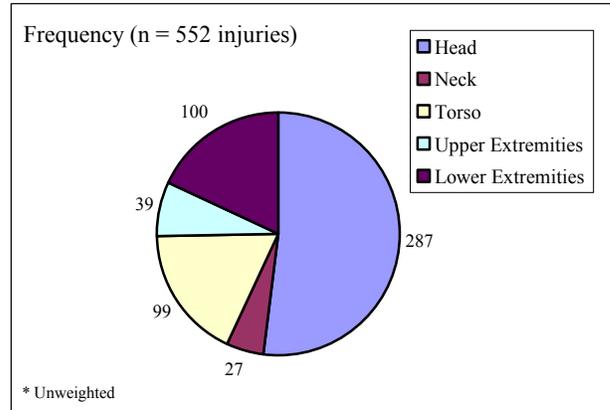
Figure 2: Distribution of injuries among body regions. Side impact crashes. Children 0 to 12 years old. $n_c = 125$ children. $\Delta V \geq 30$ kph. NASS CDS: 1995, 1996, 1998-2004

At ΔV values of 30 kph or more, there were 552 injuries recorded for the 125 injured children aged zero to twelve years old for an average of 4.4 injuries per child. The injuries were categorized as head, neck, torso, upper extremity, and lower extremity. The distribution is shown in Figure 2. The preponderance of injuries (52%; n=287) was head injuries. Torso and lower extremities injuries each

represent 18% of the overall injuries. Upper extremities and neck injuries represent 7% and 5%, respectively.

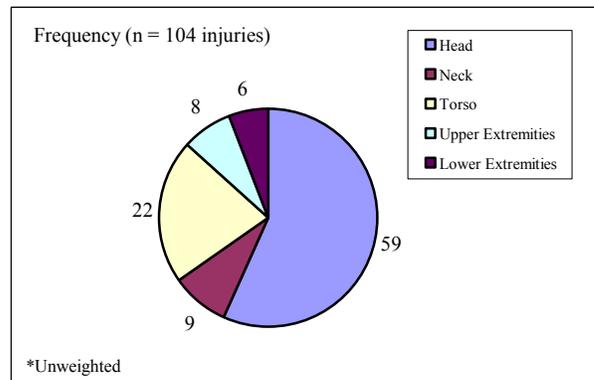
Figure 3: Distribution of injuries among body regions. Side impact crashes. Children 1 to 3 years old. $n_c = 28$ children. $\Delta V \geq 30$ kph. NASS CDS: 1995, 1996, 1998-2004

The subset of data for children one to three years old tells a slightly different story in Figure 3. There were 104 injuries distributed over 28 children (for an average of 3.7 injuries per child).

For the one to three year old subset, head injuries were slightly higher (57%) than the overall population set. The higher fraction of head injuries may be related to relatively high neck loading compared to larger children. According to Weber, there has long been a concern that a child’s cervical

The percentage of torso injuries is 21% which is similar in proportion to the overall child population. However, for the one to three year old subset, lower extremity injuries were less of an issue--only 6%. Neck injuries represented 9% while upper extremities represented 8% of the injuries for one to three year olds.

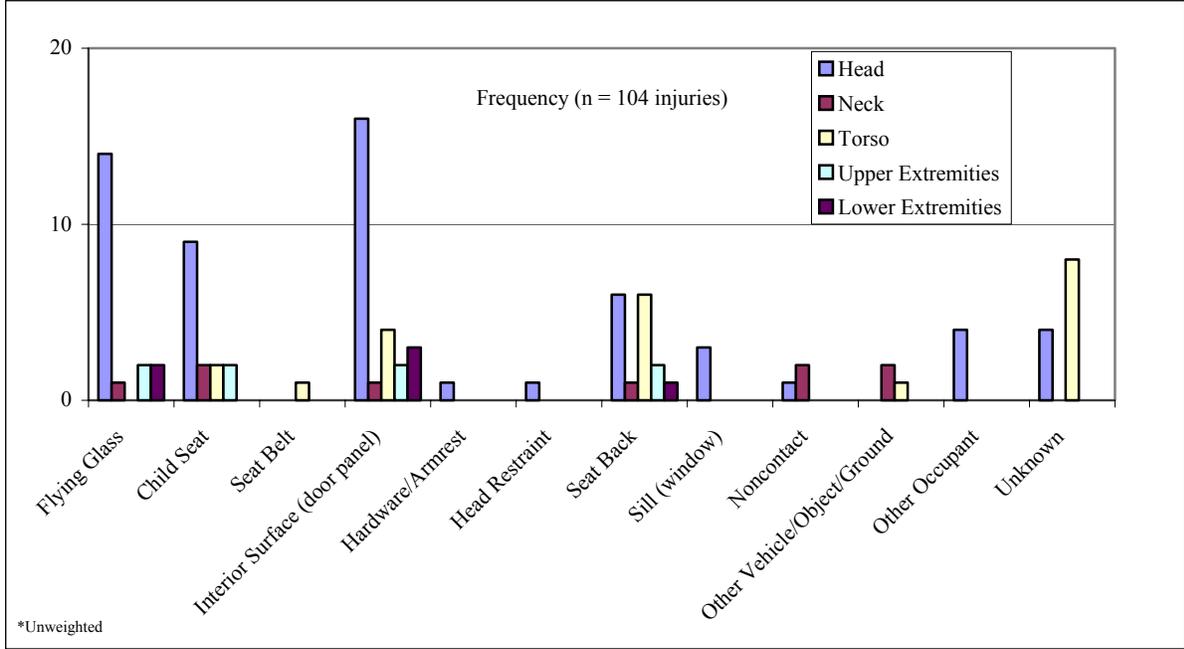
Figure 4: Distribution of injury sources among body regions. Side impact crashes. Children 1 to 3 years old. $n_c = 28$ children. $\Delta V \geq 30$ kph. NASS CDS: 1995, 1996, 1998-2004

The injuries to the 28 children can be categorized by the contact source that caused the injury. The injury contact sources are defined in the NASS-CDS Coding and Editing manual[1]. The groups are shown in Figure 4. While “flying glass” caused 19 of the 104 injuries (mostly to the head), direct contact with the vehicle interior (47 of the 104 injuries) was the most common injury source. Interior contacts included seat backs, sills, hardware, and other surfaces. Contact with the child seat represented 15 injuries. However, further review is required to determine whether the injury is caused by the child’s own CRS (possibly due to contact with an intruding component) or that of an adjacent occupant. Torso injuries were attributed to contact with interior objects/surfaces and other vehicle elements.

Figures 13 and 14 are the equivalents of Figures 4 and 5 for the restricted (forward facing) dataset. As a general trend, the injuries decrease by more than a factor of two, implying the forward facing child restraints afford significant protection. Certain contact surfaces such as interior surfaces, seat backs, head restraints, and unknown are greatly reduced or virtually eliminated as injury sources. Those injuries that do occur seem to be less severe.

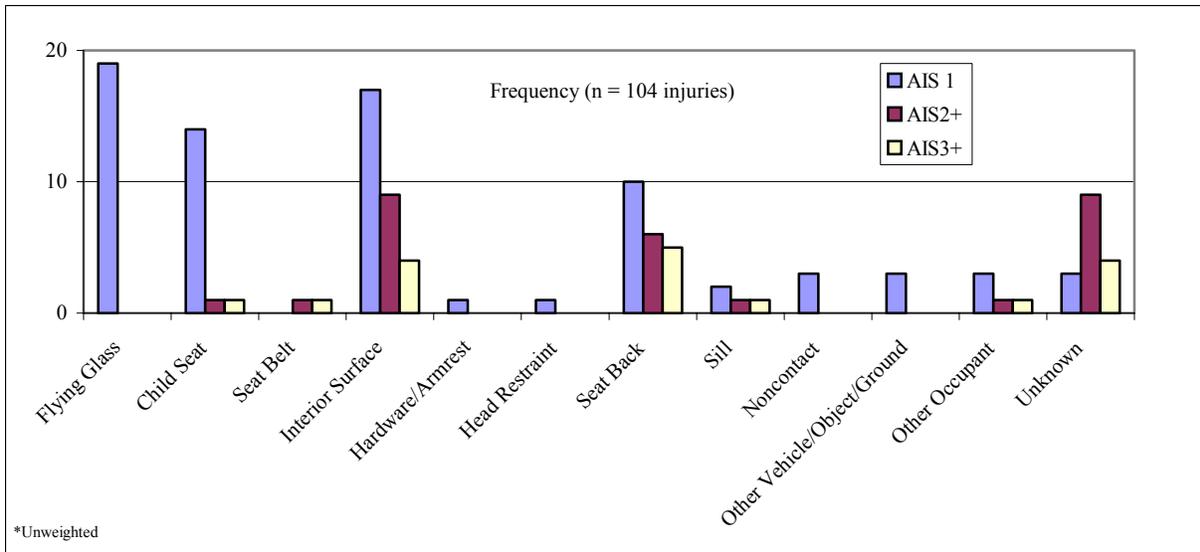
Figure 5: Distribution of injury sources among injury severities. Side impact crashes. Children 1 to 3 years old. $n_c = 28$ children. $\Delta V \geq 30$ kph. NASS CDS: 1995, 1996, 1998-2004. [Note: AIS2+ also includes AIS ≥ 3 injuries]

Figure 5 correlates these same contact groups with the injury severity level using the Abbreviated Injury Scale (AIS). Minor injuries (AIS1) were attributed to flying glass, the vehicle interior, the child seat and the seat back. However, focusing on the moderate and serious-to-fatal injuries (for known sources), Figure 5 shows that the vehicle seat back and other interior surfaces are the prevailing sources of injuries. Table 2 provides the frequency distribution of injury sources.

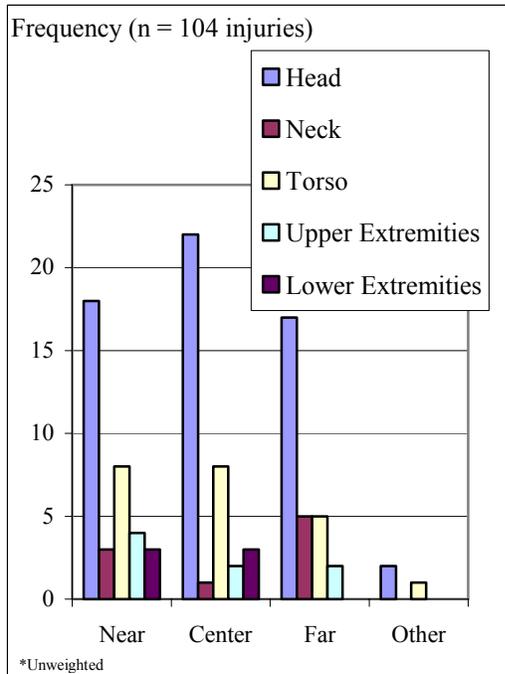
Figure 6: Distribution of relative impact location and injured body region. Side impact crashes. Children 1 to 3 years old. $n_c = 28$ children. $\Delta V \geq 30$ kph. NASS CDS: 1995, 1996, 1998-2004

The frequency of injured regions was also investigated as a function of the relative vehicle impact location. Side impacts were categorized relative to the seating position of the rear seated occupant in question; that is, near side, far side, center, or (in the case of unrestrained children not in a seat) "other." The distribution is shown in Figure 6. Note that these data include all restraint alternatives and will be evaluated in the next segment. The data seem to indicate that head injuries are always prevalent, but that far side occupants are less likely to suffer torso injuries. However, neck injuries are most prevalent with far side occupants then slightly less with near side occupants.

Figures 15 and 16 are equivalent to Figures 6 and 7 for the reduced dataset. A comparison of these figures indicates that children in the forward facing restraints are more protected from torso injuries, at least on the near side and in the center when compared to all other restraint alternatives. Figure 16 shows that occupants in forward facing restraints, in the center seat, sustained only minor (AIS1) injuries.

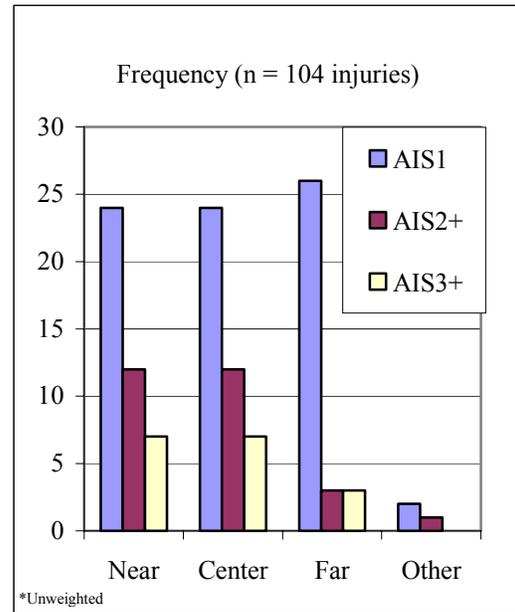
Figure 7: Distribution of relative impact location and injury severity. Side impact crashes. Children 1 to 3 years old. $n_c = 28$ children. $\Delta V \geq 30$ kph. NASS CDS: 1995, 1996, 1998-2004 [Note: AIS2+ also includes AIS ≥ 3 injuries]

These data can also be looked at in terms of injury severity by relative impact location, as shown in Figure 7. It is encouraging that many of the injuries are at the AIS 1 level, but it becomes evident that a higher percentage of the injuries of near side and center seat occupants are at the higher AIS levels for this dataset. The most significant injuries (AIS 3+) are sustained by near-side and center seated occupants for this dataset.

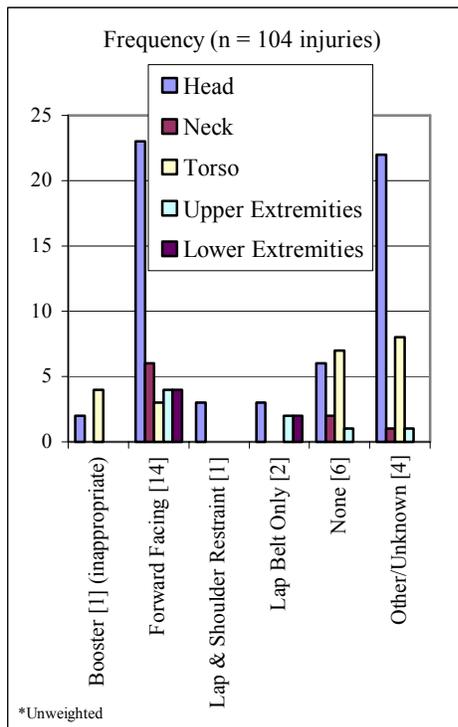
Figure 8: Distribution of restraint type and injured body region. Side impact crashes. Children 1 to 3 years old. $n_c = 28$ children. $\Delta V \geq 30$ kph. NASS CDS: 1995, 1996, 1998-2004

The injury data can be segmented by restraint type. The restraints listed in this NASS-CDS dataset were booster seats, forward facing child restraint systems, lap and shoulder (3 point) safety belts, lap belts only, unrestrained, and other/unknown. The distribution of injured body region is shown in Figure 8. With the limited amount of data across these six alternatives, no clear differences in injury patterns emerge. As a result of this limited sample size of data, the children in forward facing restraints experienced a prevalence of injuries for all body regions. As you review the data, note that the forward facing children represent half of the overall sample. While they represent half of the sample population, there are only 40 (39%) injuries sustained. Thirty five (35) of these injuries are AIS1 and are mainly due to flying glass, child seat, forward seatback and other interior contacts. This sample of restrained children (14) are reviewed in a later section of this paper.

Head injuries are clearly represented within each restraint category. The prevalence of torso injuries is second to head injuries. Although the frequency of upper and lower extremity varies by restraint type, upper extremity injuries are primarily sustained by children in forward facing, lap belt only and other/unknown restraint categories. These data show that children in forward-facing restraints (in this dataset) seem to experience more neck injury than those children in other types of restraints. Given the limited data sample size, more data and further analysis must be conducted better understand the various complexities of the crash events.

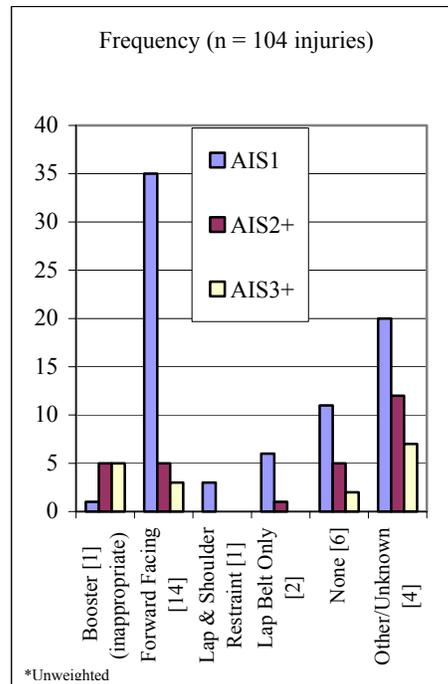
Figure 9: Distribution of restraint type and injury severity. Side impact crashes. Children 1 to 3 years old. $n_c = 28$ children. $\Delta V \geq 30$ kph. NASS CDS: 1995, 1996, 1998-2004 [Note: AIS2+ also includes AIS ≥ 3 injuries]

Injury severity was also determined based on restraint type, as shown in Figure 9. In this plot, some differences between injury severity and restraint type are evident. While only one case of premature graduation to a booster seat was included, most of that case occupant’s injuries were more severe. In contrast, most of the injuries to children in forward facing restraints were AIS 1. The unrestrained and other/unknown cases had higher percentages of injuries above the AIS 1 level.

Of the known restraint types, the most serious (AIS3+) injuries were sustained by a single child inappropriately restrained in a booster seat. This child sustained multiple significant injuries.

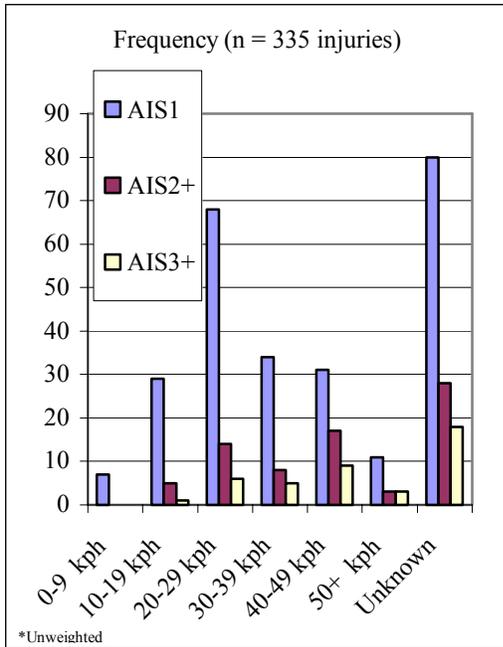
Figure 10: Distribution of ΔV and injury severity. Side impact crashes. Children 1 to 3 years old. $n_c = 117$ injured children. NASS CDS: 1995, 1996, 1998-2004

Next, it is useful to compare the injury severity distributions for some broad categories of impact speed, ΔV . Figure 10 shows the distribution of AIS level for crashes that occurred over 10 kph increments and those designated as “unknown”. Note that these are all ΔV ’s, including “unknown” values. When accounting for all ΔV ’s there are 117 injured one to three year old children who sustained a total of 335 injuries. For approximately one-third of the injuries the ΔV is unknown. Of those cases with a known ΔV , again, no clear pattern emerges. While this is surprising in that the impact speed would be expected to have a stronger influence on injury levels, there are enough confounding factors (e.g., the precise location of the intrusion relative to the occupant) that it is not unreasonable to find limited correlation in a relatively small sample.

Minor injuries (AIS 1) occur at each level of impact speed. Moderate to severe injuries (AIS 2+) seem to occur over a broad range of speeds from 20 – 49 kph. The more severe injuries (AIS3+) seem to occur at ΔV of 40-49 kph.

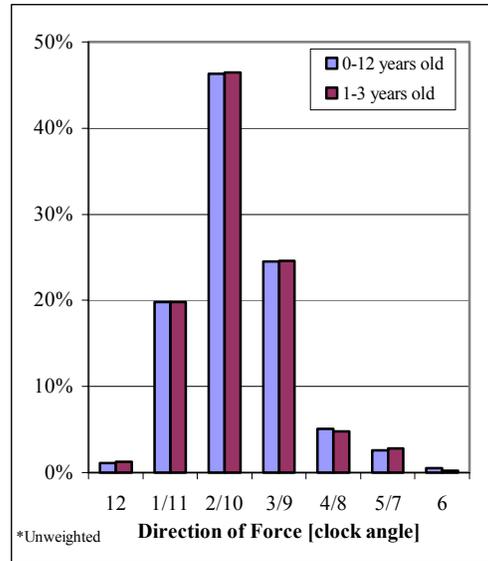
Figure 11: Distribution of Principle Direction of Force. Unweighted side impact crashes (General Area of Damage = Right Side or Left Side). $n_{c\ 1-3} = 394$ children and $n_{c\ 0-12} = 1618$ children. NASS CDS: 1996 - 2005.

Finally, another important aspect of the crash problem is the impact angle or Principle Direction of Force (PDOF). In NASS-CDS, the angles are given as clock angles (e.g., head on force is defined as “12 o’clock”). The dataset was queried to determine the distribution of PDOF for side impact crashes with children in the rear seat. The distribution is shown in Figure 11. If data are grouped by degrees from the longitudinal axis (that is, both 10 o’clock and 2 o’clock represent 60° from longitudinal), then the average impact angle is approximately 70°. If they are grouped by degree from lateral (i.e., 2 o’clock, 4 o’clock, 8 o’clock and 10 o’clock are 30° from lateral), then the average angle from lateral is approximately 30°.

The kinematics of a side impact crash will depend on both the magnitude of the impulse from the bullet vehicle as well as its relative direction. The principal direction of force for side impact crashes tends to be slightly forward of lateral. Figure 12 is a polar coordinate plot depiction of the clock angles of force (12 o’clock being a head-on direction) for side impact crashes in the NASS-CDS database. Side impact crashes are defined as those for which the general area of damage was given as “right” or “left.” In the 394 cases of a side impact crash with a one- to three-year-old occupant in the back seat, the most common angles were 10 o’clock and 2 o’clock.

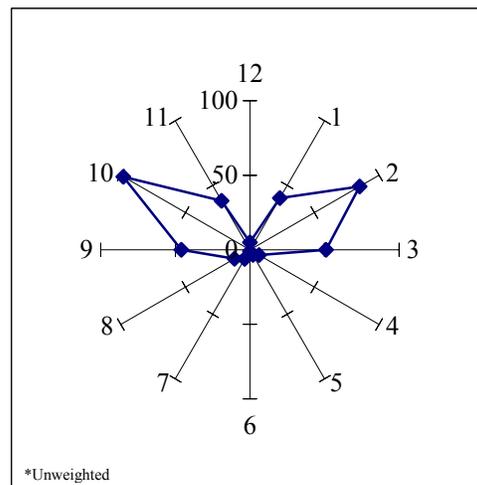
Figure 12: Distribution of principal direction of force [clock angle]. Side impact crashes (General area of damage of “left” or “right”) with a rear seat child occupant aged 1 to 3 years old. $n_c = 394$ children. NASS CDS: 1996-2005.

The data demonstrates that there is typically a longitudinal component in side impact crashes with children. Similar findings were demonstrated in the side impact case studies conducted by Arbogast, et al [3] and Nagabhushana, et al [4].

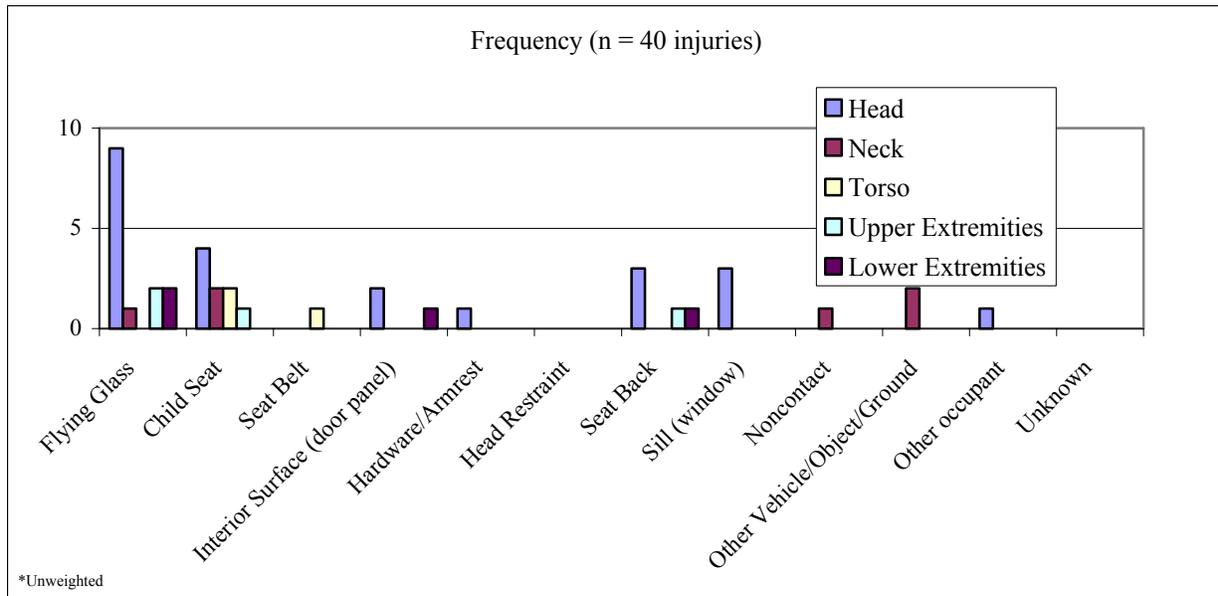
Figure 13: Distribution of injury sources among body regions. Side impact crashes. Children 1 to 3 years old in forward-facing child seats. $n_c = 14$ children. $\Delta V \geq 30$ kph. NASS CDS: 1995, 1996, 1998-2004

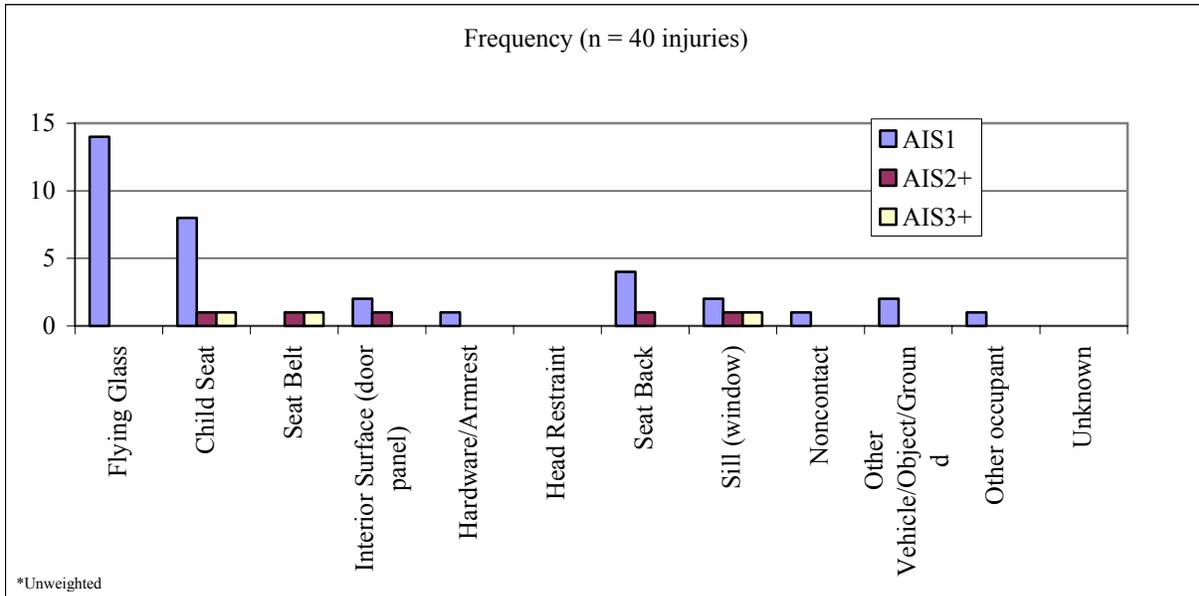
Figure 14: Distribution of injury sources among injury severities. Side impact crashes. Children 1 to 3 years old in forward-facing child seats. $n_c = 14$ children. $\Delta V \geq 30$ kph. NASS CDS: 1995, 1996, 1998-2004 [Note: AIS2+ also includes AIS ≥ 3 injuries]

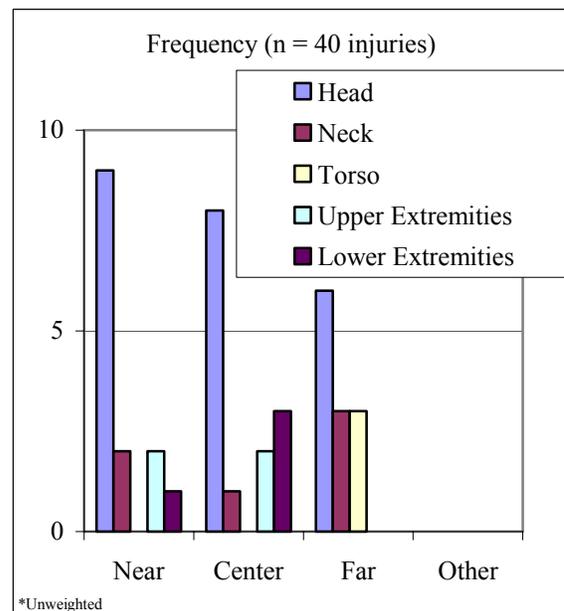
Figure 15: Distribution of relative impact location and injured body region. Side impact crashes. Children 1 to 3 years old in forward-facing child seats. $n_c = 14$ children. $\Delta V \geq 30$ kph. NASS CDS: 1995, 1996, 1998-2004

For this dataset the injuries decreased from 104 for 28 children to 40 injuries for 14 children. The reduction in severe injuries of AIS3+ decreased from 17 to 3. The 40 injuries sustained by this sample are mostly AIS1 (35). These injuries were mainly due to sources such as flying glass, the child seat, the seat back, interior surfaces, the window sill, and “other” structures. For the children aged one to three years old identified in this data, the forward facing child restraints seem quite effective.

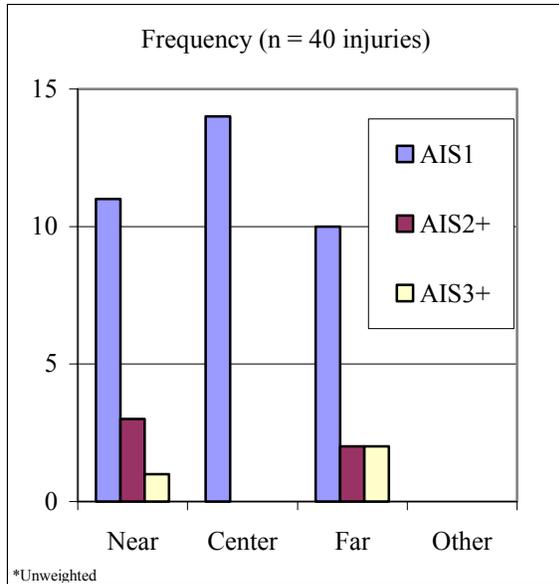
Figure 16: Distribution of relative impact location and injury severity. Side impact crashes. Children 1 to 3 years old in forward-facing child seats. $n_c = 14$ children. $\Delta V \geq 30$ kph. NASS CDS: 1995, 1996, 1998-2004 [Note: AIS2+ also includes AIS ≥ 3 injuries]

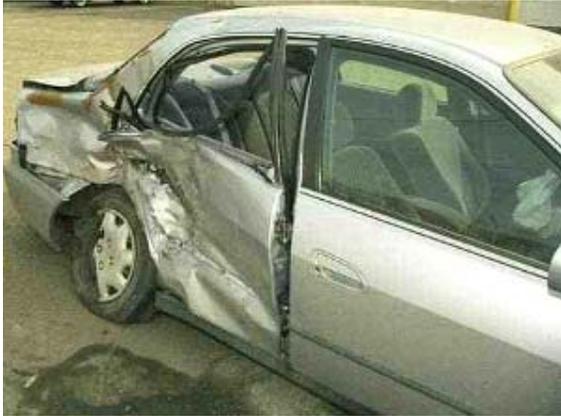
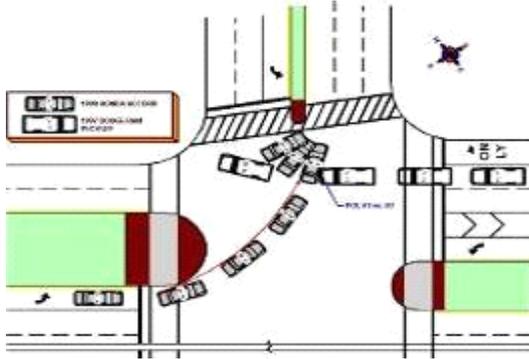
Case Number: 33088

The collision between Vehicle 1 and Vehicle 2 occurred when the driver of the northbound Vehicle 1 attempted to turn left at the intersection as Vehicle 2 was traveling southbound through the intersection. Vehicle 2 struck Vehicle 1's right side plane with its front end. After the impact, Vehicle 1 rotated clockwise to final rest position in the intersection, facing north. The final rest position of Vehicle 2 was in the intersection, facing southwest. Vehicle 1 was towed from the collision scene due to the damage sustained in this collision. Vehicle 2 was driven from the collision scene.

This case involves a 3-year old (46 months), 15 kg (33 lbs.) and 102 cm (40 in.) female seated in the second row right of a 1998 Honda Accord that was involved in a right side collision with a 1997 Dodge Ram pick-up truck. The principal direction of force (PDOF) was 50° (two o’clock) with a ΔV calculated at 19 kph (12 mph). The case vehicle damage was mainly confined to the upper rear portion of the second door, upper rear wheel and right C-pillar area (slight override). The case occupant was restrained in a convertible booster CRS by the internal harness. There was potential slack between the vehicle manual 3-point belt and restraint of the CRS due to non-use of a locking clip or use of the automatic locking retractor mode. The occupant was near-side to the impact and moved forward and to the right with respect to the vehicle. The occupant contacted the

upper portion of the intruding door panel (9 cm) with her right malar eminence (cheek bone) as evidenced by door panel scuffing and contusion/abrasion to the malar eminence. This direct compression on the malar eminence resulted in a right zygoma fracture, right maxillary sinus fracture and a right lateral orbit wall fracture. The occupant's MAIS was 3 with an ISS of 10.

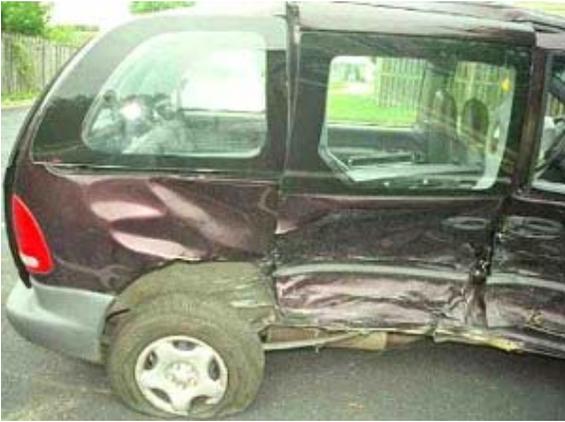
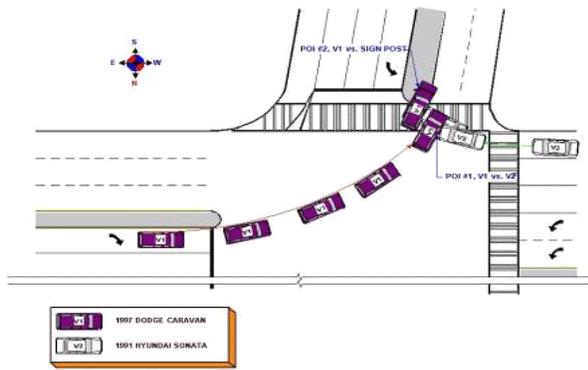
Case Number: 376028346

The collision between the two vehicles occurred when the driver of Vehicle 1 attempted to make a left turn at the intersection and Vehicle 2 was traveling through the intersection. Vehicle 2 struck Vehicle 1's right side plane with its front end (angle configuration). After the impact, Vehicle 1 was pushed sideways with the left side leading and contacted a sign post with the left side of the vehicle. Vehicle 1 came to a final rest position, facing southwest in the median of the south leg of the intersection. Vehicle 2 came to a final rest position, up against the right side of Vehicle 1, facing southeast. Vehicles 1 and 2 were towed from the collision scene due to the damage sustained in this collision.

This case involves a 2 year-old (29 months), 17 kg (37 lbs.) male seated in the third row left of a 1997 Dodge Caravan that was involved in a right side collision with a 1991 Hyundai Sonata sedan. The PDOF was 80° (three o'clock) with a ΔV calculated at 35 kph (22 mph). The case vehicle damage was distributed down the right side of the vehicle starting behind the front wheel and extending to the rear wheel, vertical damage extended past the midline. The lower sill or rocker panel was fully engaged. The case occupant was restrained in an appropriate forward facing CRS by the internal harness, but the vehicle 3-point belt was improperly routed to restrain the CRS. The occupant was far-side to the impact and moved right and slightly forward with respect to the vehicle. The improper belt routing allowed the CRS to move right prior to fully engaging the 3-point belt. The neck/cervical spine underwent lateral extension as the occupant's head moved to the right. This extension placed the brachial plexus under tension causing nerve injury within the plexus. The occupant's MAIS was 2 with an ISS of 4.

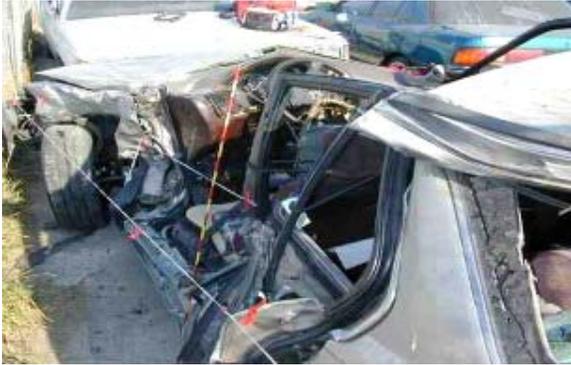
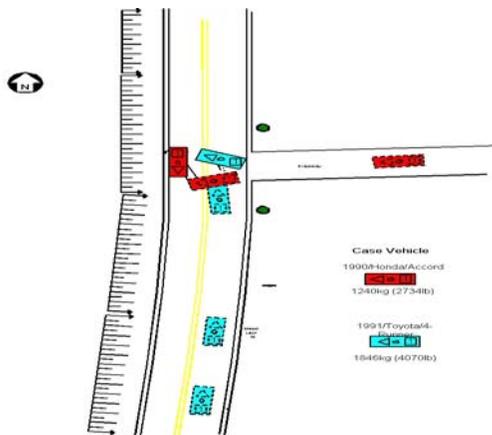
Case Number: 377037327

Vehicle #1 (Case vehicle, 1990 Honda Accord 4 door) was traveling westbound on a negative 1 percent driveway intending to travel southbound. Vehicle #2 (1991 Toyota 4-Runner Utility) was traveling northbound on a two lane positive 6 percent grade (slightly curved to the left) roadway with a posted speed limit of 40mph. As V1 entered the roadway, it intended to make a left turn to travel southbound when it was impacted on the left side by the front of V2. V1 and V2 both traveled in a north-west direction before traveling to final rest. The roadway was dry and it was sunny and clear at the time of the crash.

This case involves a 2-year old (24 months), 17kg (37 lbs.) and 91 cm (36in.) female seated in the second row right of a 1990 Honda Accord that was involved in a left side collision with a 1991 Toyota 4-Runner SUV. The PDOF was 280° (nine o'clock) with a ΔV calculated at 42 kph (26 mph). The case vehicle damage was distributed across both doors on the left side with B-pillar engagement and minimal rocker panel engagement. The case occupant was restrained in an appropriate forward facing CRS by the internal harness, but the vehicle 3-point belt was likely not locked. The occupant was far-side to the impact and moved left with respect to the vehicle. Slack in the 3-point belt allowed the CRS to rotate to the left. The occupant contacted the center second row seat back as evidenced by a large fabric scuff. The occupant contacted the seat back with the left side of her face. This compression fractured her left maxilla and nose. The occupant's MAIS was 2 with an ISS of 8.

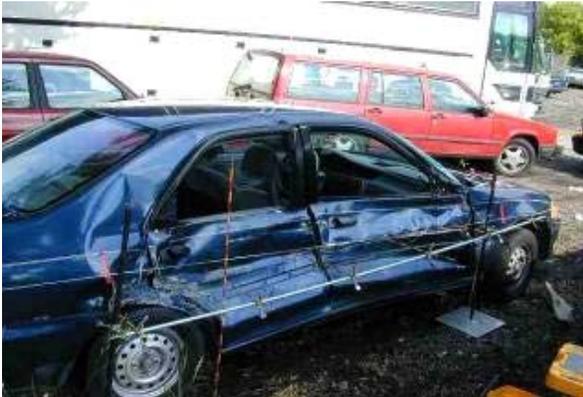
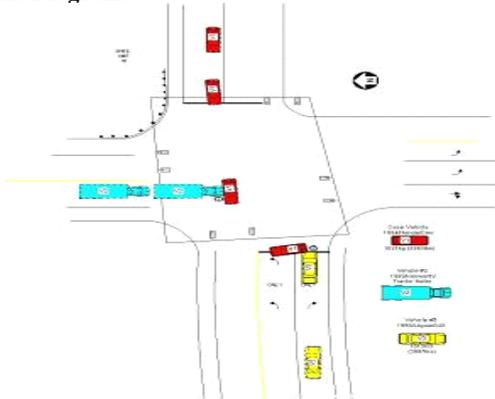
Case Number: 377039617

This crash occurred in the afternoon hours. The roadway was dry with adverse weather conditions. This crash occurred at a four legged intersection properly controlled by overhead traffic control standards. The case vehicle was initially traveling westbound in the outer travel lane on a three lane- roadway. The non-case vehicle, a 1999 Kenworth Tractor-trailer, was traveling southbound in the inner travel lane. Both vehicles entered a four-legged intersection resulting in an angle collision between the case and non-case vehicles. The initial impact caused Vehicle #1 to rotate clockwise resulting in an impact (second event) with a stopped 1998 Jaguar XJ8.

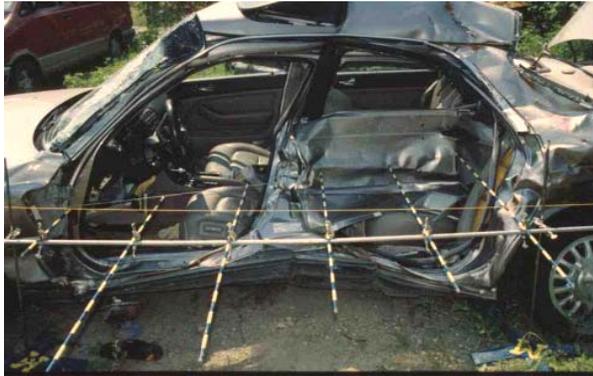
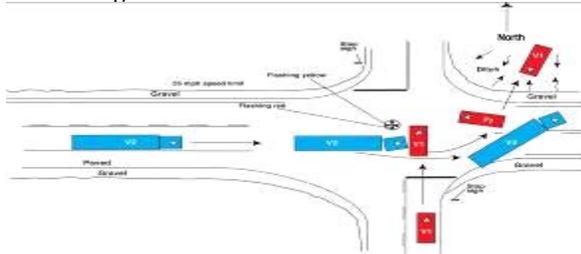
V1: Acura-Legend, 4-door sedan, hardtop-1994

V1 (case vehicle), a 1994 Acura Legend, 4-door sedan was traveling north in the northbound lane of a two-lane, two-way bituminous roadway and was approaching a four-leg intersection. V2, a 1993 International tractor-trailer (one trailer) was traveling east in the eastbound lane of the intersecting, two-lane, two-way bituminous roadway. It was daylight, clear weather, and the roadways were dry and free of defects. V1 came to a stop at the four-leg intersection. For an unknown reason, the driver of V1 pulled into the intersection with the intention of moving straight across the intersection and was struck on the left-side by the front of V2. V1 moved laterally and rotated counter-clockwise and exited the northeast corner of the intersection. V1 came to rest off the roadway facing southwest.

This case involves a 2-year old (24 months), 9 kg (20 lbs.) and 90 cm (36 in.) male seated in the second row left of a 1994 Acura Legend that was involved in a left side collision with a 1993 International tractor and trailer. The PDOF was 270° (nine o'clock) with a barrier equivalent speed calculated at 41 kph (25 mph). The case vehicle damage was distributed across both left side doors (horizontally and vertically) and over the rear wheel (significant crush). The case occupant was restrained in a forward facing CRS by the internal harness. The CRS was properly restrained to the vehicle by the 3-point belt. The occupant was near-side to the impact and moved to the left with respect to the vehicle. The occupant contacted the upper portion of the intruding door panel (50 cm) with the left side of his head in the temporal region. The intruded door panel also loaded the left side of the CRS. The compressive contact of the upper door on the occupant's head produced a subdural hematomas in the left cerebrum and cerebellum. The left scalp was contused and lacerated. The occupant's thorax and abdomen was compressed by the reinforced side of the CRS causing lung contusions on the lower lobe of the left lung and a small spleen laceration. The occupant's MAIS was 4 with an ISS of 29.

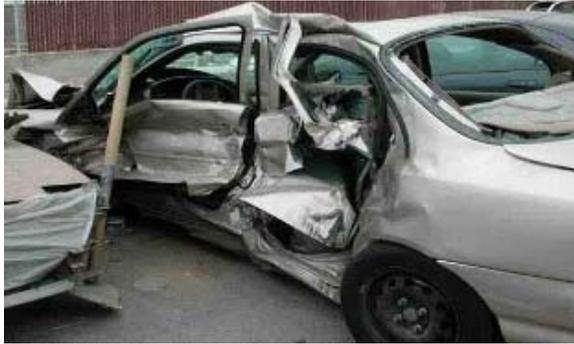
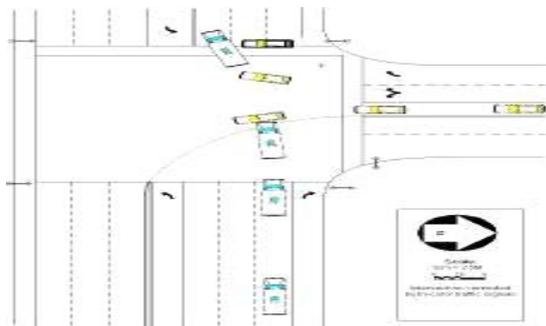
Case Number: : 470047788

This crash occurred at the three leg intersection of two urban roadways. The east/west roadway consists of seven, undivided, lanes of travel. The north/south roadway consists of five, undivided, lanes and connects to the north side of the larger east/west street. The incident occurred during daylight hours under clear, dry conditions. The case vehicle (V1) was traveling southbound approaching the intersection in the left turn lane intending to turn left. The opposing vehicle (V2) was traveling westbound in the number one lane. As V1 maneuvered into the intersection it was struck on its left side by the front of V2. V1 was pushed directly right to its final rest while V2 skidded straight to its final rest.

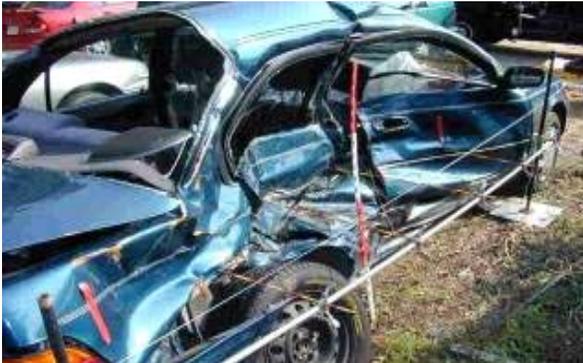
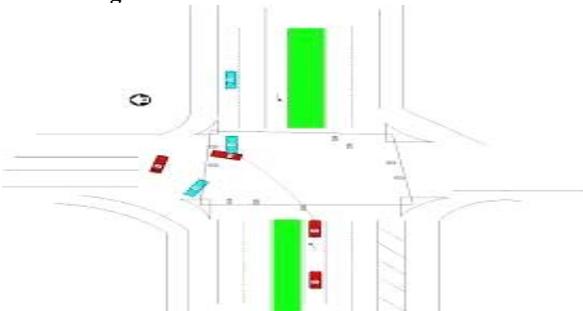
V1: Toyota-Corolla, 4-door sedan, hardtop-1994

This crash occurred in the afternoon hours. The roadway was wet with adverse weather conditions. This crash occurred at a four legged intersection properly controlled by overhead traffic control standards. The case vehicle was initially traveling eastbound in the left hand turning lane (lane 3) on a six lane-divided roadway. The non-case vehicle was traveling westbound in the outer curb lane. The case vehicle attempted a left hand turn and was struck by the non-case vehicle within the intersection.

This case involves two children in the same vehicle. The occupants are in a 1994 Toyota Corolla that is involved in a right side collision with a 1988 Ford Ranger compact pick-up truck. The PDOF was 80° (three o'clock) with a ΔV calculated at 48 kph (30 mph). The case vehicle damage was distributed across the both right side doors and over the rear wheel (slight override).

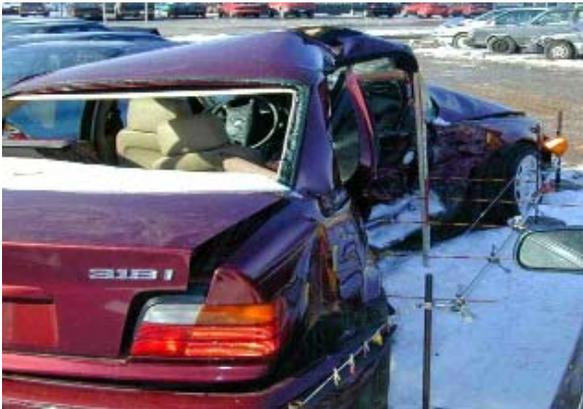
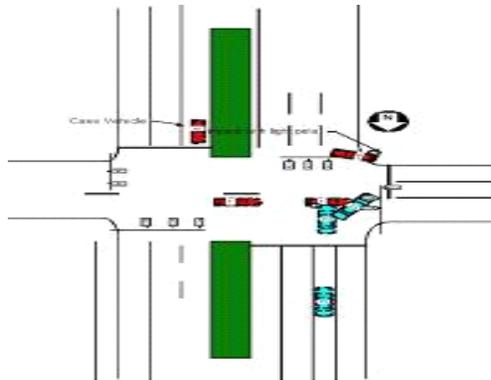
Case Number: 874034767

Vehicle #1 (case vehicle, 1997 BMW 318i) was initially traveling northbound and attempted a left turn at a four legged intersection. Vehicle #2 (non-case Vehicle, 1997 Cadillac Seville) was initially traveling southbound in the opposite direction of the case vehicle. Vehicle #1 entered the intersection and was struck on the passenger side by the front of the non-case vehicle. After impact Vehicle #1 rotated clockwise and traveled to final rest after impacting a light standard. It should be noted that the roadway was dark with no street lights and the surface was dry and the weather was clear at the time of the crash.

This case involves a 3-year old (40 months), 16 kg (35 lbs.) and 97 cm (38 in.) male seated in the second row right of a 1997 BMW 318 that was involved in a right side collision with a 1997 Cadillac Seville. The PDOF was 80° (three o'clock) with a ΔV calculated at 80 kph (50 mph). The case vehicle damage was distributed from behind the right front wheel to past the rear wheel. The rocker panel and doors were fully engaged. The case occupant was restrained in a backless booster CRS by the available manual 3-point belt. The occupant was near-side to the impact and moved forward and to the right with respect to the vehicle. The occupant contacted the intruding door panel (60 cm) with his right thorax and head resulting in bilateral lung contusions and a concussion. The intruding door panel also loaded the CRS compressing the occupant's pelvis resulting in a fracture. The occupant's MAIS was 4 with an ISS of 24.

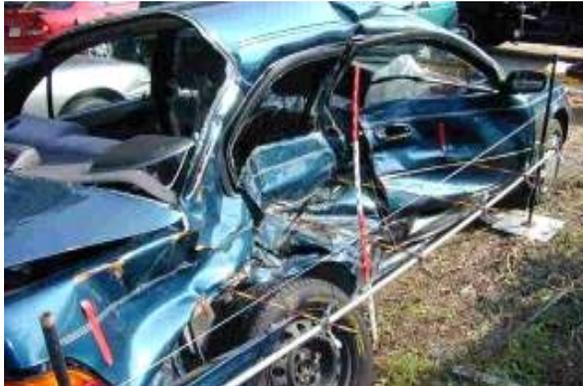
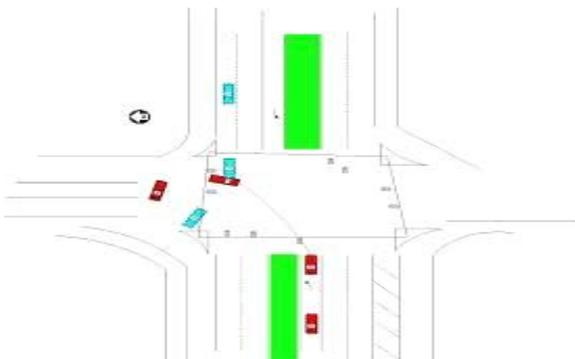
Case Number: 874037095

This crash occurred in the afternoon hours. The roadway was wet with adverse weather conditions. This crash occurred at a four legged intersection properly controlled by overhead traffic control standards. The case vehicle was initially traveling eastbound in the left hand turning lane (lane 3) on a six lane-divided roadway. The non-case vehicle was traveling westbound in the outer curb lane. The case vehicle attempted a left hand turn and was struck by the non-case vehicle within the intersection.
