# EVALUATING THE NEED FOR CHANGING CURRENT REQUIREMENTS TOWARDS INCREASING THE AMOUNT OF LIGHTING DEVICES EQUIPPING SEMI TRAILERS

Krzysztof Olejnik

Motor Transport Institute  
Poland  
Paper No. 07 – 0135

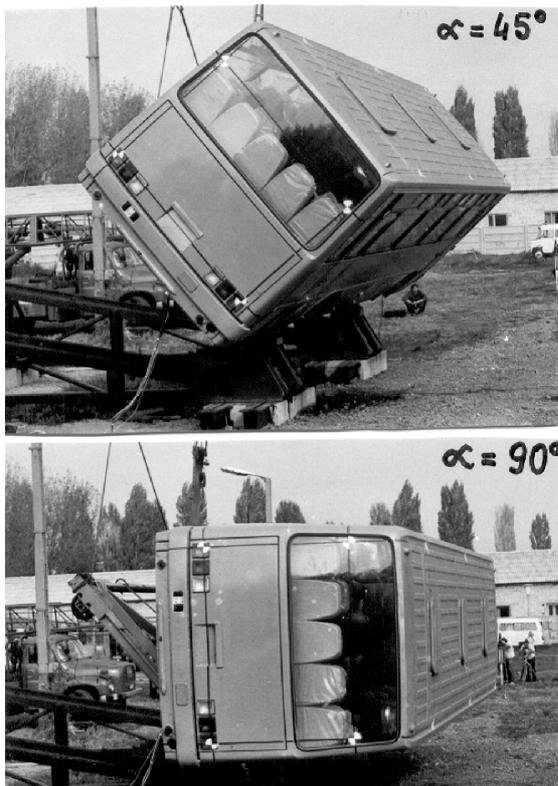
Figure 1. Lateral rollover test

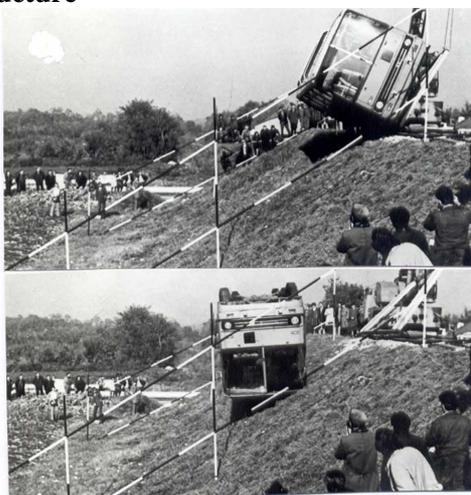
**Figure 9. Rollover test with reinforced superstructure**

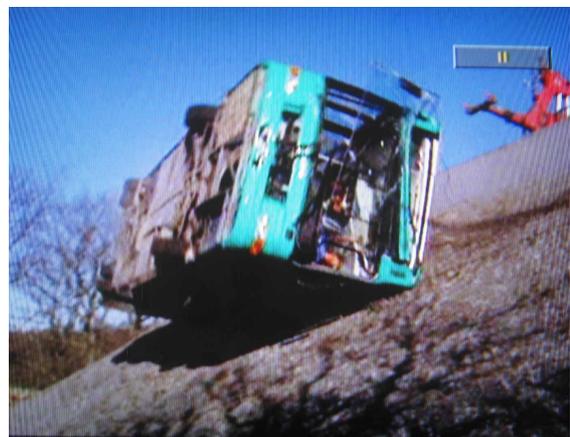
**Figure 15. VOLVO's rollover test**

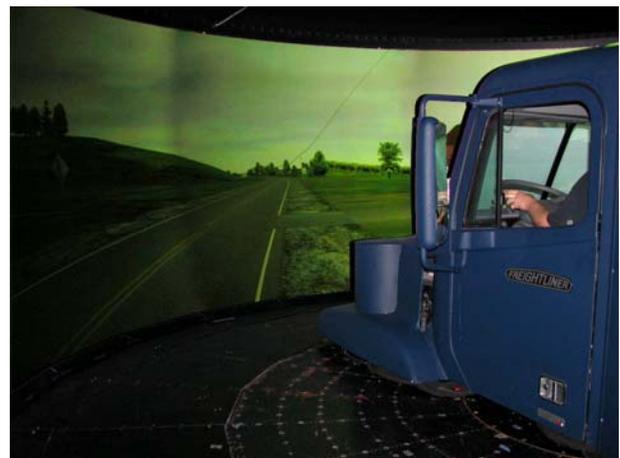
Figure 8. Truck cab in the NADS dome.

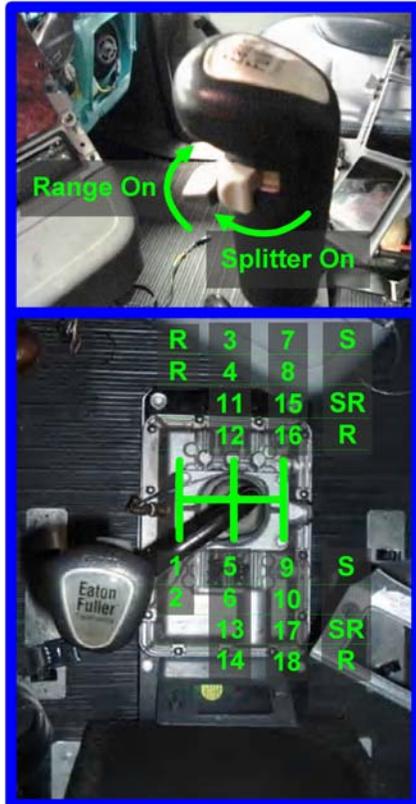
**Figure 11. Truck cab shifting.**

A manual transmission with low and high gear range selection is being used for this study (Figure 11). Before drivers were engaged in the scenarios, they were given ample time (about 20 minutes) to drive and get familiar with the transmission system. Drivers expressed different skill levels; however, none of the scenarios involved in this study required transmission shifting during the braking event.

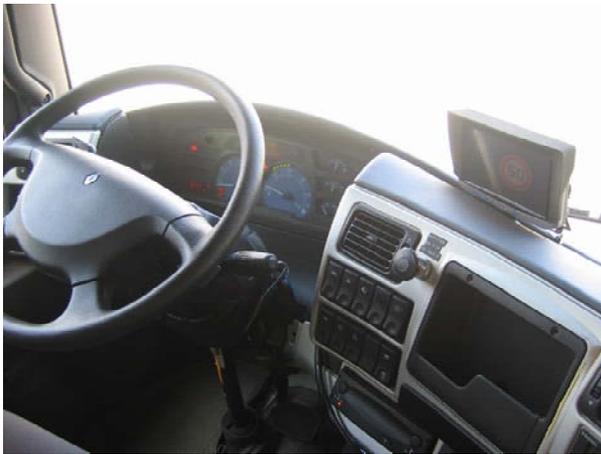
**Figure 1.** View of the Renault Magnum dashboard with the warning display.

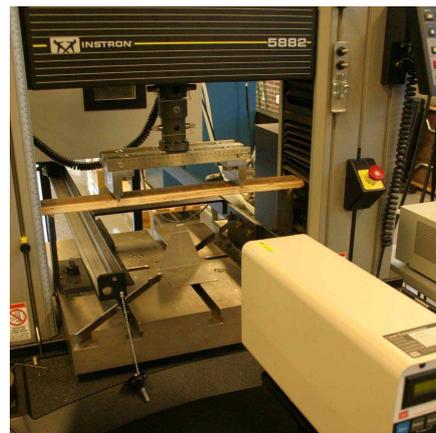
**Figure 5. A four point bending test of a plywood sample from the bus floor.**
