ROADSIDE HAZARD AND BARRIER CRASHWORTHINESS ISSUES CONFRONTING VEHICLE AND BARRIER MANUFACTURES AND GOVERNMENT REGULATORS.

Monash University, Dept. of Civil Engineering,
Australia

Paper Number 05-0149

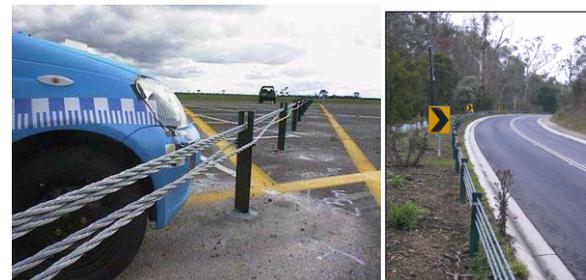
Figure 4 Left: Brifen system tested at Monash. Right: Flexfence system

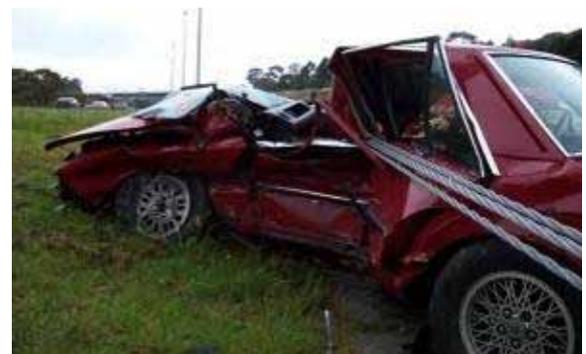
Figure 5 Wire-rope underide (after Owen, 2005)

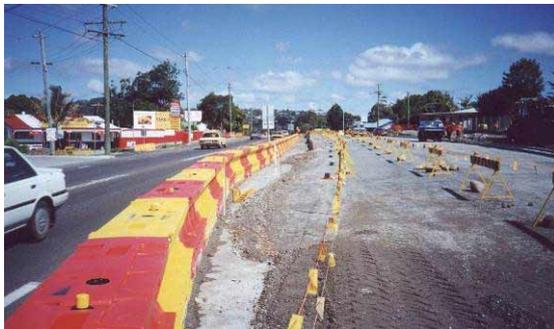
Figure 6 Waterfillable Roadliner barriers tested and certified to AS/NZS 3845.

The barriers shown in Figure 16 were redesigned to those shown in Figure 6. These barriers passed the Level 0 test as detailed previously.

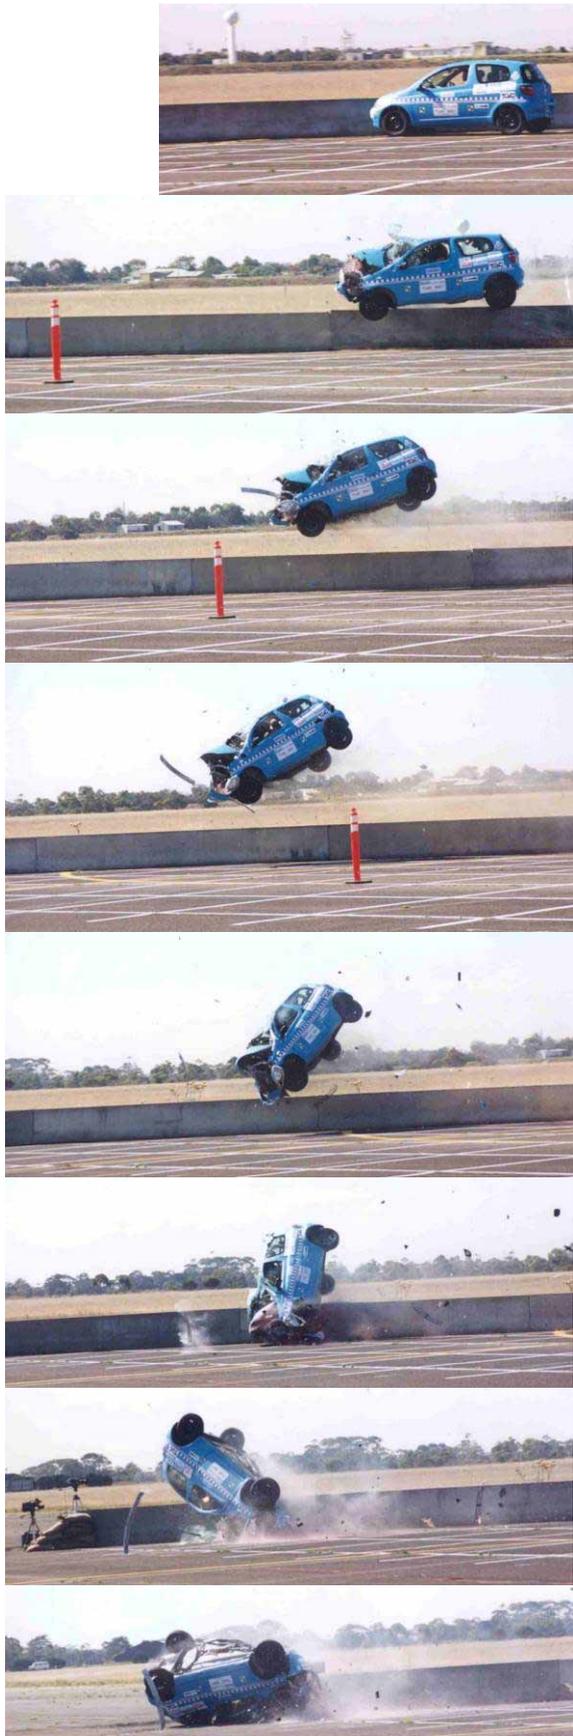
Figure 7 Impact of Echo into New Jersey barrier at 80 km/hr and 45°.

Jersey and F shape barriers will launch vehicles into the air and more than likely result in a vehicle rollover if struck at larger angles. Figure 7 shows the small car (Table 1) impacting the barrier at 80 km/hr at 45°. The crash was not survivable with large intrusion into the vehicle cabin and roof crush as

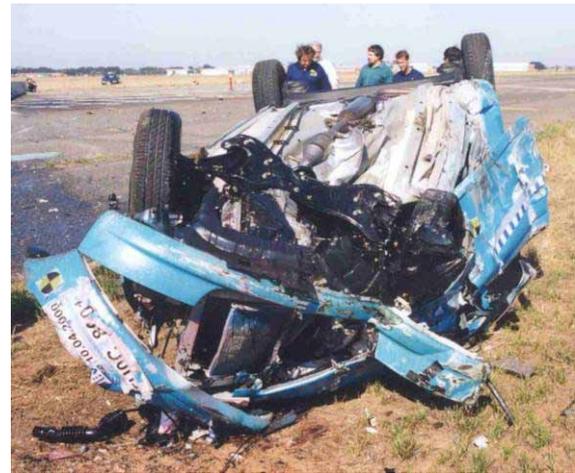
Figure 8 External and internal crush deformation for 80 km/hr at 45° impact into concrete barrier.

shown in Figure 8. Figure 9 shows how the vehicle launches in the air at 110 km/hr at 20° impact angle. The dummy's head is thrown towards the side window and the passenger's head strikes the shoulder of the driver. The dummy kinematics is a combination of a frontal offset crash and a near side impact crash for the passenger and a far side impact for the passenger. Side air curtains would provide benefit in such crashes but a frontal airbag firing would hinder recovery.

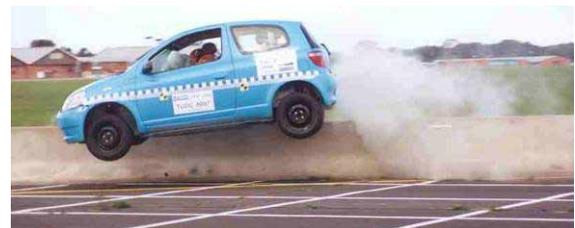
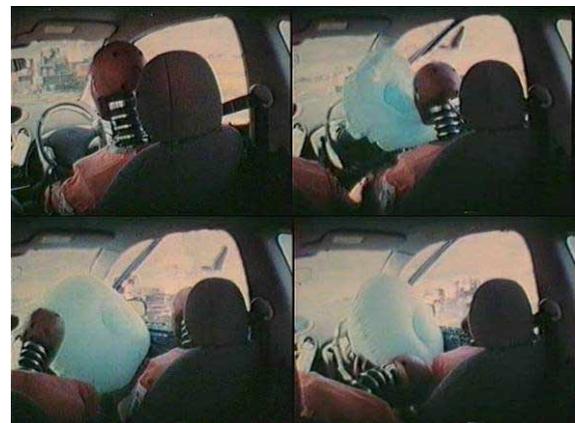
Figure 9 Impact at 110 km/hr at 20°.

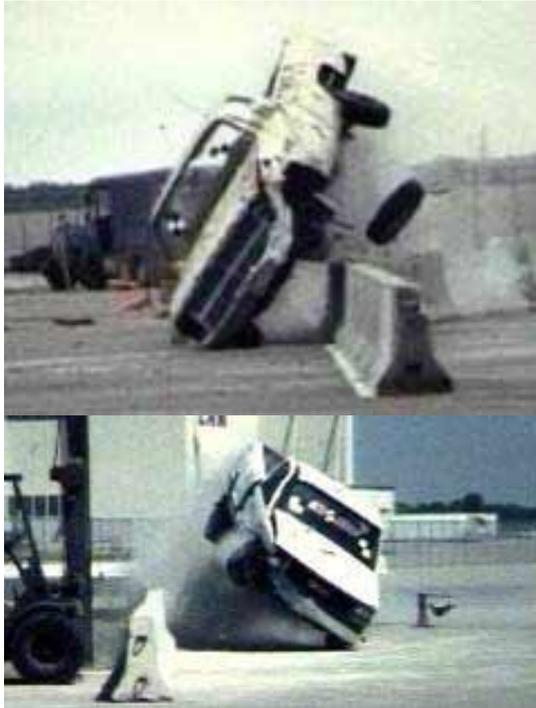
Figure 10 Top: F shape moveable, Chevy C-20 at 99.4 km/hr and 26.4° Bottom: F shape fixed, Chevy ¾ ton at 99.8 km/hr @ 25.3° (after Sicking, 2004).

Whilst there is a higher risk of rollover with the Jersey barrier than with the F shape barrier, Sicking has pointed out at a recent NCHRP 350 meeting (2004), the risk of rollover for these barriers is around 2.3 times greater for both barrier types than for a vertical barrier. Figure 10 shows how a pick up rolls over when hitting F-shape temporary and rigid barriers.

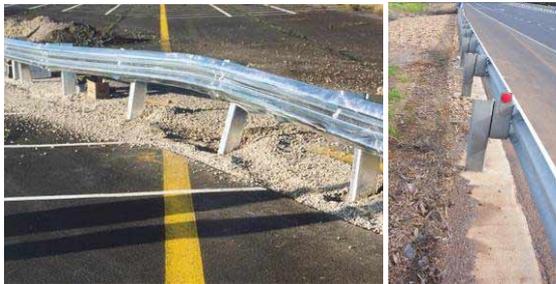
Figure 11 Guard rail barriers. Left: posts move in soil. Right: post set in concrete.

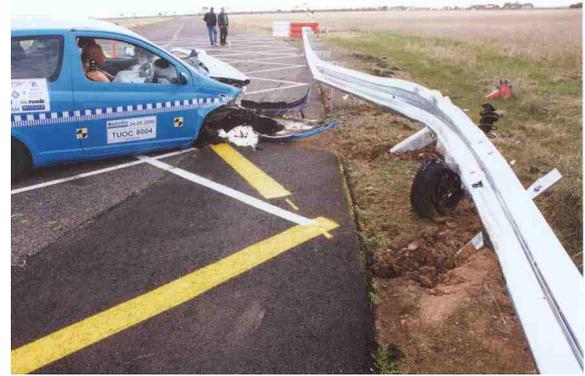
Figure 12 Pocketing and under-ride into guardrail barrier – 80 km/hr at 45°.

An interesting result was obtained with respect to the 80 km/hr at 45° impact test into the guardrail system. The vehicle "pocketed" into the barrier rather than being redirected. The front right wheel also under-rod the barrier and was torn from the vehicle during rebound as shown in Figure 12. What was revealed was the barrier was incorrectly installed by the contractor in that it was missing end

cables that provide further tensioning of the guardrail. Nevertheless it was felt that this would not have significantly altered the test outcome. The major issue was that the tyre under-rod the barrier. Hence barrier height is important and variation in wheel diameters needs to be considered by both vehicle and barrier manufacturers.

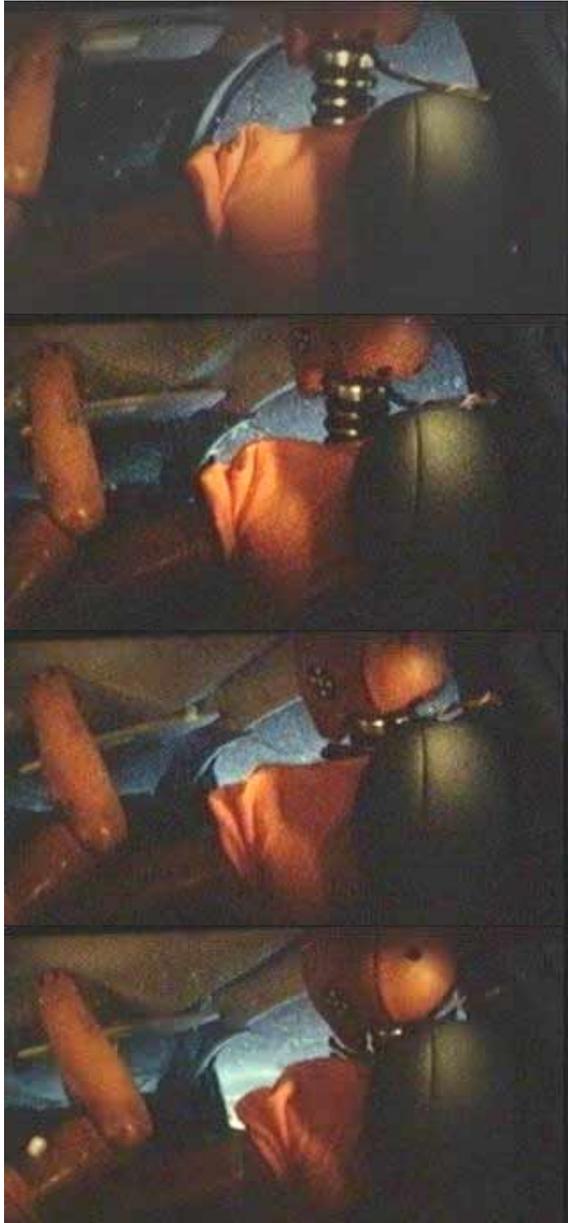
Figure 14 Roof crush in rollover compresses neck.

An interesting outcome from the rollover crash was the on board image of the roof crushing onto the dummy head as shown in Figure 14. This high speed film captured the moment when the neck of the

Hybrid III dummy is loaded and deforms into an S shape providing further good evidence of how roof crush in a rollover event can lead to either a fatality or serious neck injury where paraplegia or quadriplegia would occur. Rechnitzer et al in their study of serious neck injuries in rollover crashes pointed to the issue of roof crush as the main contributor to such injuries in 1998. The vehicle deformation shown in Figure 15 from both the Monash crash test and the vehicle shown in their paper, illustrating how an Australian football celebrity died in a rollover crash, are notably similar.

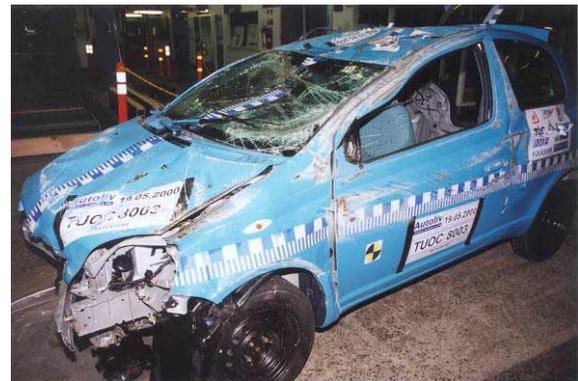
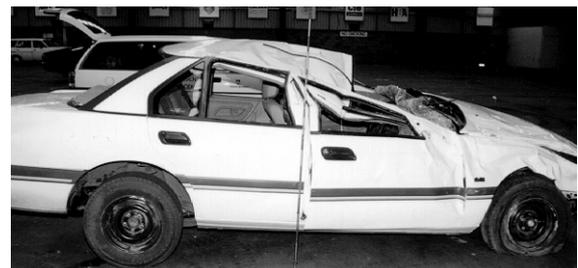
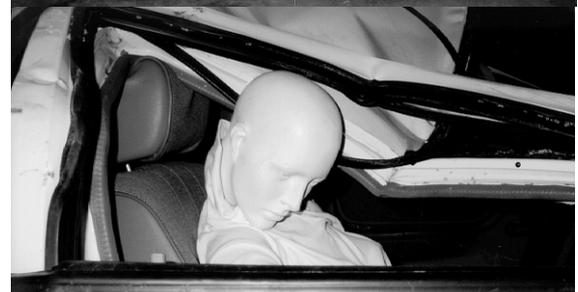
Figure 15 Top: Damaged profile of vehicle from the Monash Series wire rope crash test. Middle and bottom: Similar crush profile and injury mechanism presented by Rechnitzer et al (1998).

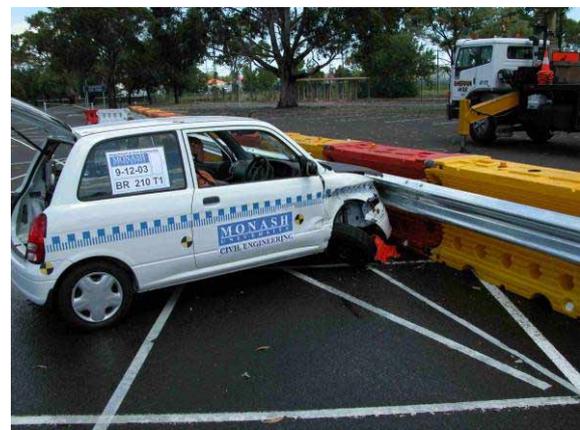
Figure 17 NCHRP 350 Level 2 (70 km/hr at 20°) barrier crash test involving a Daihatsu car.

The deceleration during impact in the Daihatsu crash test (Figure 17) was low enough that the airbag did not trigger. Whilst the engine rail tore the plastic wall the vehicle continued sliding along the barrier line where the average deceleration was around 7 g's.

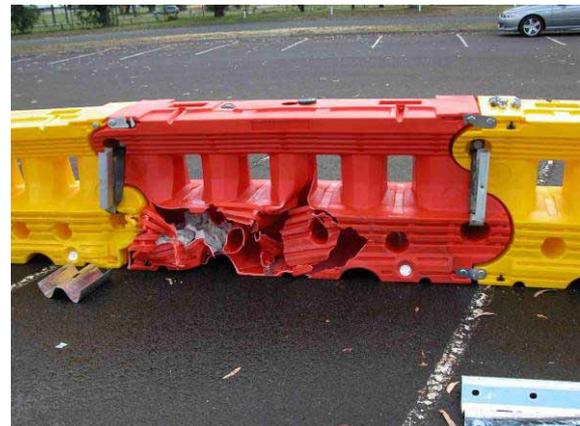
Figure 18 Tears in barriers caused by engine rail spearing through plastic.

Figure 18. The guardrail helps restrict the intrusion and snagging to some degree. The tyre under-rides the barrier, tearing the wheel in a manner somewhat similar to the crash test shown in Figure 12. Again this highlights the need for both barrier manufacturers as well as vehicle manufactures to be aware that smaller diameter wheels can lead to inappropriate snagging problems where guardrail terminals are used.

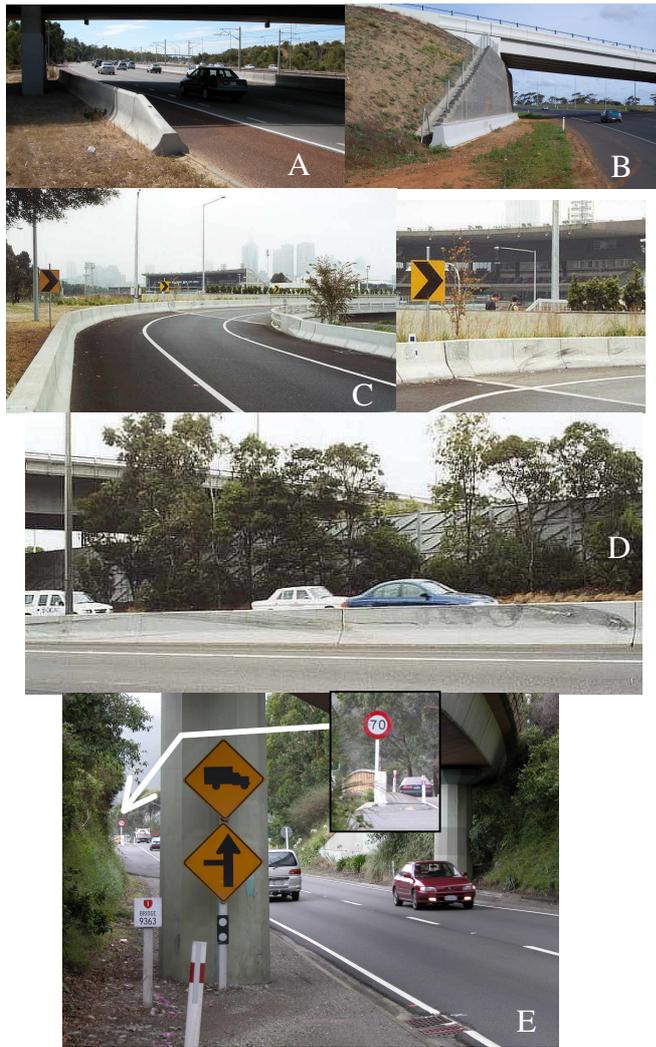
Figure 21 Real world lethal roadside hazards in Australia and New Zealand.

Figure 21 shows a small selection of roadside hazards that typify the problems encountered in regards to road design that the authors have noted and that persist despite available crash test evidence for many years that when vehicles strike such hazards the risk of a fatality or serious injury is high. The pictures are as follows; Frame A: Perth

freeway, B: Melbourne 100 km/hr new freeway, C: Melbourne exit ramp from new freeway, D: Melbourne concrete F shape barrier on 100 km/hr new freeway where wheel imprints are visible, E bridge pier in 100 km/hr zone in Wellington New Zealand with 70 km/hr speed limit zone placed 50 meters past the pier. What is of particular concern is the proliferation of hazards on completely new freeways where a large number of road safety audits have already been carried out.
