# RESEARCH TO EVALUATE SAFETY TECHNOLOGIES FOR VULNERABLE FUEL TANKS

**Kennerly Digges**
Automotive Safety Research Institute
USA

**Edmund Fournier**
**Matthew Keown**
**Jim Kot**
**Nicholas Shewchenko**
Biokinetics & Associates, Ltd.
Canada
Paper Number 230

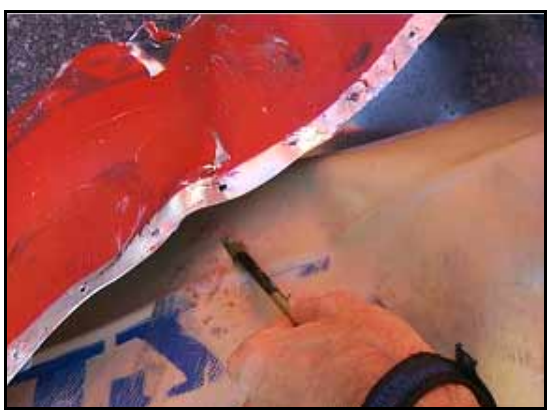
**Figure 8. Damage to the fuel cell aluminum housing (a) cut in fuel cell caused by sharp aluminum surface (b)**

With the aluminum container ruptured, the fuel cell inside was ejected from the truck. In the process, all the fuel lines connected to the tank were severed. The filler tube was disconnected from the tank, but a reverse flow flapper valve in the tank prevented spillage at the filler spud. Additionally, a rollover valve on the vent line prevented fuel leakage from the severed vent hose. There were no provisions in the fuel supply line to prevent fluid loss in the event that the line was severed and consequently it leaked fuel. However, the majority of fuel spillage stemmed from a tear in the bladder that was discovered along its lower inside edge. The damage was caused by the rear mounting bracket/strap that failed during the impact and perforated the aluminum outer housing creating sharp edges on the inside of the housing that cut or punctured the bladder. The damaged aluminum cover and fuel cell puncture are shown in Figure 8.

A second fuel cell system was assembled addressing the shortcomings identified by the results of the first test. Enhancements to the second fuel cell included fabricating the outer housing from steel rather than aluminum with through bolts instead of rivets to secure the hosing cover and the end plates of the container. The mounting brackets, which previously supported the tank from underneath, were replaced with brackets from which the tank was suspended. The intent of the new bracket arrangement was to allow the tank to deform without being restricted by the mounting brackets. To prevent fuel leakage from severed fuel lines, self-sealing breakaway connectors were installed on the fuel delivery and returns lines. As with the previous fuel cell, the vent line relied on an internal rollover valve.

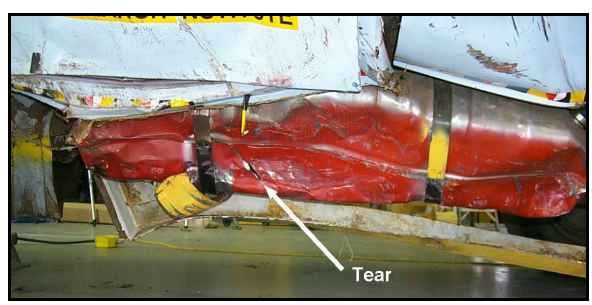
Notwithstanding the additional bracing of the rear support, neither the protective frame nor the vehicle structure to which it was bolted were capable of resisting the severe downward torque applied by the impacting vehicle, thereby, leaving the tank exposed and vulnerable to direct loading by the bullet vehicle. A significant tear in the tank resulted in excessive fluid loss. Damage to the tank and frame are shown in Figure 10.

**Figure 10. Damage to the tank protective frame**

A retest of the tank protection system was performed with a second system based on the initial frame except with two additional attachment points to specifically counteract the downward moment applied by the impacting vehicle. The front end of the guard was fastened vertically to the cab floor and

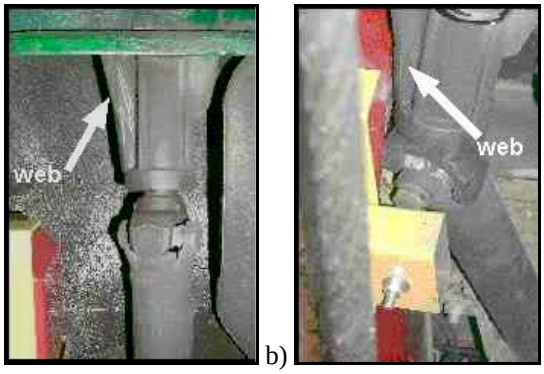
Relocating the tank between the frame rails reduces its vulnerability to side impact, but may increase vulnerability in some other crashes. In severe crashes into a rigid frontal barrier the engine and transmission move rearward. An aggressive web on one of the alternative transmission produced a leak in one frontal barrier test. In addition, the drive shaft may buckle in the direction of the tank causing damage. Figure 14 shows the location of the aggressive transmission web and the drive shaft relative to the tank before and after a frontal crash test.

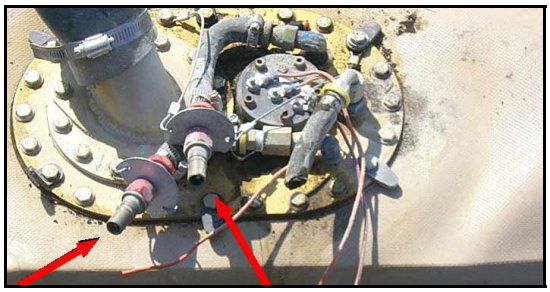
Self-sealing breakaway connectors were installed on the fuel delivery and returns lines on the racing fuel cell. In a Caprice test, the fuel lines connectors disengaged and no leakage occurred. The self-sealing breakaway connectors are shown in Figure 17 before and after the test.

**Figure 17. Self-sealing break-away couplings in fuel line before test (a) and after test (b)**
