ASSESSMENT OF THE USE OF SEAT BELTS IN BUSES BASED ON RECENT ROAD TRAFFIC ACCIDENTS IN SPAIN

Ignasi Ferrer
IDIADA AUTOMOTIVE TECHNOLOGY SA
Juan L. de Miguel
CENTRO ZARAGOZA
Spain
Paper Number 222

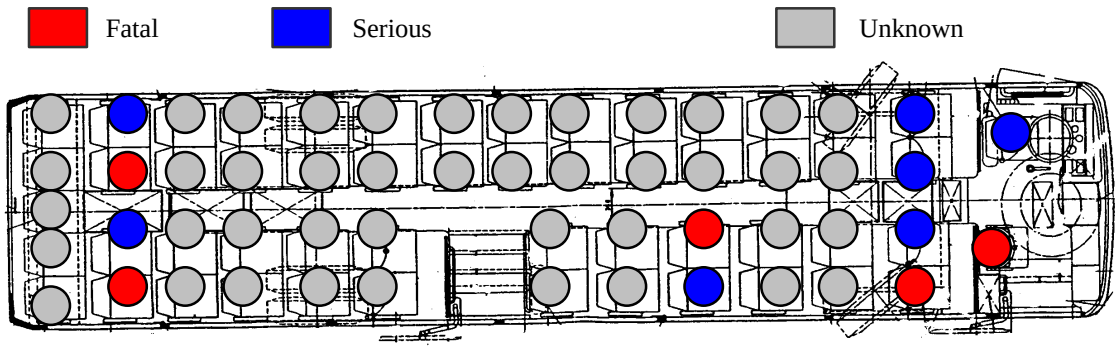
Figure 3. Severity of occupant injuries.

The occupants whose position before the accident is known are represented in different colours. The persons who occupied those positions painted in red, died. The occupants of the seating positions coloured in blue were considered seriously injured by the police.
This case is a typical situation of occupant ejection in a rollover accident. The vehicle kinematics during the rollover has not been precisely determined. The position of most of the passengers before and after the accident is unknown. Most passengers drowned in the watercourse. An occupant simulation was not carried out in this case. It had been difficult to fix the boundary conditions and validate any possible results.

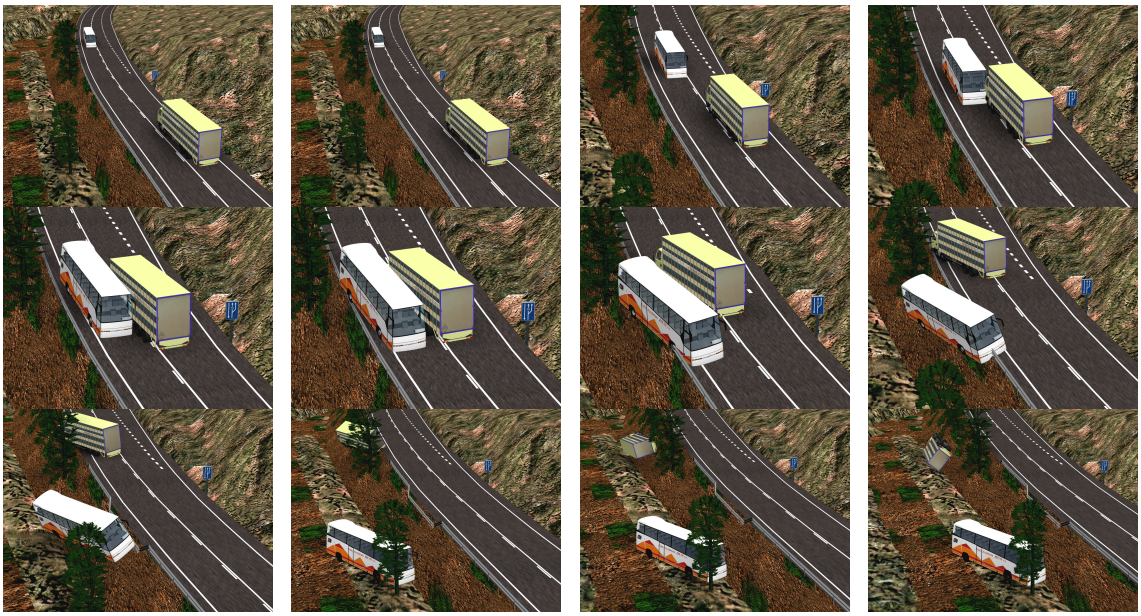
The sequence of the accident is shown in Figure 6. The truck was driving towards a curve to the right on a national road at 81 km/h. The truck invaded the opposite lane and collided with the bus, driving in its lane at 99 km/h. During the collision the left side of the coach was extremely deformed. After the impact, the truck followed a straight trajectory through the opposite lane, it crossed the barrier and left the road. The bus left the road on its right side moving laterally.

Figure 6. Sequence of the accident.

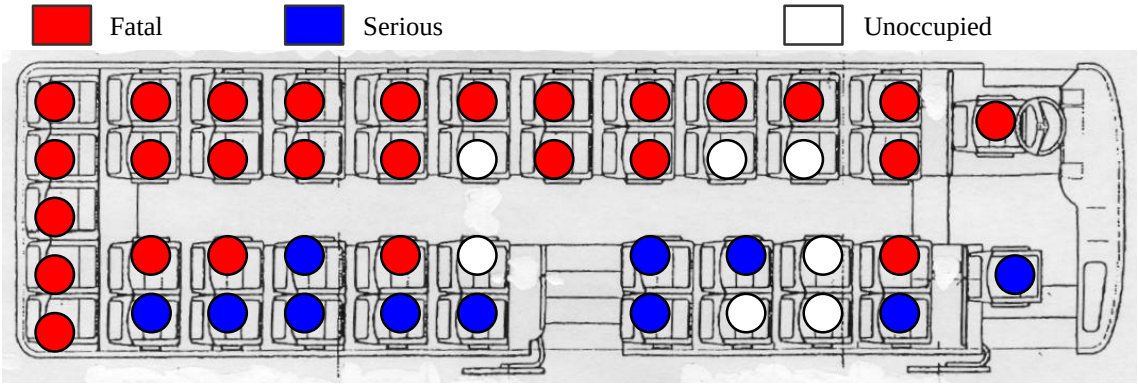
The seating positions in the coach are shown in Figure 7. The persons who occupied those positions painted in red, died. The occupants of the seating positions coloured in blue were seriously injured, according to the subjective evaluation of the police. Six seats were unoccupied.

Figure 7. Severity of occupant injuries.

All passengers sitting at the left side of the coach died. The occupants would not benefit from wearing a seat belt. The photographs of the vehicle after the accident in Figure 8 show the deformations at this area.

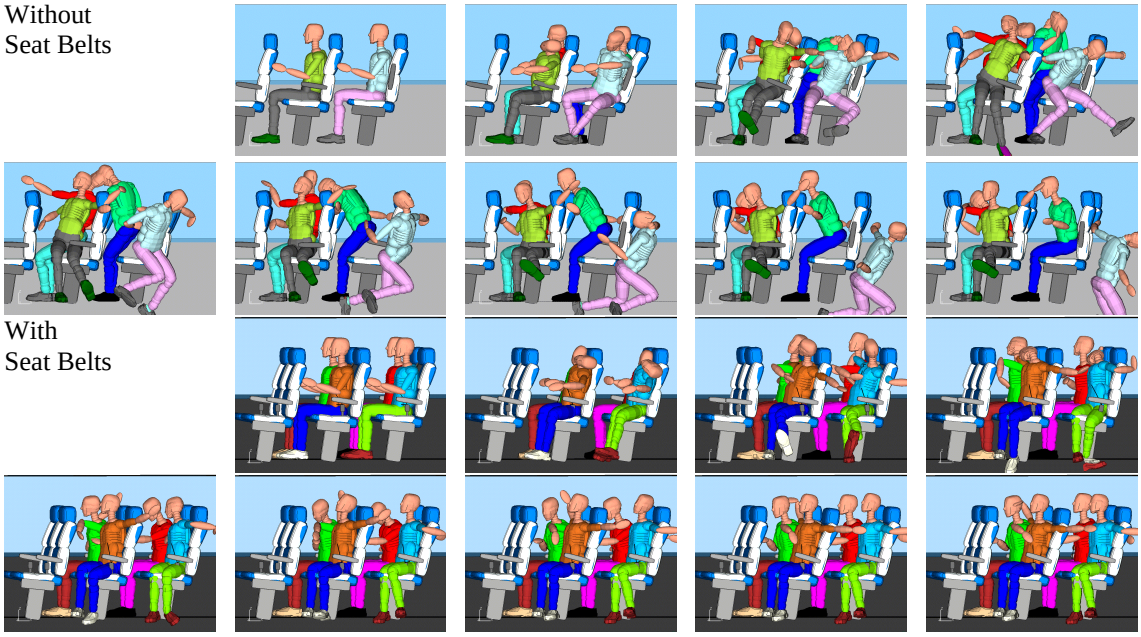
Figure 9. MADYMO® animations for the right-side area.

The occupant simulation without seatbelt considers that the armrest is down in the first row. The ejection is avoided but the armrest produces serious abdominal injuries. At the second row the armrest is folded up and the occupant is ejected to the left. This is the case producing fatal injuries to the occupants sitting on the central positions at the right side of the coach. With three-point seat belts, there is no ejection and the position of the armrests has almost no influence on the results.

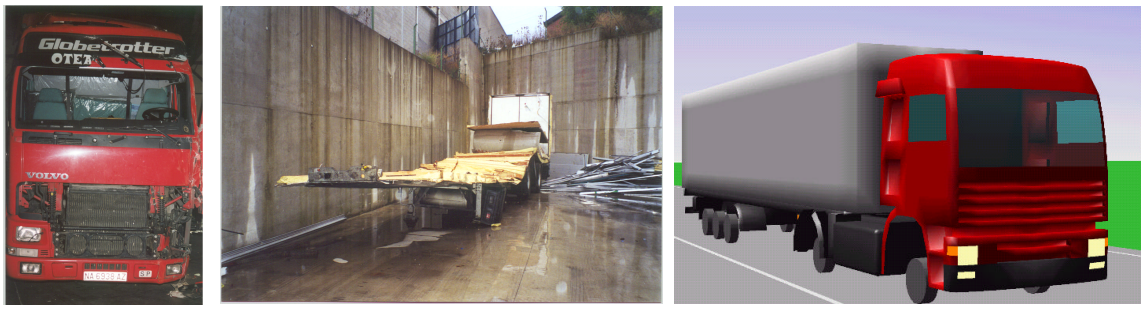
Figure 11. Photographs and model of the articulated lorry.

The lorry consists of a VOLVO FH12 tractor and a LAMBERET LVFS semitrailer. The tractor has a single front axle and a double rear axle and its kerb weight is 6300 kg. The semitrailer has three single axles with a kerb weight of 8500 kg. It was a refrigerator truck carrying tinned food and the weight of the load was calculated to be 2000 kg.
The sequence of events is shown in Figure 12. The articulated lorry was driving at 96 km/h on the motorway when it started an overtaking manoeuvre. While changing to the left lane it went out of the asphalt. The driver tried to correct its way but the lorry rolled over on its left side while the driver was jumping out of the tractor cabin. The overtaken truck stopped from 70 km/h on the right lane and turned the warning lights on. The articulated lorry was lying on its left side across both lanes of the motorway. The distance between the two trucks was 50 meters when stopped. Some seconds after, the single-decker coach was driving towards that point at 105 km/h. The driver saw the truck stopped on the right lane but he did not reduce the speed of the bus. Instead, he decided to overtake that truck at cruising speed. While driving on the left lane, he was making signals with the full-beam headlights. He noticed the obstacle at a distance between 40 and 50 m to the overturned lorry and braked. The bus crashed against the underbody structure of the semitrailer. The impact speed was 70 km/h.

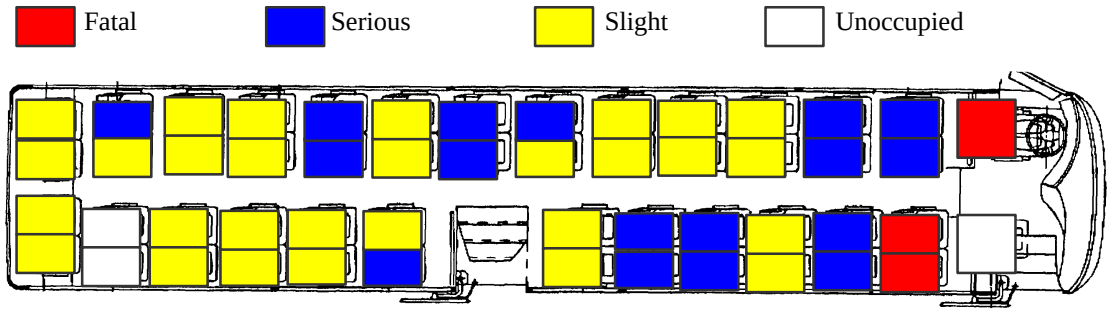
The seating positions in the coach are shown in Figure 13. The persons who occupied those positions painted in red, died. The occupants of the seating positions coloured in blue were seriously injured, according to the subjective evaluation of the police. The passengers of those seats painted in yellow were considered slightly injured by the police. There were

Figure 13. Severity of occupant injuries according to the police report.

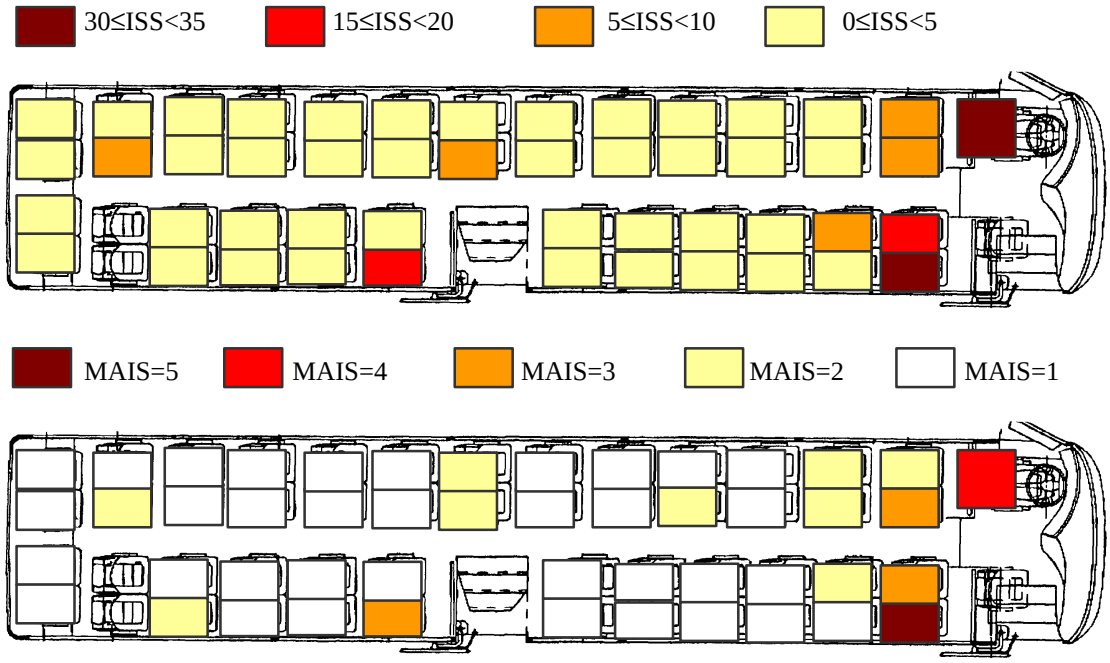
The classification of injuries according to the Injury Severity Score (ISS) and the Maximum Abbreviated Injury Scale (MAIS) is represented in Figure 14.

Figure 14. Severity of occupant injuries according to the classification scales.

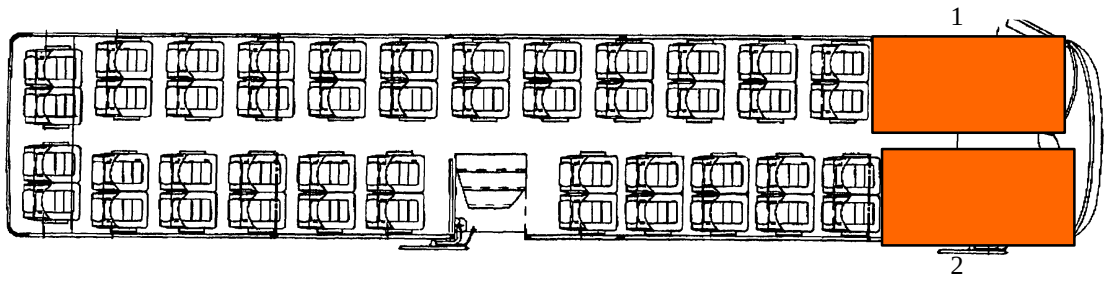
The positions selected for an in-depth analysis are marked in Figure 15. They are corresponding to two representative situations. The area no. 1 comprises the driver and the passengers just behind him. The area no. 2 considers the passengers behind the guide seat.

Figure 15. Areas selected for in-depth analysis.

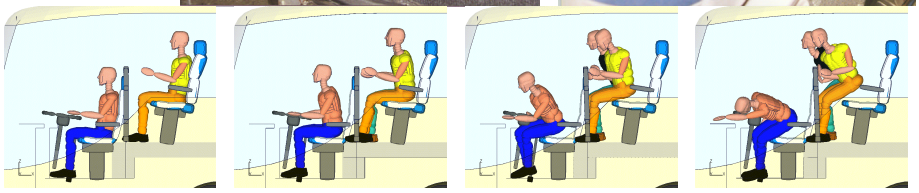
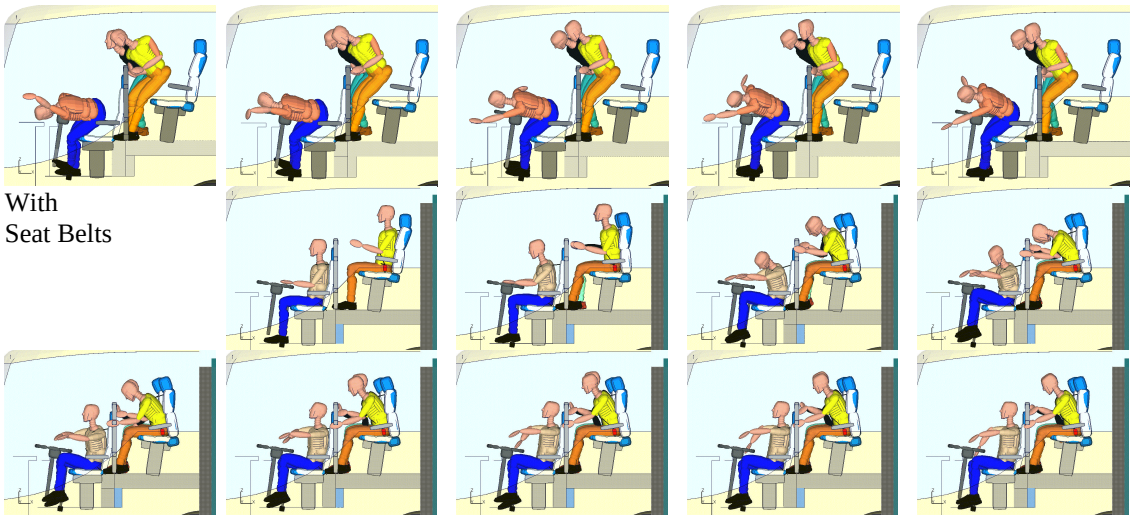
Figure 16. Photographs and MADYMO® animations for area no. 1.

The passengers behind the driver are ejected from their seating positions. The passenger on the left side is injured in the head due to an impact against the side structure of the vehicle and his legs hit the structure between him and the driver. The passenger on the right side suffers a serious injury in the upper part of the left femur, due to an impact against the structure in front of him. None of these injuries would be expected using a three-point seat belt.

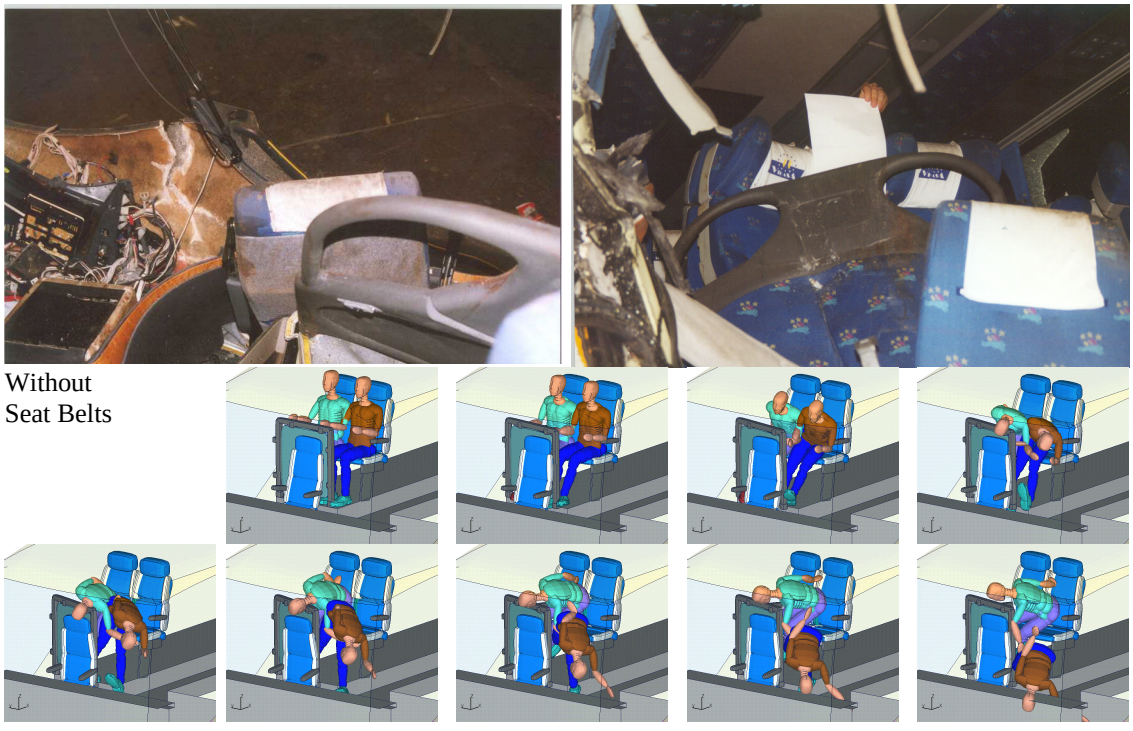
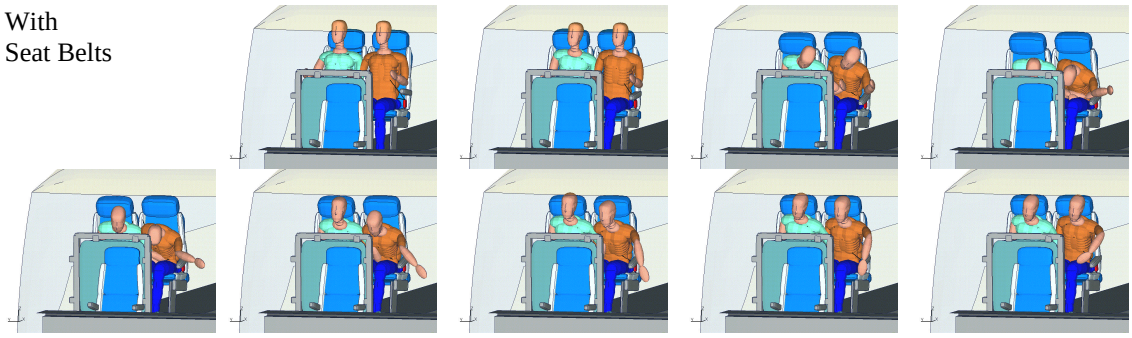
In the area no. 2, the occupants move towards the corridor. Photographs and simulation results are shown in Figure 17. The total ejection of the left side passenger makes his head hit the floor. He died due to a head trauma and suffered multiple injuries in different parts of his body. The right side passenger died due to fatal injuries in the chest produced when hitting the structure between his position and the guide seat. None of these injuries would be expected using a three-point seat belt.

Figure 17. Photographs and MADYMO® animations for area no. 2.
