## CRASH TEST PERFORMANCE OF LARGE TRUCK REAR UNDERRIDE GUARDS

**Matthew L. Brumbelow**

Insurance Institute for Highway Safety

Paper No. 11-0074

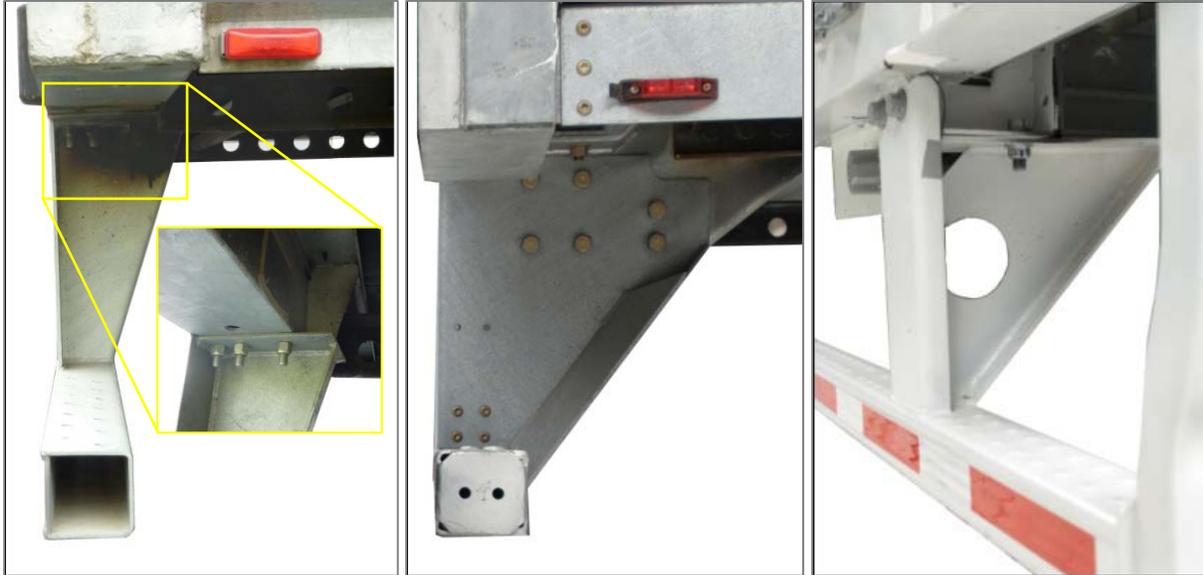
The 2007 Hyundai, 2007 Vanguard, and 2011 Wabash semi-trailers were selected for testing based on their availability through local dealers and the presence of major visible differences in the design of their underride guards. The most obvious differences pertained to the design of the guards' main vertical support members (Figure 1). The Hyundai's vertical supports were bolted directly to the lower rear cross-member of the trailer without any forward attachment points to the trailer's axle slide rails or other structure. The Vanguard and Wabash both had diagonal gussets to forward portions of the trailer chassis, but there also was a difference between the designs. The Vanguard relied on the shear strength of the attachment bolts as the only load path between the guard and trailer, whereas the Wabash was designed to transfer loads from the guard to the chassis through overlapping steel plates.

**Figure 1. Vertical underride guard support members of 2007 Hyundai (left), 2007 Vanguard (middle), and 2011 Wabash (right) semi-trailers.**

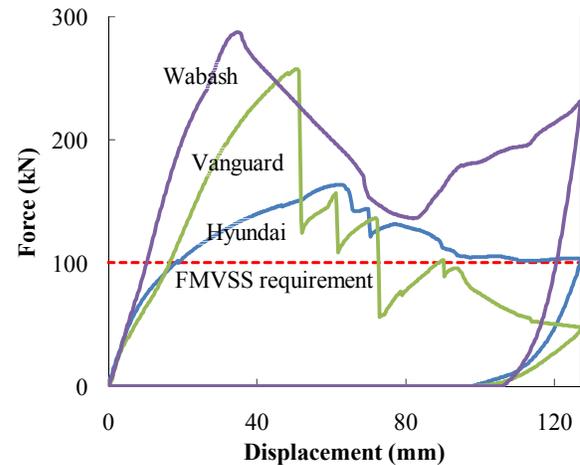
Deformation patterns of the underride guards varied substantially in the quasi-static tests. For example, in the FMVSS 223 P3 test, the vertical support member of the Hyundai guard was pulled slowly from some of the bolts attaching it to the fixture, whereas the vertical member itself deformed only minimally. In the same test, the Vanguard's vertical member flexed for the first 50 mm of loading and then the attachment bolts began to shear, causing the measured force to drop below that measured for the Hyundai

later in the test. The Wabash guard reached its peak force earliest, and then the vertical member began buckling near its attachment to the horizontal member. As the buckling continued, the rear surface of the guard eventually bottomed out against the diagonal gusset, causing the load to increase again late in the test. Figure 3 shows the force-displacement curves for all three guards in the FMVSS 223 P3 test.

Figure 3. FMVSS 223 P3 test results.
