CRASH-TEST RESULTS TO ANALYSE THE IMPACT OF NON-PROFESSIONAL REPAIR ON THE PERFORMANCE OF SIDE STRUCTURE OF A CAR

Uwe, Schmortte
KTI GmbH & Co. KG
Germany
Paper Number 11-0310

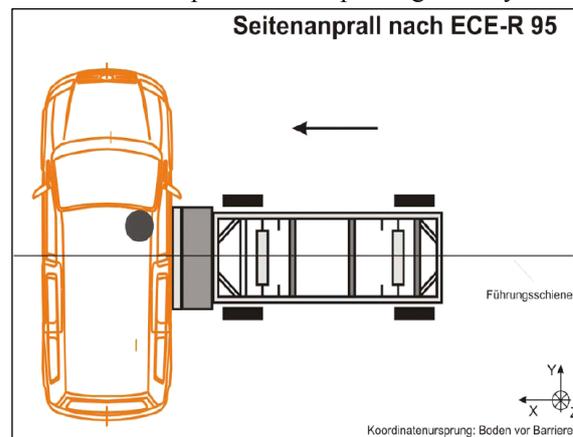
Figure 2. Test setup

As depicted in Figures 2 and 3 (the first crash test setup), the car was positioned relative to the carriage with its deformable barrier. The test was carried out at a speed of 50 km/h (+/- 1 km/h). A Dummy, ES-1, 50% male, 72 kg (+/- 1.2 kg) was positioned on the front passenger side seat and weight dummies of 76 kg on the back seat. The restraint systems were active. After the crash, the damaged car was repaired with recognized methods of car repair, but without specific information for this model i.e. non-professional repair. Subsequently the Passat underwent a second crash test in the same configuration. Finally, differences in deformation behaviour between the two crashes were analysed to determine the implications for passenger safety.

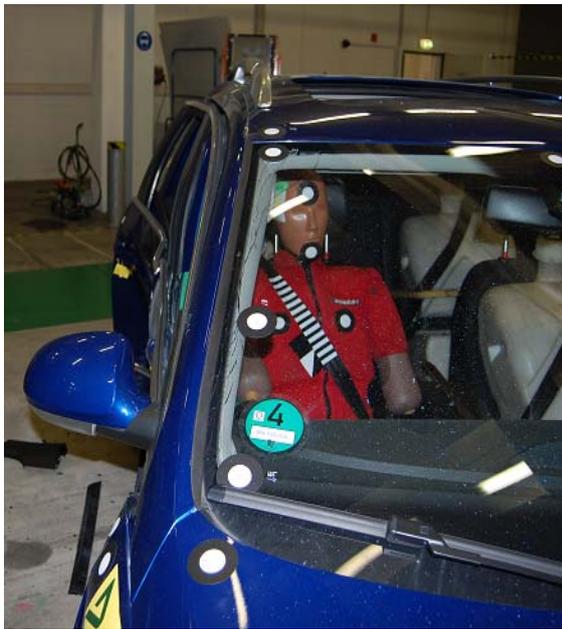
Figure 4. Head-on view

After the side impact the car was severely damaged on the passenger side, as intended. The sill and the floor/undercarriage behind it were particularly distorted. Additionally, the doors and the B-pillar were considerably damaged (Figure 5). There was no damage to the screen pillar or windscreen glass. The pyrotechnic protection/restraint systems (Front and rear passenger side airbags, front passenger belt pre-tensioner and passenger side curtain airbag) were correctly deployed. Overall the car body structure deformed and behaved as expected. As well as the visual analysis, electronic measurement of the car body was carried out. This showed the maximum intrusion to be 161 mm.

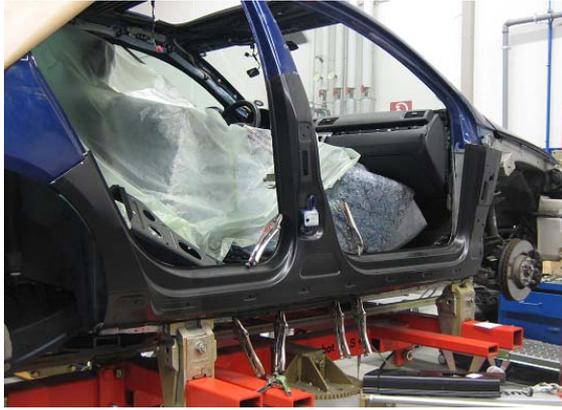
Figure 8. Positioning the outer panel

The damaged car was repaired with an older spot welding machine with fixed pressure and 6.4 kA maximum current.

It is recommended that an Inverter type welding machine is used with 10 kA maximum current and a variable pressure (maximum 10 bar) to join the high strength steel safely. The deformed inner sill, made from ultra high strength steel, was re-shaped and partially replaced on a bench then re-fitted using a MAG welding process. Figures 6 to 9 show the non professional repair being carried out.

The “Professional” repair would include complete renewal of the B-Pillar and other deformed structures with components made from high strength steel. A partial repair of such steels is not acceptable, as the structure and therefore the strength of the material will be severely degraded while welding and reforming.

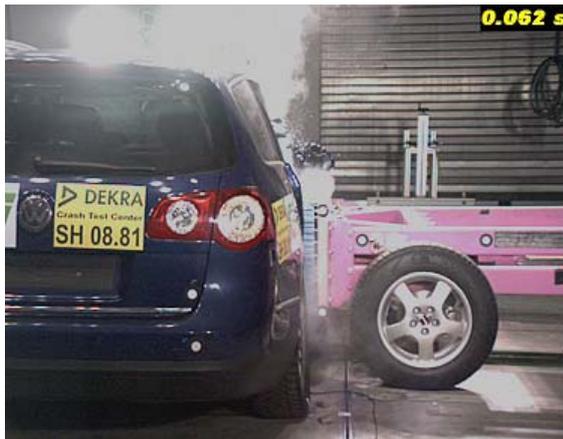
Figure 12. Crash 1

With the help of the time analysis in the high-speed crash-movies we can for instance compare the time of highest intrusion (Figures 12 and 13). The analysis clearly shows higher intrusion at the same moment in time in the second crash test.

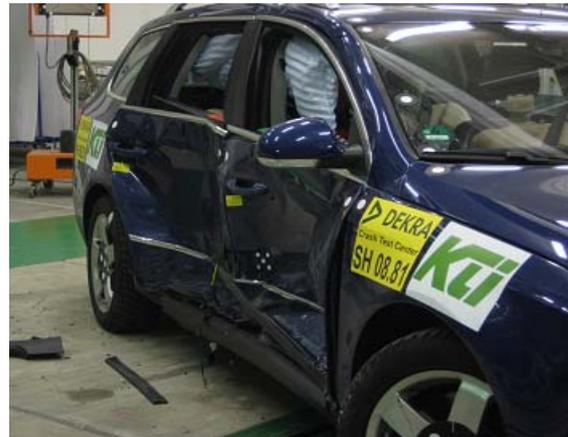
Figure 14. Side structure after first crash

The higher deformation of the B-pillar has an important influence on the intrusion of the doors, which moved further into the seat area of the passenger compartment, increasing the bio-mechanical stress on the occupant, the co-driver in this case (Figures 14 and 15).

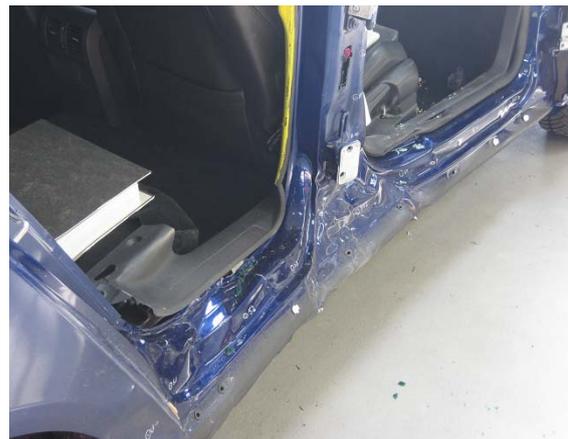
Figure 16. B-pillar and sill after first crash

After removing the doors and the sill trim panel the deeper intrusion can be clearly seen on the side frame (Figures 16 and 17). The movement of the sill has reduced the normal distance between the B-pillar/door and the co-driver's seat dramatically (Figures 18 and 19). Additionally, although the front passenger's side airbag deployed, it was restricted by the close proximity of the seat to the pillar. Consequently a controlled deployment of the bag was not possible because the space between B-pillar and seat was too small, too early in the deformation process.

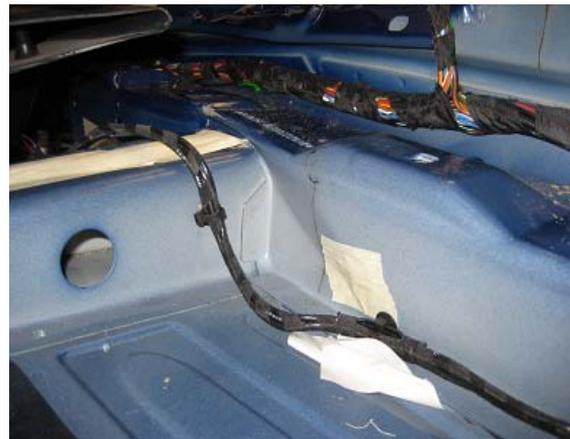
Figure 20. Front seat anchor cross member/transmission tunnel after first crash

After removing all the seats and necessary trim the deformation of the transmission tunnel after the second test was clear to see. The cross-member which supported the front seat had pushed into the transmission tunnel, distorting it severely. In comparison, there were no measurable changes at the transmission tunnel during the first attempt. (Figures 20 and 21).

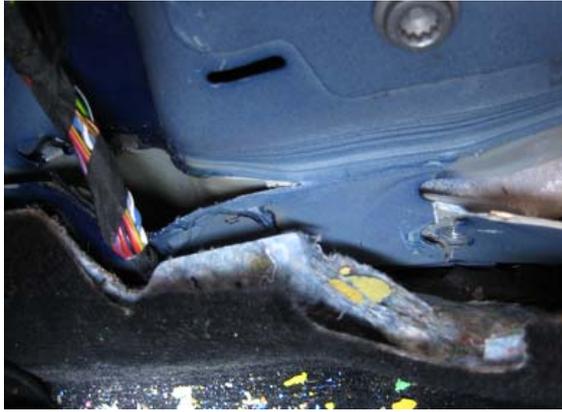
Figure 26. Disconnection between lower B-and inner sill after first crash

The connection of the B-pillar with the inner sill was joined with MAG welding. The structure of the high-strength steel parts was changed by the welding process and re-shaping. The welded seam was totally broken after the second crash, being unable to withstand the stress and the distortion (Figures 25 and 26).
