SUVS involving: Rollovers, Frontal Offsets and Corner Impacts called FLEES.

CIREN Seattle

HARBORVIEW
MEDICAL
CENTER
INJURY PREVENTION
AND RESEARCH CENTER

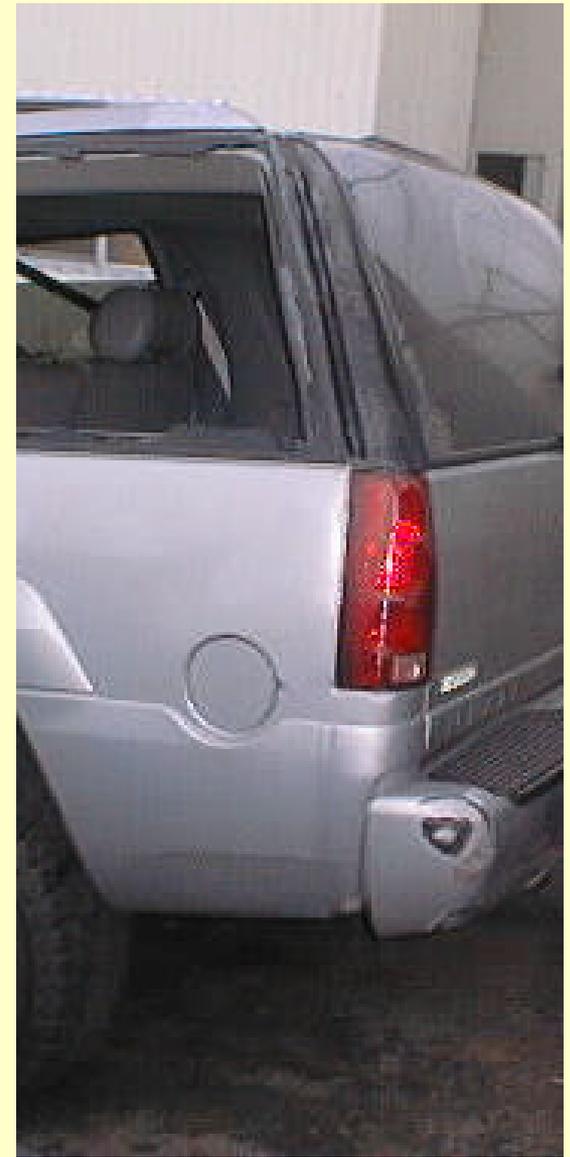
Rollover - 00TDDO4

Max Crush = 31 cm of Driver Seat Area

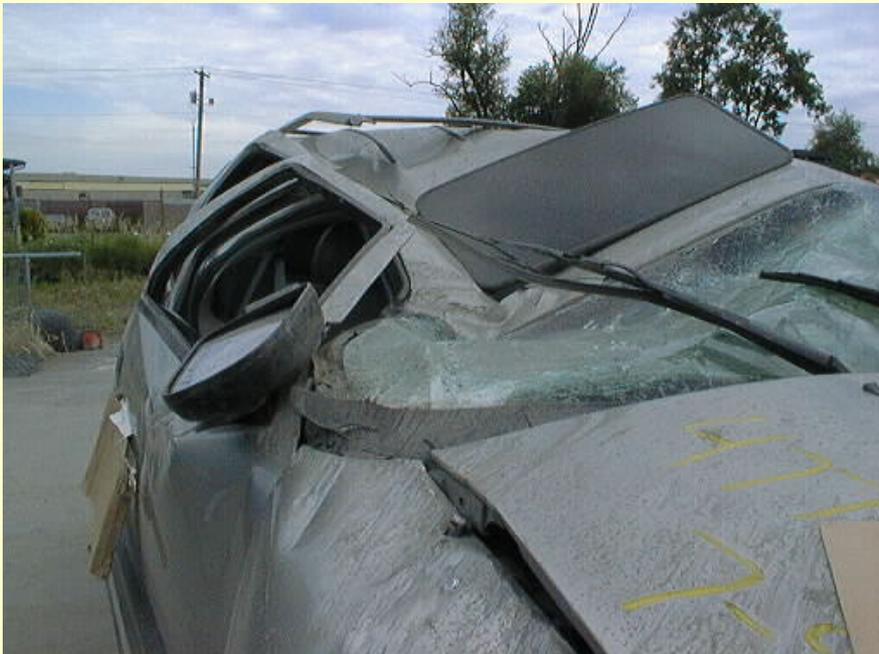
Single Rollover Event
Four quarters

CDC = 00TDDO5

Max Crush = 38 cm
@ Right
windshield header

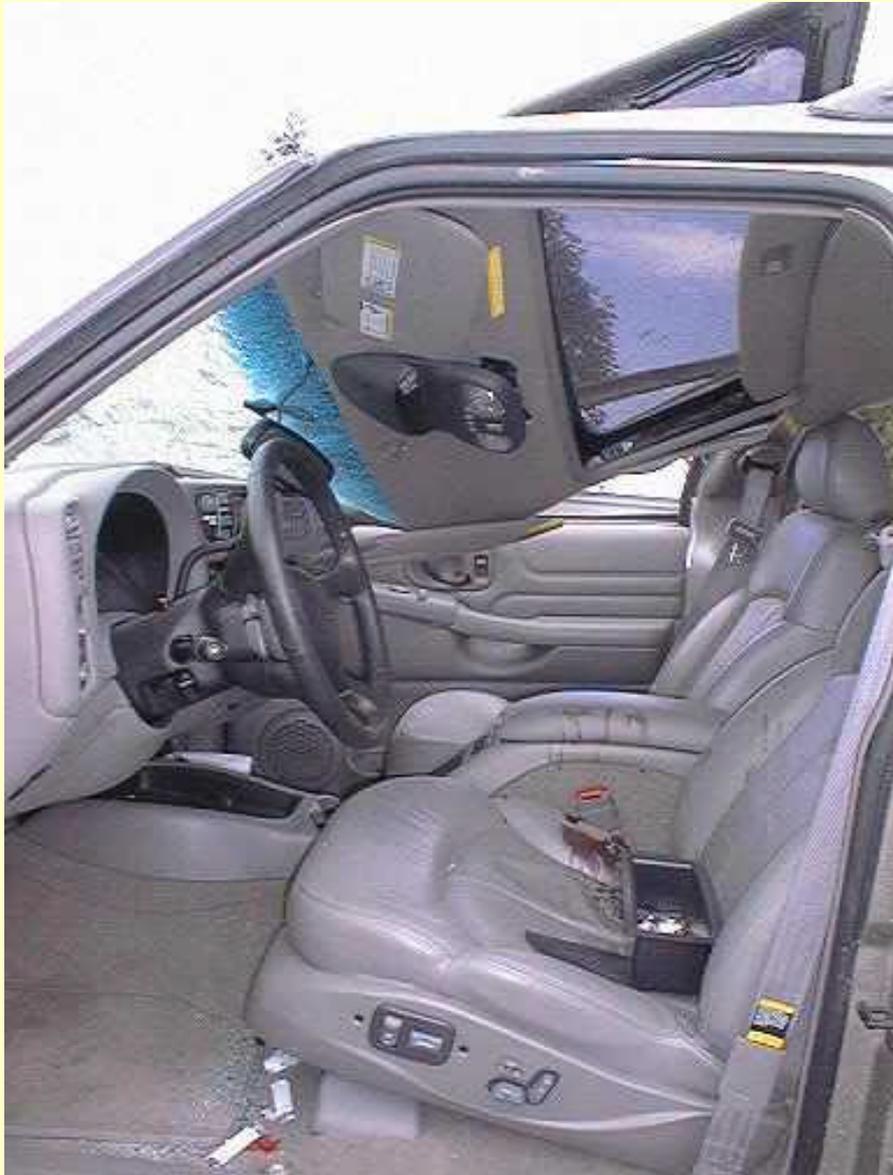
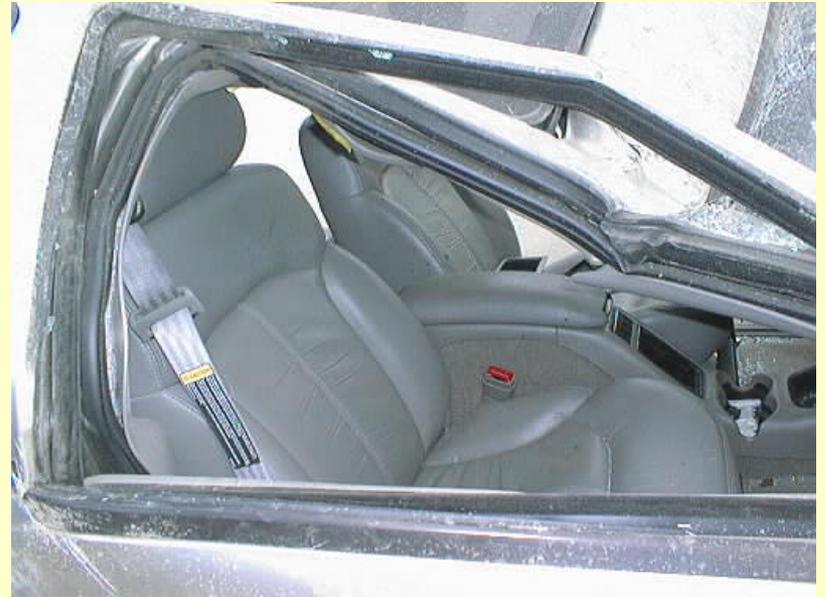
Max Roof Intrusion location

Row	Position	Area	Intruded Component	Comparison	Intruded	Intrusion	Magnitude	Crush Direction
Front Seat	Right	Interior	Windshield header	102	62	40	≥ 30 to < 46 cms	Vertical
Front Seat	Right	Interior	Roof (or convertible top)	110	68	42	≥ 30 to < 46 cms	Vertical
Front Seat	Right	Interior	A (A1/A2)-pillar	102	62	40	≥ 30 to < 46 cms	Vertical
Front Seat	Right	Interior	Roof side rail	103	64	39	≥ 30 to < 46 cms	Vertical
Front Seat	Middle	Interior	Windshield	25	0	25	≥ 15 to < 30 cms	Vertical
Front Seat	Right	Interior	Windshield	25	0	25	≥ 15 to < 30 cms	Vertical
Front Seat	Right	Interior	B-pillar	102	87	15	≥ 15 to < 30 cms	Vertical
Front Seat	Middle	Interior	Windshield header	33	12	21	≥ 15 to < 30 cms	Vertical
Second Seat	Right	Interior	Roof (or convertible top)	110	95	15	≥ 15 to < 30 cms	Vertical
Front Seat	Middle	Interior	Roof (or convertible top)	110	86	24	≥ 15 to < 30 cms	Vertical
Front Seat	Left	Interior	Roof (or convertible top)	110	101	9	≥ 8 to < 15 cms	Vertical

Second Seat	Right	Interior	Roof side rail	103	94	9	≥ 8 to < 15 cms	Vertical
Front Seat	Left	Interior	Windshield	25	20	5	≥ 3 to < 8 cms	Vertical
Second Seat	Middle	Interior	Roof (or convertible top)	110	104	6	≥ 3 to < 8 cms	Vertical
Front Seat	Left	Interior	Windshield header	33	29	4	≥ 3 to < 8 cms	Vertical

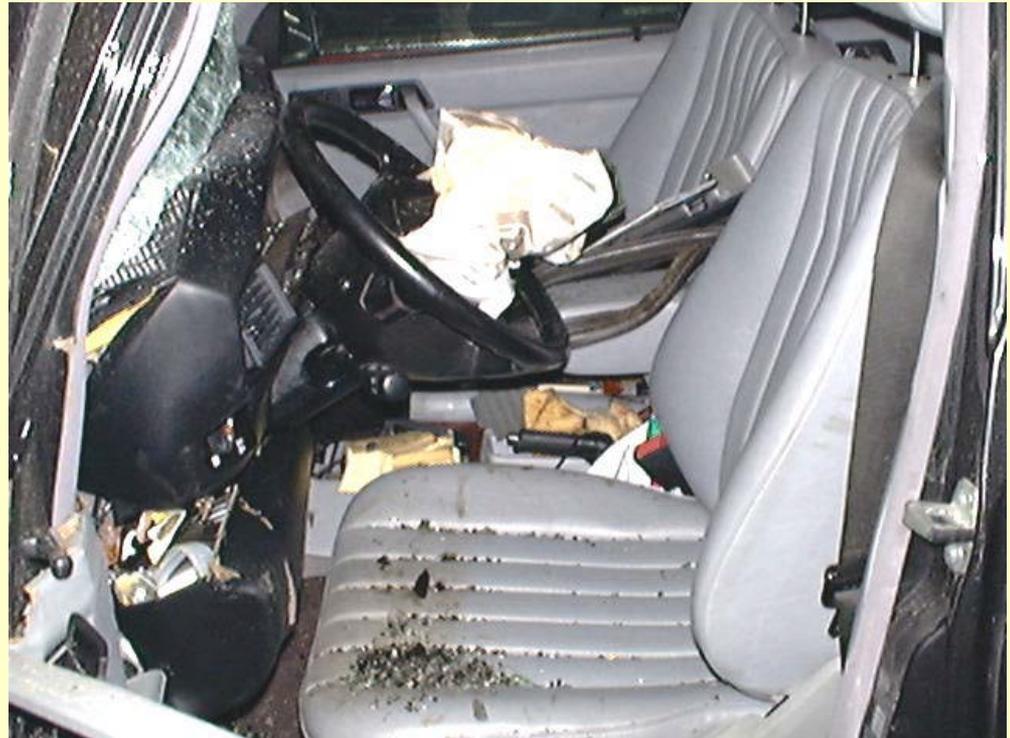
Major Driver area Intrusions

Knee bolster	- 21 cm
Left Instr. Panel	- 20 cm
Hood/windshield	- 20 cm
A pillar	- 17 cm
Toe pan	- 13 cm
Steering assembly	- 10 cm

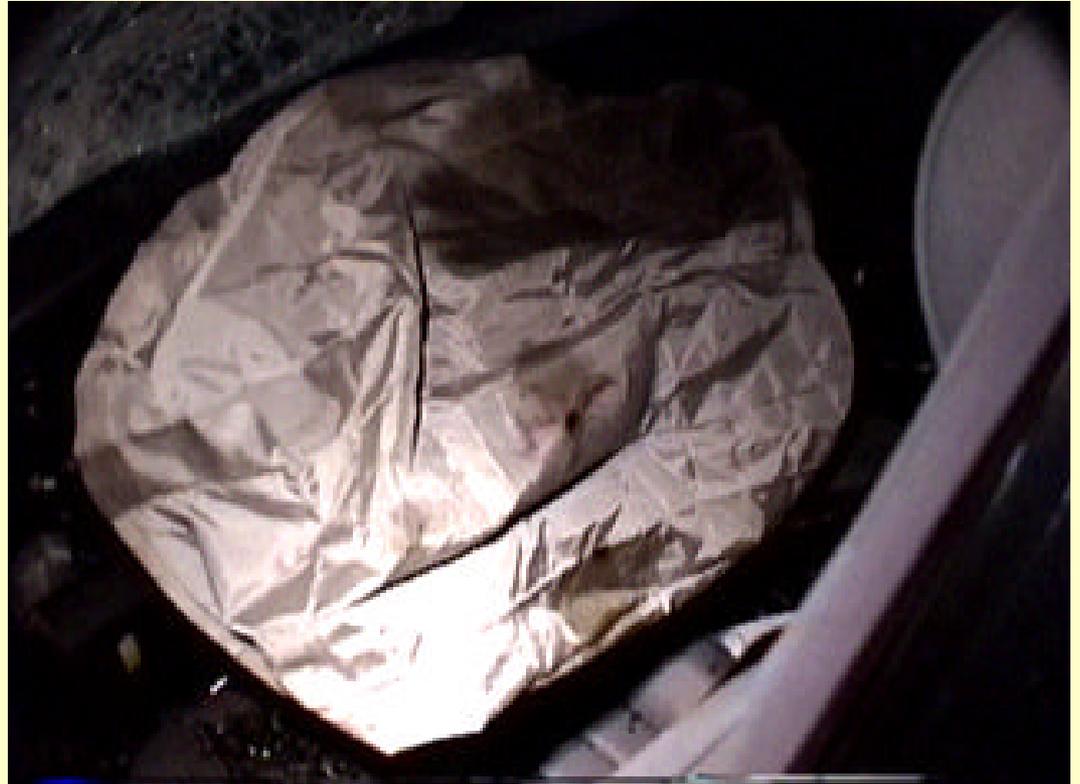
Airbag - Lipstick

- A: Knee bolster
- B: L inst panel
- C: L inst panel
- D: Airbag

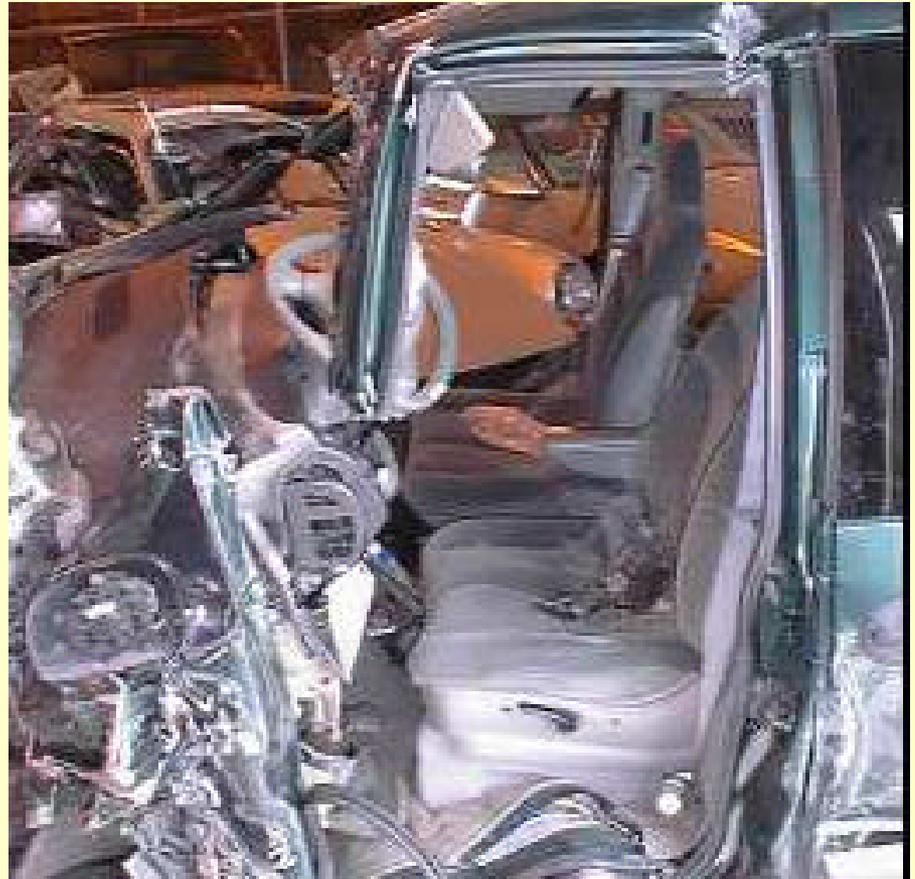
Driver Area Intrusions

Toe pan = 45 cm

Instr.Panel = 42 cm

A pillar = 52 cm

Windshield = 24 cm

Kick panel = 18 cm

Steering col. = 15 cm

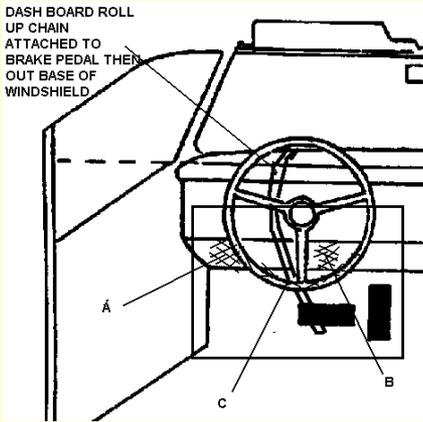
Steering Rim Deformity

DASH BOARD ROLL
UP CHAIN
ATTACHED TO
BRAKE PEDAL THEN
OUT BASE OF
WINDSHIELD

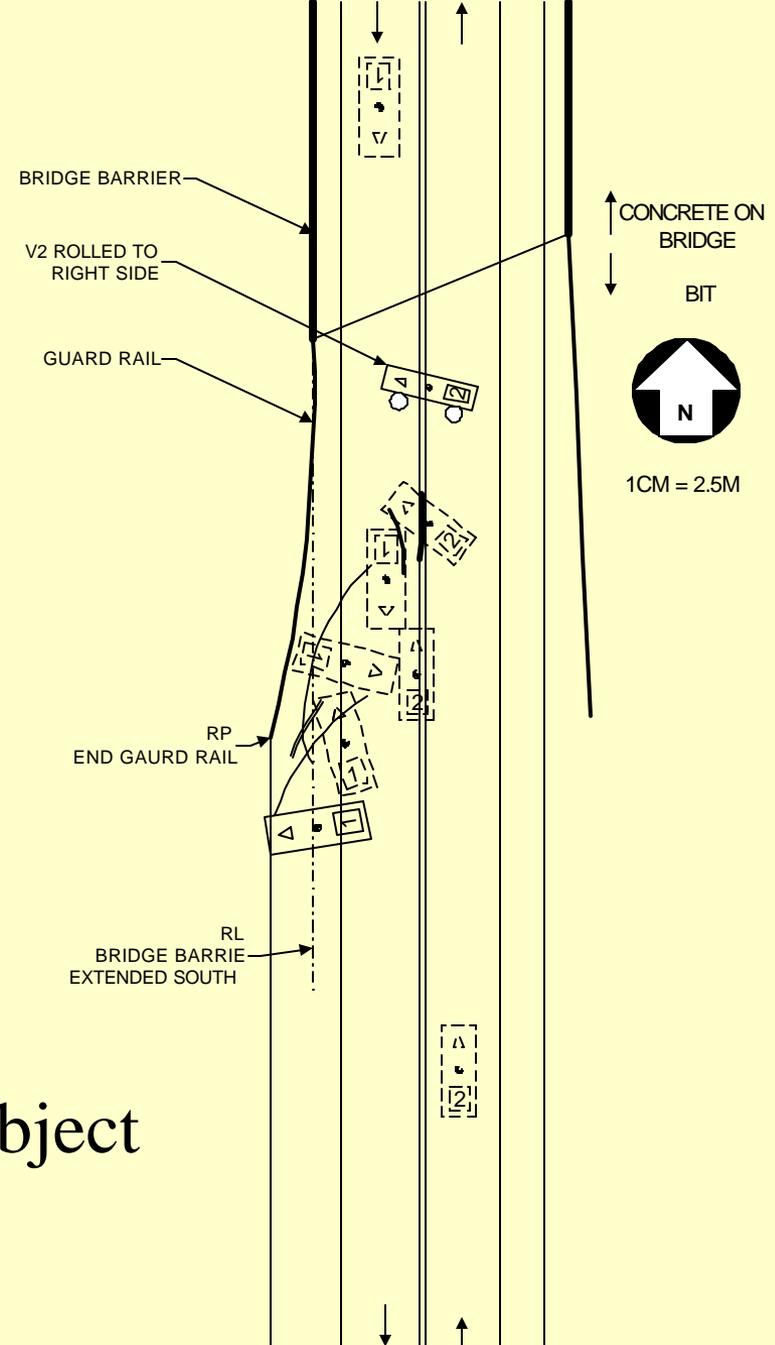
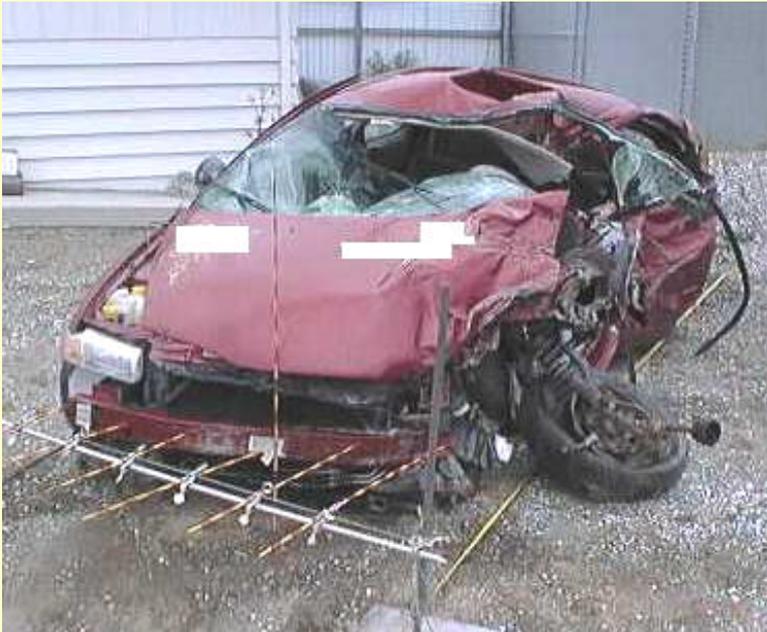
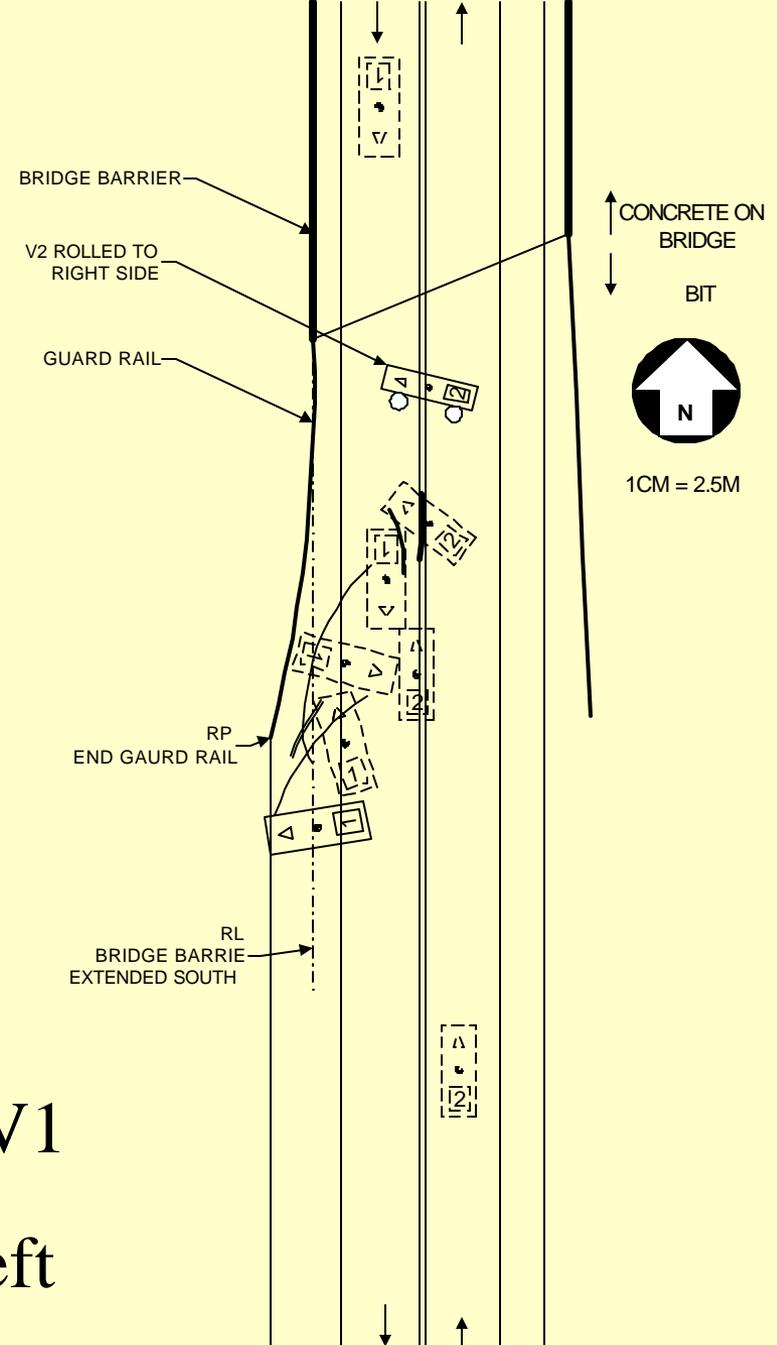
V1 - 90's Plymouth Breeze - Subject

V2 - 80's Chevrolet Blazer

Offset FLEE into an SUV

Three case subjects enrolled in V1
Driver, Front Right, 2nd Seat Left

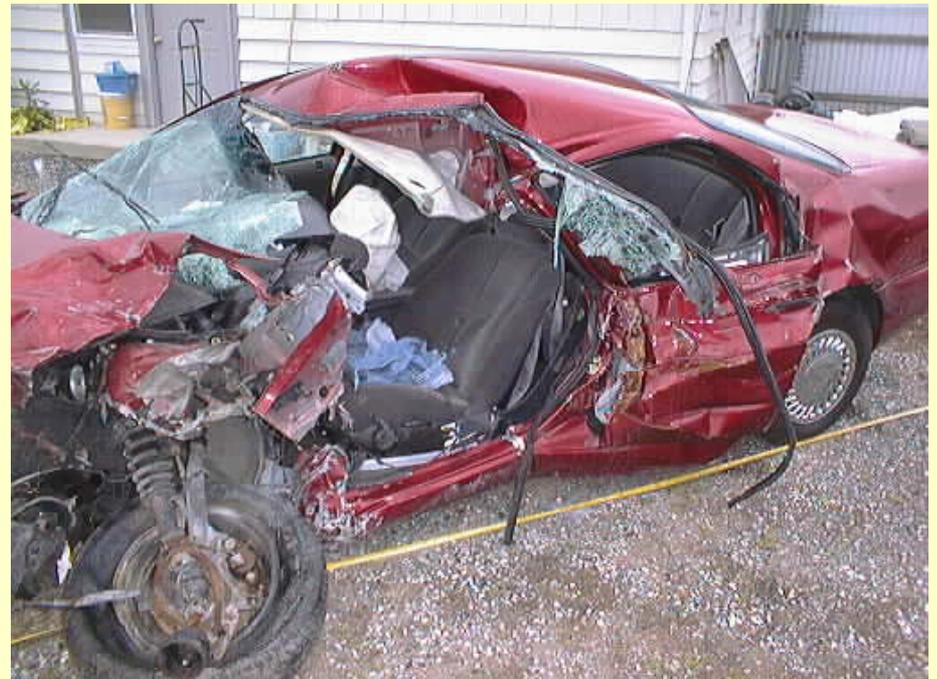
CDC - 12FLEE9

Smash Missing vehicle

Delta V = 20 mph

Database - Severe

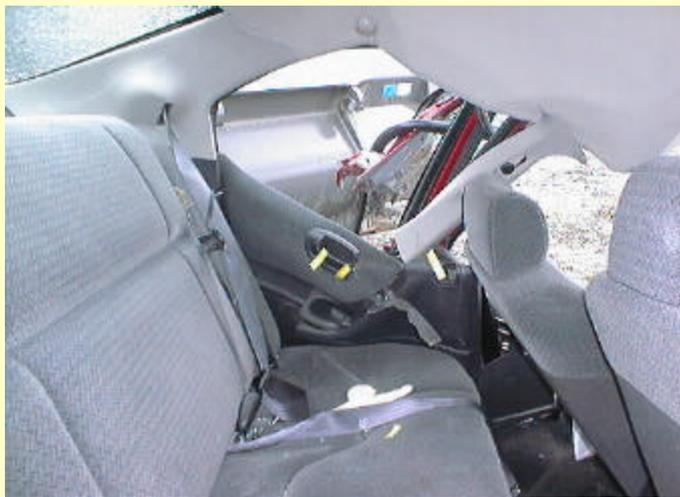
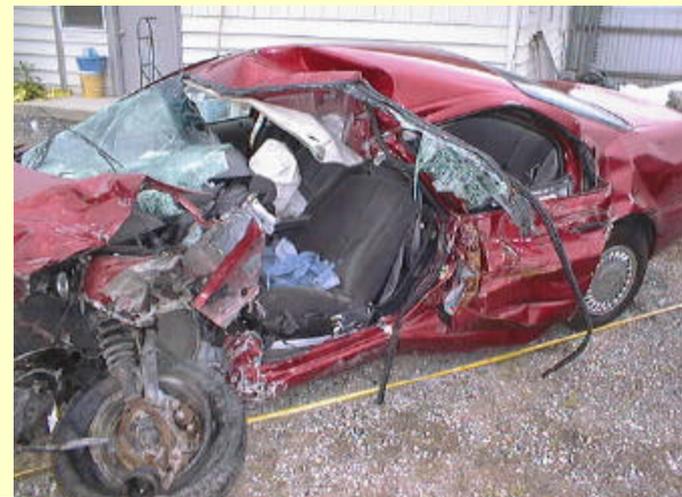
I n t r u s i o n s

Row	Position	Intruded Component	Intrusion	Magnitude	Crush Direction
Front Seat	Left	Side panel - forward of the A1	32	≥ 30 to < 46 cms	Lateral
Front Seat	Left	Instrument panel left	28	≥ 15 to < 30 cms	Longitudinal
Front Seat	Middle	Instrument panel center	15	≥ 15 to < 30 cms	Longitudinal
Front Seat	Left	Side panel - forward of the A1	19	≥ 15 to < 30 cms	Longitudinal
Front Seat	Left	Roof (or convertible top)	26	≥ 15 to < 30 cms	Vertical
Second Seat	Left	Door panel (side)	27	≥ 15 to < 30 cms	Lateral
Front Seat	Left	Roof side rail	20	≥ 15 to < 30 cms	Lateral
Front Seat	Left	A (A1/A2)-pillar	23	≥ 15 to < 30 cms	Longitudinal
Second Seat	Left	B-pillar	16	≥ 15 to < 30 cms	Lateral
Front Seat	Left	Steering Assembly	15	≥ 15 to < 30 cms	Longitudinal
Front Seat	Left	Door panel (side)	14	≥ 8 to < 15 cms	Lateral
Second Seat	Left	Roof side rail	8	≥ 8 to < 15 cms	Lateral
Front Seat	Right	Instrument panel right	3	≥ 3 to < 8 cms	Longitudinal

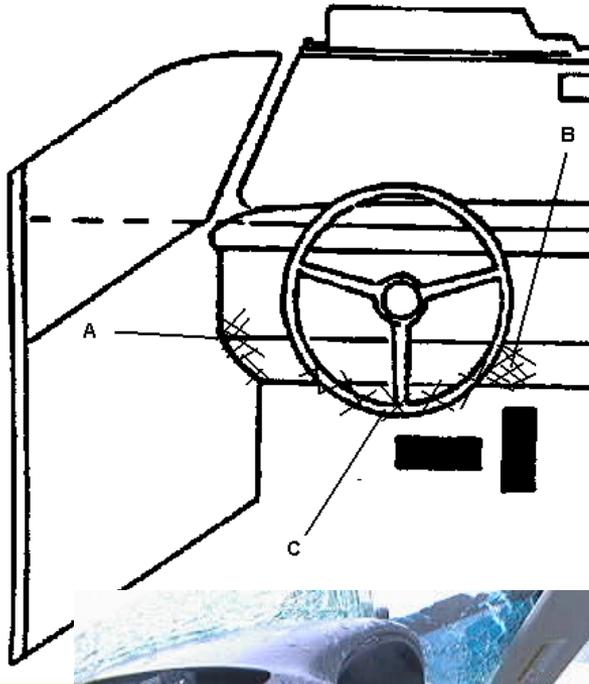
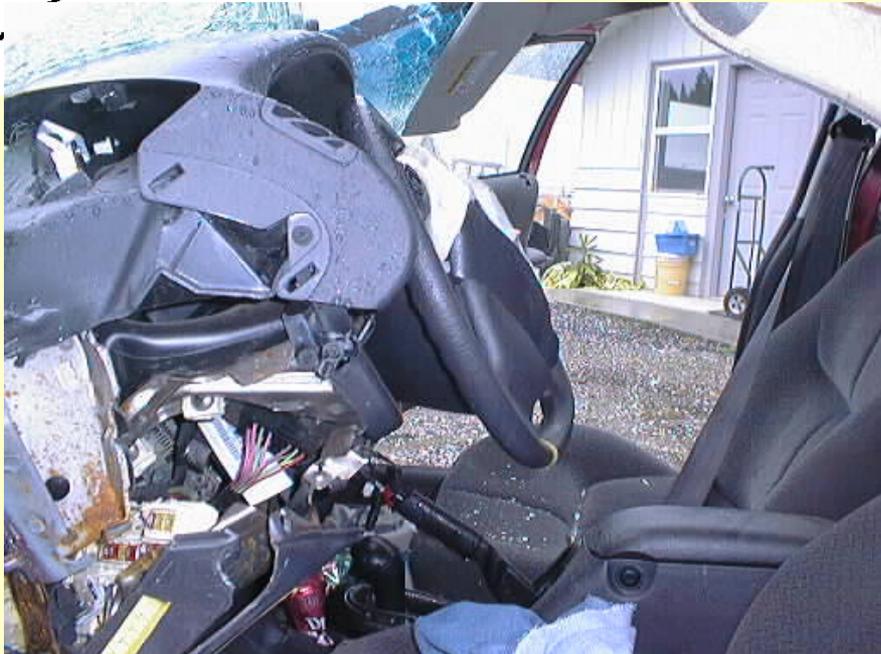
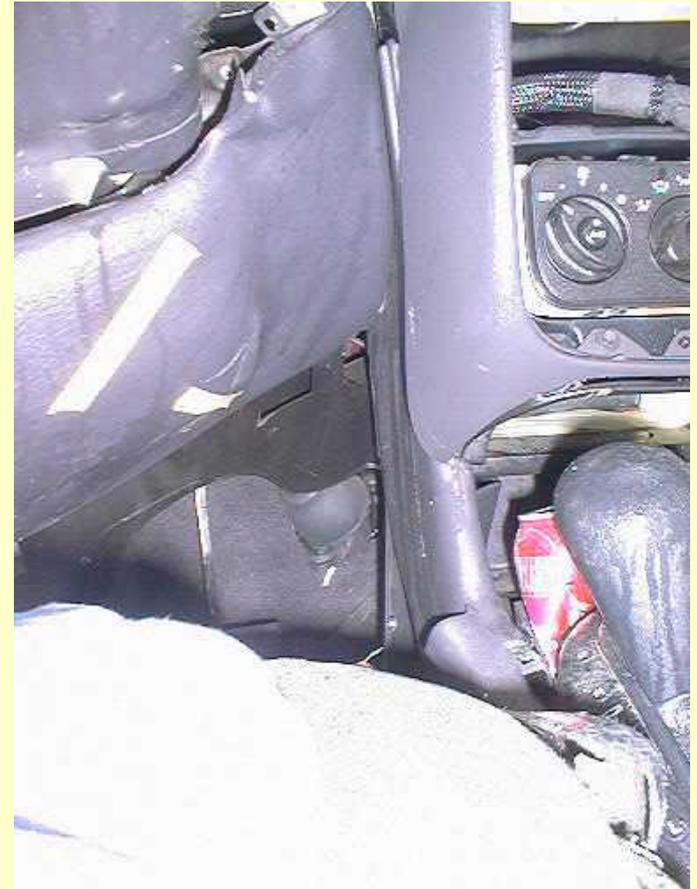
Driver Contacts

AIS	Region	Description
3	Head	minor TBI/concussion w/deficits
3	Low Ext	L transverse/posterior wall acetabular Fx with sciatic nerve contusion
2		L hip dislocation
2	Abdomen	L perinephric hematoma (Grade I)
1		Multiple minor contusions

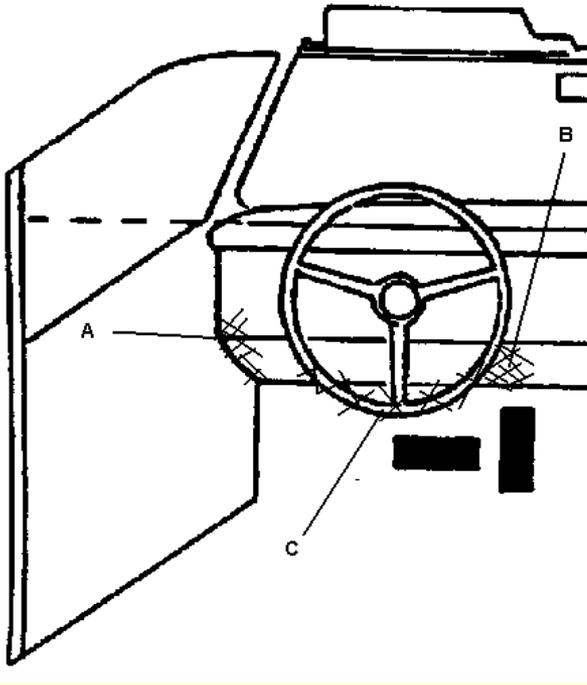
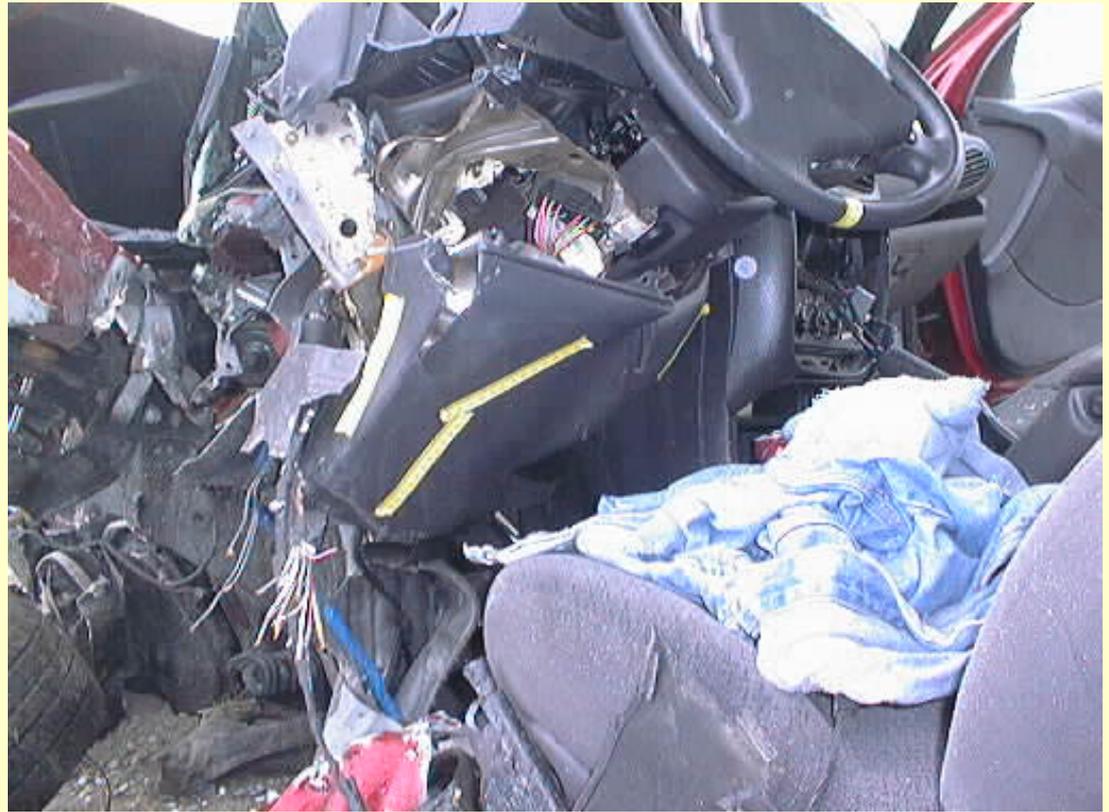
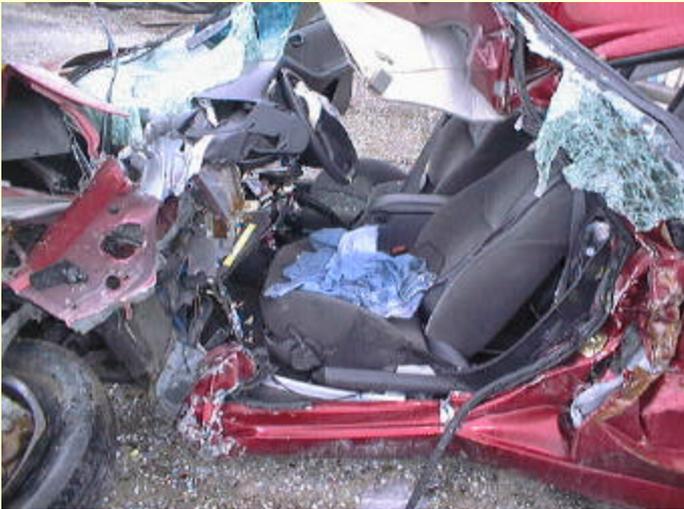
Driver Contacts

Driver door remove by Ecrew.

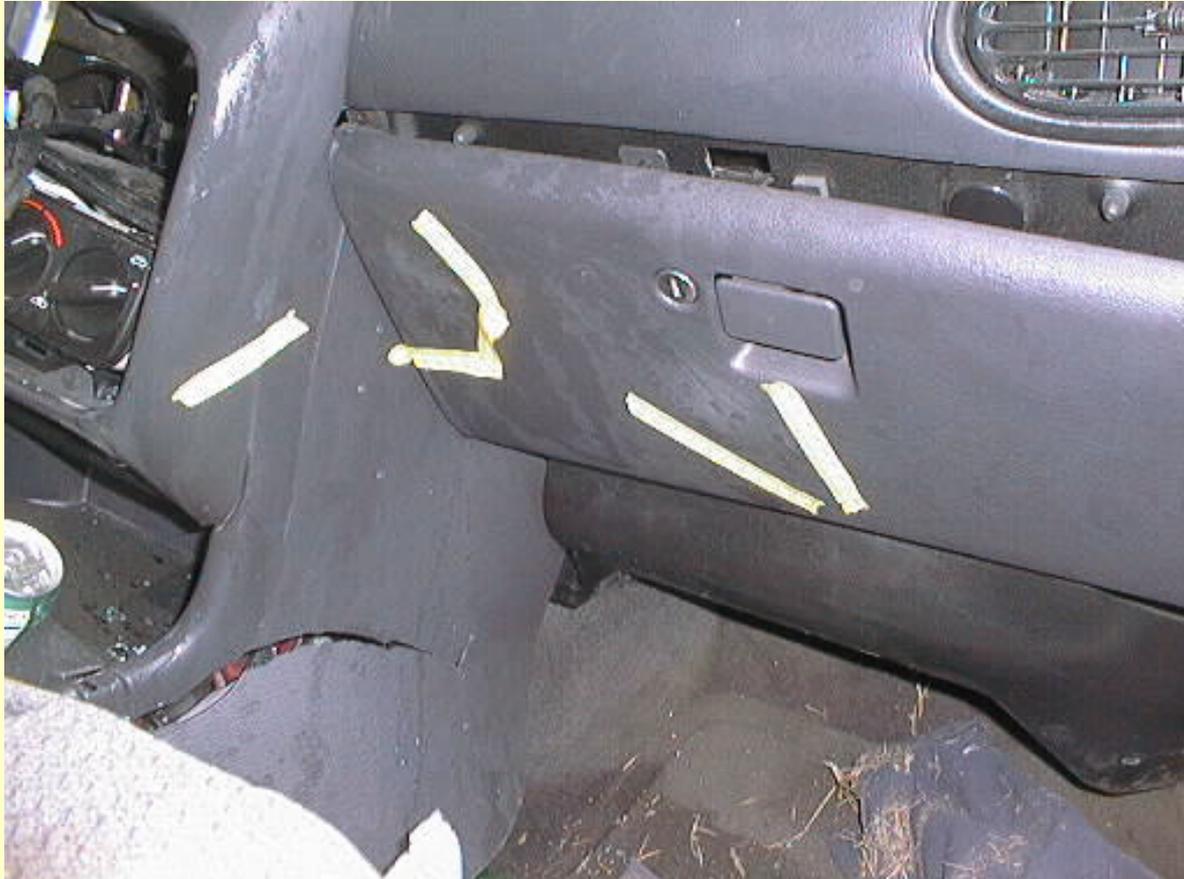
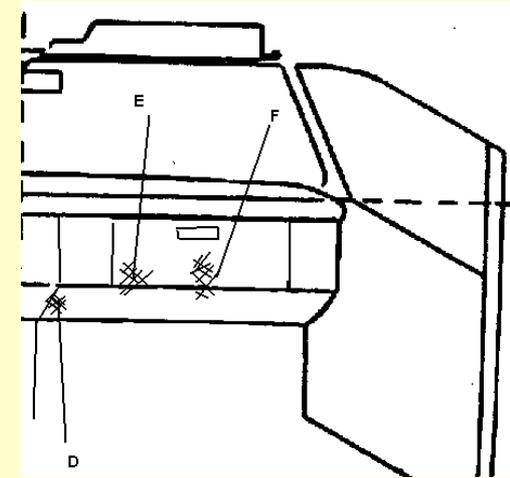
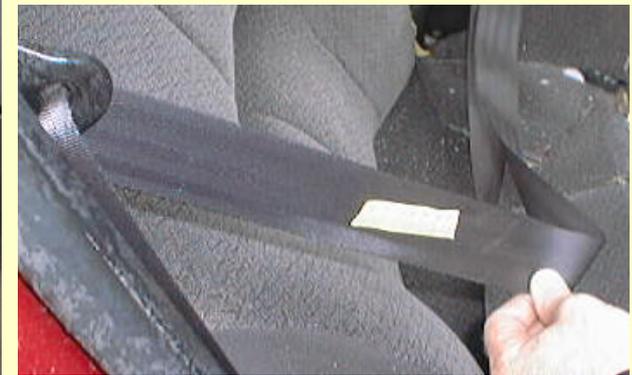
Front Right Passenger Contacts

<u>AIS</u>	<u>Region</u>	<u>Description</u>
2	Head	+ LOC/concussion
1	Upper Ext	L upper arm contusion
1		L upper arm abrasion
1	Abdomen	Inferior lower abdomen contusions
1	Thorax	L chest wall contusions
1		L breast contusion

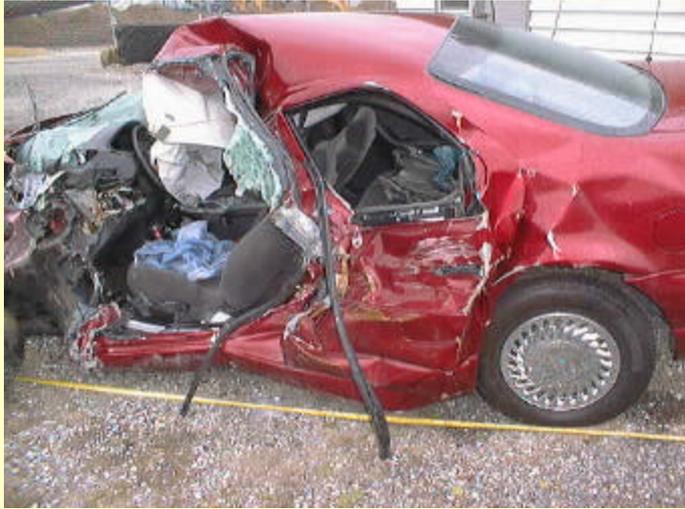
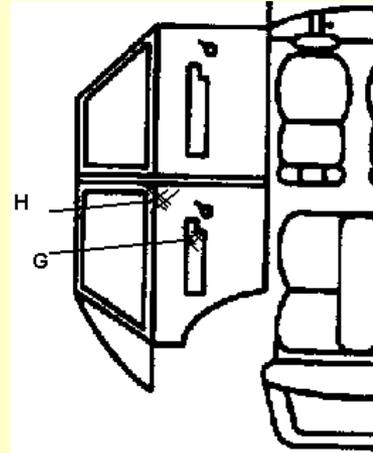
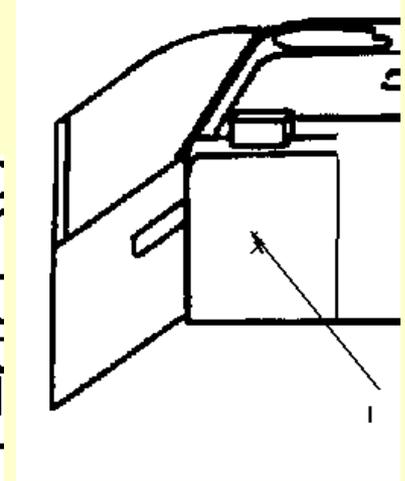
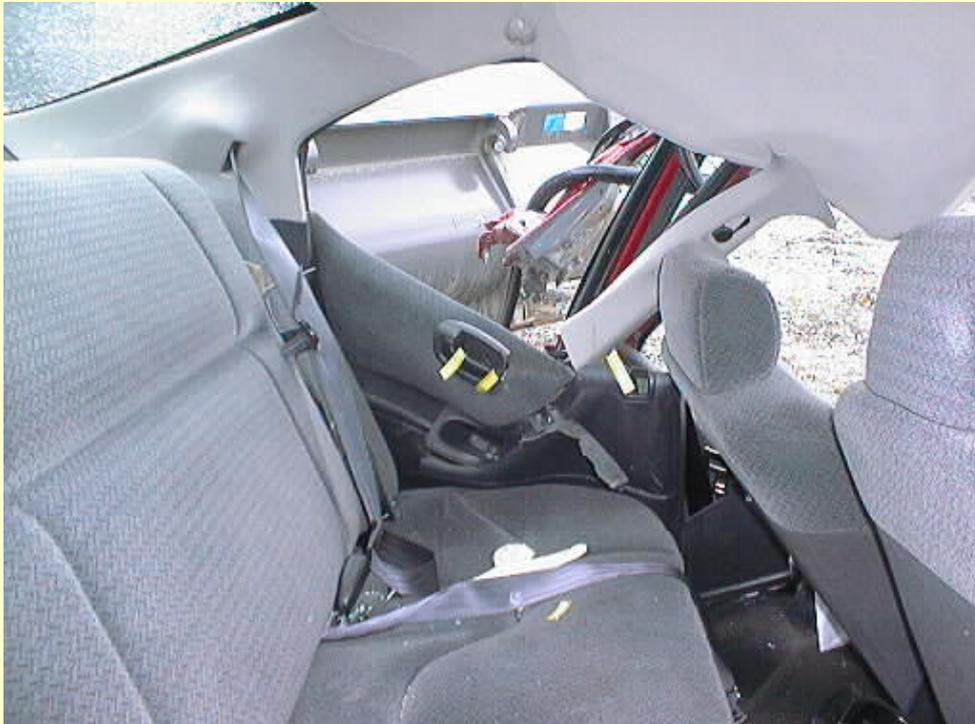
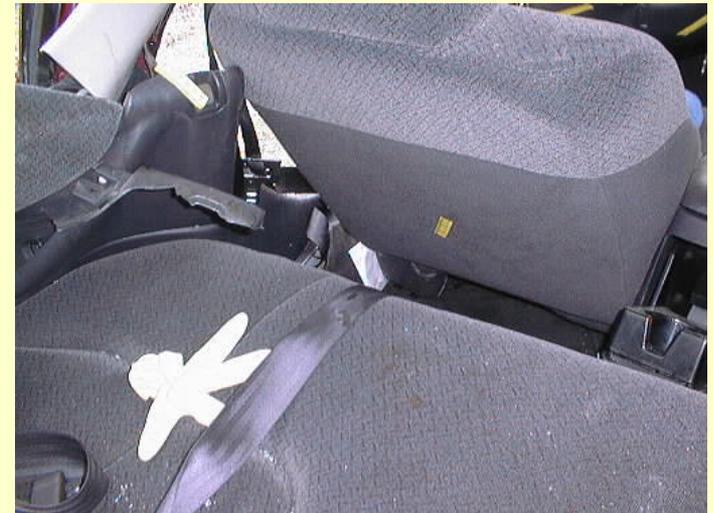
Seat 21 Contacts

<u>AIS</u>	<u>Region</u>	<u>Description</u>
2	Head	10 cm crown head lac (stapled)
1	Neck	L neck abrasions
1	Lower Ext	B knee contusions
1		L lower thigh contusion
1	Upper Ext	L elbow contusion
1		L 4th finger/nailbed contusion
