BASIC RESEARCH IN AUTOMOBILE CRASHWORTHINESS— TESTING AND EVALUATION OF MODIFICATIONS FOR SIDE IMPACTS

CAL No. YB-2684-V-3

INTERIM TECHNICAL REPORT

CORNELL AERONAUTICAL LABORATORY, INC.

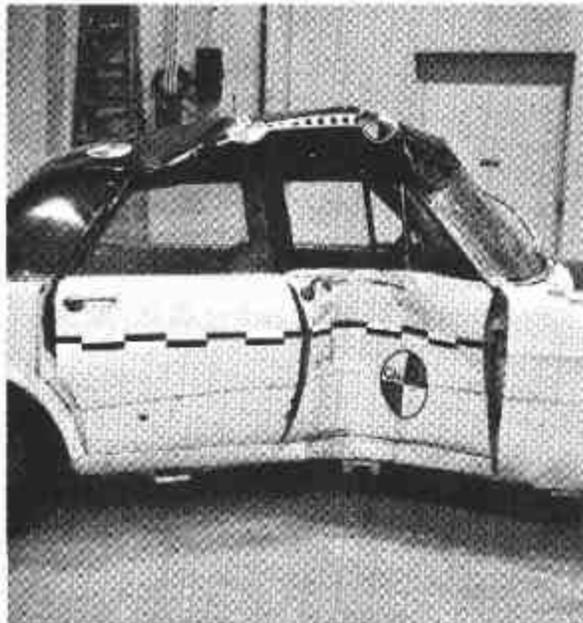
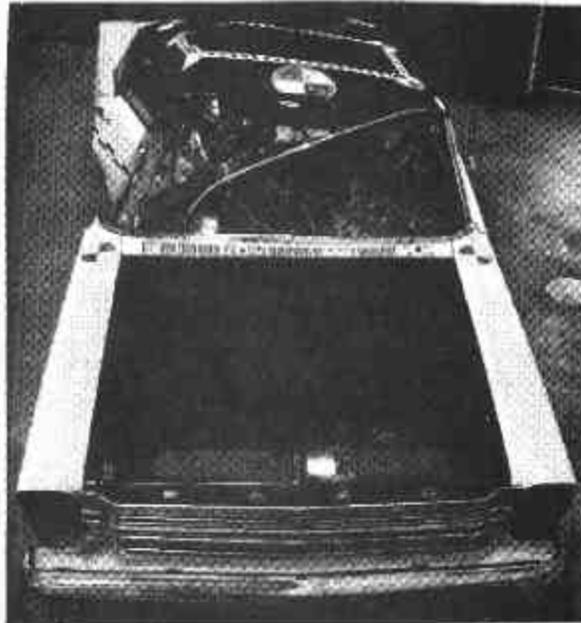
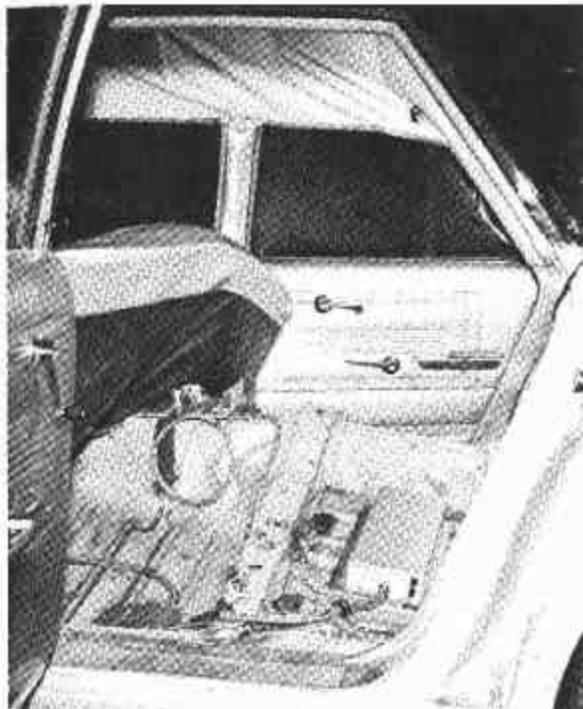
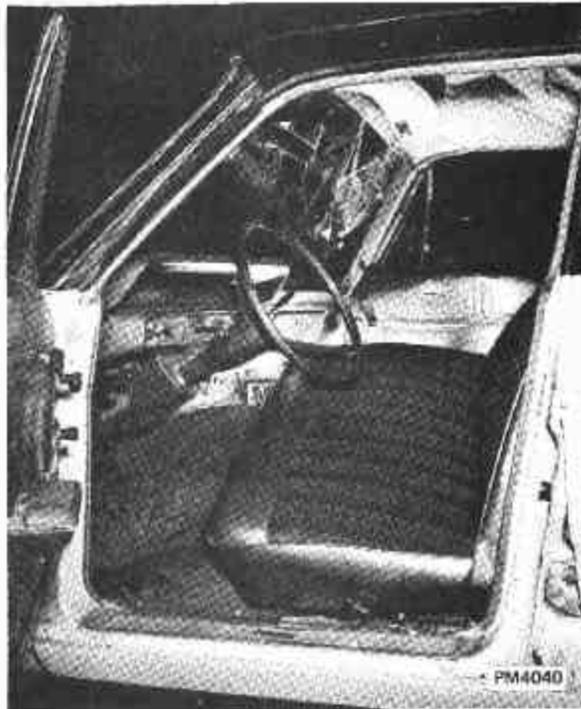
Figure 5-4 BASE LINE TEST No. 3: SIDE POLE IMPACT

Photographs of the test vehicle after the collision are presented in Figure 5-4. Figures 5-4(c) and 5-4(d) show the upward displacement of the floorpan in the front and rear compartment areas and the fairly large bend in the front bench seat. Measured permanent deformation was approximately 24 inches.

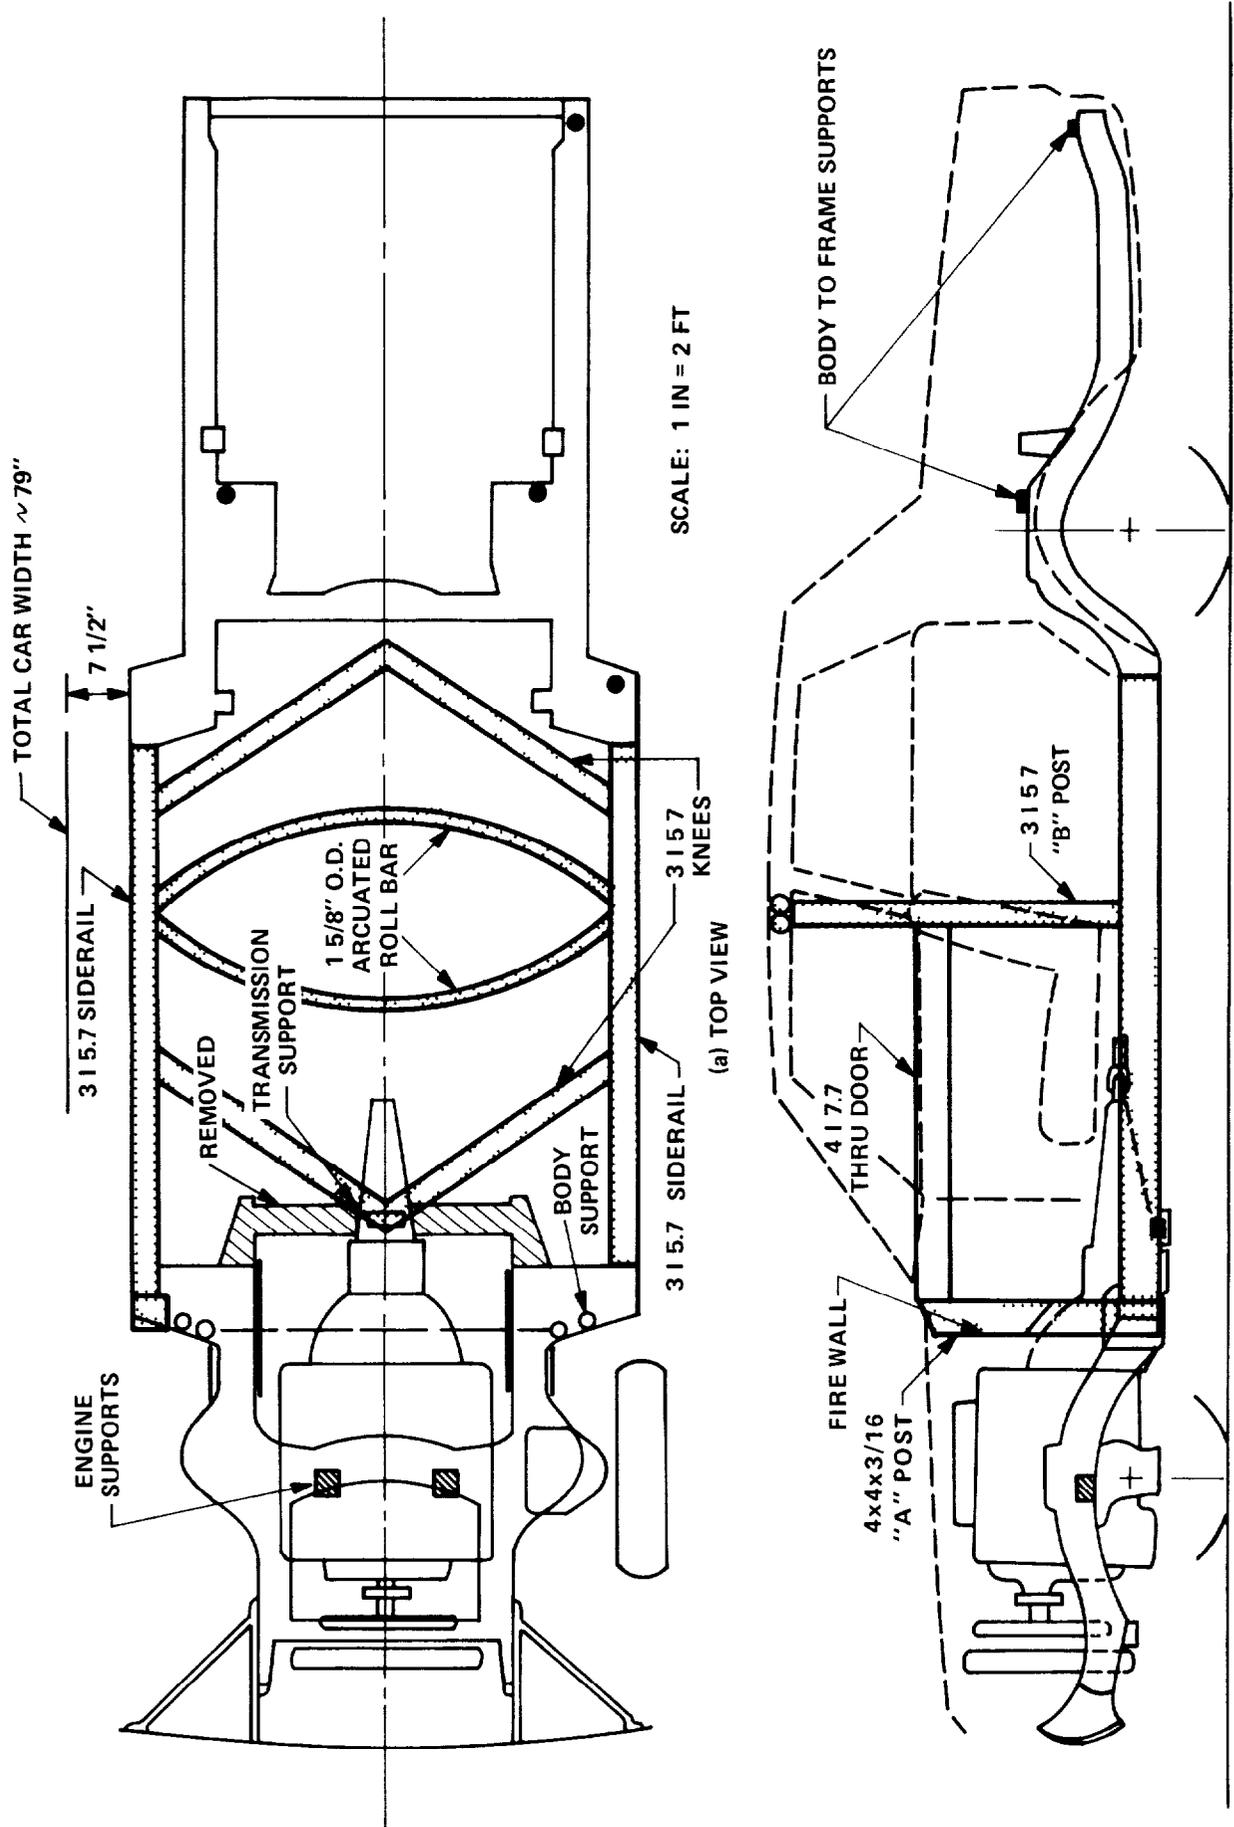
Figure 6-5 STRUCTURAL CONFIGURATION: MOD. 3A (1)

The shaded members of Figure 6-5 comprise the basic structural concept utilized for the Mod. 3A vehicles. The existing thin wall rectangular side rails have been replaced by I-beams of approximately the same weight for increased bending strength in the horizontal plane. The side rails are connected by two knee-shaped cross members aligned along the center lines of the front and rear passenger doors. The purpose of the knees is to obtain the constant load behavior demonstrated by static component tests and to distribute load to the nonimpact side. In this modification, an I-beam between the "A" and "B" posts is included to simulate the increased strength of a Mod. 3 type reinforced door while avoiding the fabrication difficulties encountered in the Mod. 3 approach. Both the door beam and the side rail are rigidly framed to a vertical box beam which provides a substantially stronger "A" post to direct the impact force to the heavy existing members in the vicinity of the engine.

The structural sizes that are indicated in Figure 6-5 specifically apply to the Mod. 3A(1) vehicle, which is further described in Section 9. Mod. 3A(2) was partially constructed along with Mod. 3A(1), but incorporates minor changes that were deemed necessary based on the results of the Mod. 3A(1) test. These changes are discussed in Section 10.

Referring to Figure 6-5, which illustrates the structural concept and indicates cross-sectional sizes of the added components, the frame side rails and energy-absorbing knee-shaped cross members are shown to be fabricated from 3I5.7 (I-beam) structural steel. "B" posts were also reinforced using 3I5.7 beams. A 4 x 4 x 3/16 box beam was built into the impact side "A" post to carry load applied to the door into the main frame. The effect of including a practicable reinforced door was simulated by adding a beam between the stiffened "A" and "B" posts through the conventional door. Arcuated lateral struts fabricated from 1-5/8" O.D. pipe connect the stiffened "B" posts at roof level. These struts are intended to serve the dual purpose of absorbing energy in side impacts and providing additional rollover protection.

A number of compromises were necessary in the design to expedite actual construction of the vehicle. Figure 6-5 shows that the outer periphery of the vehicle is 7-1/2 inches outboard of the vehicle frame. Ideally, it would be desirable to engage the heavier frame member at the earliest possible instant in the impact, i. e., the frame side rails should be at the outer periphery of the vehicle. Since the body has been designed to mate with the existing frame dimensions, a considerable effort would be required to rework the body structure if the frame width were increased, thus, it was decided to observe test results of the simpler modification before considering more extensive changes. Also, due to the interference of the drive shaft both the forward and rear knees between the side rails were sloped downward. Since this introduced weak axis bending and torsional moments in the knee, straps were added to tie the knees to the floorpan of the body.

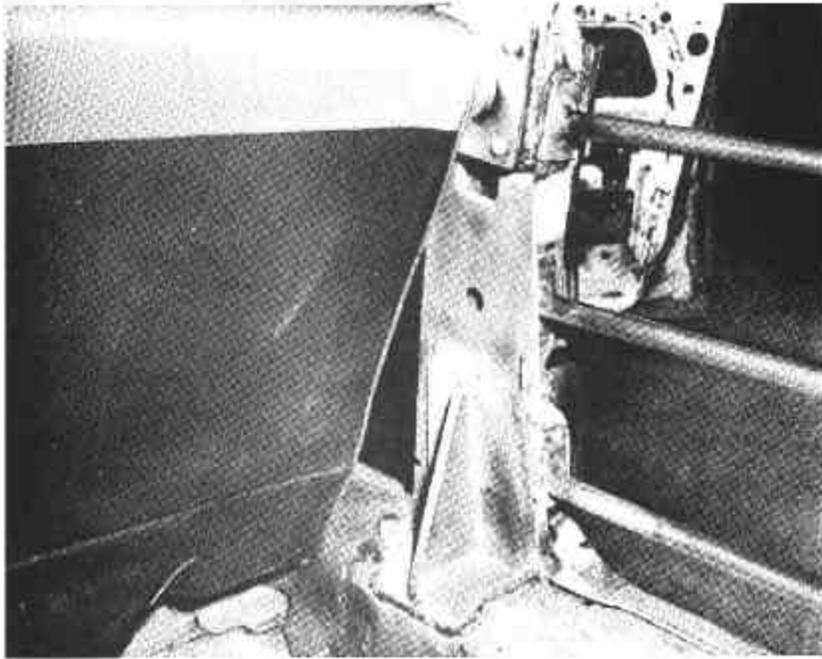
Figure 7-4 CLIP ANGLE AT "B" POST

The two straps which were added to strengthen the bottom of the door followed the deformed contour. The clip angles at the "B" posts, Figure 7-4, showed no signs of overstress and could be reduced in size. The "A" post clip angle received substantial load and was certainly necessary. In examining the relative deformation of the three hat section door beams, Figure 7-13, it is apparent that the lower beam received less load than the upper two and could possibly be eliminated in a future test.

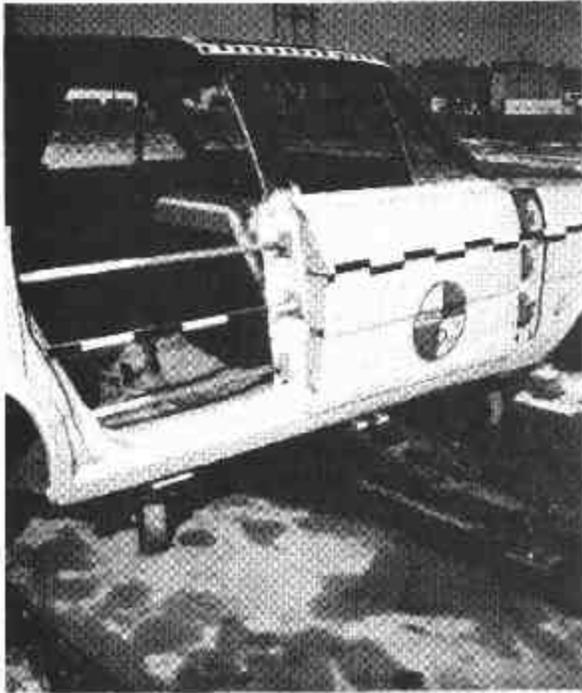
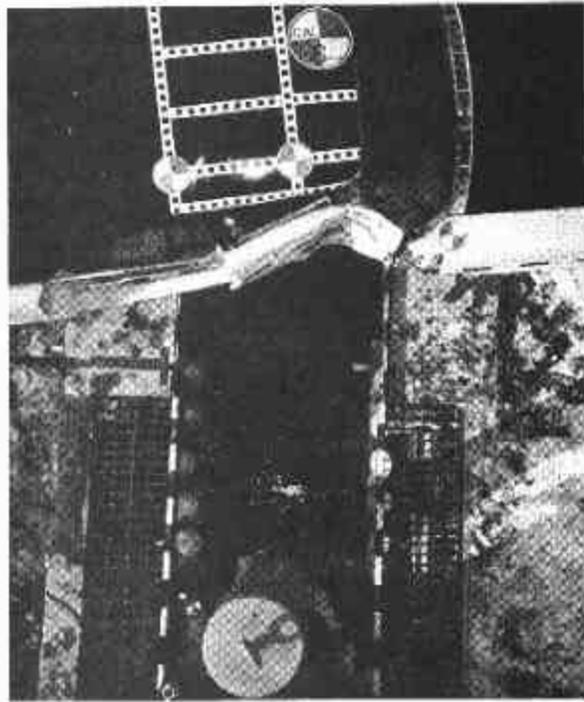
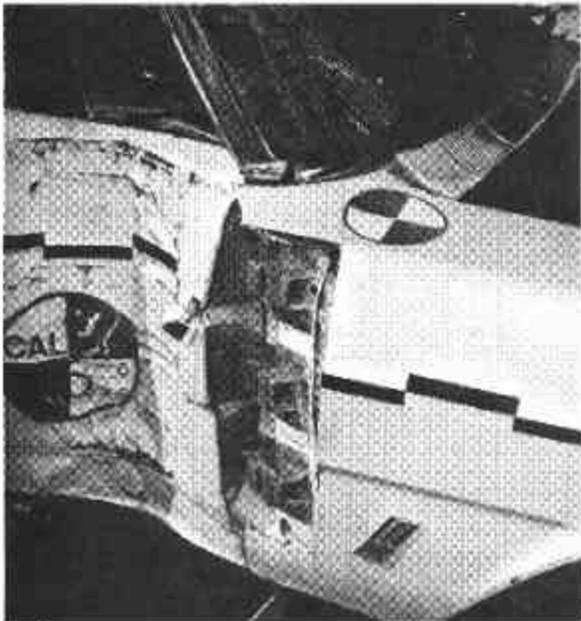
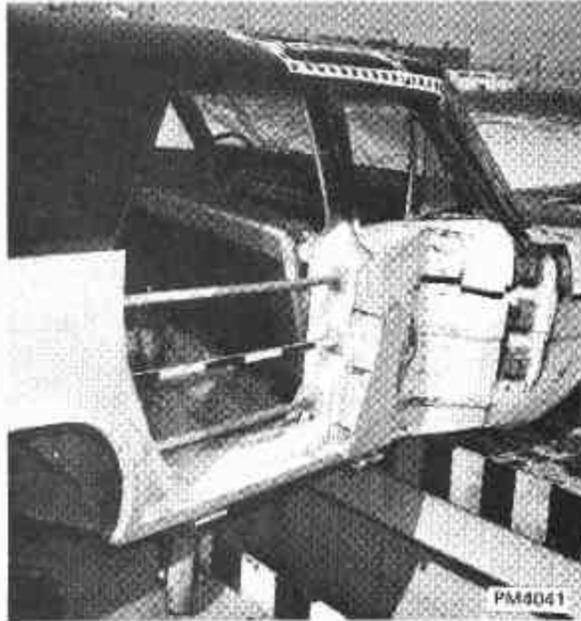
Figure 7-11 MOD. 3 TEST, SIDE POLE IMPACT

Photographs of the Mod. 3 vehicle are shown in Figure 7-11, with a pretest photo of the impact side shown in Figure 7-11(a). The deformed profile can be seen in the top view shown in Figure 7-11(b).

The plan view profile of Mod. 3 was measured in the same manner as the base line test. This profile was superimposed over the undamaged car and base line profiles in Figure 7-12 for direct comparison. Note that Mod. 3 sustained 14 inches of permanent deformation compared with 24 inches for the base line test. Mod. 3 also exhibited less "pole wraparound" than the unmodified vehicle.

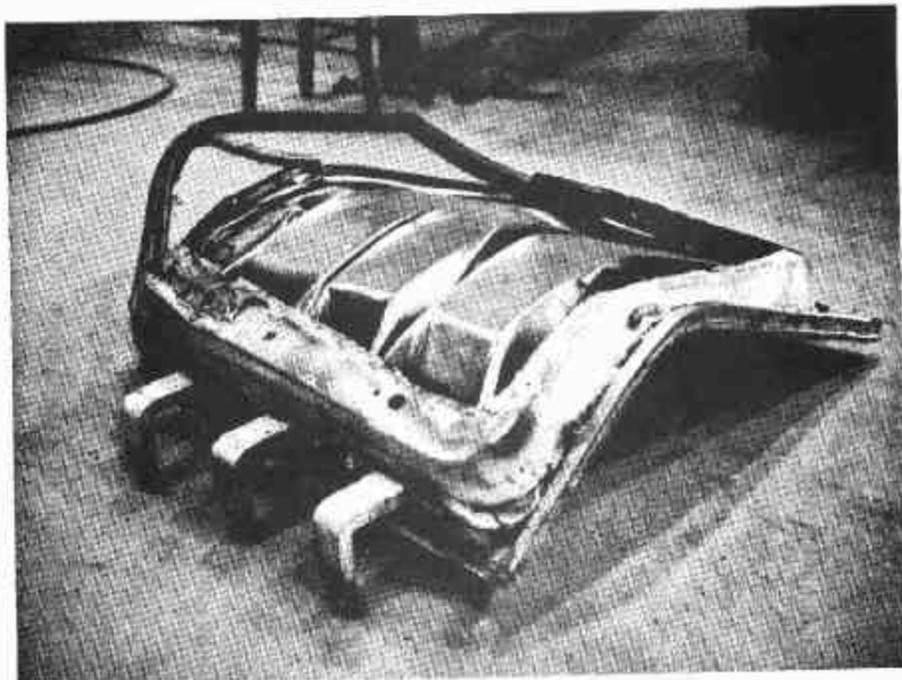
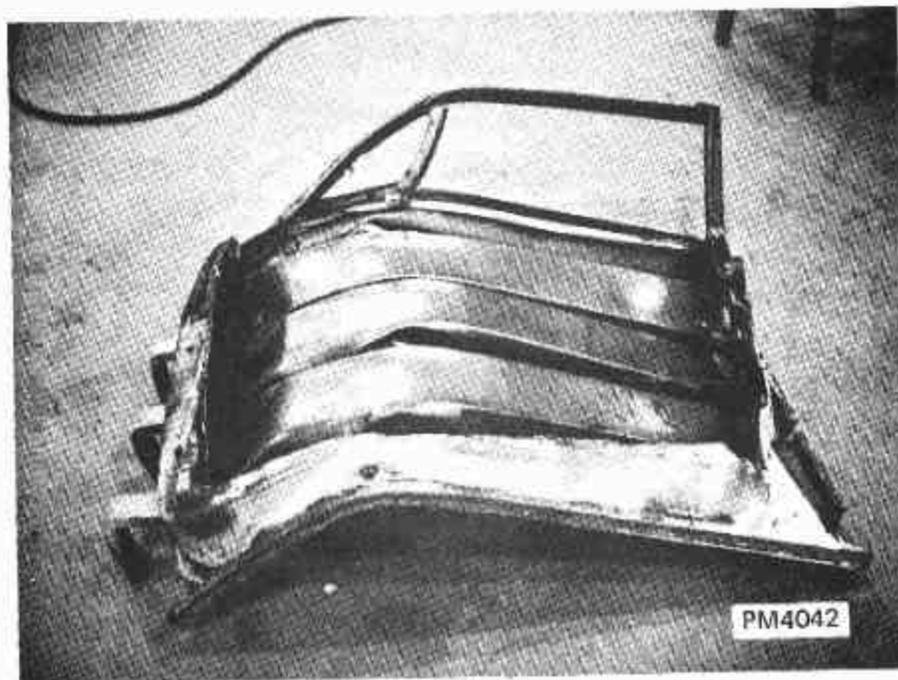
Figure 7-13 MODIFIED DOOR AFTER IMPACT

In evaluating overall structural performance, it is worthwhile to restate the two specific objectives of the modification: (1) to limit intrusion and (2) to spread the localized pole load by developing cable effects in the door beams. Figures 7-13(a) and 7-13(b) are photographs of the modified door which was removed for inspection. The pole impact point was at the third point of the beam toward the "A" post. This fact, coupled with an impact velocity under target, resulted in an undertest of the design concept. As a result, the "B" post door latches did not operate as anticipated. The loads were transferred through the tack welds that were added as a result of the component test failure (see Section 7.1) and by bearing, but not by the locking action hoped for. Also, the load carried by the transverse strut was somewhat less than 9000 lbs, whereas 15,000 lbs was expected. Accordingly, the design details were closely examined for evidence of cable action. The plates connecting the rods that simulated the action of a modified rear door (Figure 7-7) indicated that significant tensile loads were transmitted by each rod. The vertical seam added to provide the connection to the front fender was also subjected to high tensile loads. Based on examination of the above and other details, it can be conclusively stated that the desired tension action was achieved. The difference in crush between Mod. 3 and the base line vehicle (14 vs. 24 inches) is greater than that which could be attributed to the velocity difference (17.4 vs. 21.5 MPH).

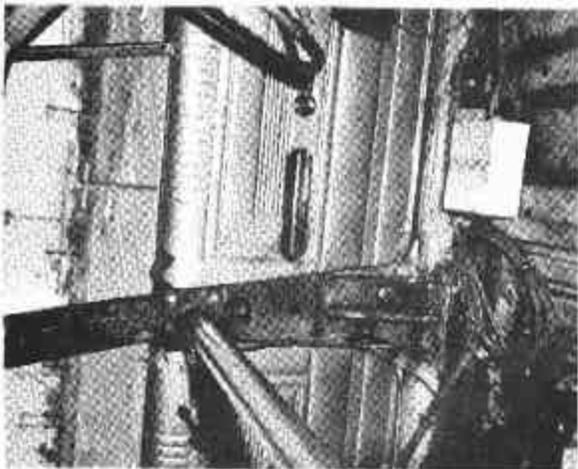
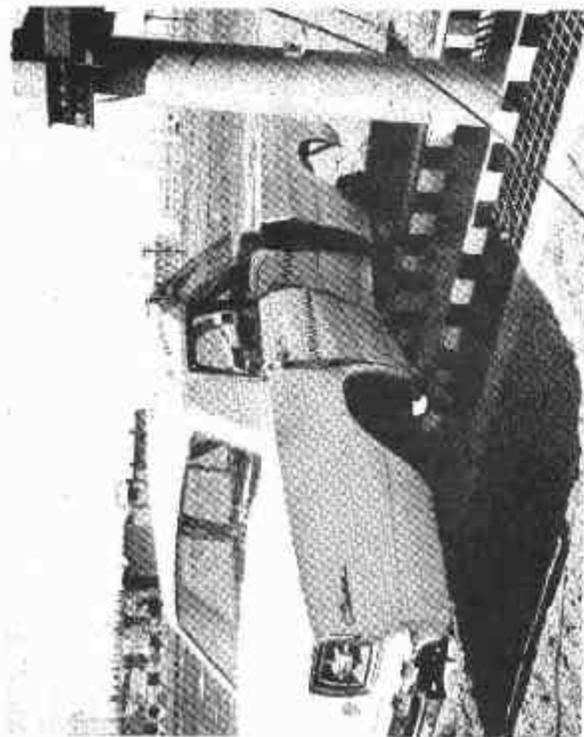
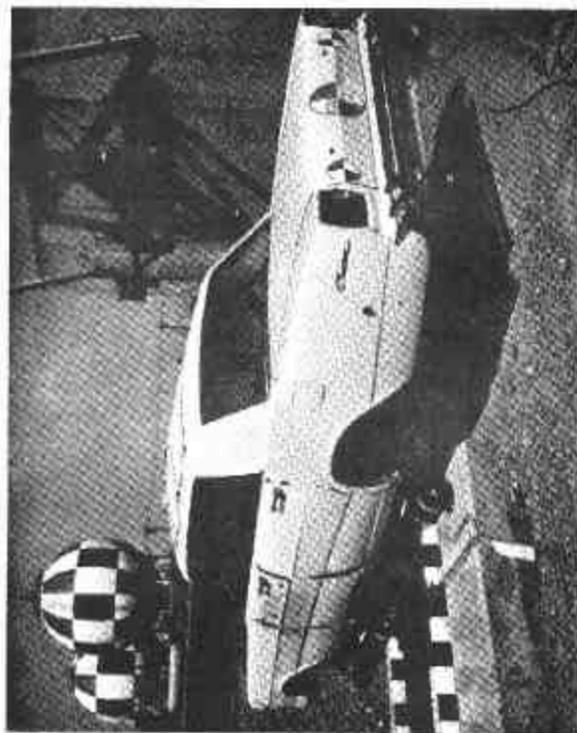
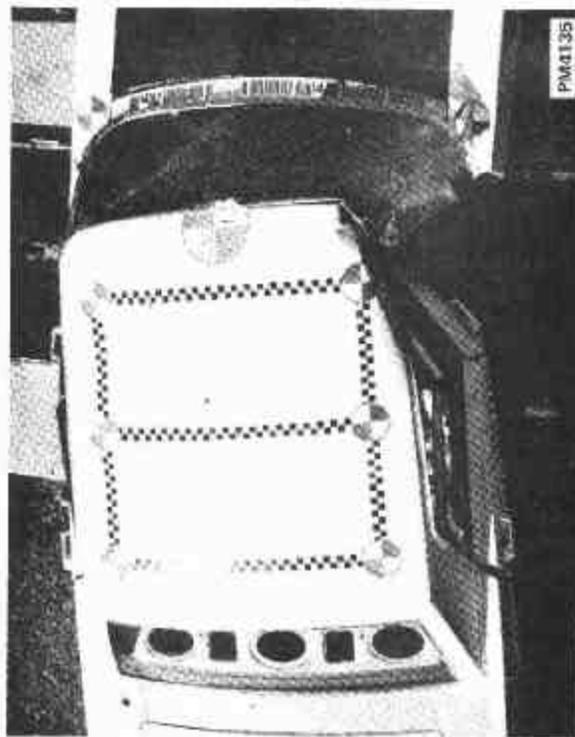
Figure 8-7 D-2 TEST, SIDE IMPACT WITH POLE

Photographs of the D-2 test vehicle are shown in Figure 8-7. The interior pole brace between the "B" pillars can be seen in Figure 8-7(a) along with some of the on-board instrumentation. Figures 8-7(b) and 8-7(d) show the amount of damage sustained from the impact and the slight bowing of the left side "B" pillar is noticeable in Figure 8-7(c).

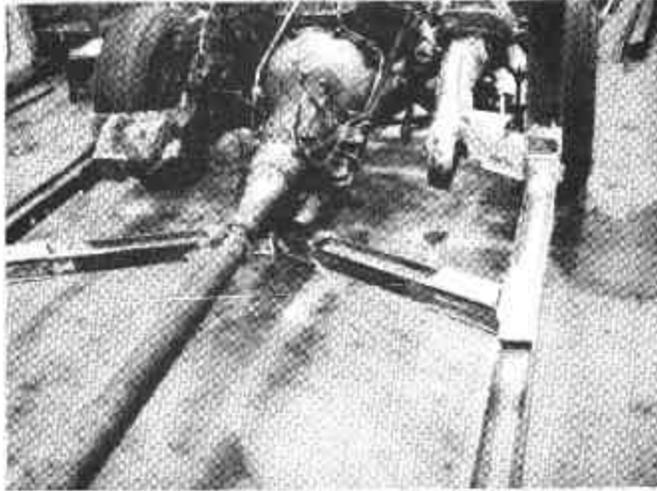
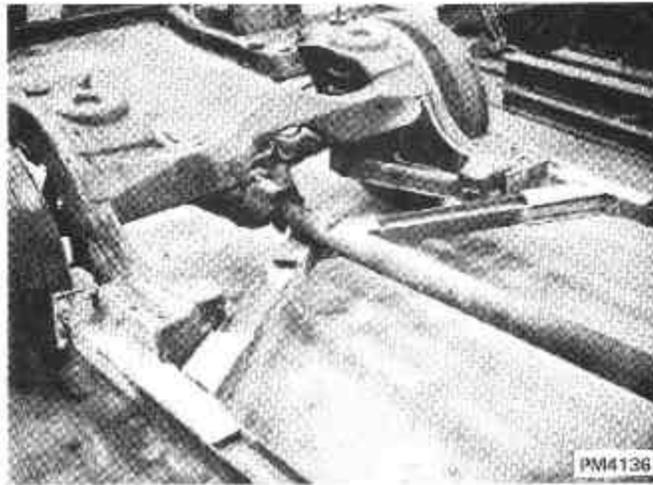
Figure 9-2 FORWARD AND REAR KNEES

Photographs of the forward and rear knee-shaped struts between the frame side rails are shown in Figure 9-2. Figure 9-3 shows the redesigned torque box section and the frame connected "A" post reinforcing structure. The overall modified frame is shown in Figure 9-4.

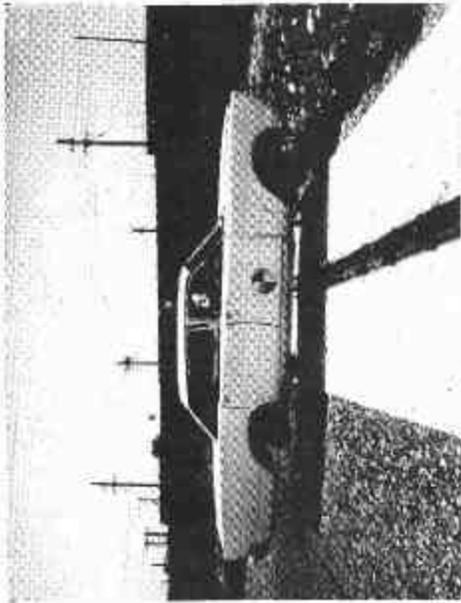
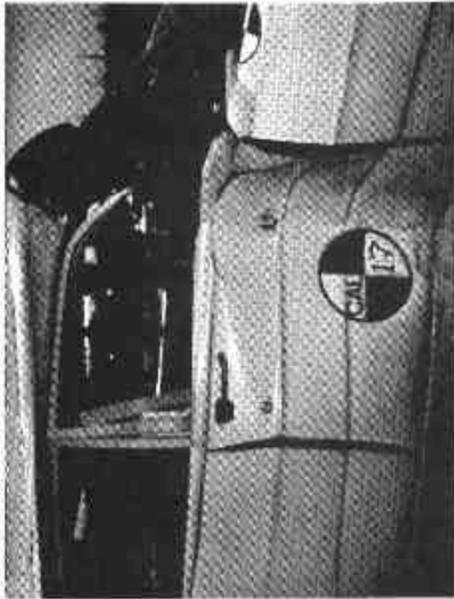
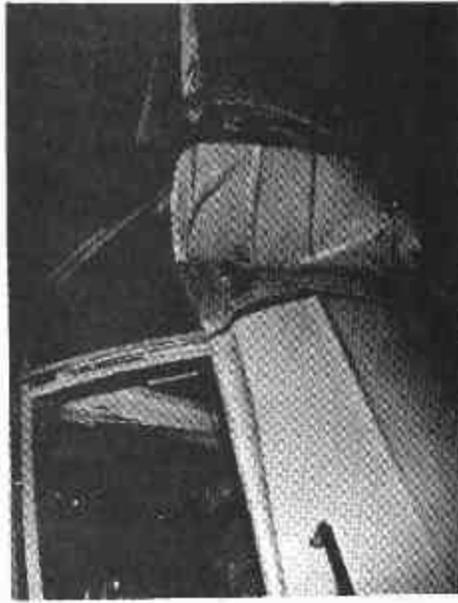
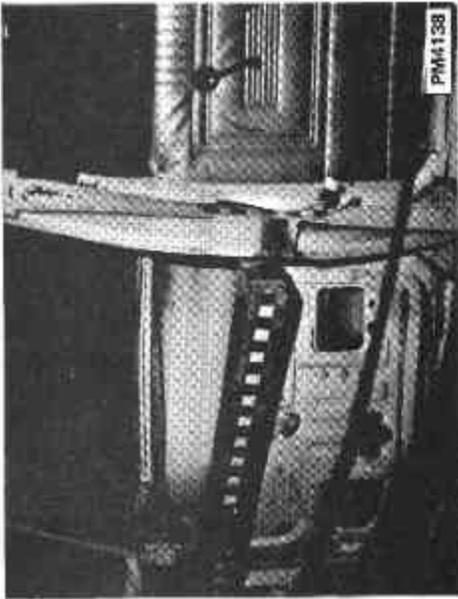
Figure 9-10 MOD. 3A(1): SIDE IMPACT WITH POLE

Photographs of the Mod. 3A(1) vehicle are presented in Figure 9-10. Figure 9-10(a) shows the car before the crash test and the remaining three photos indicate the degree of deformation obtained from the 22 MPH impact. An interior view of the impacted door and its reinforcing structure is shown in Figure 9-10(d).

Figure 9-18 is a post-crash photo of the split roll bar, which failed to yield or to absorb energy during the impact. This behavior is attributed to excessive twisting of the I-beam used for the "B" post (see Figure 9-10 (d)). This implies that either the I-beam is too weak in torsion or the roll bar structure is too stiff. Although the roll bar did not operate as planned, it was only a proportionally small feature of the whole, the frame modification being the salient feature.

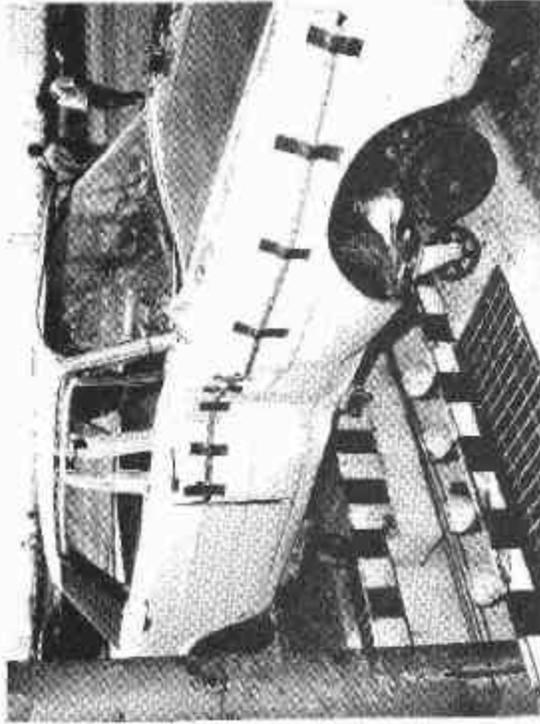
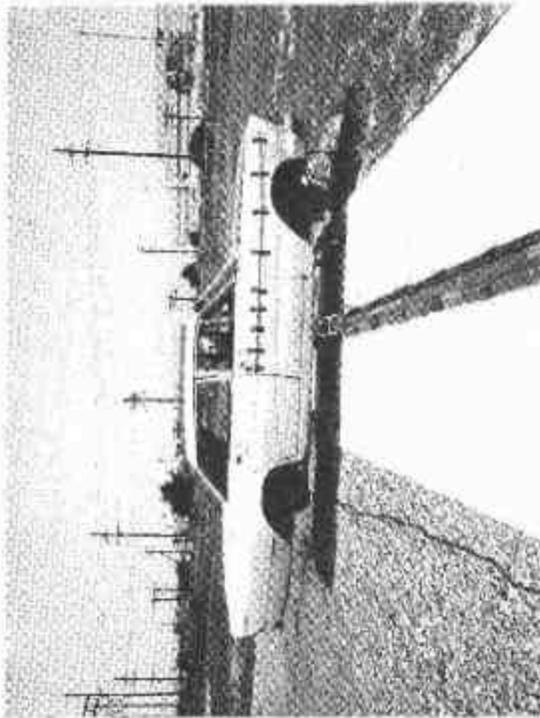
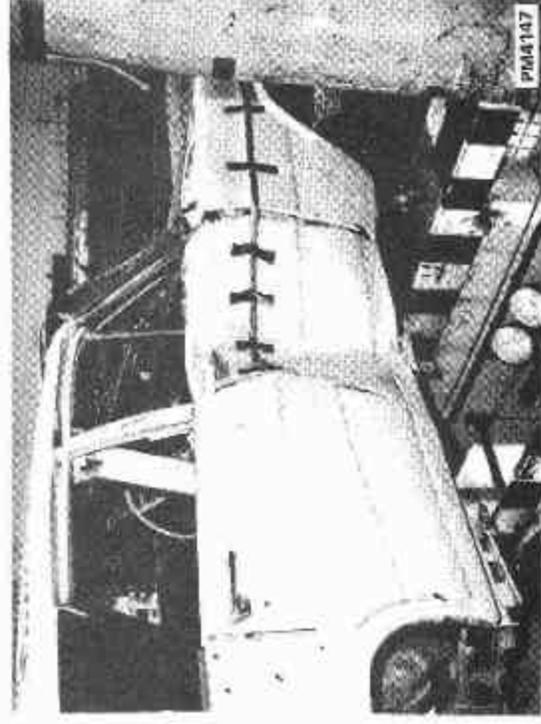
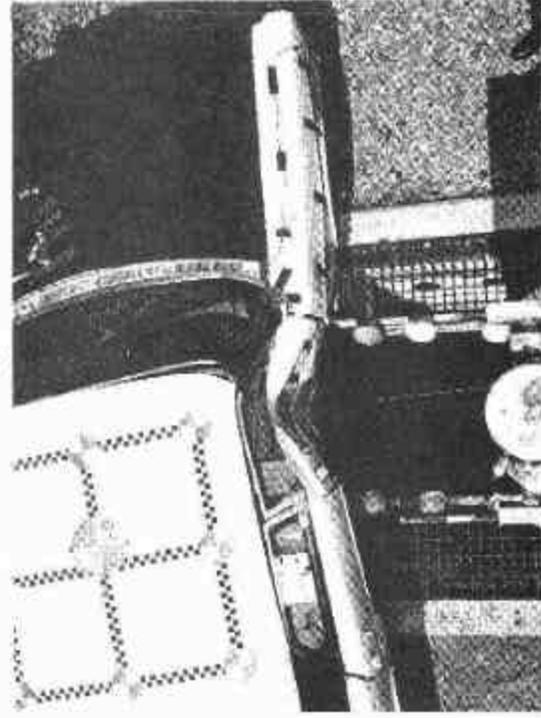
Figure 10-8 MOD. 3A(2); SIDE IMPACT WITH POLE

Photographs of the Mod. 3A(2) vehicle are presented in Figure 10-8. Figure 10-8(a) shows the car before the test and the remaining three photos indicate the degree of deformation resulting from the impact. Note in Figure 10-8(c) that the pole penetrated inward only as far as the roof line.

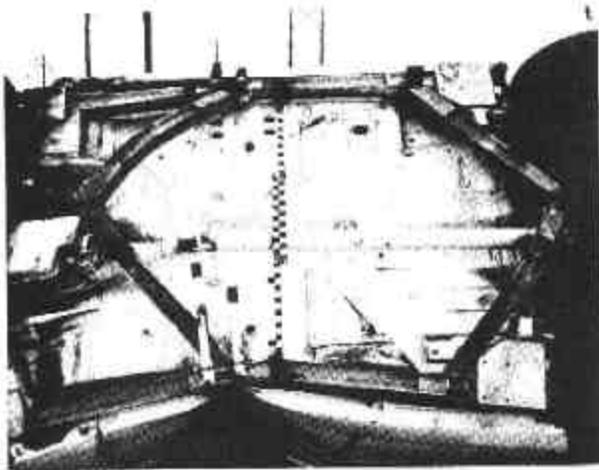
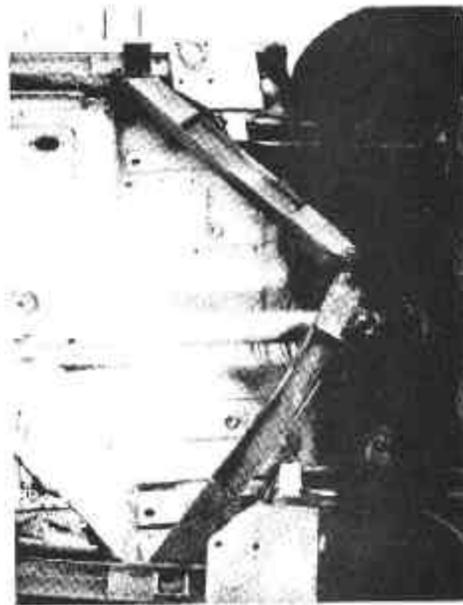
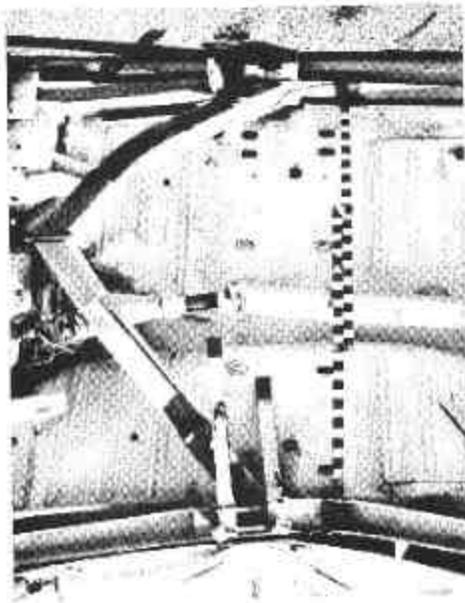
Figure 10-12 MOD. 3A(2): FRAME DAMAGE

As for Mod. 3A(1), the photographs of the deformed frame, Figure 10-12, present evidence of effective distribution of the loads to the non-impact side of the frame and substantial energy absorption by the knee-shaped frame cross members. Figure 10-13 shows the hinge formed at the center of the square tube serving as the "B" post. The interior photo, Figure 10-13(B), also shows the arcuated roll bar which again failed to yield or absorb energy. However, post-collision examination of the roll bar structure and analysis of high speed movies from an on-board camera (which showed 1 inch maximum separation at center) reveal that yielding was incipient. The roll bar is, therefore, too strong for effective energy

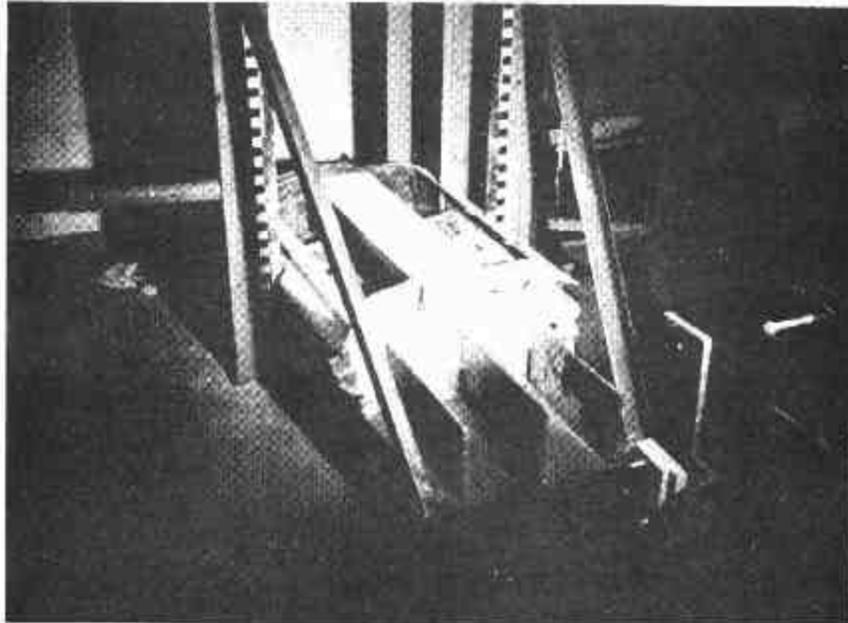
(A)

The objective of the door drop test was to observe the latching mechanism under impact conditions. Figure A-1(a) shows the door in the guillotine drop mechanism. Figure A-1(b) shows the door after the test. The latching mechanism, which failed to engage, is shown in the foreground of Figure A-1(b). Figure A-1(c) shows another view. To better approximate actual conditions, the latching mechanism was mounted on an actual "B" post taken from a previously tested vehicle.

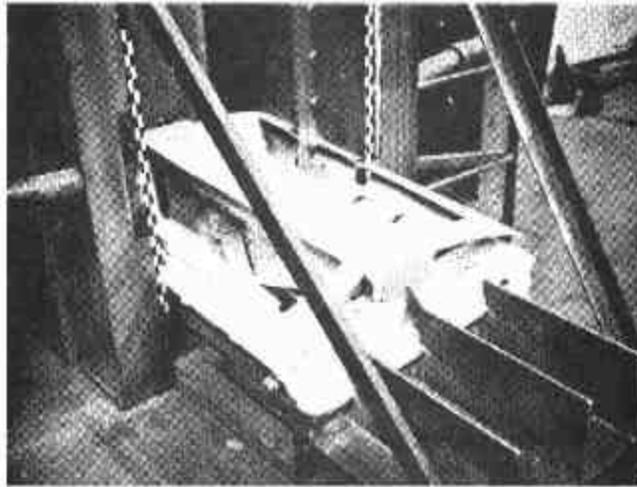
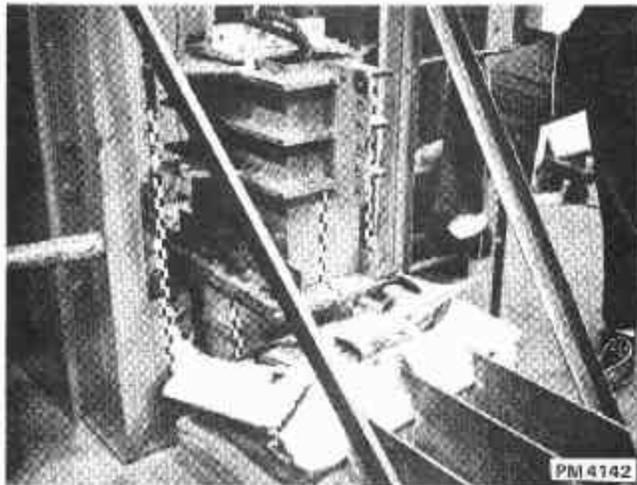
Figure A-4 MODIFIED DOOR IMPACT TEST

As shown in Figure A-3, the latch was modified by the addition of a backing plate to prevent initial rotation and by enlarging the dovetail engaging slots; otherwise, the test conditions were the same as Test No. 1. Figure A-4(a) shows the door mounted in the drop test facility, the backing plate can be seen in the foreground.

The condition of the door following impact can be seen in Figure A-4(b). The latch engaged successfully, as revealed by high speed film of the impact and obvious deformation of the "A" and "B" post supports which was caused by the cabling effect of the beam. The cabling effect was somewhat diminished, however, by a hinge formed at the connection between the hat section and latch which caused the latch to rotate while engaged. The magnitude of the rotation is apparent in Figure A-4(b). As a result of the reduced cabling effect, the deflection of the hat section was larger than anticipated and was crushed against the foundation of the supporting fixtures.

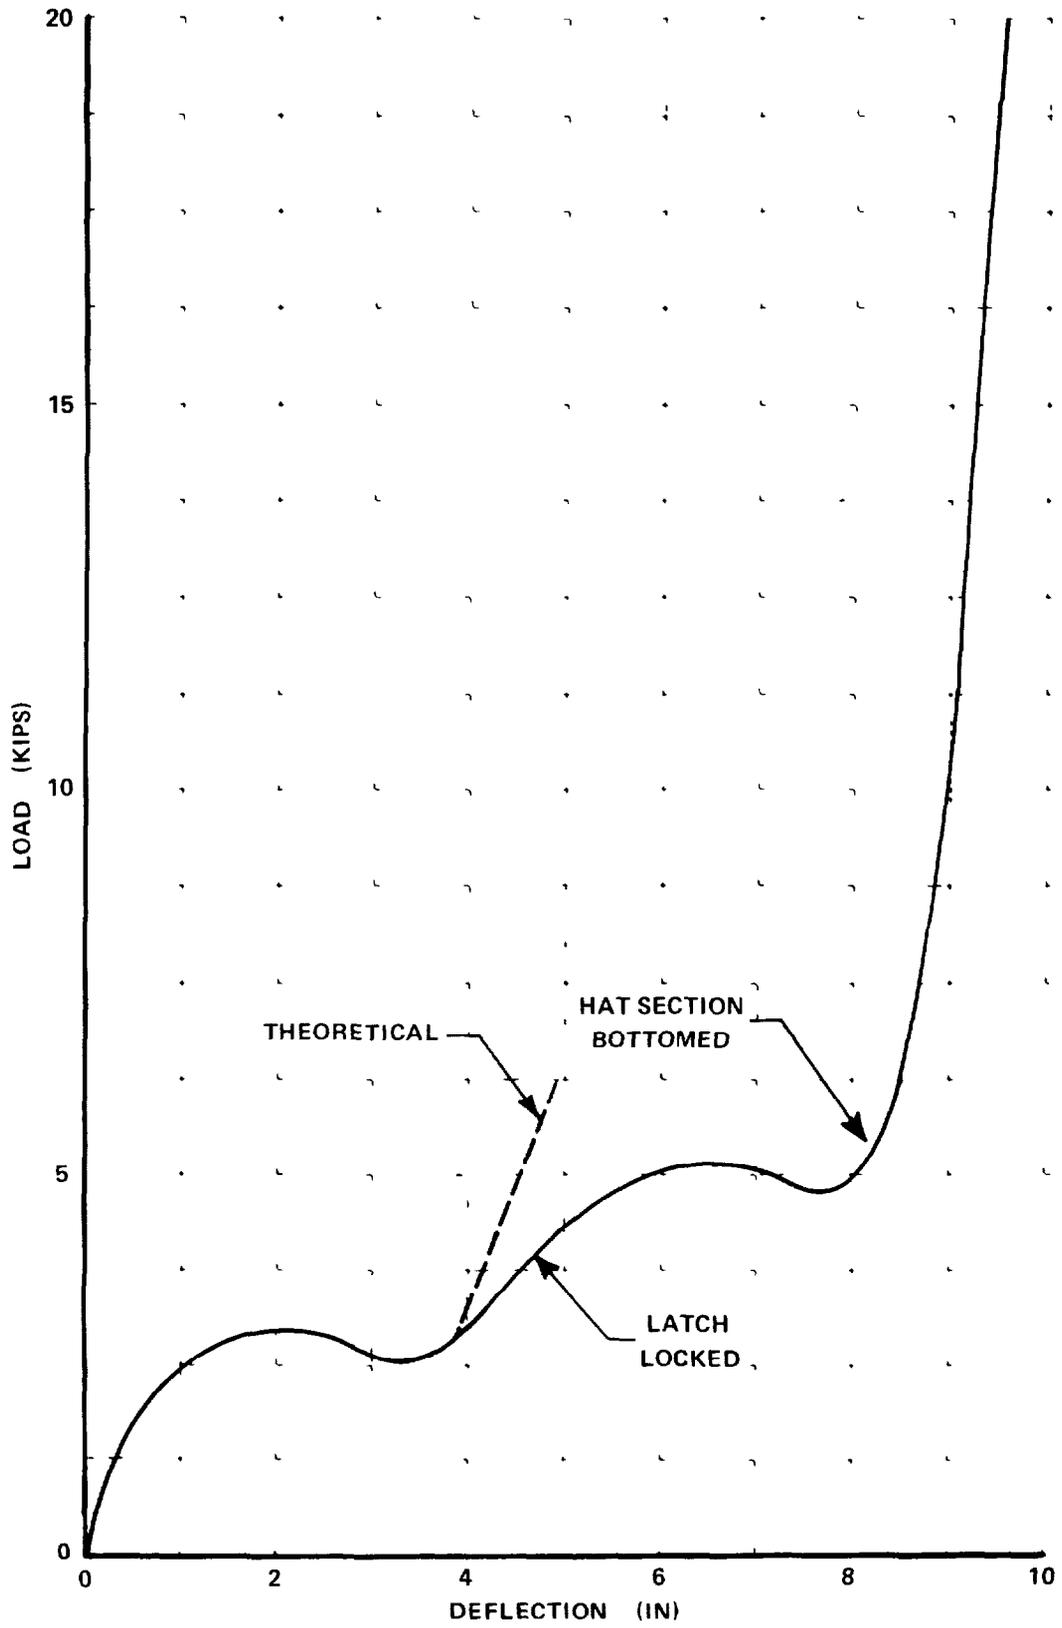
Figure A 5 DYNAMIC LOAD-DEFLECTION BEHAVIOR OF TEST NO. 2 DOOR

The dynamic load-deflection characteristic of the door, as developed from acceleration data from the impact head, is contained in Figure A-5. The curve reflects the "two-stage" behavior of the hat section beam, the first portion of the curve resulting from beam bending only (before latch engagement) and the second portion due to cabling action. The dashed line on the curve shows the calculated spring rate (for cable effects) of 3.3 K/in. Although the theoretical value was not realized, it is apparent that cable action due to lateral restraint did occur. The events noted in the figure were determined from high speed film analysis.

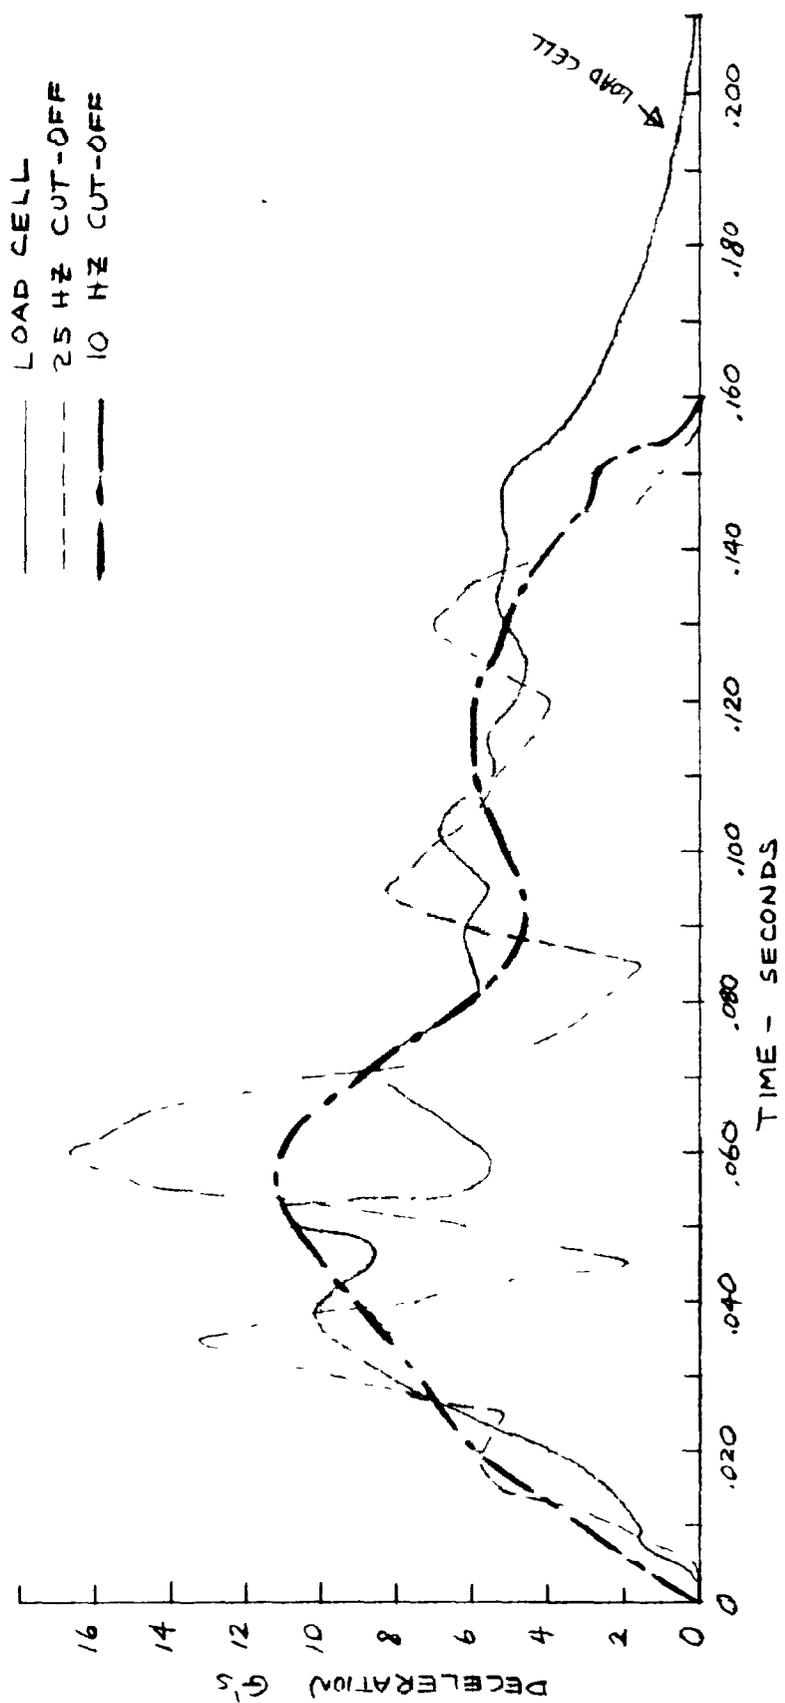
Figure B-1 COMPARISON OF ACCELERATION DERIVED FROM LOAD CELL (FORCE) DATA WITH FLOOR PAN ACCELEROMETER FOR VARIOUS FILTERS

Since the accelerations derived by dividing the force measured by the load cells by the vehicle weight should be indicative of the gross vehicle, it is of interest to compare these inferred accelerations to those directly measured and filtered with various cutoffs. Figure B-1 presents this comparison for the output of the accelerometer mounted on the floor pan which has been processed through 25 and 10 Hz cutoff filters. Figures B-2 and B-3 present corresponding results for accelerometers attached to the frame and to the B-post. Close examination of the three figures leads to the following observations. The 10 Hz data is filtered too heavily to reproduce the excursions sensed by the load cell; alternatively, the 25 Hz filter appears to be

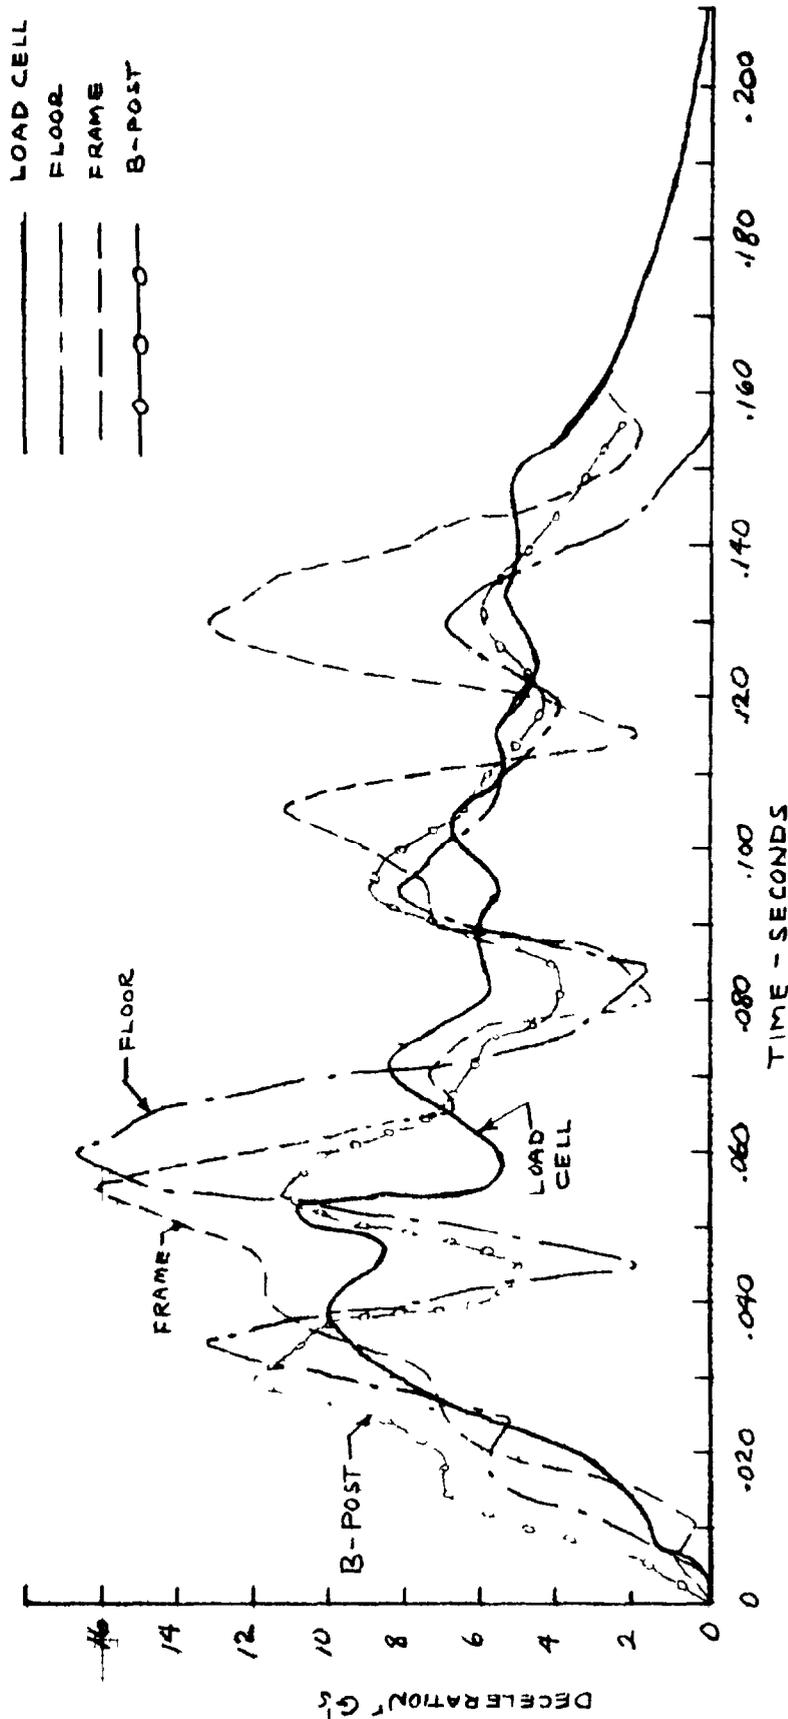
Figure B-4 COMPARISON OF ACCELERATION DERIVED FROM LOAD CELL (FORCE) DATA WITH ACCELEROMETERS FILTERED AT 25 Hz CUTOFF

An added reason for the redundant measurements was to see what conclusion could be made concerning accelerometer location. Figure B-4 is a plot of the calculated load cell accelerations and data from all three locations which have been processed through a 25 Hz cutoff filter. It can be seen that the rise times are similar -- the first peak for all four curves occurs at approximately 30 milliseconds. It can also be observed that subsequent peaks show good agreement in their time of occurrence. A further observation is that the "noise" of the individual curves increases as the flexibility of the attachment point. The floor is the most flexible

location, and the B-post is the stiffest location -- the accelerometer is, in fact, attached to a heavy gusset added to the base of the post. One possible conclusion is that the stiffer the accelerometer location, the better the agreement with the load cell data. It was originally thought that filtering with a very low cutoff would tend to remove localized effects and all curves, including the accelerations derived from the load cells, would converge to the "true" deceleration curve for the vehicle. Figure B-5 depicts the same data as in the previous figure, but the cutoff frequency is now 10 Hz. While much of the differences between the curves have been filtered out, substantial percentage differences still exist. For example, the peak amplitude of the accelerometer on the frame is 13.1 g's compared to 9.3 for the B-post. Also, the variations between accelerometers are greater than the variation between an accelerometer and the load cell data. Whenever two points undergo different accelerations, then it follows that the relative displacement between the points must be varying. Figure B-6 plots the relative displacement between the frame and the B-post as a function of time. The curve was obtained by a double integration of both accelerometer outputs. The low magnitude of the relative displacement, especially at times when differences in acceleration levels between the points are pronounced, is particularly significant. Displacements of this magnitude could easily escape detection by camera coverage or post-collision examination. Due to the small times involved, only small relative displacements result when sizable differences in accelerations exist between points on the same vehicle. Because of this fact, the original hypothesis that filtering with a very low cutoff would result in all curves converging to the "true" curve must be abandoned.
