FRONTAL CRASH INCOMPATIBILITY OF HEAVY GOODS VEHICLE IN CRASH TEST WITH PASSENGER CAR

Paper Number 23-0321

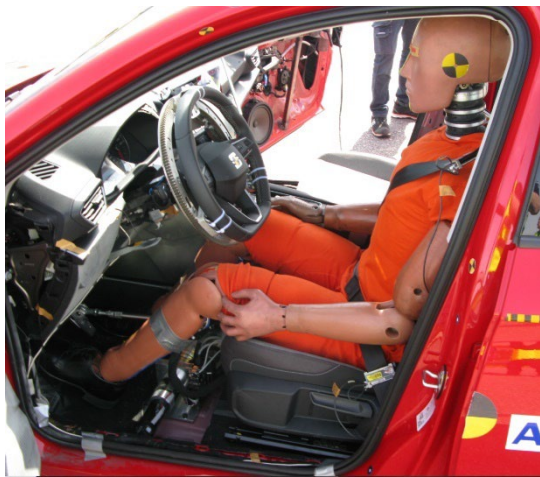
The car was fitted with a HIII 50% male dummy (HIII 50M) in the driver position. The driving robot employed did not interfere with the upper body of the HIII 50M. The throttle actuator did not allow for the right foot to be positioned on the throttle (Figure 3). No dummy was placed in the HGV.

Figure 3. Driver position - note position of right foot.

Considering the severe loading in this crash, the car's safety systems performed reasonably well. The right femur loads were the highest and surprising given the severe loading to the vehicle structures in the vicinity of the left femur. It is possible that the driving robot equipment and resulting right leg positioning (Figure 3) influenced the loading to the right leg and could be ignored in further analyses. With restraint systems adapted to the high severity of the car-to-HGV crashes, car occupant protection can be improved in terms of reducing occupant motion to prevent head impact to interior structures. With stiffer seat belts (higher load limiting force), excessive motion of the chest and head can be reduced, without increasing the loading to the chest if the stiffness of interior components such as seat and knee bolster can be adjusted accordingly [11]. Improved head protection also seems feasible using larger frontal airbags [10], or non-symmetric frontal airbags [19] which can have larger airbag volume in the left A-pillar region to prevent head rolling off the airbag and to avoid head strike-through. Finally, inflatable curtains extended to cover the A-pillar is another means of mitigating head impact to the near side structures in oblique crashes [20]. All such countermeasures are feasible if they can be made adaptive, so that protection in moderate-severity crashes is retained.

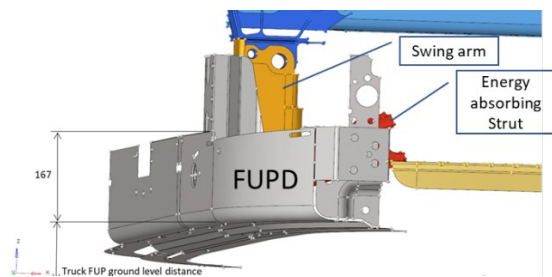
Figure 6. FUPD design.

The left outboard section of the FUPD on the HGV fractured at the connection bracket to the energy absorbing element. This fracture eliminated potential for intended interactions between the HGV FUPD and car's main structural members. The HGV steering arm separated from the steering rack and the steering servo was sheared from the frame rail where it is mounted. The car bumper loaded the left front tire of the truck, puncturing it and driving the rim rearward. Figure 11 shows the damage to the HGV which was confined to the structures below the cab. As seen in Figure 8, the combination of steering system damage and punctured left front tire caused the HGV to move laterally to the left after the impact.

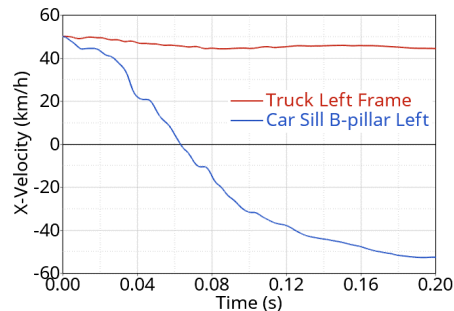
Figure 7: Car and truck velocity time profiles.

The car experienced a 100 km/h change in velocity as seen in Figure 7. The car came to rest approximately 30 m from the point of impact and rotated 460 degrees counterclockwise. The HG and car brakes were activated after the time of impact as per the test protocol. The truck's velocity change during the impact was less than 6 km/h (Figure 7). The vehicle positions and orientations after the collision are shown in Figure 8.

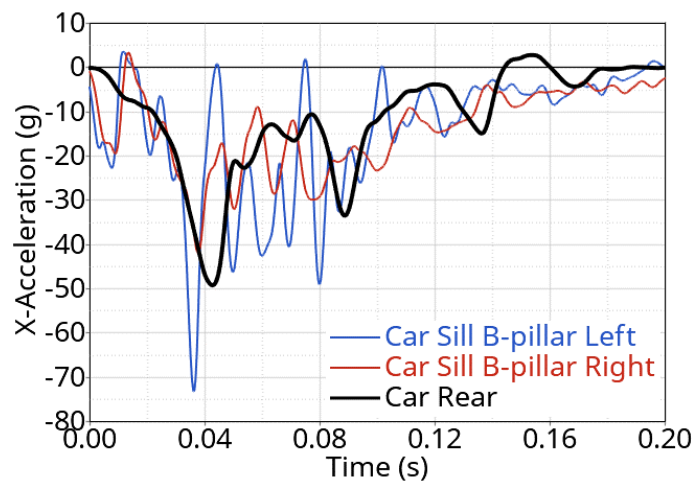
Figure 13. Car x-accelerations.

The passenger car accelerations, shown in Figure 13 exhibit three main peaks corresponding to the events observed in the videos. The initial loading of the FUPD and metallic structures with a peak in the first 50 ms, the contact and loading of the tire after 60 ms, and the vehicle-rim bottoming out on the rear wheel-well structures. The concentrated loads on the left side of the car are readily apparent in the high (70 g) accelerations measured in the left B-Pillar compared to the right (40 g). The car rotation was minimal during contact with the truck but the resulting rotation post crash was considerable (over 400 degrees).

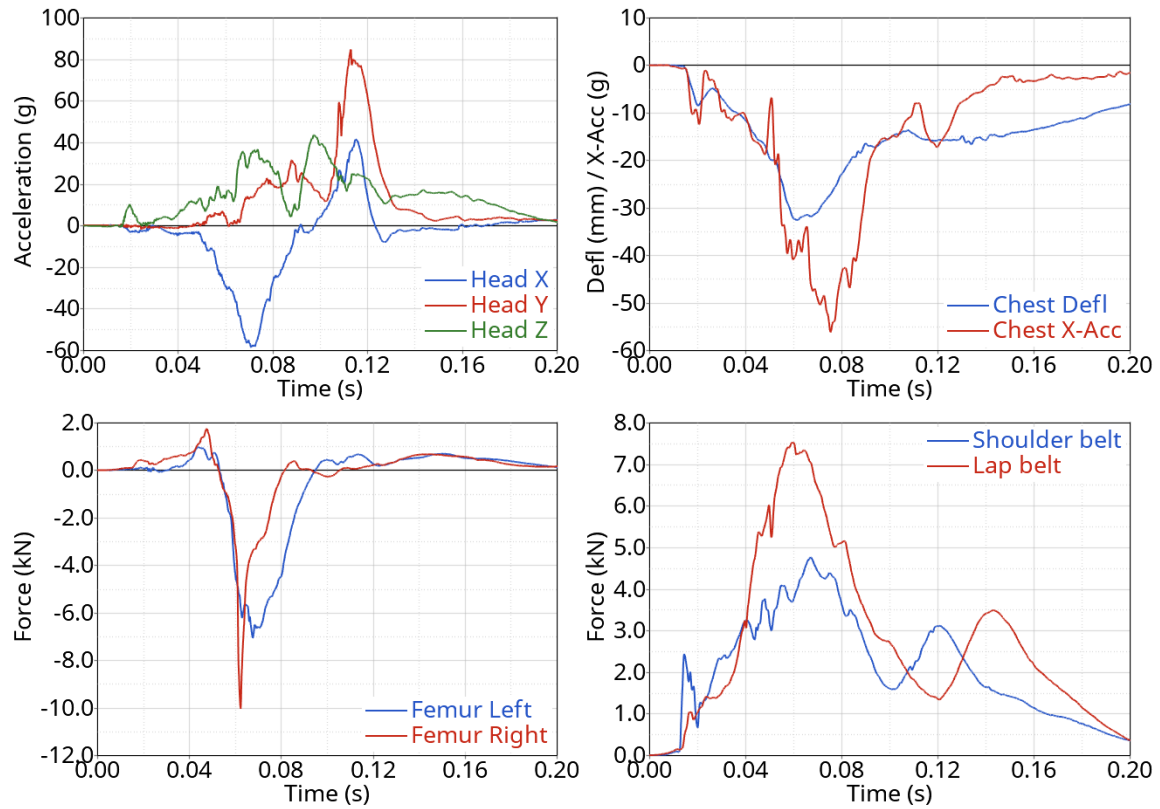
The HIII 50M dummy in the driver position experienced considerable loading with several injury criteria exceeding the proposed performance limits. The head, chest, and lower extremities all had weak to poor injury ratings, shown in Table 1, compared to the Euro NCAP criteria proposed in [16]. Time-history data of the HIII head and chest accelerations, chest deflections and femur forces together with seat belt forces are shown in the Appendix A: Figure A1.

Figure A1. HII head accelerations (upper left), chest deflections and accelerations (upper right), and femur forces (lower left). Car seat belt forces (lower right).
