FIREWORTHINESS OF CABIN EXHAUSTER VENTS AND THE EFFECT OF AGEING

Christopher Clarke
Brian Herbst
Lauren Bell
SAFE
USA

Jack Bish
SAFE Laboratories
USA
Paper Number 23-0324

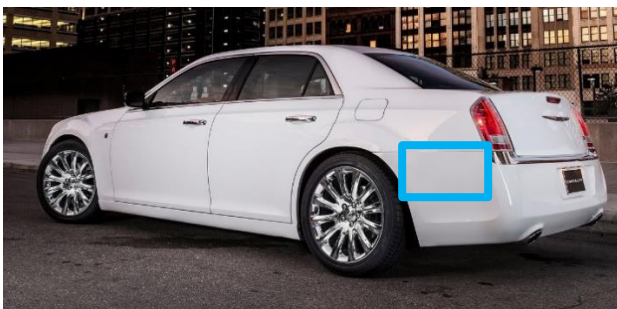
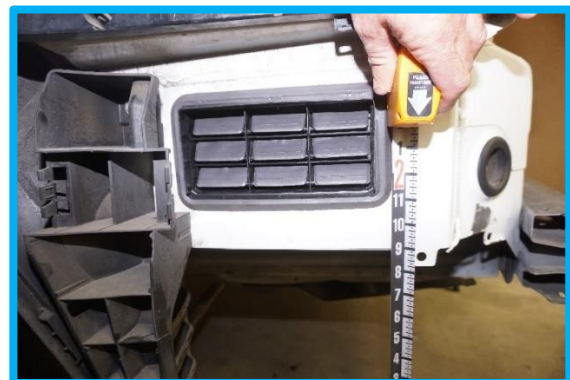
Figure 1: Cabin Exhaust Vent

Numerous real world post-collision fire incidents have been analyzed in which it was determined that fire propagated into the occupant compartment through exhauster vent openings in the body sheet metal. Exhauster vent openings are among the largest openings found in body panels, rivaled only by openings in the cowl for the HVAC air intake. In addition, exhauster vents are typically located low on the vehicle where they are exposed to pool or underbody fire scenarios. Because of their exposed location and construction with combustible materials, exhauster vents are not well suited to protect the large openings they occupy in the body structure.

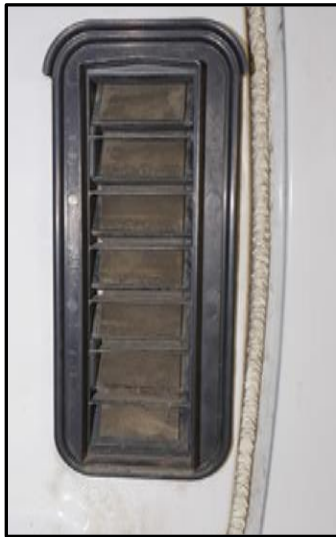
Aged Vent from 18 Year Old Exemplar Cab

Burn testing was conducted to evaluate the fire resistance of the vent design used on a domestic pickup cab using gasoline in a burn pan positioned underneath the exhauster vent. An exemplar cab was obtained from a vehicle that was approximately 18 years old at the time of the test. The aged vent in this cab was subjected to testing. In addition, a new OEM vent was subjected to burn testing in a sheet metal bench testing fixture configured in a manner consistent with the portion of the cab where the vent is installed. The setup for each test is shown in Figure 7. It was noted that the design of the new OEM replacement vent had changed compared to the vent from the 18 year old exemplar cab. While both vents were designed to fit the same opening, the new OEM vent had fewer flaps.

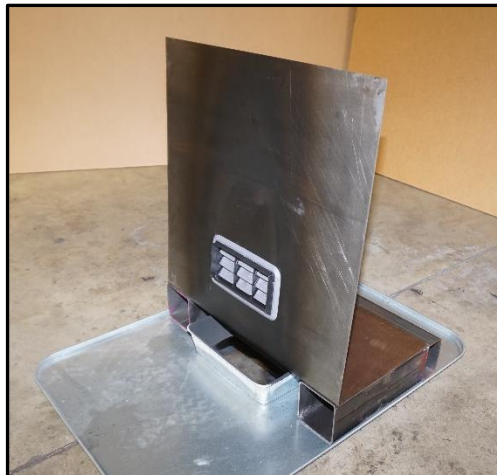
Figure 14: Test Setup

Improved vent designs were fabricated and subjected to burn testing in a benchtop fixture similar to the one used in Test Series 3. A new OEM replacement vent of the same design evaluated in Test Series 3 was also tested in order to establish a baseline level of fire resistance. For each test, a tray containing a quantity of gasoline sufficient to burn for approximately 20 minutes was ignited underneath the vent.

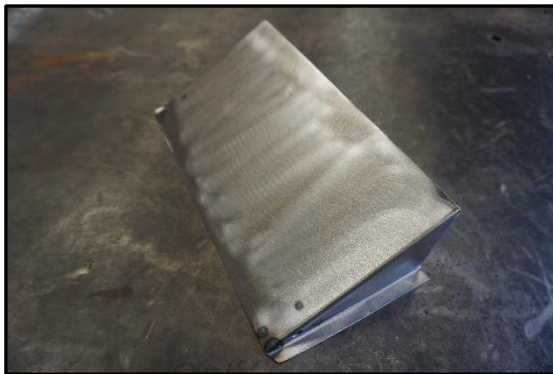
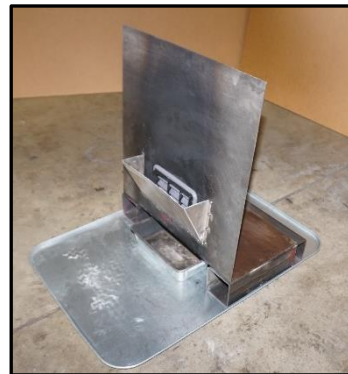
Figure 16: Improved Design – Diverter Shield

A diverter shield was constructed and fitted to the test fixture, shown in Figure 16. The shield was approximately 3 inches wider and 2 inches taller than the OEM vent assembly, and extended from the surface of the test fixture at its base to approximately 3 ½ inches away from the test fixture at its top.

A new OEM vent was fitted in the test fixture behind the diverter shield and subjected to burn testing. As the test progressed, some smoke was observed to emanate from the interior side of the vent but it did not ignite. At approximately 285 seconds, the plastic vent assembly had melted to the extent that it fell into the interior side of the test fixture. However, it did not ignite. An elastomeric flange from the exterior side of the vent remained in place, stuck to its original position on the exterior side of the opening in the fixture. This flange eventually caught fire and fell away from the opening, propagating the fire to the inside of the vent opening. At approximately 522 seconds, the body of the vent on the inside of the test fixture was observed to have ignited. Figure 15 shows the progression of the test.

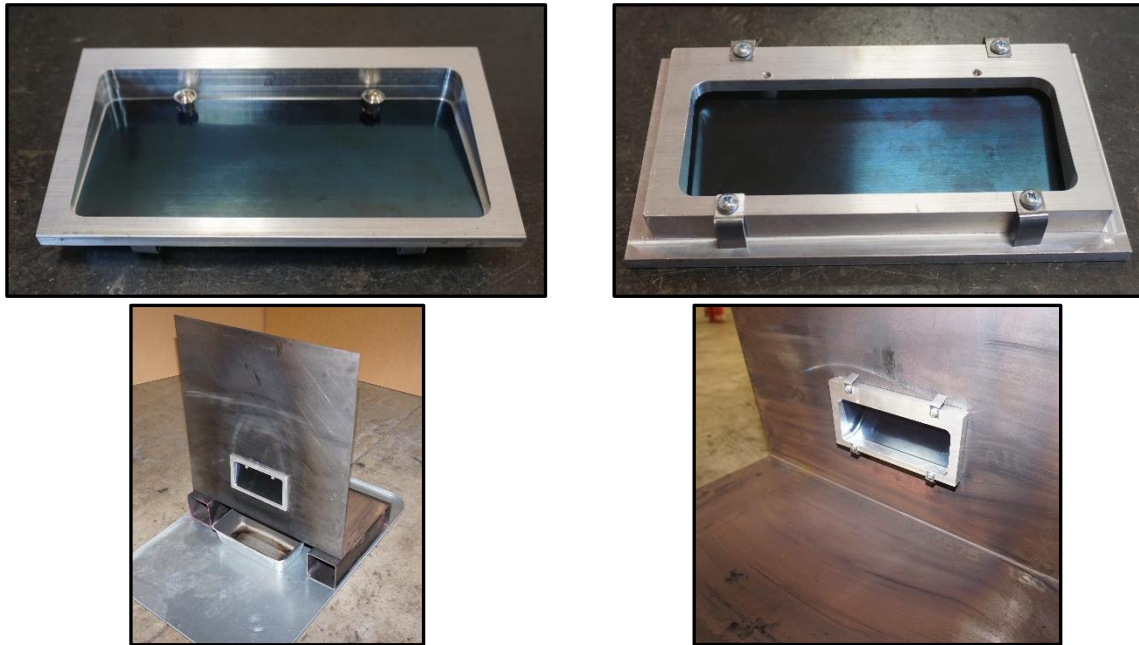
Figure 18: Improved Design – Metal Vent Assembly

An all metal vent assembly was fabricated and subjected to burn testing. The vent was designed to fit the same opening as the production OEM vents tested previously. The vent assembly was constructed with a machined aluminum housing, and a single flap made of thin steel was attached to the top of the housing at two pivot points as shown in Figure 18.

The all metal vent assembly was installed in the test fixture and subjected to burn testing. The vent assembly remained intact during the test and did not ignite. Some slight warping of the flap was observed during the test. The gasoline burned out after approximately 20 minutes. Figure 19 shows the beginning of the test and shortly before the gasoline burned out.
