# WORLD SID-50M FITNESS ASSESSMENT IN FMVSS NO. 214 MOVING DEFORMABLE BARRIER AND OBLIQUE POLE CRASH TESTS

**Whitney Tatem**  
**Allison Loudon**  
NHTSA  
USA

Paper Number 23-0340

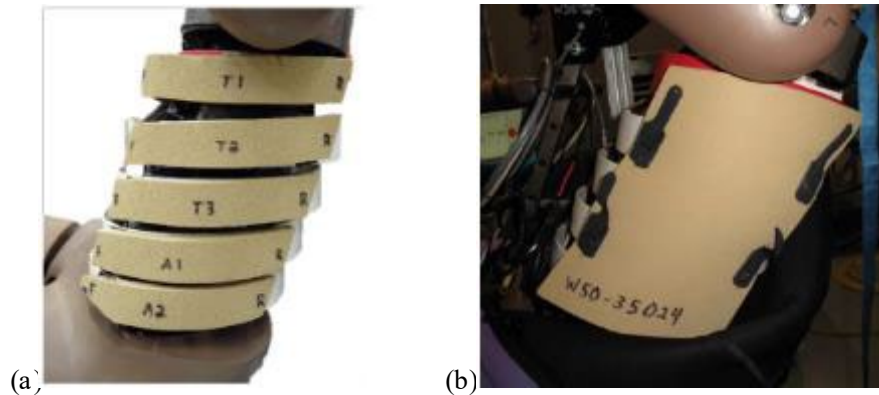
The original WorldSID-50M build has a single thorax pad between the outside of the ribs and jacket. Because NHTSA witnessed these pads tearing during evaluation testing, it was thought that it would be beneficial to split the single pad into pads for each individual rib as depicted in Figure 4(a). The split pad design was used in the first sixteen crash tests of this series. In parallel, a new probe face was developed within the ISO WorldSID 50<sup>th</sup> Task Group for qualification testing. This development proved to significantly reduce the risk for tearing of the single thorax pad during qualification tests, which had been impetus for developing the split pad concept. With the new probe face greatly alleviating pad durability concerns, NHTSA chose to revert to the original one-piece thorax pad as depicted in Figure 4(b), harmonizing with the ISO group. The last two tests of the series were conducted with this single pad design.

*Figure 4. WorldSID-50M (a) split and (b) single thorax pads.*

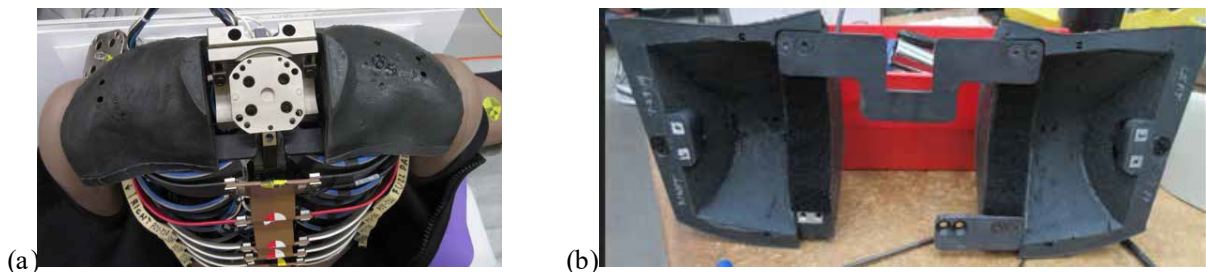
The original design of the WorldSID-50M shoulder pad by Humanetics was a soft vinyl and foam pad. During testing in 2016 with the original foam shoulder pad and RibEye, it was observed that the shoulder pad would protrude into the shoulder rib cavity during impact causing shoulder LED blockages. Therefore, prior to this series of testing, a new shoulder pad designed by VRTC (Figure 5) with a similar footprint but hollowed-out underside, with stiffening qualities that prevent it from being pushed into the shoulder rib cavity of the ATD was developed, tested, and evaluated by NHTSA in the 2018-2019 R&R crash test series.

*Figure 5. Top (a) and bottom (b) view of VRTC's prototype WorldSID-50M shoulder pad design.*

For this crash test series, in the first few crash tests, VRTC's prototype design was used with a screw attachment at the shoulder rib. However, during the test series, it was noted that the aluminum screw mounting blocks molded into the shoulder pads were tearing out of the pads during testing. Therefore, the design was modified mid-series with a minor change where the screw was replaced by a single pin at the shoulder rib clamp. This new design was implemented to improve the ease of use of the shoulder pads, along with improving the durability of the shoulder pads.

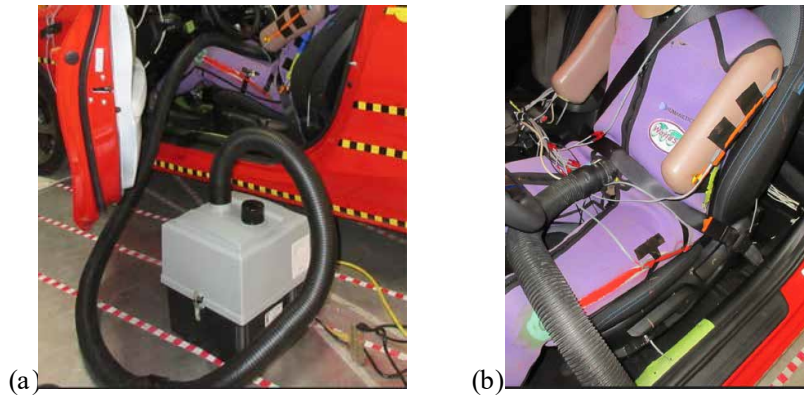
**Figure 9. The implemented ATD fume extractor, shown (a) outside of a test vehicle and (b) with its connection to the WorldSID-50M.**

The Hyundai Veloster pole test, 11604, was the first test that the fume extractor was used in to cool down the WorldSID-50M following trigger check. It was extremely effective in cutting down the time required for the ATD to cool down. On subsequent tests, including 11606 as seen in Figure 10, the fume extractor was implemented whenever there was any sort of delay with the ATD DAS turned on. As displayed in Figure 10, the final switching ‘ON’ of the DAS unit occurred ~3:37pm, and the fume extractor was activated ~4:00pm. This prevented the rib temperature (dashed blue line) from exceeding the limit, also preventing any additional temperature related delays. Throughout the remainder of the test series, this device demonstrated good effectiveness at reducing the WorldSID-50M internal temperature in a short period of time.

Without any countmeasures, when the temperature exceeds the limit, it is advisable to delay the test until the temperature drops back below the threshold, if feasible. To reduce the amount of time needed for the WorldSID-50M to cool down, and to prevent it from overheating in the first place, a fume extractor<sup>7</sup> was used in many of the remaining crash tests to cool and maintain the internal ATD temperature pre-crash, as depicted in Figure 9. This device provides air movement, forcing the hot air out of the ATD via a suction hose that is easily inserted into the suit opening below the abdomen ribs. Subsequently, cool ambient air is pulled through existing openings in the suit around the neck and arms, over the spine box, RibEye controller, and ribs.

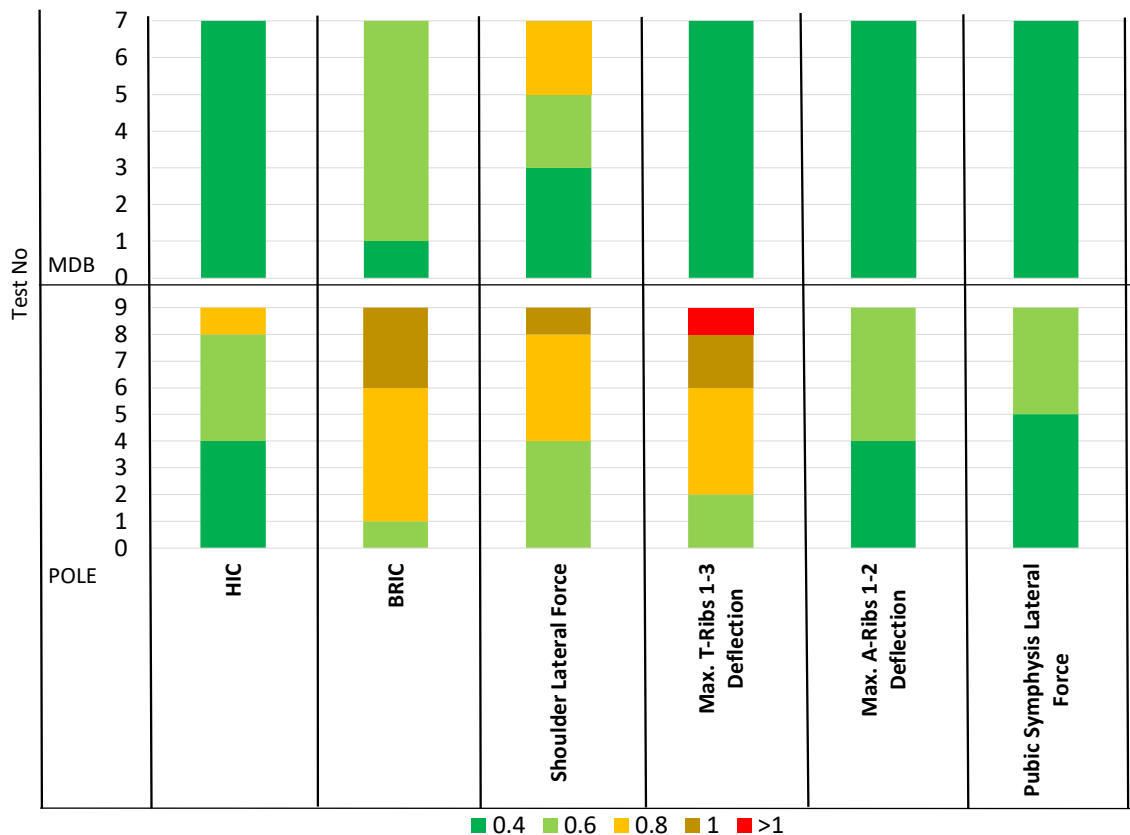
Figure 12 displays the degree to which the various body regions of the WorldSID-50M were exposed to injurious conditions. In both crash configurations, each body region had at least a couple moderate-risk exposures. By considering Figure 12, it can be concluded that the pole tests were universally more injurious. While maximum thoracic rib deflection was the greatest injury metric in pole tests, the maximum lateral shoulder force was greatest in the MDB tests. In both crash configurations, the pubic symphysis lateral force yields a comparatively low injury metric to all others.

Despite numerous moderate- to high-risk crash test exposures, none of the WorldSID-50M sustained irreparable damage. Therefore, this crash test series demonstrates how the WorldSID-50M can sustain the rigors of current FMVSS No. 214 crash testing.

Figure 12. WorldSID-50M: Comparative injury metrics by exposure.

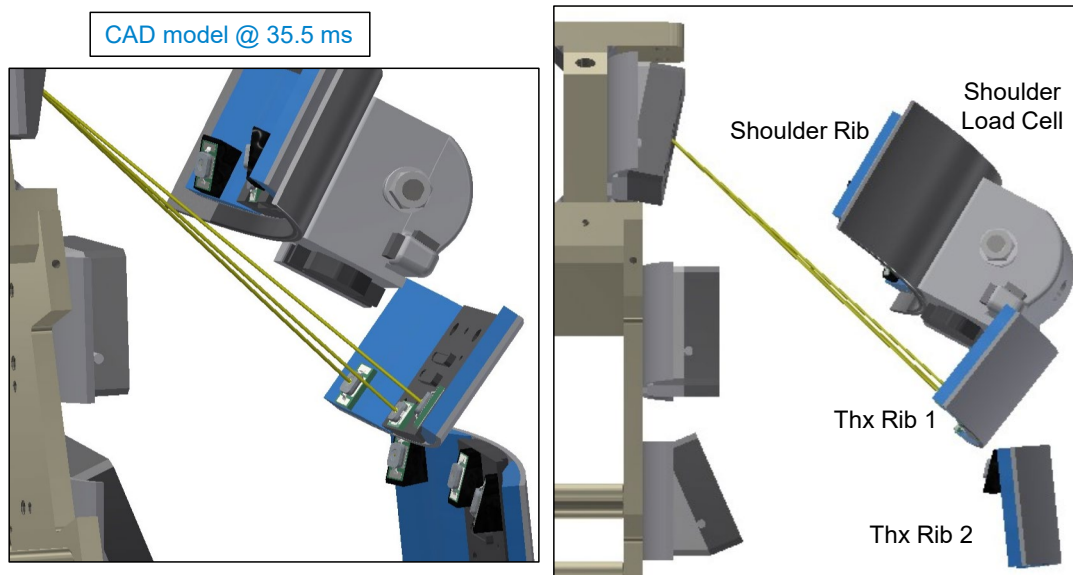
Once this adjustment was made, test 11656 was conducted as a repeat of the right-side pole test on a 2019 Mini Cooper S convertible with the updated LED locations. An identical 2019 Mini Cooper Convertible was used with all the test setup parameters matching the previous test as closely as possible. Thorax rib 1 did not record any error codes in the repeat pole test, and the thorax rib 1 LEDs were clearly visible to the top sensor, as depicted in the below rendering (Figure 17). By overlaying the rib deflection data of these two tests, it was confirmed that the rib response was nearly identical. Therefore, it can be concluded that the relocation of the thorax rib 1 LEDs resolved the blockage that occurred in the first Mini Cooper test, and the maximum thorax deflection was successfully recorded in the repeat test.

**Figure 17. 3D CAD model of the rib motion during crash test 11656 in which the LEDs on thorax rib 1 are visible to the top sensor at maximum deflection.**

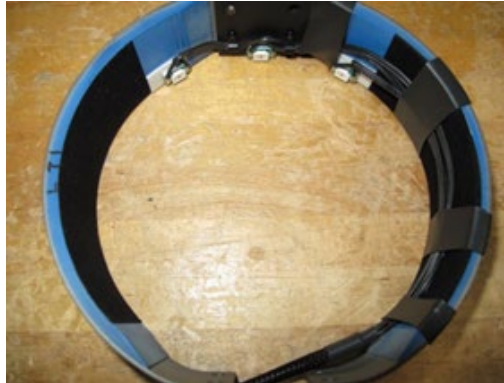
After this test, the RibEye LED locations were further refined to allow for more deflection of the adjacent ribs where blockages might occur. In this iteration, the LEDs on both thorax rib 1 and abdomen rib 1 were moved to the bottom of the rib from center as depicted in Figure 18. The LEDs were also all rotated to be oriented horizontally rather than vertically. To evaluate these LED location adjustments, the 2020 Toyota Tacoma and 2020 Kia Soul were selected

***Figure 18. LEDs on thorax rib 1 of the WorldSID-50M after relocation from the centerline to the bottom edge where all the LEDs are horizontally oriented (view is looking down onto the top of the rib).***

In the tests of these vehicles – 14356 and 14355, respectively – the maximum deflection of the thorax and abdomen body regions were recorded successfully. Relocation of the LEDs on thorax rib 1 and abdomen rib 1 allowed for more clearance and movement of the shoulder rib and thorax rib 3 to prevent LED blockages. These results serve as preliminary validation of the RibEye LED relocations. More RibEye evaluation is underway to further support these updates.
