## STATUS OF NHTSA MOTORCOACH SAFETY PLAN

National Highway Traffic Safety Administration  
United States

Paper Number: 09-0448

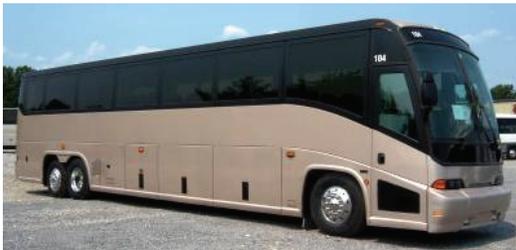
The agency conducted a crash test in December 2007 at the NHTSA Vehicle Research and Test Center in E. Liberty, Ohio (Test # 6294 in NHTSA Vehicle Crash Test Database). Figure 1 shows the motorcoach used in the test. It was a 2000 MCI 102EL3 Renaissance with a Series 60 diesel engine and B500 Allison Automatic transmission. The coach was 45 ft long, 12 ft 6 inches tall, with 54 seats (34 inches apart longitudinally). The weight as tested (including dummies and equipment) was 42,720 lbs.

**Figure 1. Motorcoach Used for Crash Test**

The coach had unbelted seats from American Seating Co, seats with 2 and 3-point belts from Amaya/Fainsa and a seat with 3-point belts from Freedman Seating Co.

The crash test speed was 30 mph (48.3 kph) into a fixed rigid barrier at 0 degrees, full overlap condition. The test collected data from 355

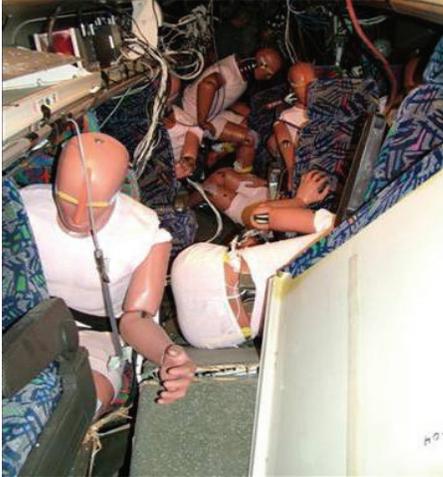
the floor attachment. This unoccupied seat had unbelted 50th M and 95th M in the row behind it. Baseline seats and the Freedman seat had bent/broken seatbacks when impacted by unbelted dummies in the seat behind it. Figure 3 is an image from the crash test.

**Figure 3. Belted Dummies (on left) Remained in Their Seats; Unbelted Dummies (on right) Did Not.**

Unbelted dummies typically made head contact with the seatback in front within 150-180 ms. The unbelted dummies in the aisle seat ended up in the aisle, while those in the window seat ended up in the row in front or on the floor.

Structurally, all seats remained attached to the bus at all seat anchor locations. One baseline (unbelted) seat had a failure of the seat frame at

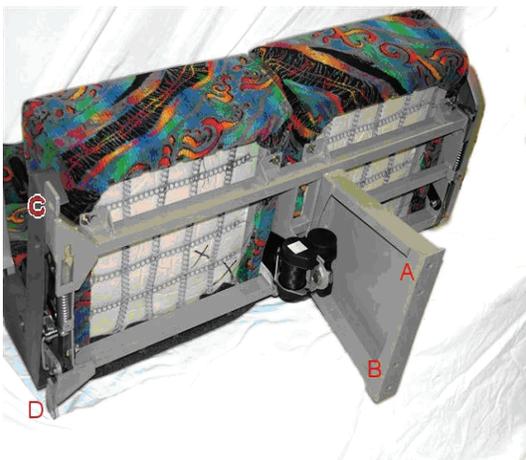
Each seat was attached at 4 locations; 2 on the floor, and 2 on the side. These are marked in Figure 6 as locations A, B, C, D, respectively. For the sled test program, the center row seat was mounted at the 4 locations with rigid attachments with 3-axis load cells. Forces in 3 directions were measured at each of the seat anchor locations.

**Figure 6. Motorcoach Seat Anchor Locations**

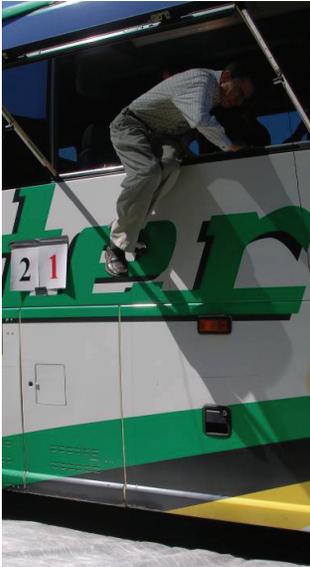
passengers have the strength and agility to open the windows and climb out, and if methods of holding the windows open are available as shown in Figure 7.

**Figure 7. Window Emergency Egress with Support Mechanism**

Some of the preliminary findings [NHTSA, 2009] from the testing and literature review are: the front access door of the motorcoach is the fastest and safest path of egress; the time required for passengers to determine how to open the front access door (in those cases where the motorcoach operator is unavailable) can take longer than the time required for a full load of passengers to evacuate through the door; conspicuous placement of the service door interior release mechanism and operational instructions are critical for passengers; able-bodied bus passengers are capable of egressing through a rear side door without steps (such as a wheel chair access door) at a rate that would allow evacuation of a fully loaded motorcoach in less than three minutes; the time to evacuate a fully loaded motorcoach through emergency exit windows is less than two minutes provided that
