# STUDY OF IMPROVED SAFETY FOR MINIBUSES BY BETTER SEAT AND OCCUPANT RETENTION

TRL Ltd  
United Kingdom  
Paper Number 01-S9-334

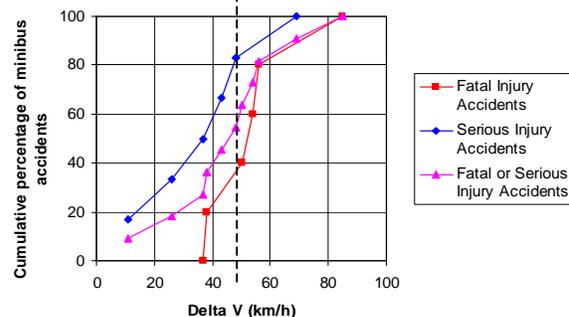
**Figure 1. Cumulative percentage of accident severity by change in minibus speed**

These data have been used to plot the cumulative percentage of minibus accident according to the most serious occupant injury severity against the change in

minibus speed at first contact (delta V), see Figure 1.

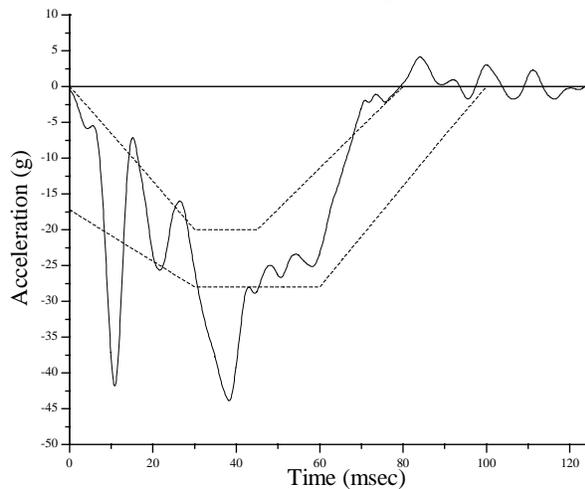
**Figure 2. Full scale crash test results overlaid with ECE Regulation 44 crash pulse**

One full-scale minibus crash test was found which matched the most common impact condition, identified above, of 100% overlap. This was a Ford Transit minibus crash test conducted at TRL. The vehicle, a 1983, 12 seat Ford Transit (line built), was subjected to a perpendicular impact into a large concrete block, with full overlap at a speed of 49.5 km/h (30.9 mph). Figure 2 shows the time history for that test from the fore and aft accelerometer mounted on the B post.

accelerations due to it forcing all the stiffest frontal structures to deform. In a minibus to other vehicle impact these stiff structures are likely to deform slightly less because they are likely to penetrate the other vehicle. Taking these considerations into account it was concluded that the acceleration time history from this full-scale test would be suitable for developing a crash pulse. Ideally it would be preferable to test a range of different makes of minibus against cars and heavy vehicles to select an average or a worst case acceleration time history. However, taking into account the accuracy with which the delta V value could be established from accident data the results from this one vehicle model are thought to be acceptable. Therefore, the sled crash pulse for tests of minibus shells in this project was based around the acceleration performance of the Ford Transit to concrete block tests illustrated in Figure 2.

For a sled test some simplification of the acceleration pulse is acceptable to take account of the nature of sled arresting systems and the frequency response of seatbelt systems. In addition, a tolerance is required to make reasonable allowances for the test to test variations common to sled test systems. Both of these requirements are normally taken into account by providing "a crash pulse corridor." Sled test regulations were examined for guidance on this and it was noted that the ECE Regulation 44 pulse (Economic Commission for Europe, 1998) (for testing child restraint systems) has the same test velocity, and an acceleration history similar to, but slightly lower than, the average level of acceleration found in the Transit test. Figure 2 shows the Regulation 44 crash pulse corridor overlaid on the full-scale crash test result. It was decided to use this corridor for minibus sled tests in this research programme.

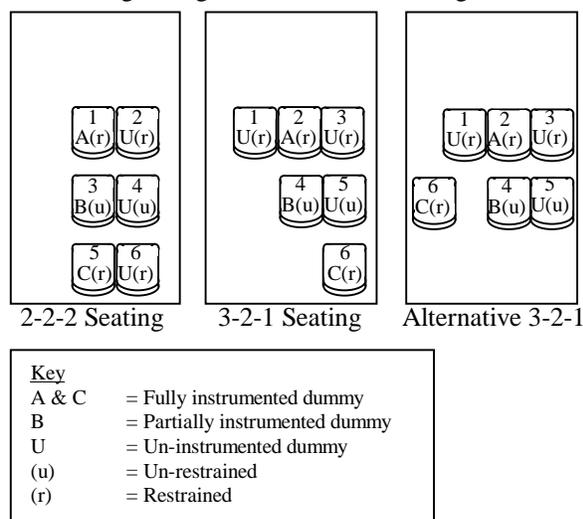
**Figure 3. Plan view of the seating arrangements used in the sled tests**

In each of the sled tests performed, a total of six passenger seats were fitted into the minibus shell in two or three rows. The seat rows were made up of single, double and triple seat units. The exact seat arrangement depended on the seat plan of the minibus concerned. For the vehicles tested there were three basic seating configurations as shown in Figure 3.
