THE SIGNIFICANCE OF ISOFIX IN REDUCING MISUSE -ANALYSIS OF POTENTIAL ON THE BASIS OF FIELD OBSERVATIONS AND SLED TESTS

GDV Institute for Vehicle Safety, Munich
Germany

Paper Number 495

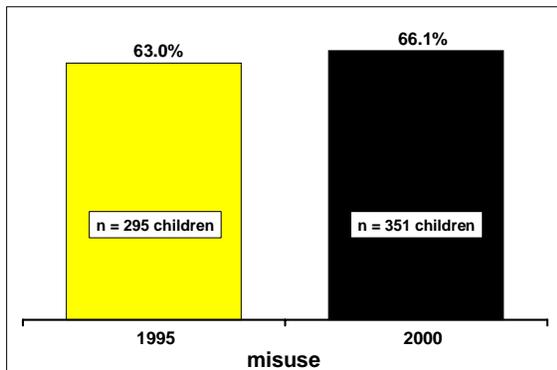
Figure 4. Frequency of misuse – comparison of the 2000 and 1995 studies

In the 2000 study, the percentage of children secured incorrectly, or in a restraint system that was not correctly installed in the vehicle was 66.1%. This absolute "misuse frequency" value was thus approximately 3% higher than the frequency observed in the 1995 study (Figure 4).

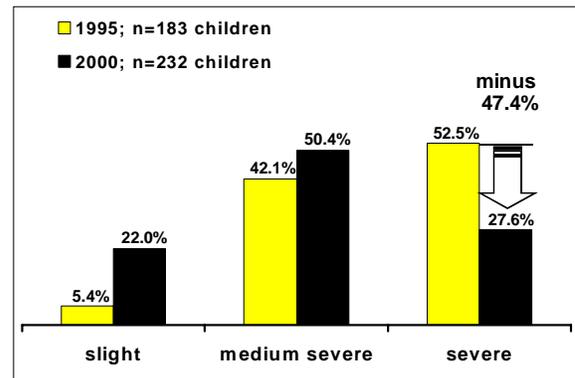
Figure 5. Severity of misuse - comparison of the 2000 and 1995 studies

The study carried out in 1995 showed that almost half of all handling errors fell into the "severe misuse" category because these errors resulted in the greatest impact on the level of protection. Figure 5 shows that fortunately the proportion of severe handling errors has dropped by 47.4% since the 1995 study. This means that although the actual frequency of occurrences of misuse remains at an unchanged high level, there was however a considerable improvement

in the quality of installation and restraint as can be seen by the reduction in the number of severe errors.

As shown in Figure 5, the tendency shown by the current study was towards "medium severe" misuse with a value of 50.4%, followed by severe misuse (27.6%) and slight misuse (22.0%). Looking at the differences in results according to system types (Figure 7) clearly shows that systems which require

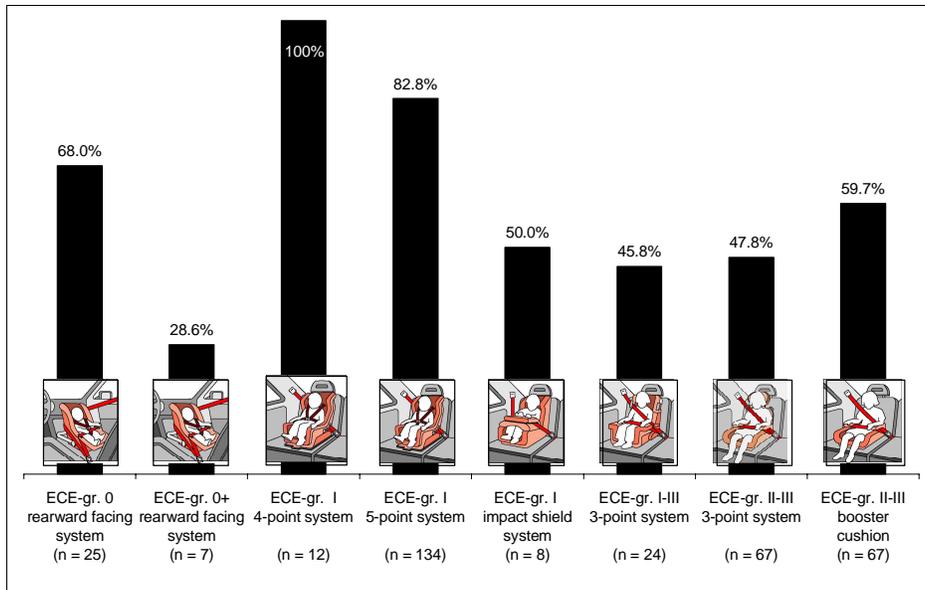
Figure 6. Misuse rates for the various types of system
Only systems with a sufficient number of cases (n>5) are shown here

The misuse rate provides information on the extent to which at least one handling error occurred for each system type. Handling errors here refer to both the incorrect installation of a seat or to the incorrect restraint of a child in a seat. Figure 6 is an overview showing the number of seats of each system type investigated in the study and the rate of misuse that was observed for each of these systems. The highest rates of misuse were found for the 4 and 5 point harness systems of Group I with values of 100% and 82.8% respectively, followed by the rearward-facing systems of Group 0 with 68% and the booster cushion systems of Groups II-III with a value of 59.7%. The rates for the more recently introduced Group 0+ systems were considerably lower with values of 28.6%, and 45.8% and 47.8% for the 3 point harnesses of Groups I-III and II-III respectively. The impact shield systems of Group I showed a rate of 50%.

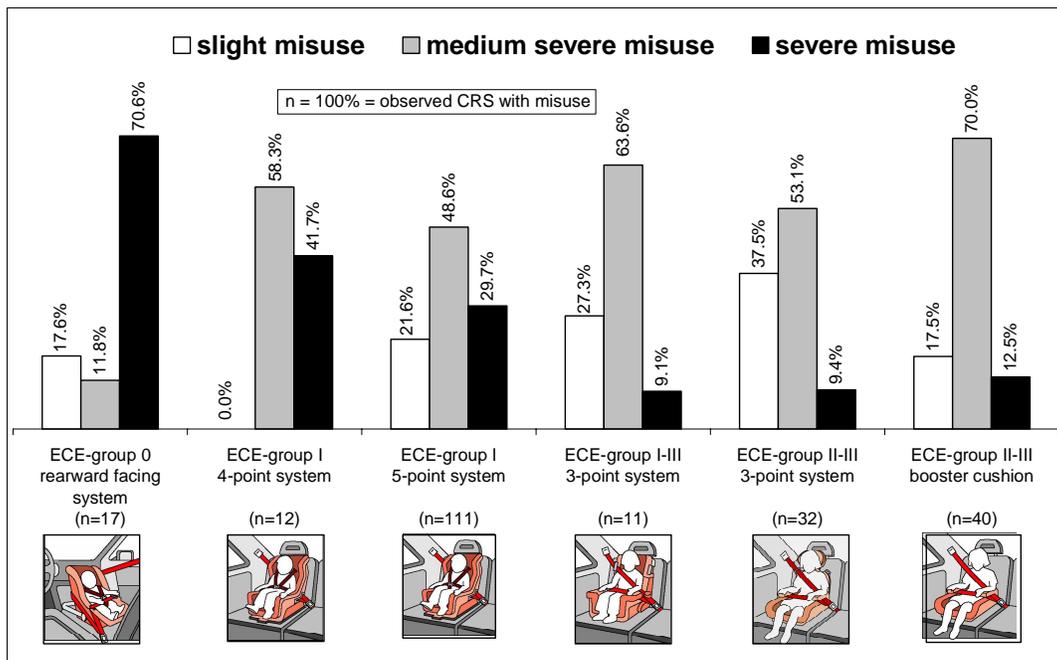
Figure 7: Misuse severity for the various types of system
Only systems with a sufficient number of cases are shown here

two separate processes to install the seat and to secure the child lead to more frequent occurrences of serious misuse. This rate is particularly high for the rearward-facing systems of Group 0, namely 70.6%, and for the 4/5 point harness systems which are 41.7% and 29.7% respectively.

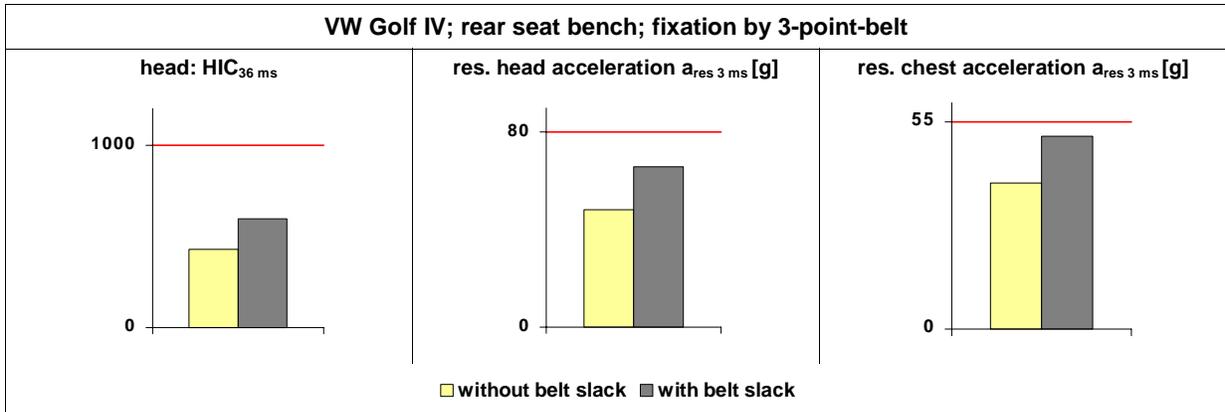
Figure 8. Rear seat of a VW Golf IV: 3-point belt attachment with and without belt slack

In 1999, the IFM performed sled tests [12] to study the consequences of a loosely installed seat with a view to the biomechanical loads (for limits see Table 2) exerted on the restrained child. An impact shield system was installed both correctly and incorrectly (with 75 mm belt slack) using a three-point seat belt in a real car body (VW Golf IV) mounted on a deceleration sled. The measurement data presented in Figure 8 indicates that the dummy loads in the misuse tests were approx. 30–40% higher than with correct installation.

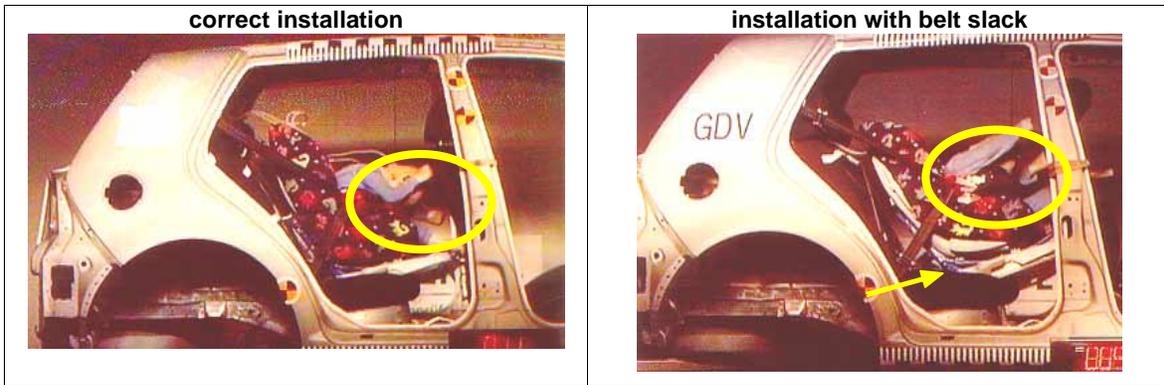
Figure 9. 3-point belt attachment: a comparison of "correct" and "incorrect" attachment

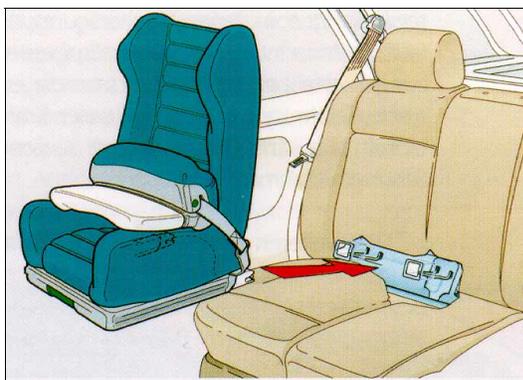
Figure 10. Schematic illustration of a 2-point ISOFIX system (source: VW/Audi)

The CRS is firmly anchored in the motor vehicle by two anchorages which are 6 mm thick, spaced 280 mm apart and located in the seat bight. When installing the seat, two snap fasteners located on the CRS connectors snap around these anchorages and firmly bolt the seat to the vehicle (Figure 10). In the event of an accident, this form of attachment enables immediate, controllable participation of the CRS in the deceleration of the vehicle.

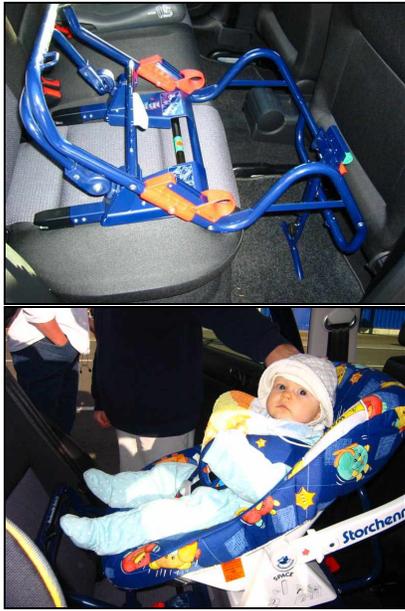
Figure 11. ISOFIX frame with baby shell seat (Group 0+)

In order to obtain current and realistic results, IFM carried out another ISOFIX installation study in 2002. Now for the first time, it was possible to test commercial series production seats that use the ISOFIX system. The seats used in the survey were 2 point ISOFIX harness systems which meet the ISO standard 13216 from May 1999. The ISOFIX seats made available by German child restraint manufacturers were installed and tested in a midsize family car. The car had been equipped as standard with ISOFIX anchorage points on both outer rear seats and the ISOFIX seats had the vehicle-specific approval required for use. The ISOFIX seats were, 1) a Group 0+ rearward-facing seat, made up of a ISOFIX frame and a shell seat (Figure 11) and 2) a Group I forward-facing seat with harness system and integrated ISOFIX (Figure 12).

ISOFIX seat (Group 0+) – This seat was a combination seat made up of an ISOFIX frame and a baby shell seat. The two items are installed separately. The ISOFIX frame differs from the Group I ISOFIX seat in that the locks do not operate separately. Instead, they operate synchronously and the frame does not have to be pressed into place subsequently. Of the 20 installation attempts carried out, all test persons were able to successfully install the seat, and on only two occasions was a second attempt necessary (Figure 14). When compared to the Group I seat, the fundamentally different construction (separate locking compared to coupled locking) meant that the functionality of ISOFIX must be seen as better. All attempts to install the seat were tested by checking correct locking using the status display, and a tug test on both sides. The deinstallation/removal of the ISOFIX frame was considered difficult (requiring a relatively high degree of strength) by 10% of test persons.

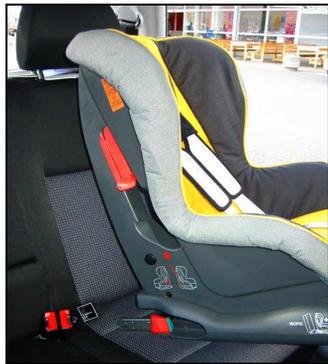
Figure 12. Group I seat with integrated ISOFIX

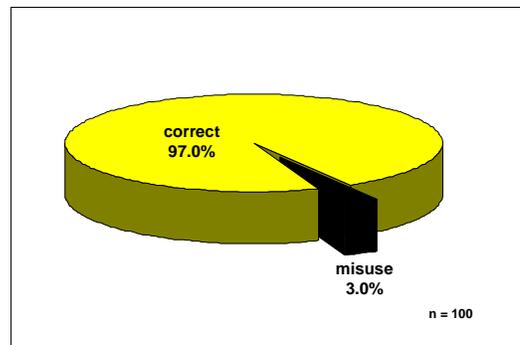
Figure 13. Frequency of installation errors made when using the ISOFIX, Group I seat

Figure 13 shows that 97% of test persons installed the ISOFIX seat correctly. Only 3 of 100 installations showed instances of misuse; in one case the test person was unable to lock the system into place, and in two cases only one side locked. At this point we should also mention that in 14 instances the installation of the seat was not successful at the first attempt. This indicates that the functionality of ISOFIX could still be improved in a way that would do even more justice to the "click and go" claim. It would also appear that the principle of individual locking hinders simple and instantaneous locking. Apart from the instances in which misuse was observed, the locking was checked using the status display and a subsequent tug test. When it came to pressing the seat into place, however, the test persons were not so diligent, and in seven instances, the seat was not pressed into place and in eleven instances this was not carried out to a sufficient degree. In a real life situation, this can lead to a risk of reduced

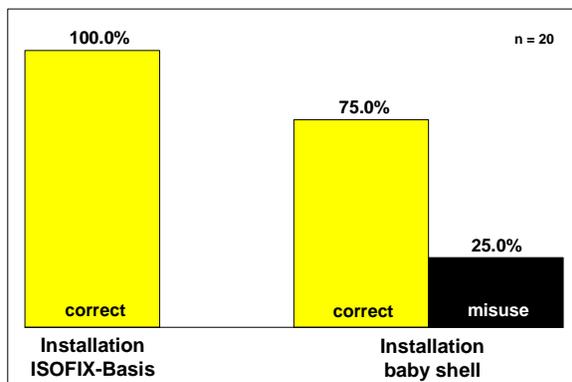
Figure 14. : Frequency of installation errors; ISOFIX frame and baby shell seat Group 0+

As Figure 14 clearly shows, the installation of the baby shell seat proved more difficult and resulted in misuse in 5 instances (25%) of 20. The reasons for this were, in one case that the shell seat was not attached, and in two cases that it was not locked into place. On two further occasions the shell seat was neither attached nor locked into place. In the event of a collision taking place, errors of this nature would lead to a serious risk of injury to the child and, in a worst case scenario, would result in a complete lack of protection. Here the manufacturers of child seats need to implement better thought-out concepts in order to preclude all possible handling errors.

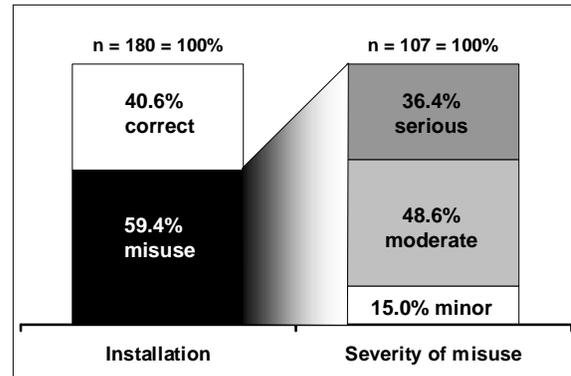
Figure 16. : Proportion of misuse when installing seats and severity of this misuse

As can be seen from Table 1 (on page 5), installation misuse only occurred with system types where installation and securing are carried out as two separate procedures. This refers to the rearward-facing systems of Groups 0, 0+ and 0/I and the 4/5 point harness systems of Group I. Figure 16 shows the levels of installation misuse observed for these system types. Almost 60% of child seats that require a separate installation were not installed correctly. 85% of these errors were of the medium severe or severe categories. Of the 107 CRS installations where misuse occurred, the most frequent error with a value of 78.5%, was of the type "loose seat attachment", followed by "incorrect belt route" and "incorrect installation direction" at 11.2% and 4.7% respectively. Exactly how these installation errors affect the loads exerted on dummies was tested during the sled testing which was carried out as part of the BASt study [6, Chap. 5.3]. The forward displacement as well as the load placed on the head and chest of the dummies were, in part, considerably higher than the relevant reference values. In the event of an accident taking place, this would result in a considerable reduction in the level of protection afforded to the child. Even in the event of an accident

with a severity lower than is simulated in testing for ECE-R 44, these installation misuses could lead to severe/life-threatening injuries for the child. The results that have been gathered by this study clearly indicate the extent to which installation misuse can be eliminated by the use of ISOFIX.

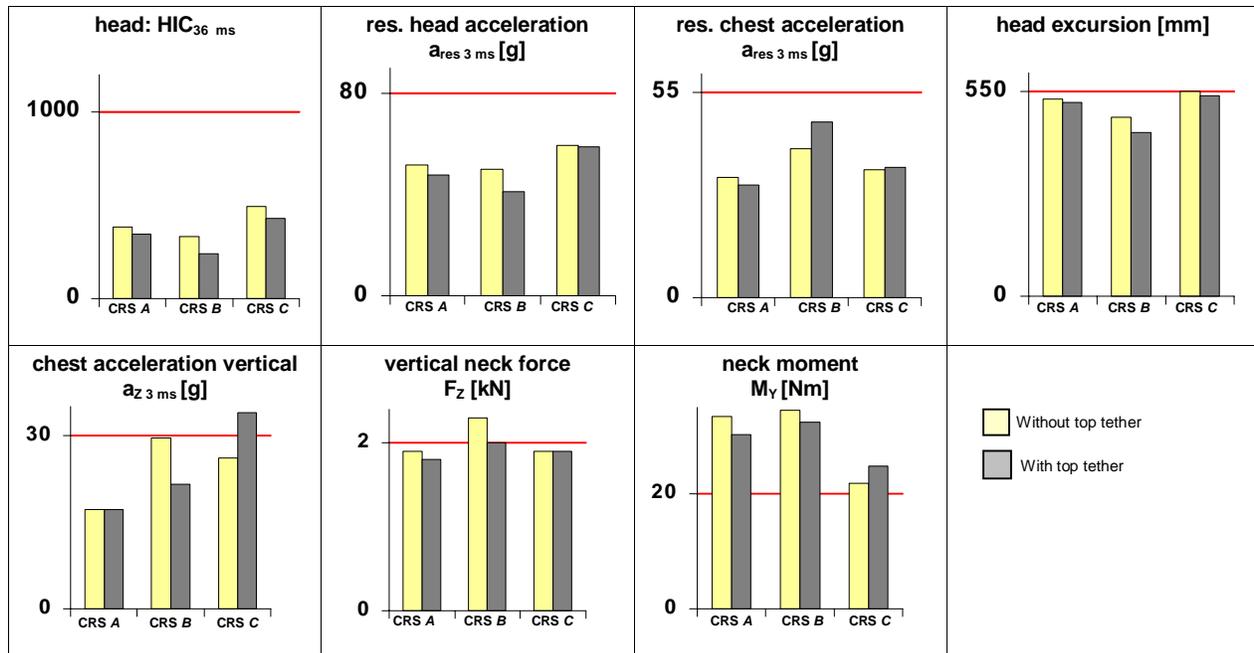
Figure 17: Results of measurement with and without top tether

In order to test the effects of the top tether system, the IFM carried out a further series of tests [17]. In this series, three different ISOFIX seats (CRS A, CRS B, CRS C) were tested with and without the a top tether in a real vehicle chassis (BMW 3 Series) in accordance with FMVSS 213. The measured values, as shown in Figure 17 indicate that the use of a top tether has no real effect on the biomechanical loads. Both the loads exerted on the head ($HIC_{36\text{ ms}}$ and $a_{\text{res } 3\text{ ms}}$), and the chest acceleration remained below under the legal limits regardless of the type of installation. The differences between an installation using a top tether and a pure ISOFIX installation were within the measuring tolerances. The vertical chest acceleration ($a_{z\ 3\text{ ms}}$) also showed that the use of a top tether did not reduce the loads. Indeed, in one case, the use of a top tether even led to the legal limits being exceeded. The vertical forces on the neck are almost identical for both types of installation. The legal limit was only exceeded by the model "CRS B without top tether", but even with the top tether this particular model was at the upper limit.

Regardless of the installation method, the measured neck moment was considerably greater the reference value for all three models (Table 2). Further development is still required here.
